**Contract No.: CV/2021/09  
Handling of Surplus Public Fill  
(2022-2023)**

**TSEUNG KWAN O AREA 137 FILL BANK**

**MONTHLY EM&A REPORT NO.16**

**(APRIL 2023)**

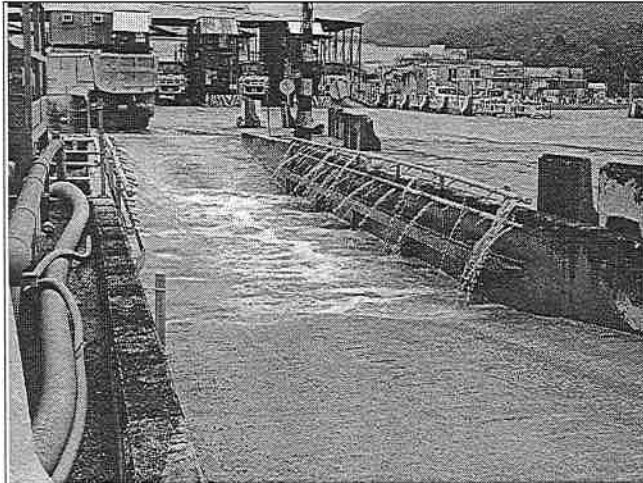
Photo 230404\_001

Item	Details of defective works or observations	Proposed Follow Up Action	Photo Ref.	Further Action Required (Yes/No)	Follow up Date
1	The water in car washing bay should be replaced.	To replace the water properly	230404_001	Yes	2023-04-12
2	Oil drum should be removed from soil platform.	To remove the oil drum properly	230404_002	Yes	2023-04-12
