PROJECT PROFILE

CLP Power Hong Kong Limited
中華電力有限公司

TETRA Radio Base Station at Kai
Kung Leng, Lam Tsuen Country Park,
Yuen Long, New Territories

September 2010

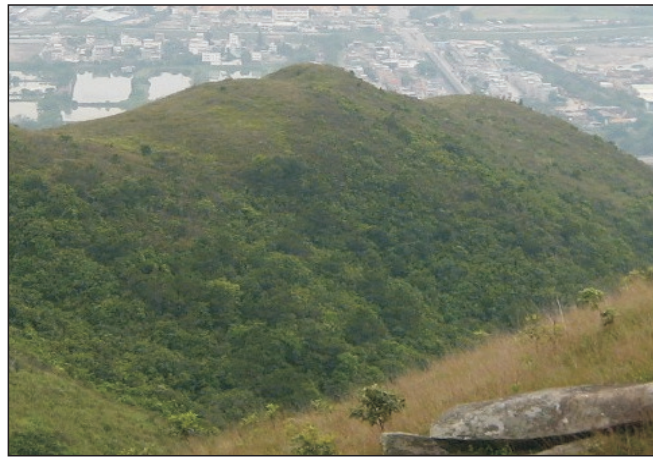
Young Woodland (Study Area)
幼樹林 (研究範圍)

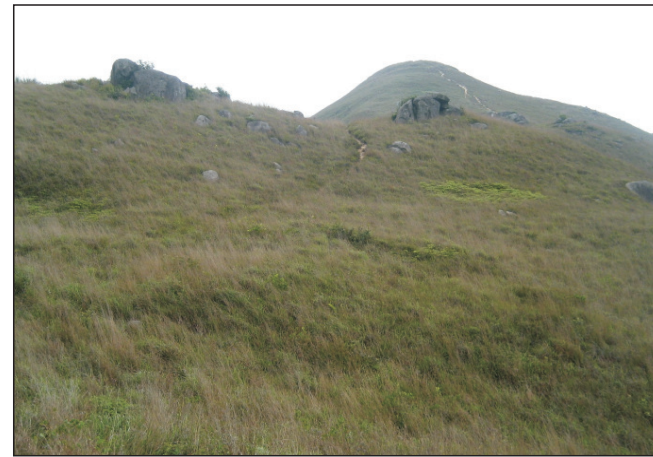
Habitat	Area	Ecological Value	Note
Grassland	49.6 ha	Low	Grassland was dominated by a few very common, native species including the herb <i>Arundinella setosa</i> , the shrub <i>Baeckea frutescens</i> and the fern <i>Dicranopteris pedata</i> . Although <i>Baeckea frutescens</i> when fully grown is considered a shrub, plants found were young. Since almost no other woody species were found in this habitat, it was termed grassland. No plant species of conservation interest were recorded in the grassland.
Developed Area	~83 m ²	Low	Developed area consisted of the existing transposer station. No plant species of conservation interest were recorded in the developed area.
Project Site (Grassland)	~18 m ²	Low	Like the rest of the grassland in the Study Area, the Project Site was dominated the very common, native species, <i>Arundinella setosa</i> , <i>Baeckea frutescens</i> and <i>Dicranopteris pedata</i> . Neither rare protected nor plant species of interest were recorded in the site.

Grassland (Study Area)
草地 (研究範圍)

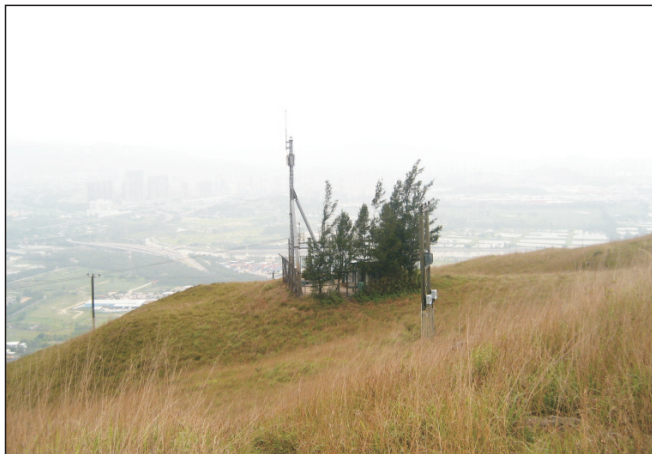
The Project Site is located within an area shown as grassland on the habitat map in *Figure 4.1* and has the same characteristics as the grassland habitat in the Study Area. No rare or protected plant species were found within the Project Site and it is considered to be of low ecological value. The habitat within the Project Site area and on the immediately adjacent land has been slightly modified by the existing TVB transposer station, situated just northwest of the Project Site.

Overview of Project Site
工程項目地點概覽

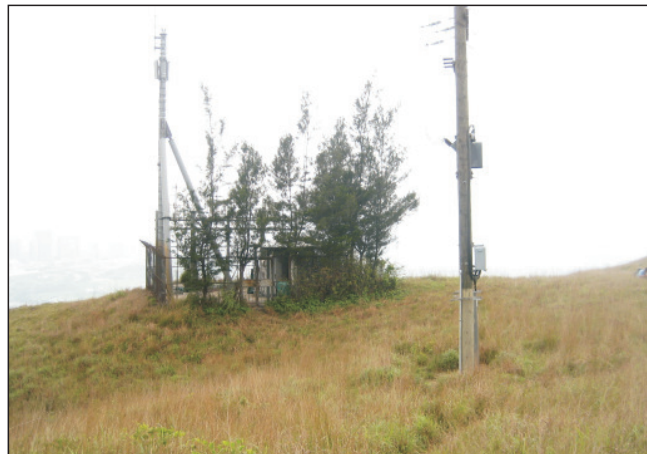
The developed area in the Study Area was made up of the area occupied by the existing TVB transposer station and accounted for approximately 0.01% of the whole Study Area. Several individuals of exotic Horsetail Tree (*Casuarina equisetifolia*) were planted along the boundary of the station as a visual mitigation measure (see *Figure 4.2*). Overall, developed area is considered to be of low ecological value.

Developed Area – Existing Transposer Station
已發展地區 – 現有電視轉播站

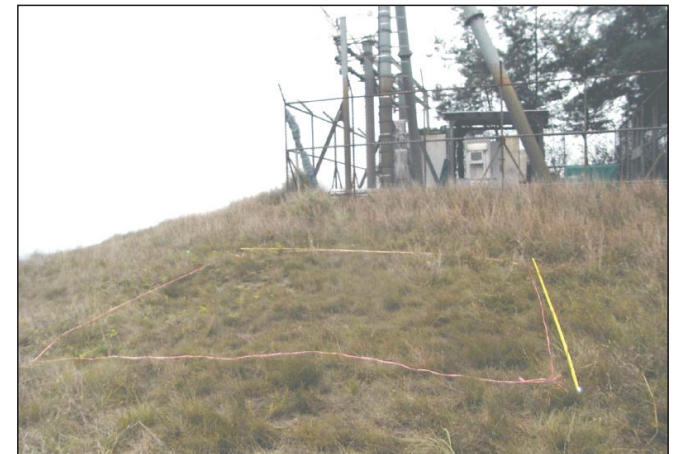
Grassland (Project Site)
草地 (工程項目地點)

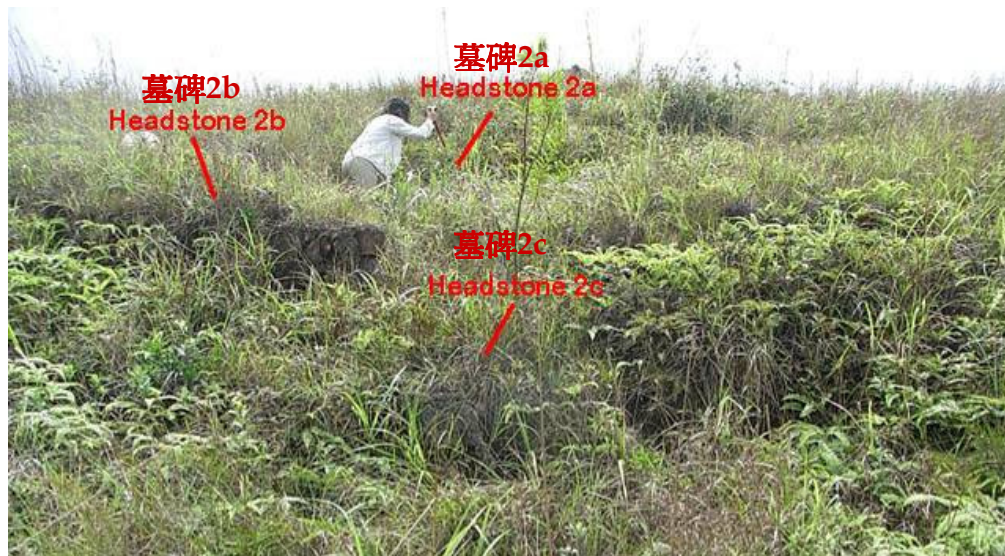
<p data-bbox="550 795 702 862">Headstone 2b 墓碑2b</p>	  <p data-bbox="1069 817 1220 884">Headstone 2c 墓碑2c</p>	
<p>Architectural Appraisal 建築評估:</p> <p>This Man clan grave is in the shape of a horseshoe and mostly overgrown with vegetation. Its size is approximately 5.5m (L) x 3m (W) x 2m (H) and finished with cement. There is a dug pit in front of Headstone 2a. It is believed that the remains have been removed.</p> <p>這個墳墓呈馬蹄形(長約5.5米、闊3米和高2米)，表面為水泥，墳墓大部份被植物包圍著。在墓碑2a前面有一個坑，相信此墳墓的遺體及遺物均已被移走。</p> <p>three headstones were identified at the grave. Headstones 2a and 2c are observed to be oriented towards the northwest and Headstones 2b was observed to be oriented towards the southwest.</p> <p>在此墳墓發現三個可辨認的墓碑。墓碑2a及2c面向西北，而墓碑2b則面向西南。</p>		
<p>Existing Condition: Poor 現狀: 惡劣</p>		
<p>Past and Present Uses: 過往及現在用途:</p>	<p>Grave 墳墓</p>

General View of the Grave G2
墳墓G2的位置及附近環境

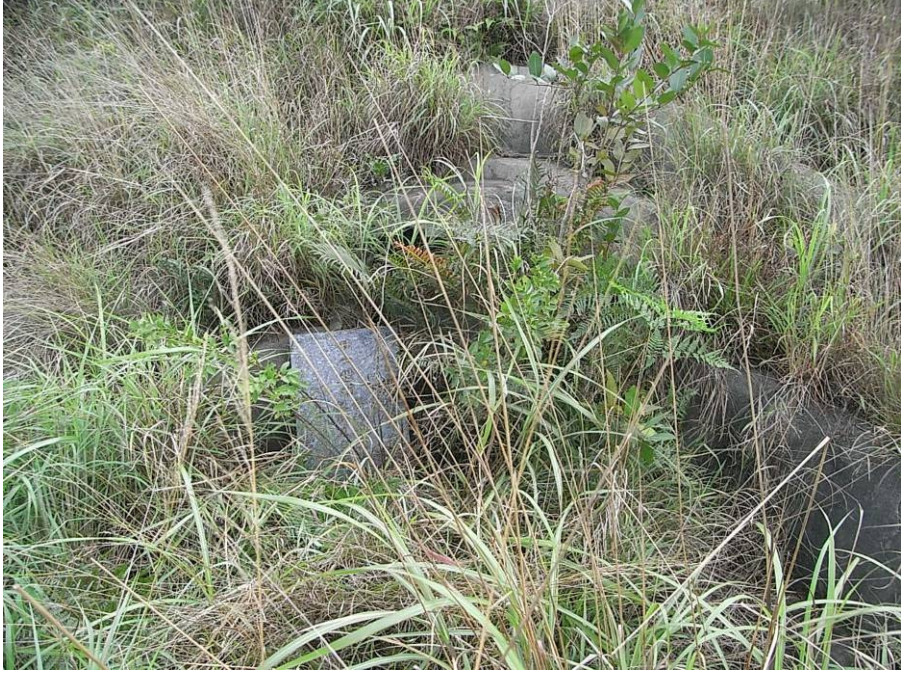
Architectural Appraisal 建築評估:	A grave is overgrown with vegetation. The size of the grave is approximately 2.5 (L) x 1.5cm (W) x 1m (H). 此墳墓被植物包圍著。此墳墓長2.5米、闊1.5米和高1米。		
Existing Condition: 現狀:	Poor 惡劣		
Past and Present Uses: 過往及現有用途:	Grave 墳墓

Feature Code: G3 項目編號:	Feature Name: Man (文) Clan Grave 項目名稱: 文氏祖墳
Notes on any Modifications: 改建評論:	The grave was renovated in 1979 and the remains appear to have been removed. 此墳基於1979年復修，遺體及遺物看似已經被移走。
Photographic Records 相片記錄:

<p style="text-align: center;">General View of the Grave G3 墳墓G3的位置及附近環境</p>

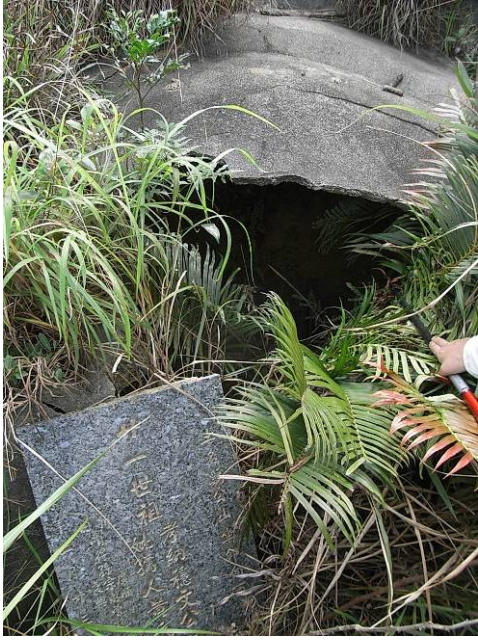
<p style="text-align: center;">The remains appear to have been removed. 遺體及遺物看似已被移走。</p>

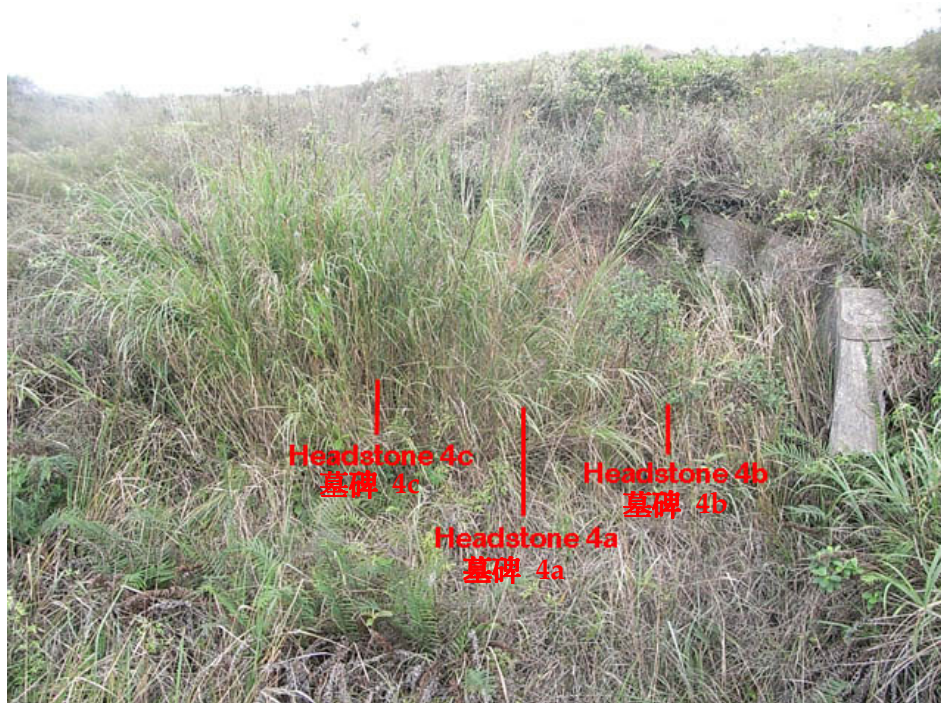
Existing Condition: Poor
現狀: 惡劣

Notes on any Modifications: The grave was renovated in 1921.
改建評論: 此墳墓於1921年復修

General View of Grave G4
墳墓G4的位置及附近環境

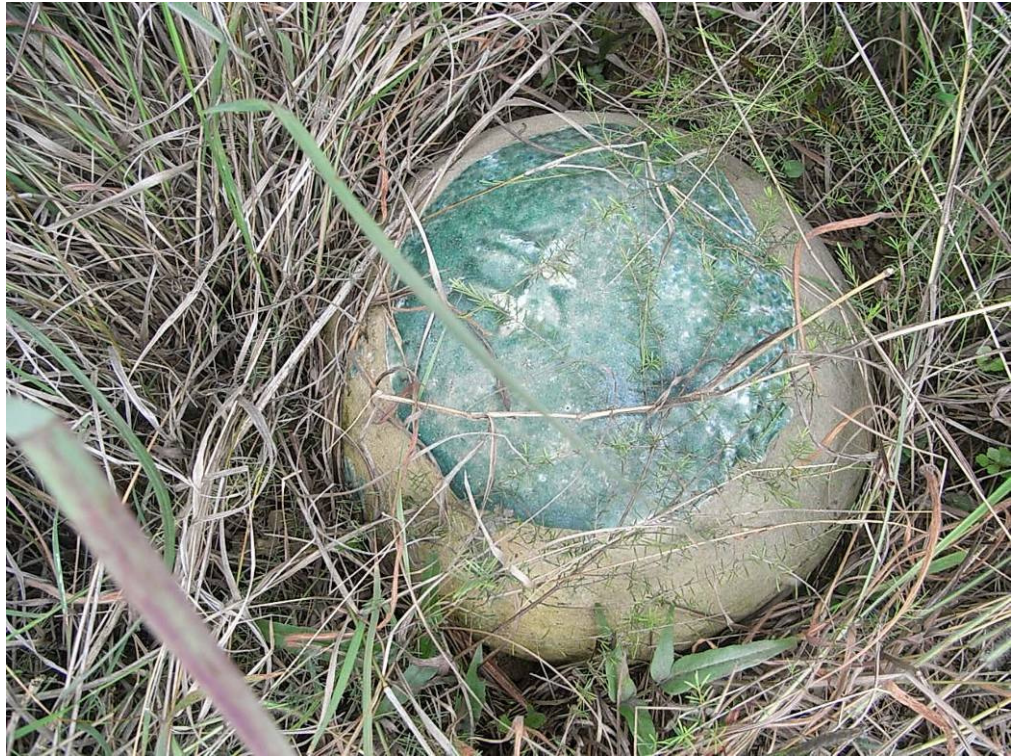
Lid of the urn exposed on the ground
露出地面的骨灰甕蓋
