Replacement of the Existing 11kV Submarine Cable Circuit Connecting Liu Ko Ngam and Pak Sha Tau Tsui at Kat O

Project Profile

30 May 2013
2013年5月30日

Environmental Resources Management

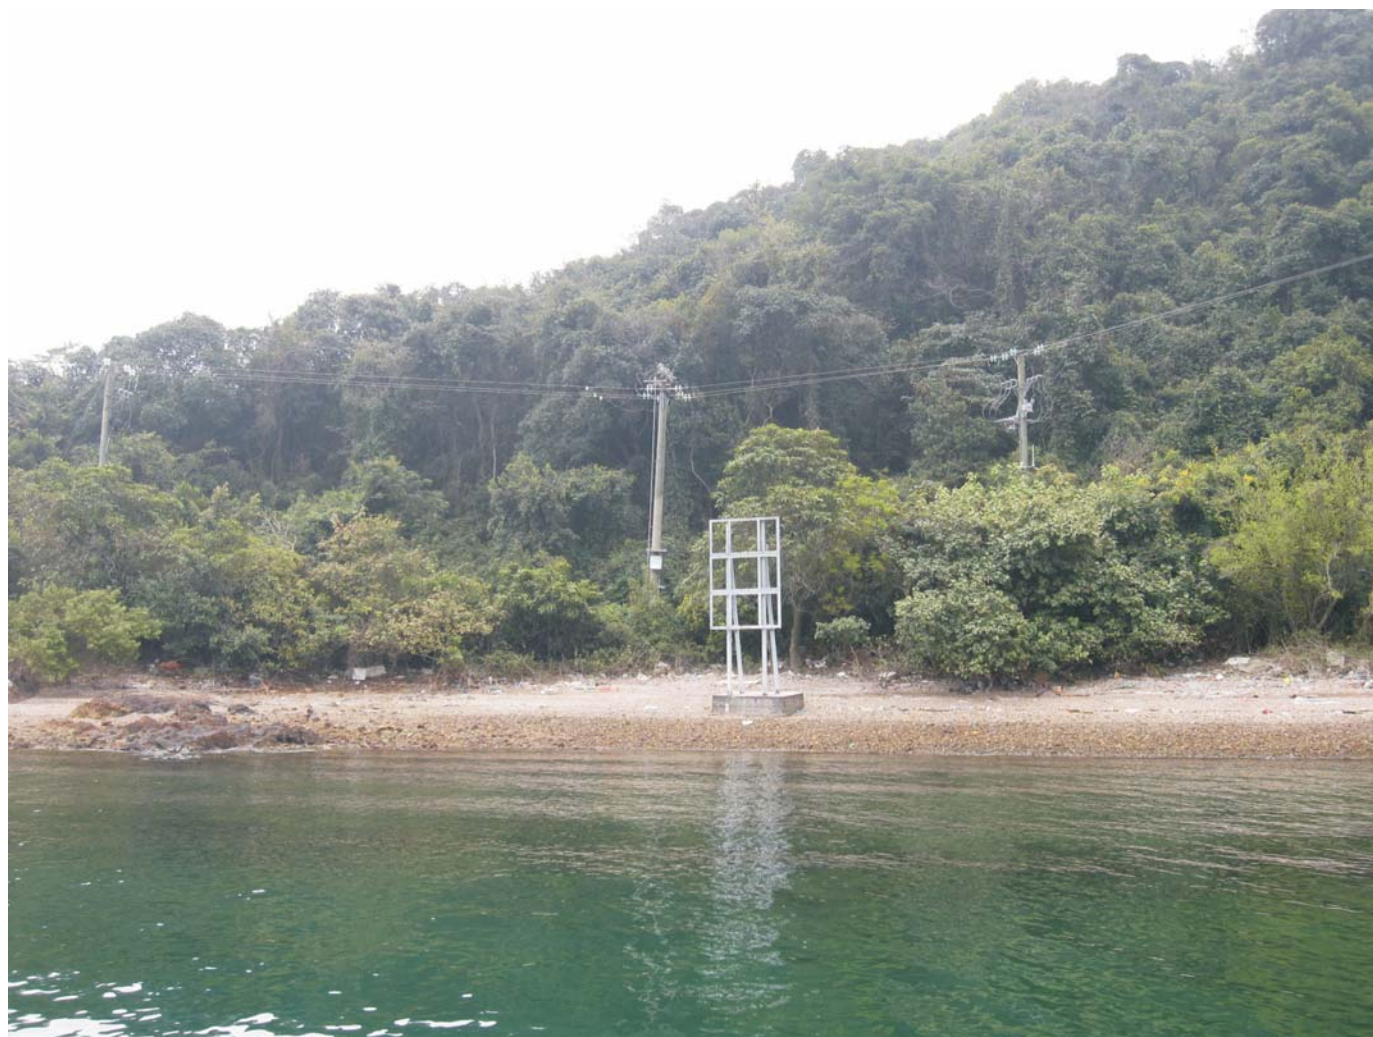
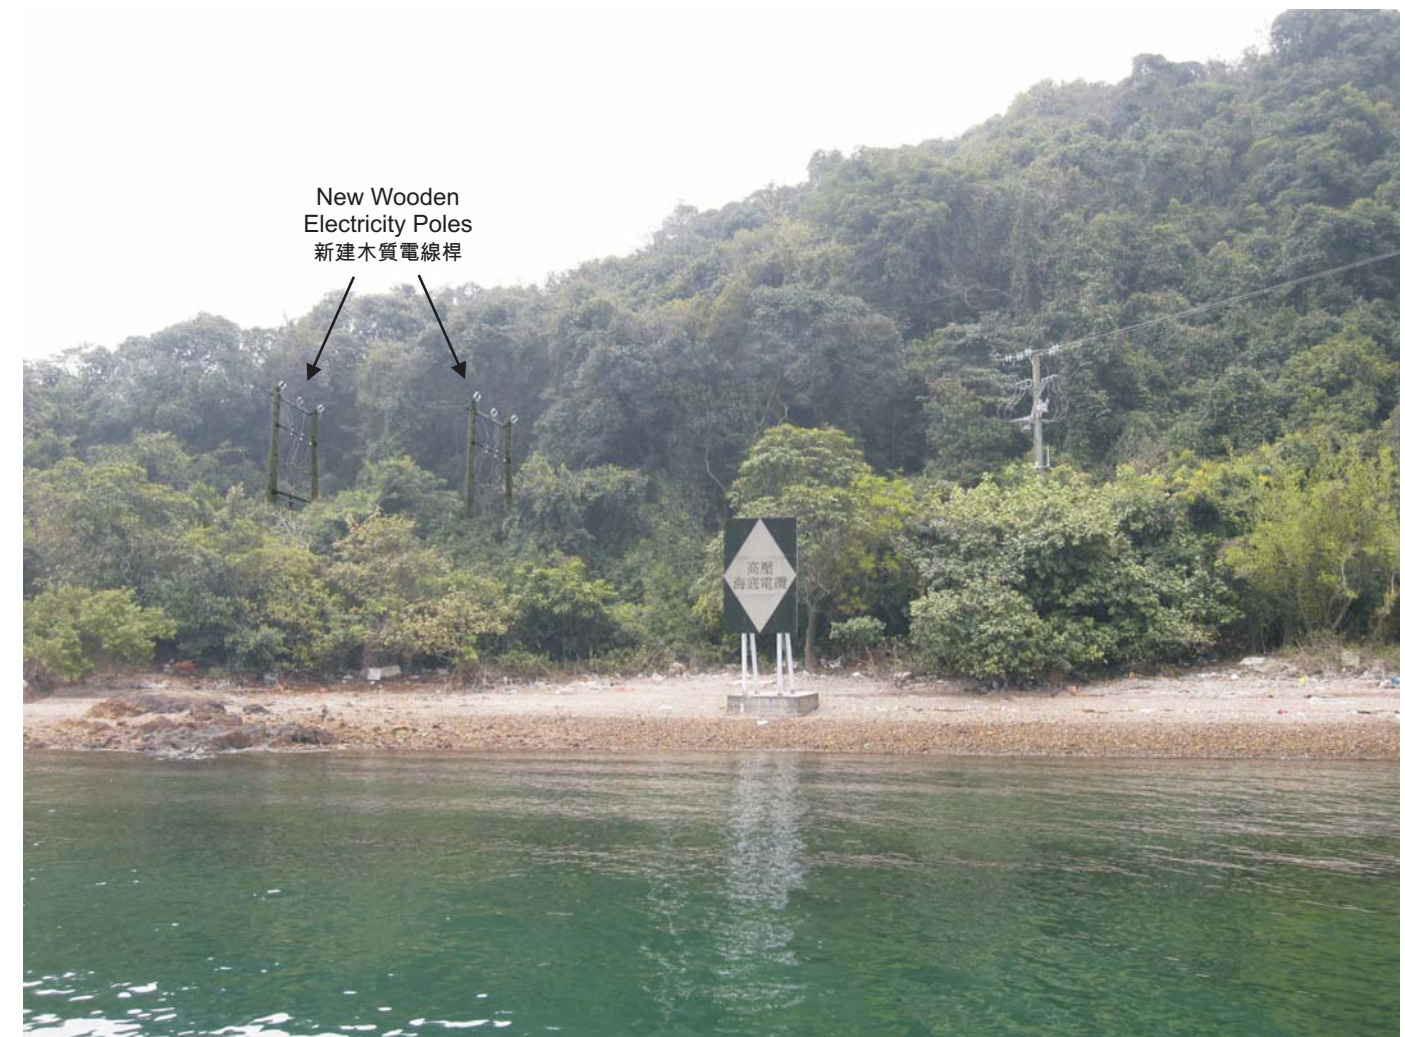
Figure 4.3
圖 4.3

Photomontage showing the Site Before and After the Construction at Liu Ko Ngam
顯示了哥岩登岸地點在施工前和施工後情況的合成照片

Ngam and Pak Sha Tau Tsui landing sites from the sea in *Figures 4.3 and 4.4* respectively. With minimal change to transient views of occasional visitors, the visual impact of the Project will be minimal.

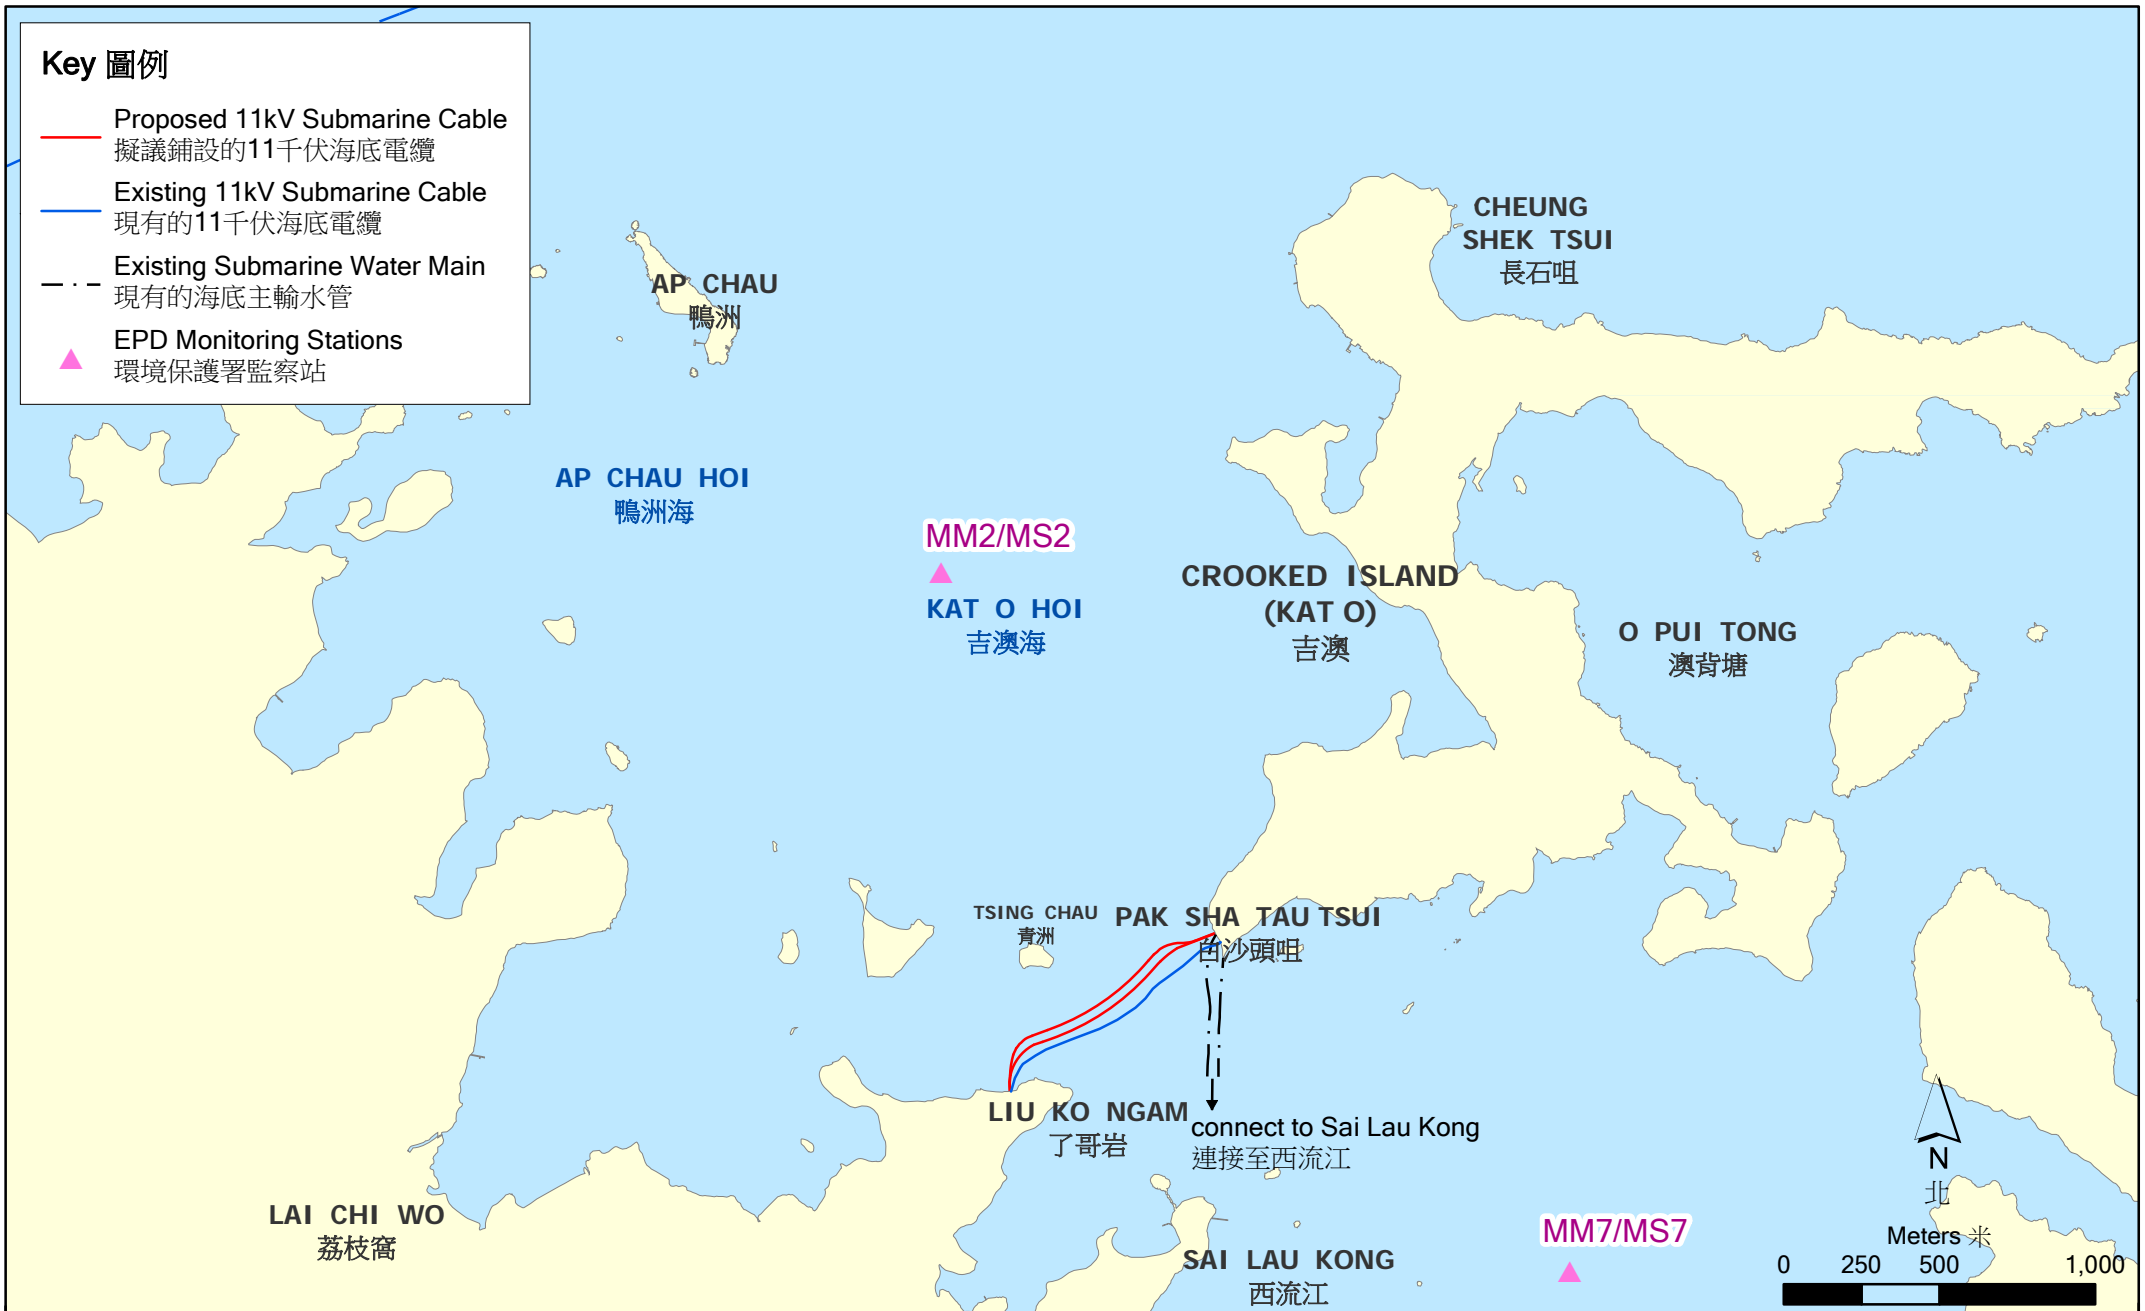
Figure A1
圖A1

Location of the Routine Water Quality and Sediment Monitoring Stations

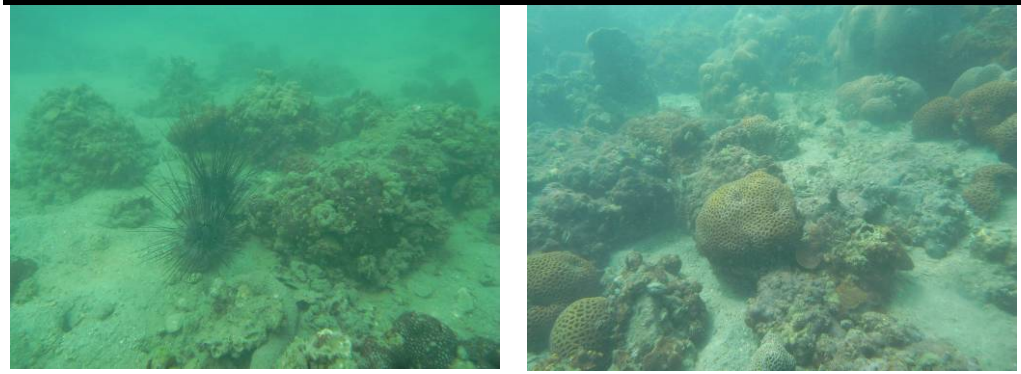
Figure B3 *Representative photos taken at LKN-1*

Similar to LKN-2 & LKN-3, the hard coral community was dominated by species from the Family Faviidae and this is the coral community type most commonly recorded in the north eastern waters of Hong Kong

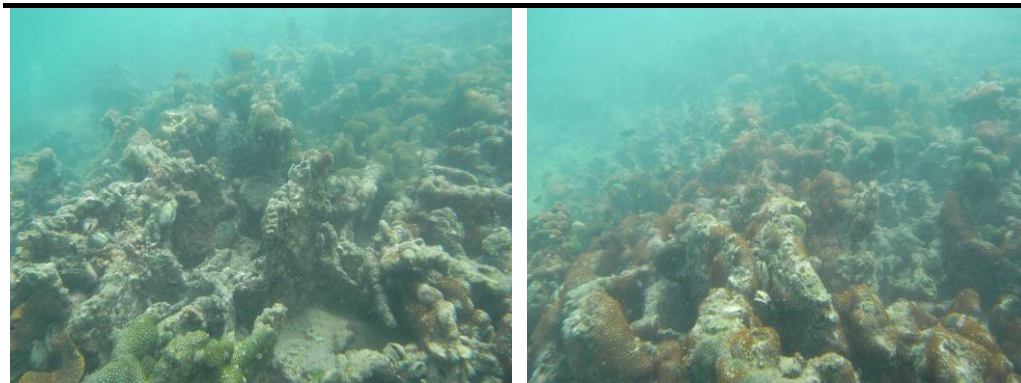
Figure B4 *Representative photos taken at LKN-2*

Stand of dead *Pavona* was observed with zoanthids and small hard coral colonies colonizing the dead coral framework

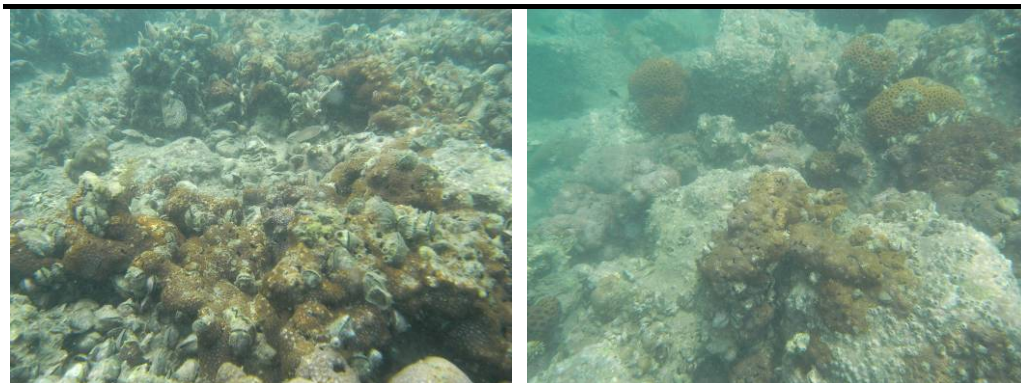
Figure B5 *Representative photos taken at LKN-3*

Acropora tumida, *A. pruinosa*, *Galaxea astreata* and *Acanthastrea echinata* observed at LKN-3 during the REA survey are considered as uncommon hard coral species in Hong Kong though they are most frequently recorded in the northeastern waters

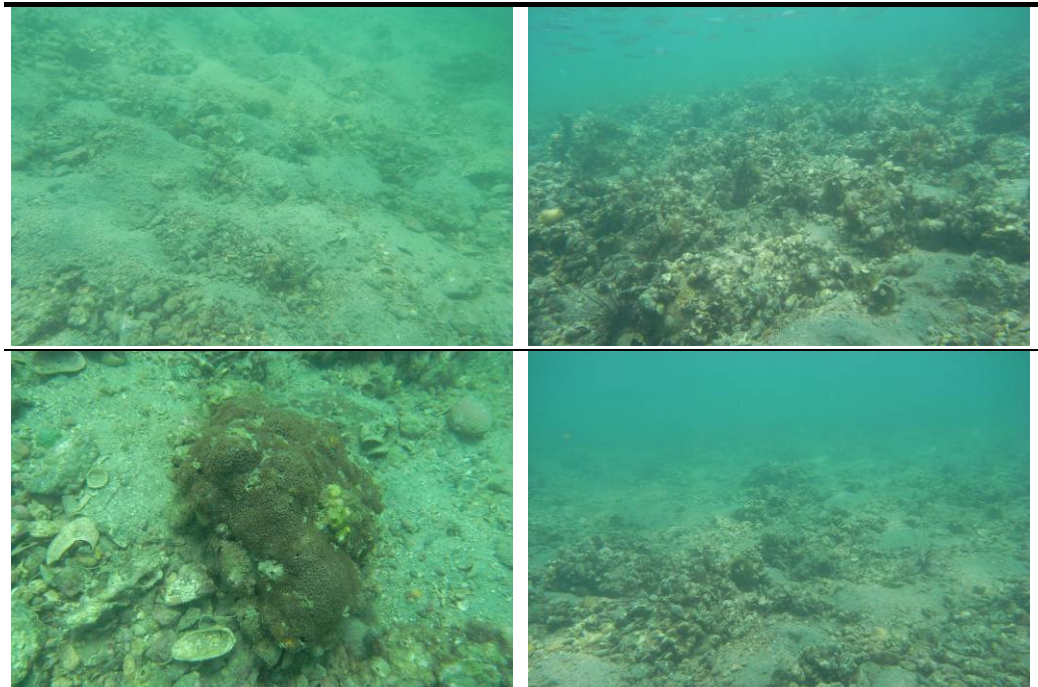
Figure B9 *Representative photos taken at TC-3*

The seabed of all the three zones was generally rocky in nature with higher cover of sand recorded at TC-3. Only two species of hermatypic hard coral and low hard coral cover (1-5%) were recorded at TC-3.

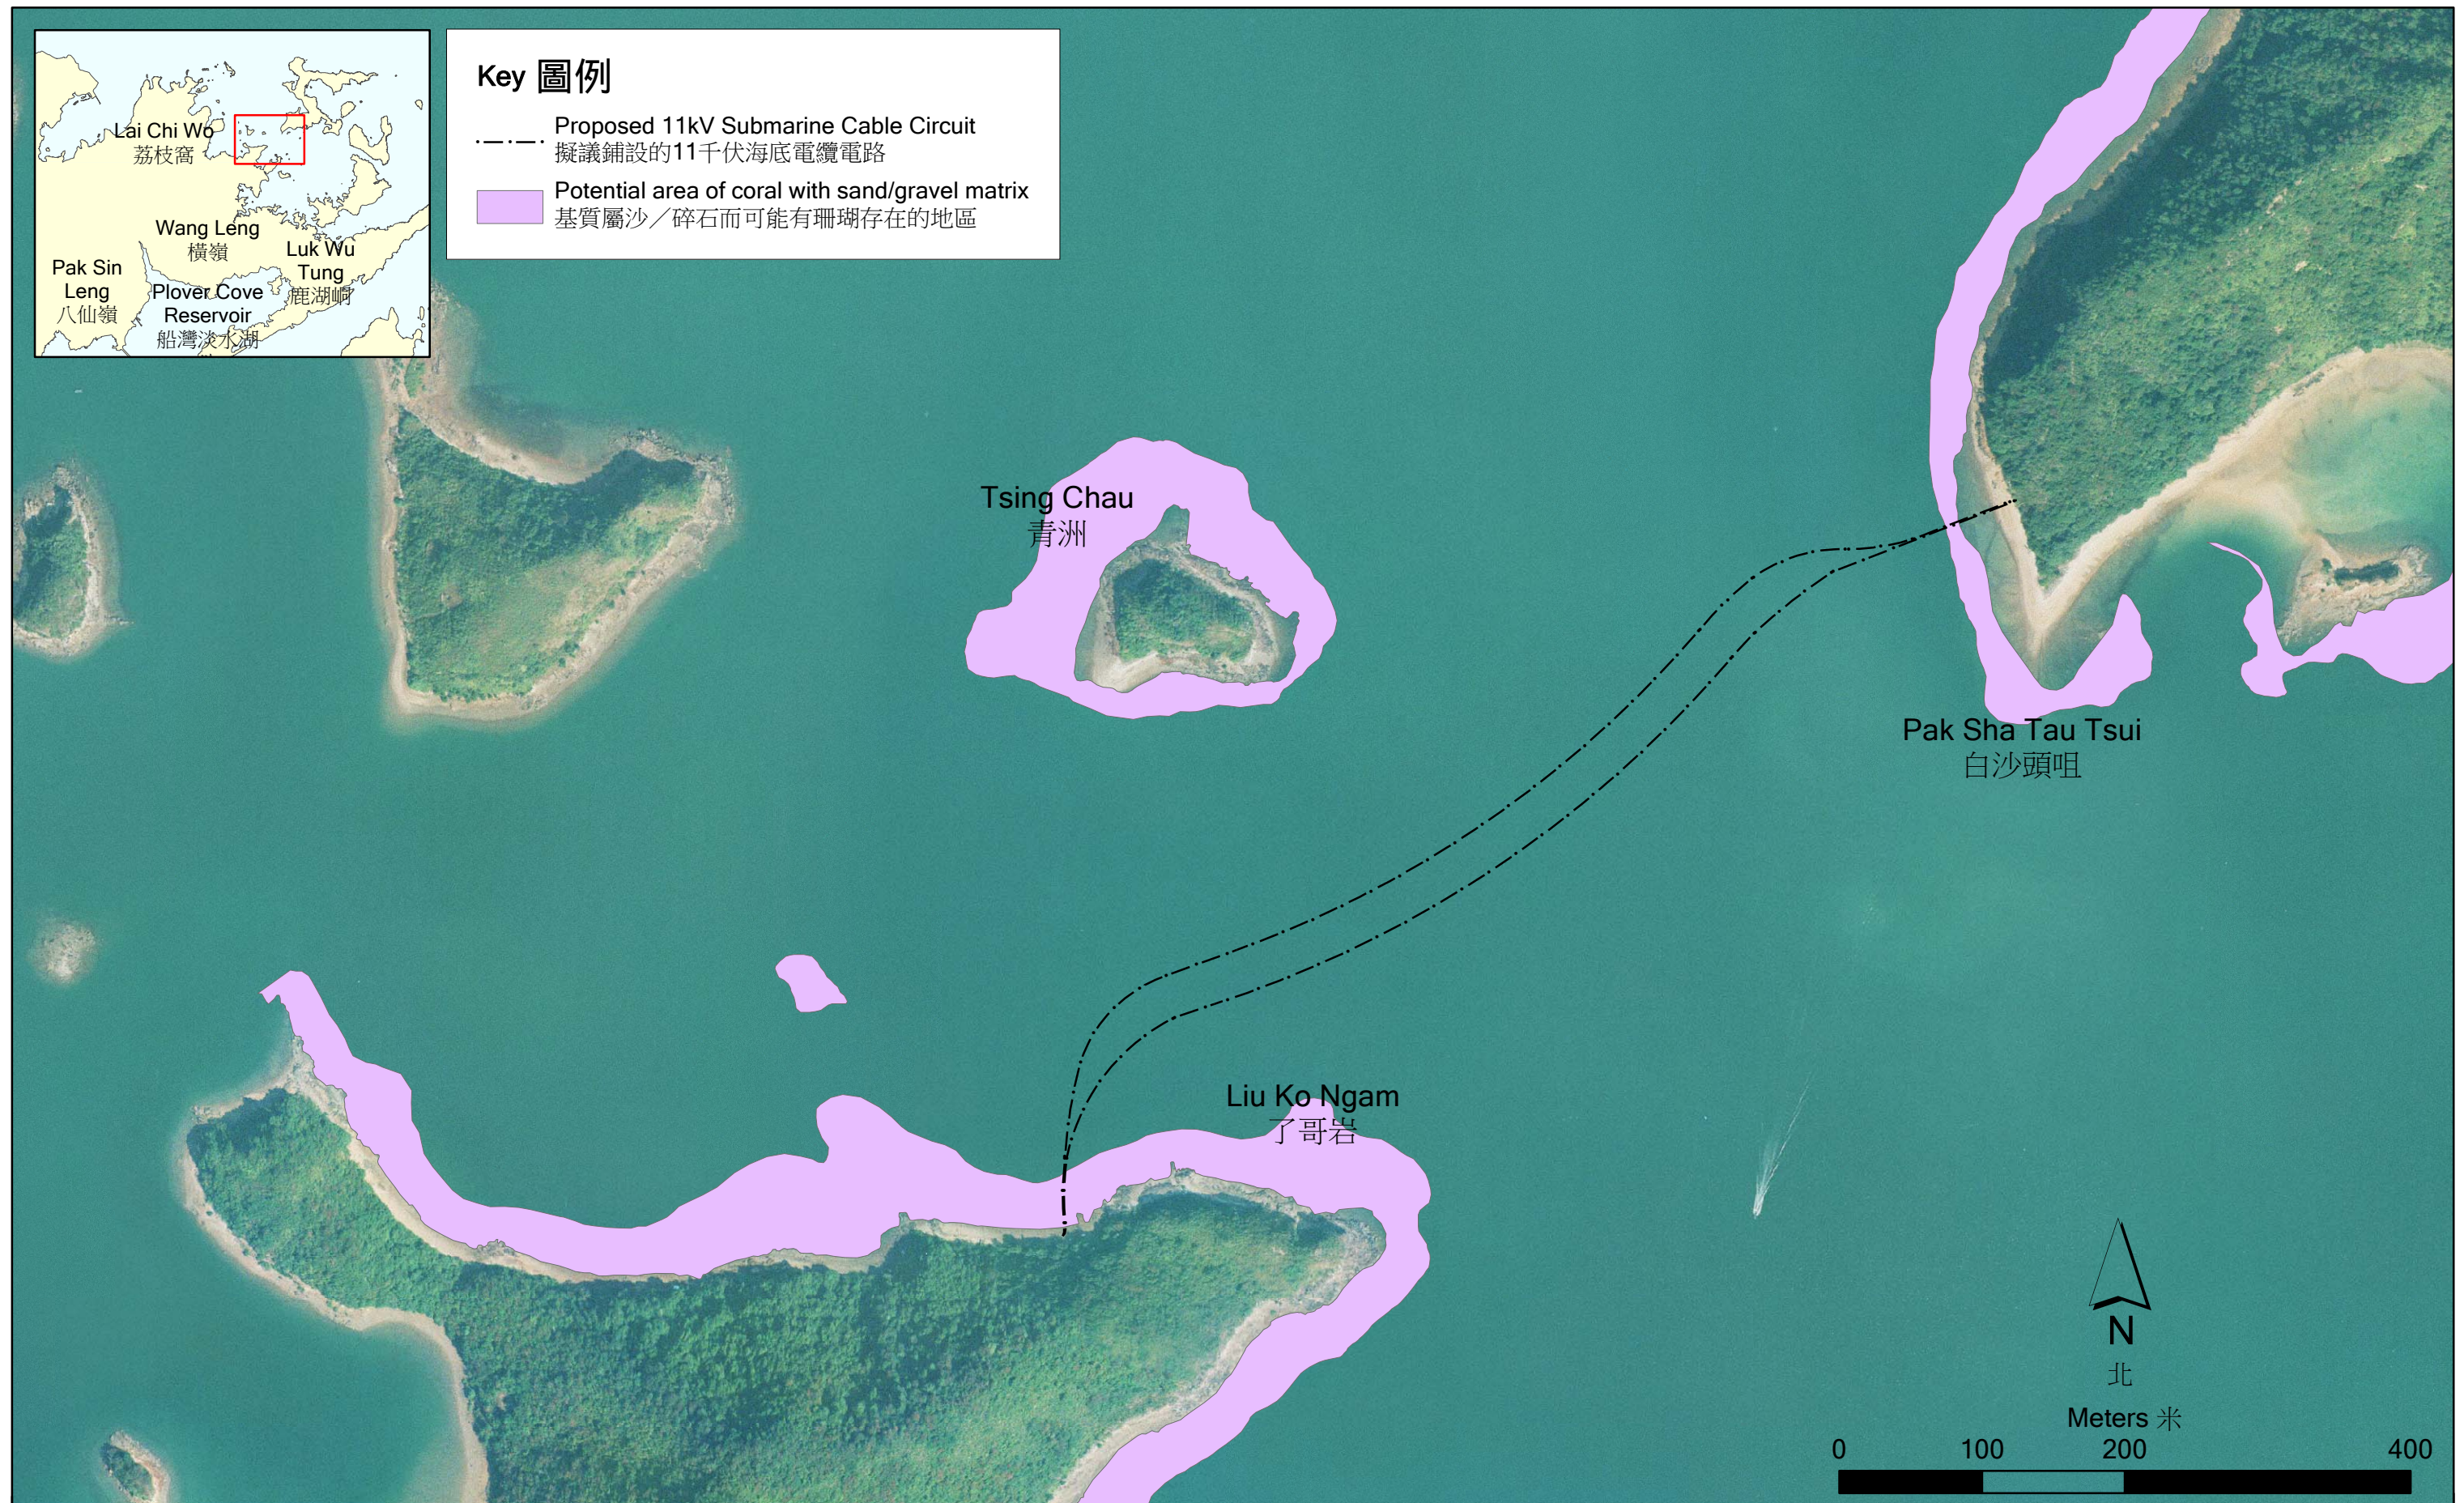
Figure B10
圖B10

Potential Area of Coral with Sand/Gravel Matrix

Potential hard substrates identified along the proposed cable alignment by the geophysical survey were investigated during the Stage 1 survey using spot dive checking technique. No hard substrates or corals were found at these locations and it is thus not considered necessary to adjust the proposed cable alignment from the perspective of avoiding direct impacts to corals during cable laying works.

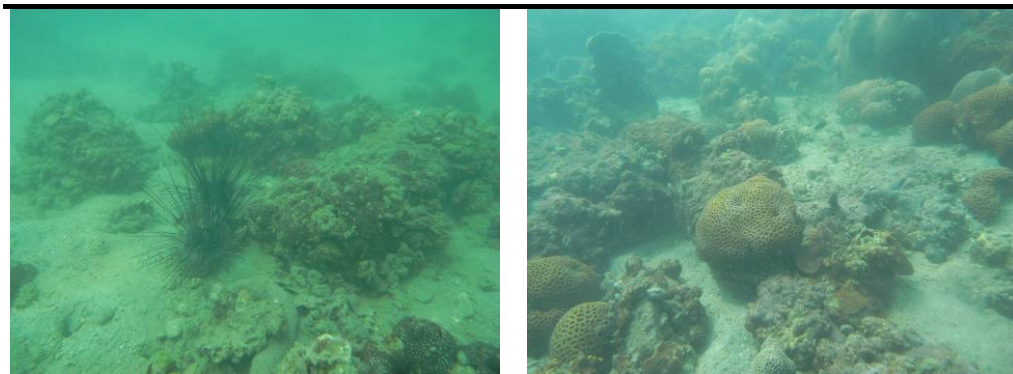
圖 B3

與 LKN-2 和 LKN-3 相似，這裏的硬珊瑚群落的主要品種是蜂巢珊瑚科。這個品種是香港東北部海域最經常錄得的珊瑚群落。

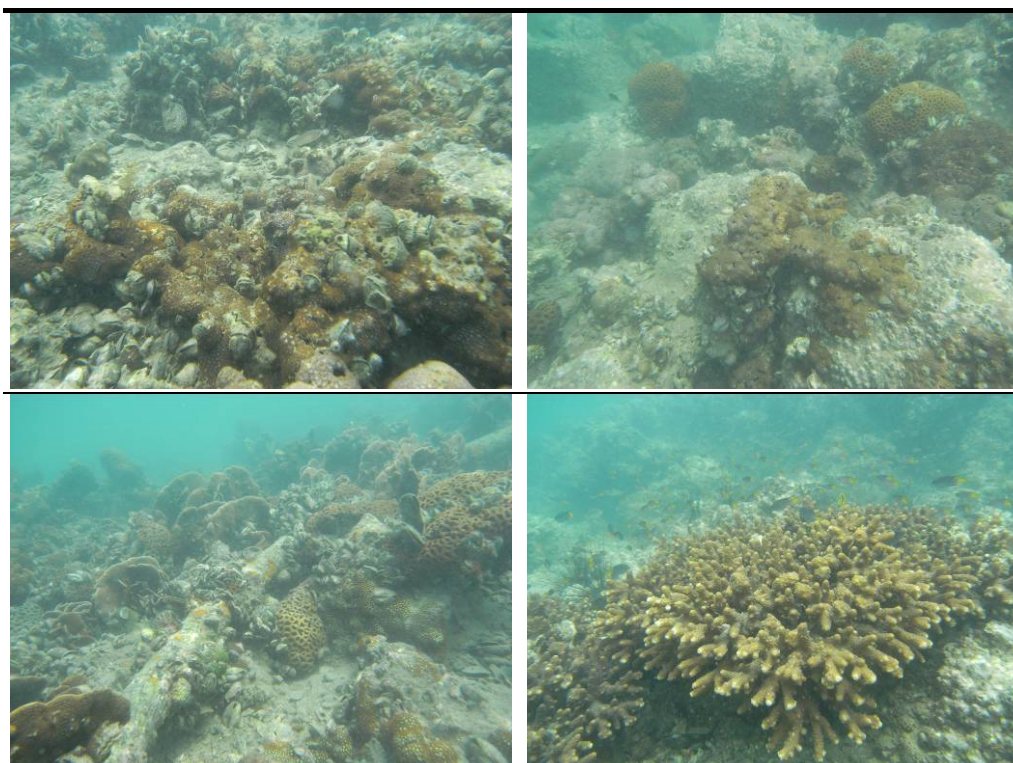
圖 B5

在 LKN-3 進行快速生態評估調查時發現的 *Acropora tumida*、*A. pruinosa*、*Galaxea astreata* 和 *Acanthastrea echinata*，都屬於香港不常見的硬珊瑚種類，雖然牠們通常都較多在東北海域被發現。

註：現有的 11 千伏海底電纜展示於左下角的照片上。應予注意的是，已經有相當數量的珊瑚群落，成功地重新聚集於現有的電纜表面。

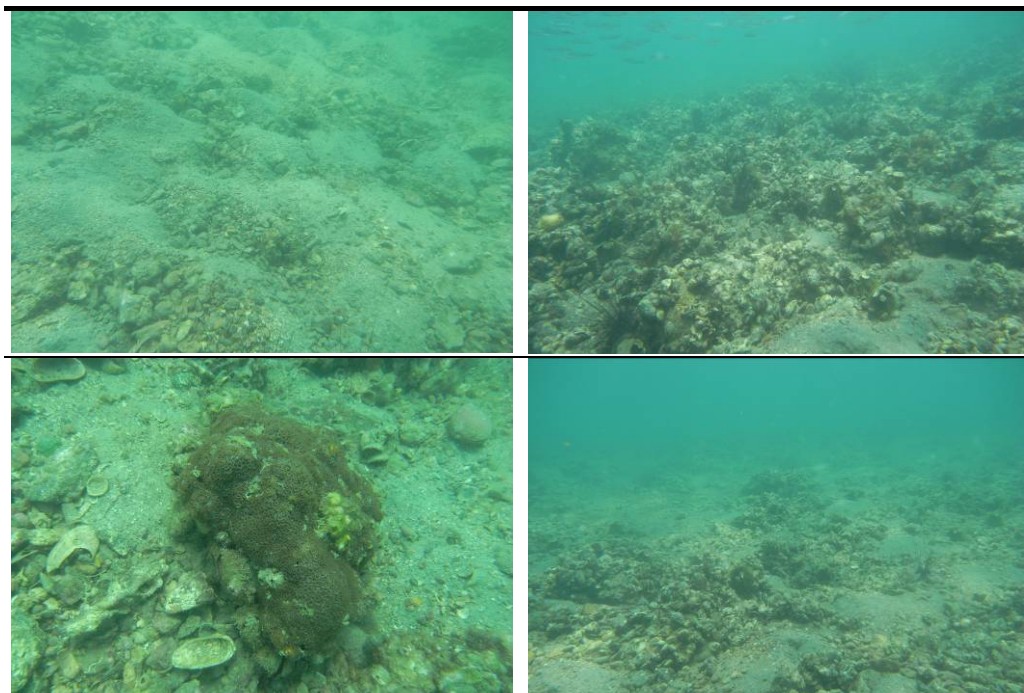
圖 B9 在 TC-3 拍攝的具代表性照片

三個分區的海床大致上都屬於石質，只有 TC-3 有較多沙覆蓋。在 TC-3 只發現兩種造礁硬珊瑚；該分區的硬珊瑚覆蓋率也較低（1-5%）。

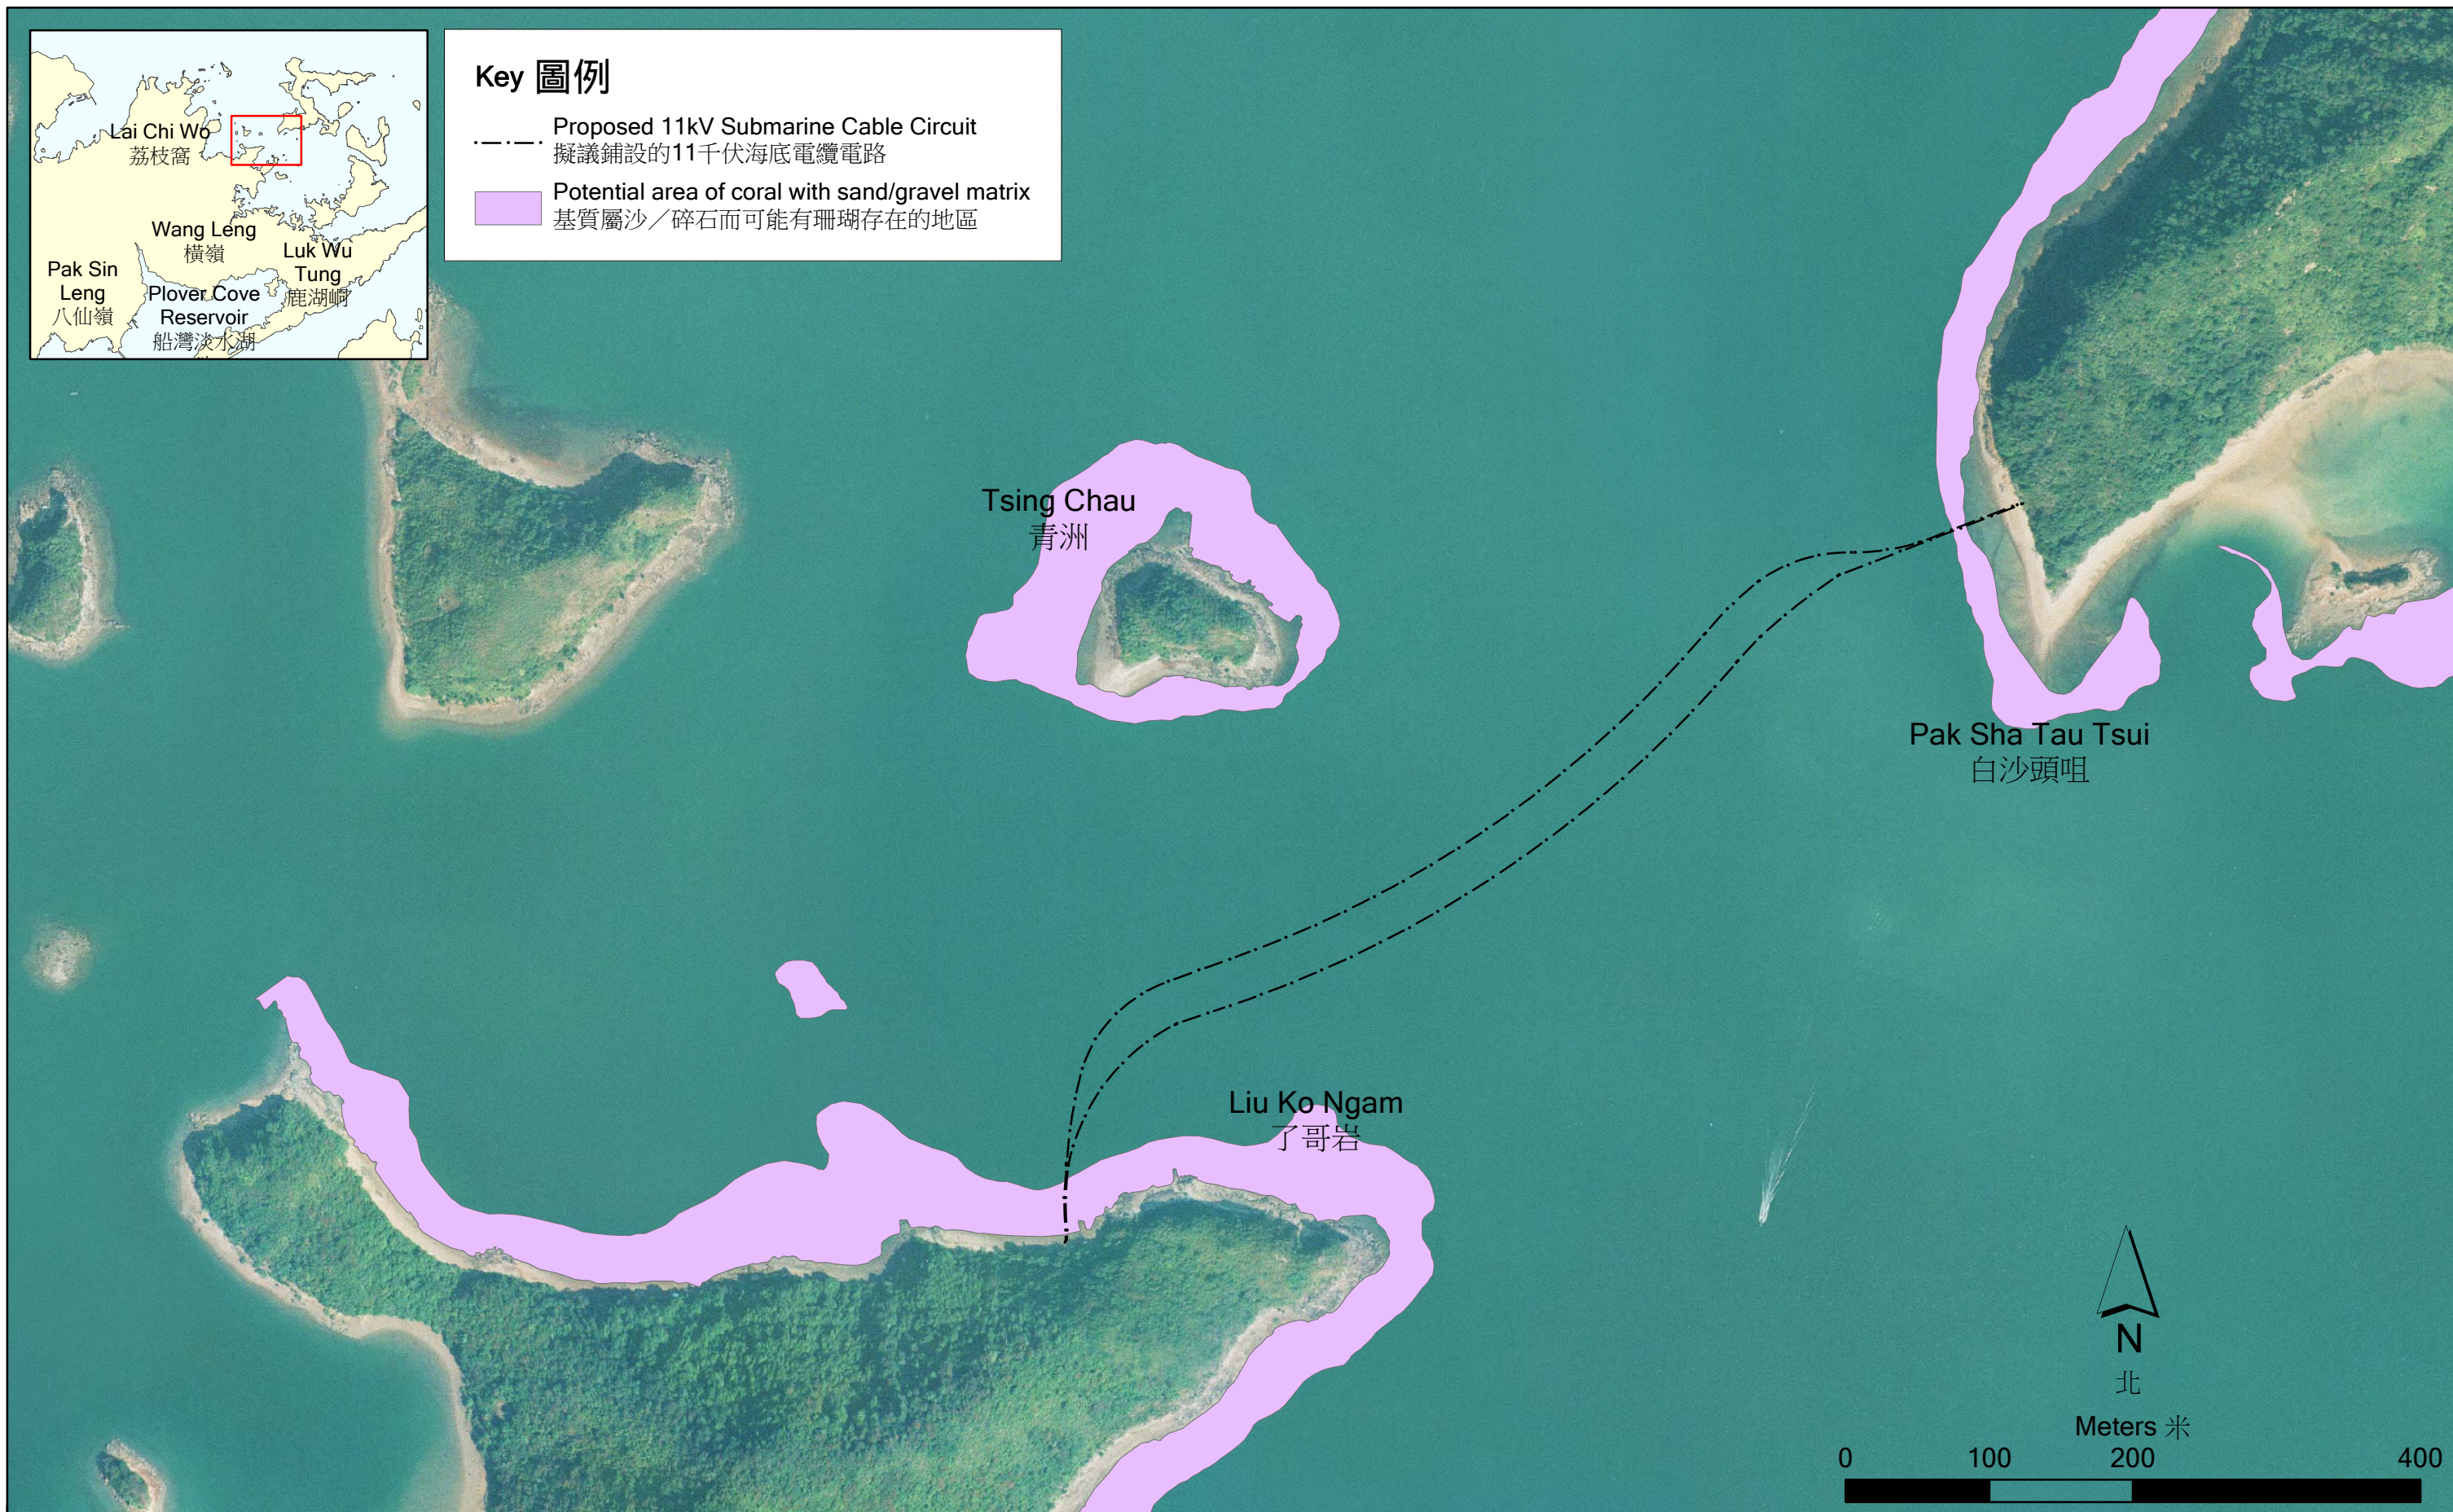
Figure B10
圖B10

- Proposed 11kV Submarine Cable Circuit
擬議鋪設的11千伏海底電纜電路
- Potential area of coral with sand/gravel matrix
基質屬沙/碎石而可能有珊瑚存在的地區

Potential Area of Coral with Sand/Gravel Matrix

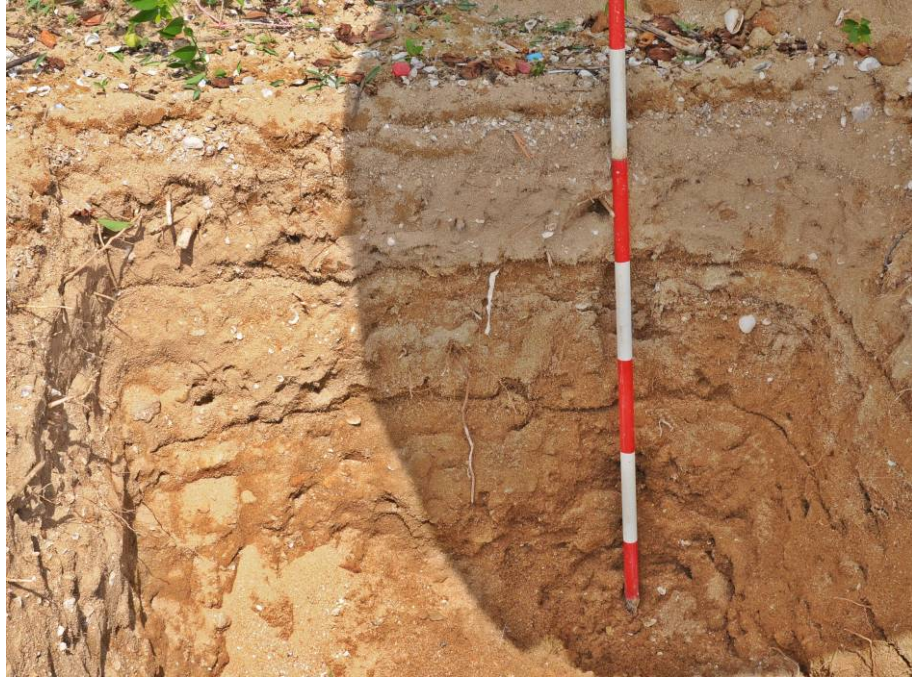
地點代號	KOPST2012		探方代號	TA1	
探方座標	E847516.972	N843689.772	探方尺寸	1.5米 x 1.5米	
挖掘方法	人手挖掘		地面標高	主水平基準2.5-2.6米	
地層情況					
分層	說明	文物	測定年代	地面標高 以下深度 (米)	厚度 (米)
1	灰白色海沙，雜有很多貝殼碎片和塑膠碎片		現代	0	0.35-0.40
2	比第1層粗糙的海沙，雜有少量貝殼碎片、塑膠碎塊和玻璃碎片	鄉村器物碎片、瓷器碎片、瓦片	現代	0.35-0.40	0.28-0.30
3	灰白色海沙、比第2層粗糙，雜有圓卵石	鄉村器物碎片、瓦片	不早於20世紀	0.65-0.70	>0.35-0.40
示意圖

東段

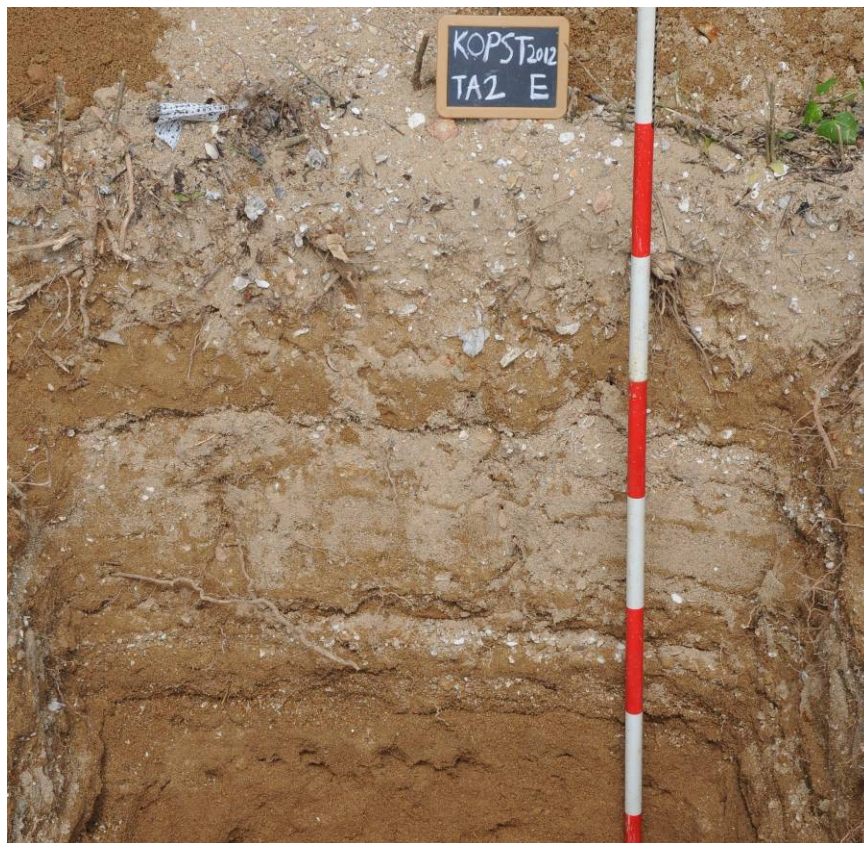
地點代號	KOPST2012		探方代號	TA2	
探方座標	E847520.905	N843681.966	探方尺寸	2米 x 1.5米	
挖掘方法	人手挖掘		地面標高	主水平基準2.5-2.6米	
地層情況					
分層	說明	文物	測定年代	地面標高 以下深度 (米)	厚度 (米)
1	灰白色海沙，雜有濃密的植物根，以及貝殼碎片和塑膠碎片		現代	0	0.45-0.50
2	灰白色海沙，比第1層粗糙，雜有貝殼碎片和塑膠碎片	瓷器碎片、瓦片	現代	0.45-0.50	0.25-0.35
3	灰白色海沙，比第2層粗糙，雜有較少的貝殼碎片和一塊混凝土	鄉村器物的碎片、瓦片	現代	0.75-0.80	0.15-0.25
4	灰白色海沙、比第3層粗糙，雜有碎石	鄉村器物碎片	不早於20世紀	0.95-100	>0.20-0.25
示意圖					
<p style="text-align: center;">北 南</p> <p style="text-align: center;">東段</p>

東段

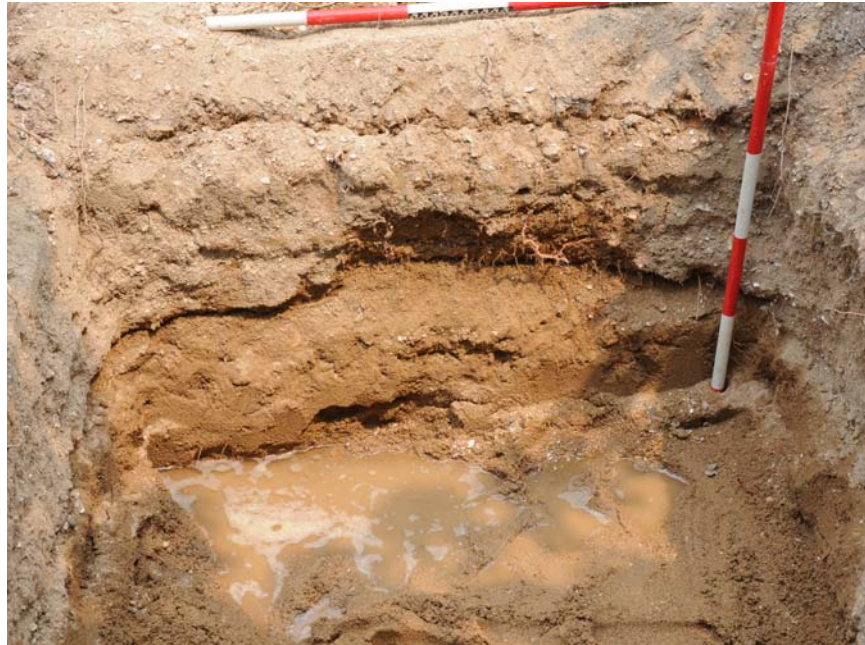
地點代號	KOPST2012		探方代號	TA3	
探方座標	E847525.792	N843686.775	探方尺寸	2米 x 1.5米	
挖掘方法	人手挖掘		地面標高	主水平基準2.5米	
地層情況					
分層	說明	文物	測定年代	地面標高 以下深度 (米)	厚度 (米)
1	灰白色細沙，雜有貝殼碎片和現代垃圾	沒有文物	現代	0	0.19-0.20
2	灰白色海沙，雜有一些貝殼碎片和玻璃酒瓶碎片	沒有文物	現代	0.19-0.20	0.40
3	灰白色海沙，比第2層粗糙，雜有一些貝殼碎片和玻璃酒瓶碎片	沒有文物	現代	0.60	>0.40
示意圖

東南段
