ANNEX A - SECTIONS 1/9 TO 9/9 OF CHANNEL CORRIDOR SURVEY, EASTERN MDC

Annex 3-A Channel Corridor Survey Record Sheets

CHANNEL CORRIDOR SURVEY, EASTERN MDC

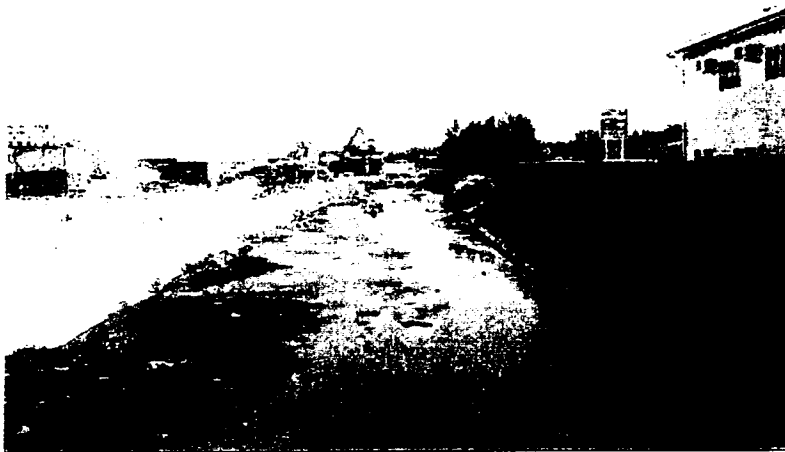
PHOTO #3, SECTION 1/9

CHANNEL CORRIDOR SURVEY RECORD SHEET 1 of 9	
Channel: Eastern MDC, San Tin	Date of survey: 20 & 28 / 05 / 1997
Surveyor(s): CIF, KHK, YML, JK	Weather conditions: Sunny, 30°C
Photographic record: P 3	Aerial photos: CNI 6699
Notes: Good access at inter-section between Castle Peak Road and San Sham Road.	
<p>SPECIAL AND TYPICAL FEATURES OF CHANNEL CORRIDOR, MARGINAL VEGETATION AND BANK ZONE HABITATS</p> <p>Channel: Concrete lined (previous works project), little vegetation on aquatic and marginal zone, stream non-flowing, water odorous and appeared highly polluted.</p> <p>Vegetation: <i>Panicum sp.</i>, <i>Lantana camara</i>, <i>Solanum nigrum</i>, <i>Trema orientalis</i>, <i>Bidens pilosa</i>, <i>Ricinus communis</i></p>	
<p>ADJACENT LAND USE</p> <p>Open container storage to West. Construction works - Site office (East side) and Polder Village Protection Scheme (West side).</p>	
<p>NOTES ON INSECTS, BIRDS, MAMMALS AND FEATURES OF SPECIAL INTEREST</p> <p>Tree Sparrow and Crested Myna (carrying nesting material, which indicates an active usage of natural or artificial local nesting sites) were recorded.</p>

<p>DRAINAGE CHANNEL CHARACTERISTICS</p> <p>Top Span: 28.6m</p> <p>Proposed maintenance road on either side of trapezoidal channel: 5.5m (including verges).</p> <p>Total width: 39.6m~130ft</p>	
<p>POTENTIAL ECOLOGICAL IMPACTS</p> <p>Due to condition of channel there are no potential impacts.</p>	
<p>PROPOSED MITIGATION/SUGGESTIONS FOR HABITAT IMPROVEMENTS</p> <ol style="list-style-type: none"> 1. Retain existing aquatic zone vegetation as a foundation for further growth and to act as a biological pollution filter. 2. Undertake suitable hydroseeding with native species and of beneficial use to wildlife along channel embankments. 	
<p>RESIDUAL ECOLOGICAL IMPACTS</p> <p>After habitat improvement no residual impacts are expected. Residual Impact : Minimal</p>	
<p>KEY ISSUES / SUMMARY</p> <p>Section 1/9 is assessed as being of minimal ecological importance.</p>

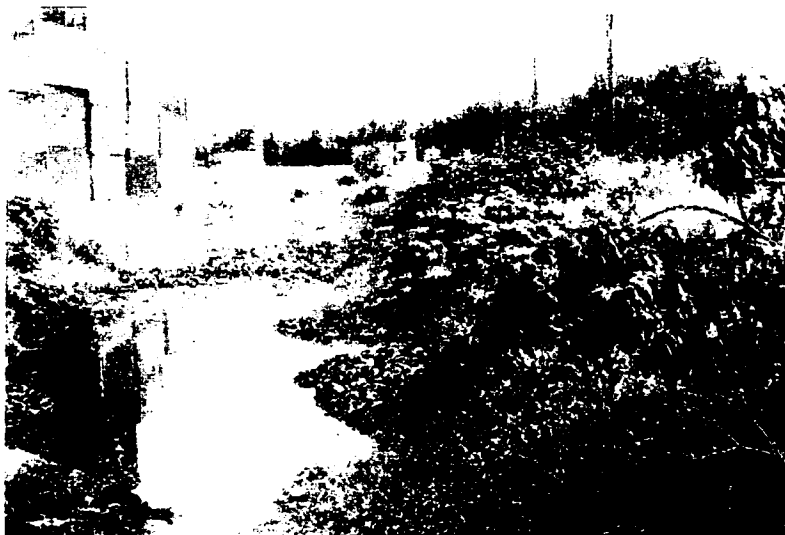
PHOTO #4, SECTION 2/9

CHANNEL CORRIDOR SURVEY RECORD SHEET 2 of 9	
Channel: Eastern MDC, San Tin.	Date of survey: 20 & 28 / 05 / 1997
Surveyor(s): CIF, KHK, YML, JK	Weather conditions: Sunny, 30°C
Photographic record: P 4	Aerial photos: CNI 6699
Notes: Good access via San Sham Road and border road. Wooden foot bridge across existing channel.	
<p>SPECIAL AND TYPICAL FEATURES OF CHANNEL CORRIDOR, MARGINAL VEGETATION AND BANK ZONE HABITATS</p> <p>Fish ponds and open storage on West bank, vegetation and border road on East bank.</p> <p>Aquatic zone: polluted water, dense stands of <i>Eichhornia crassipes</i></p> <p>Bank zone: <i>Ricinus communis</i>, <i>Leucaena leucocephala</i>, <i>Panicum</i> spp.</p> <p>Pond bunds : grassy.</p>	
<p>ADJACENT LAND USE</p> <p>Concrete lined channel with grassy banks on NE side.</p> <p>Active fish ponds surrounded by open storage for containers.</p>	
<p>NOTES ON INSECTS, BIRDS, MAMMALS AND FEATURES OF SPECIAL INTEREST</p> <p>Little Egret, House swift, Barn Swallow, Plain Prinia, Yellow bellied Prinia, Common Tailorbird, Crested Myna (carrying nesting material) recorded foraging on the edge of aquatic habitats.</p>

<p>DRAINAGE CHANNEL CHARACTERISTICS</p> <p>Top Span: 28.6m</p> <p>Proposed maintenance road on either side of trapezoidal channel: 5.5m, (including verge).</p> <p>Total width:39.6m~130ft</p>	
<p>POTENTIAL ECOLOGICAL IMPACTS</p> <ol style="list-style-type: none"> 1.Loss of stream channel aquatic vegetation and marginal zone flora. 2.Permanent loss of adjacent fish ponds. 	
<p>PROPOSED MITIGATION/SUGGESTIONS FOR HABITAT IMPROVEMENTS</p> <ol style="list-style-type: none"> 1.Undertake suitable hydroseeding with native species and of beneficial use to wildlife along channel embankments. 2.Create compensatory wetland and scrub habitats. 	
<p>RESIDUAL ECOLOGICAL IMPACTS</p> <p>After habitat improvement no residual impacts are expected. Residual Impact : Minimal</p>	
<p>KEY ISSUES / SUMMARY</p> <p>Section 2/9 is assessed as being of minimal ecological importance.</p>

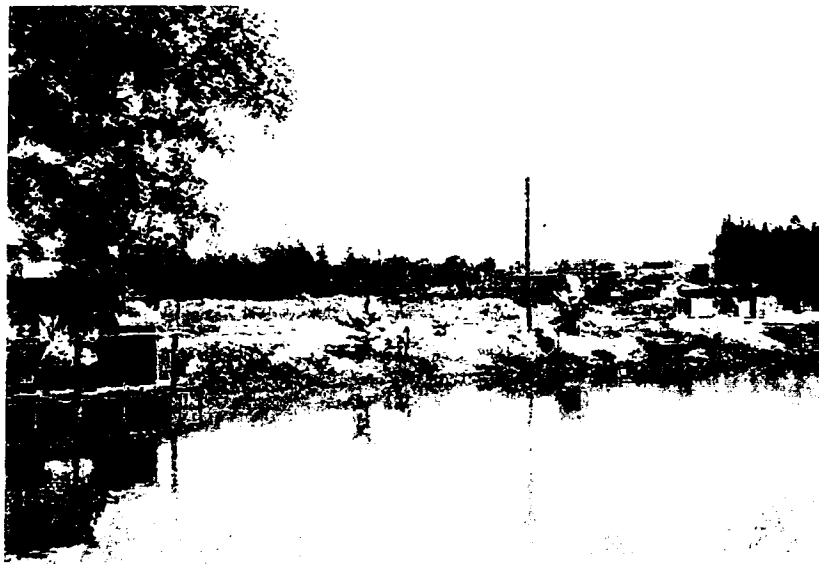
PHOTO #5, SECTION 3/9

CHANNEL CORRIDOR SURVEY RECORD SHEET 3 of 9	
Channel: Eastern MDC, San Tin.	Date of survey: 20 & 28 / 05 / 1997
Surveyor(s): CIF, KHK, YML, JK	Weather conditions: Sunny, 30°C
Photographic record: P 5	Aerial photos: CNI 6736
Notes: Access via footbridge across channel from border Road. Cross section of stream channel profile.	
<p>SPECIAL AND TYPICAL FEATURES OF CHANNEL CORRIDOR, MARGINAL VEGETATION AND BANK ZONE HABITATS</p> <p>Pond bunds: vegetation included <i>Albizia lebbbeck</i>, <i>Musa paradisiaca</i>, <i>Panicum maximum</i>, <i>Melia azedarach</i>, <i>Commelina nudiflora</i>.</p> <p>Stream channel: water was black, non flowing, and highly polluted. Soft muddy banks.</p> <p>Aquatic zone: isolated patches of <i>Eichhornia crassipes</i>.</p> <p>Bank Zone: <i>Panicum spp.</i>, <i>Polygonum hydropiper</i>, <i>Ricinus communis</i>, <i>Phragmites communis</i>.</p>	
<p>ADJACENT LAND USE</p> <p>Border road on NE side. Active fish ponds on SW side</p>

<p>NOTES ON INSECTS, BIRDS, MAMMALS AND FEATURES OF SPECIAL INTEREST</p> <p>Yellow Bittern, Feral Pigeon, Common Kingfisher, Barn Swallow, Plain Prinia, Rufous-backed Shrike, Crested Myna and Tree Sparrow recorded foraging near to aquatic habitats.</p> <p>Un identified burrows on pond bunds, probably belonging to rodents.</p>	
<p>DRAINAGE CHANNEL CHARACTERISTICS</p> <p>Top Span: 28.6m</p> <p>Proposed maintenance road on either side of trapezoidal channel: 5.5m (including verges).</p> <p>Total width: 39.6m~130ft</p>	
<p>POTENTIAL ECOLOGICAL IMPACTS</p> <ol style="list-style-type: none"> 1. Loss of stream channel aquatic vegetation. 2. Loss of active fish pond. 3. Habitat loss for insects, birds, and mammals. 	
<p>PROPOSED MITIGATION / SUGGESTIONS FOR HABITAT IMPROVEMENTS</p> <ol style="list-style-type: none"> 1. Undertake suitable hydroseeding with native species of beneficial use to wildlife along channel embankments. 2. Create compensatory habitat such as wetland and scrubland.

<p>RESIDUAL ECOLOGICAL IMPACTS</p> <p>After habitat improvement no residual impacts are expected. Residual Impact : Minimal</p>	
<p>KEY ISSUES / SUMMARY</p> <p>Section 3/9 is assessed as being of moderate ecological importance.</p>

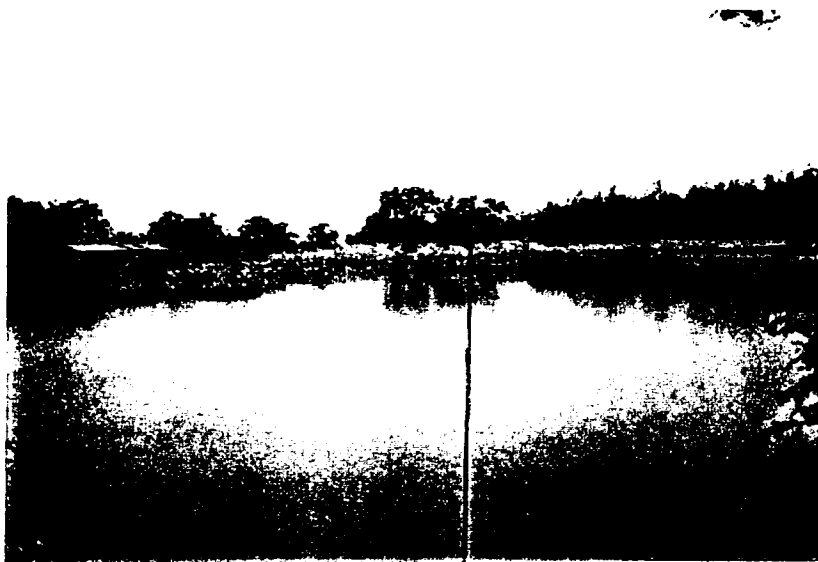
PHOTO #6, SECTION 4/9

CHANNEL CORRIDOR SURVEY RECORD SHEET 4 OF 9	
Channel: Eastern MDC, San Tin	Date of survey: 20 & 28 / 05 / 1997
Surveyor(s): CIF, KHK, YML, JK	Weather conditions: Sunny 30°C
Photographic record: P 6	Aerial photos: CNI 6736
Notes: Access via grassy pond bunds. <u>Site 1</u> Quantitative Survey	
<p>SPECIAL AND TYPICAL FEATURES OF CHANNEL CORRIDOR, MARGINAL VEGETATION AND BANK ZONE HABITATS</p> <p>Tree belt: <i>Casuarina equisetifolia</i>, <i>Hibiscus tiliaceus</i>.</p> <p>Dried channel: dense stand of <i>Eichhornia crassipes</i>, <i>Panicum maximum</i> along marginal zone.</p> <p>Pond bunds: pond bund vegetation included <i>Albizia lebbeck</i>, <i>Melia azedarach</i>, <i>Lantana camara</i>, <i>Digitaria</i> sp. and fruit trees (<i>Citrus maximum</i>, <i>Psidium guajava</i>, <i>Musa paradisiaca</i>, <i>Amygdalus persica</i>).</p>	
<p>ADJACENT LAND USE</p> <p>Infilled fish pond, parking area and border road on NE side.</p> <p>Active fish ponds and Chicken farm, on SW and West side.</p>

<p>NOTES ON INSECTS, BIRDS, MAMMALS AND FEATURES OF SPECIAL INTEREST</p> <p>Spotted Dove, Common Kingfisher, Barn Swallow, Magpie Robin, Plain Prinia, Black-necked Starling, Crested Myna, Tree Sparrow and White-Breasted Waterhen recorded foraging in aquatic habitats.</p>	
<p>DRAINAGE CHANNEL CHARACTERISTICS</p> <p>Top Span: 28.6m</p> <p>Proposed maintenance road on either side of trapezoidal channel: 5.5m (including verges).</p> <p>Total width: 39.6m~130ft</p>	
<p>POTENTIAL ECOLOGICAL IMPACTS</p> <ol style="list-style-type: none"> 1. Loss of active fish pond and permanent partial loss of adjacent fish ponds. 2. Disturbance to exotic woodland belt and scrubland from construction activities. 3. Loss of marsh and seasonal flooding due to MDC containment. 4. Habitat loss for foraging birds. 	
<p>PROPOSED MITIGATION / SUGGESTIONS FOR HABITAT IMPROVEMENTS</p> <ol style="list-style-type: none"> 1. Undertake suitable hydroseeding with native species of beneficial use to wildlife along embankments. 2. Create compensatory habitat such as wetland and woodland. 3. Fish ponds reinstated to pre-project standard. 4. Retain and protect all existing trees along border road.

<p>RESIDUAL ECOLOGICAL IMPACTS</p> <p>After habitat improvement no residual impacts are expected. Residual Impact : Minimal</p>	
<p>KEY ISSUES / SUMMARY</p> <p>Section 4/9 is assessed as being of moderate ecological importance.</p>

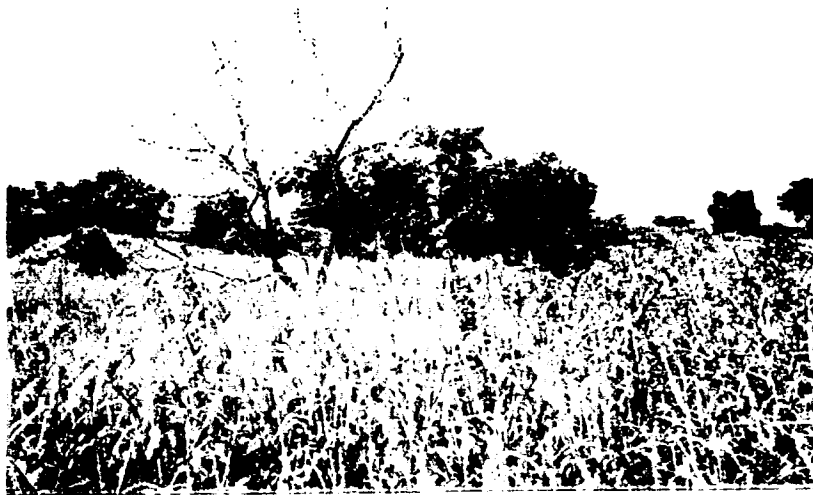
PHOTO #7, Section 5/9

CHANNEL CORRIDOR SURVEY RECORD SHEET 5 of 9	
Channel: Eastern MDC, San Tin.	Date of survey: 20 & 28 / 05 / 1997
Surveyor(s): CIF, KHK, YML, JK	Weather conditions: Sunny, 30°C
Photographic record: P 7	Aerial photos: CNI 6736
Notes: Access via border road	
<p>SPECIAL AND TYPICAL FEATURES OF CHANNEL CORRIDOR, MARGINAL VEGETATION AND BANK ZONE HABITATS</p> <p>Tree belt: <i>Casuarina equisetifolia</i>, <i>Hibiscus tiliaceus</i>.</p> <p>Marsh: <i>Phragmites communis</i>, <i>Panicum repens</i>, <i>Sapium sebiferum</i> with standing black and odorous water.</p> <p>Pond bunds: vegetation included, <i>Melia azedarach</i>, <i>Musa paradisiaca</i>, <i>Macaranga tanarius</i>, <i>Panicum maximum</i>.</p>	
<p>ADJACENT LAND USE</p> <p>Border road to East. Fish ponds on West.</p>	
<p>NOTES ON INSECTS, BIRDS, MAMMALS, REPTILES AND FEATURES OF SPECIAL INTEREST</p> <p>Chinese Pond Heron, Little Egret, Spotted Dove, Barn Swallow, Plain Prinia (carrying nesting material), Yellow-bellied Prinia recorded foraging and roosting along aquatic and woodland habitats.</p> <p>Unidentified dead snake on border road.</p>

<p>DRAINAGE CHANNEL CHARACTERISTICS</p> <p>Top Span: 44m</p> <p>Proposed maintenance road on either side of trapezoidal channel: 5.5m (including verges).</p> <p>Total width: 55m~180ft</p>	
<p>POTENTIAL ECOLOGICAL IMPACTS</p> <ol style="list-style-type: none"> 1. Loss of active fish ponds and permanent partial loss of adjacent fish ponds 2. Disturbance to exotic woodland belt and scrubland from construction activities 3. Loss of marsh and seasonal flooding due to MDC containment. 4. Habitat loss for insects, birds mammals reptiles and amphibians. 	
<p>PROPOSED MITIGATION / SUGGESTIONS FOR HABITAT IMPROVEMENTS</p> <ol style="list-style-type: none"> 1. Undertake suitable hydroseeding with native species of beneficial use to wildlife along both channel embankments. 2. Create compensatory habitat such as wetland and woodland. 3. Fish ponds reinstated to pre-project condition. 4. Retain and protect all existing trees along border road.

<p>RESIDUAL ECOLOGICAL IMPACTS</p> <p>After habitat improvement no residual impacts are expected. Residual Impact : Minimal</p>	
<p>KEY ISSUES / SUMMARY</p> <p>Section 5/9 is assessed as being of moderate ecological importance.</p>
