APPENDIX 3D

DETAILS OF STADIUM NOISE IMPACT ASSESSMENT

APPENDIX A3.4

REPORT ON STADIUM NOISE MONITORING

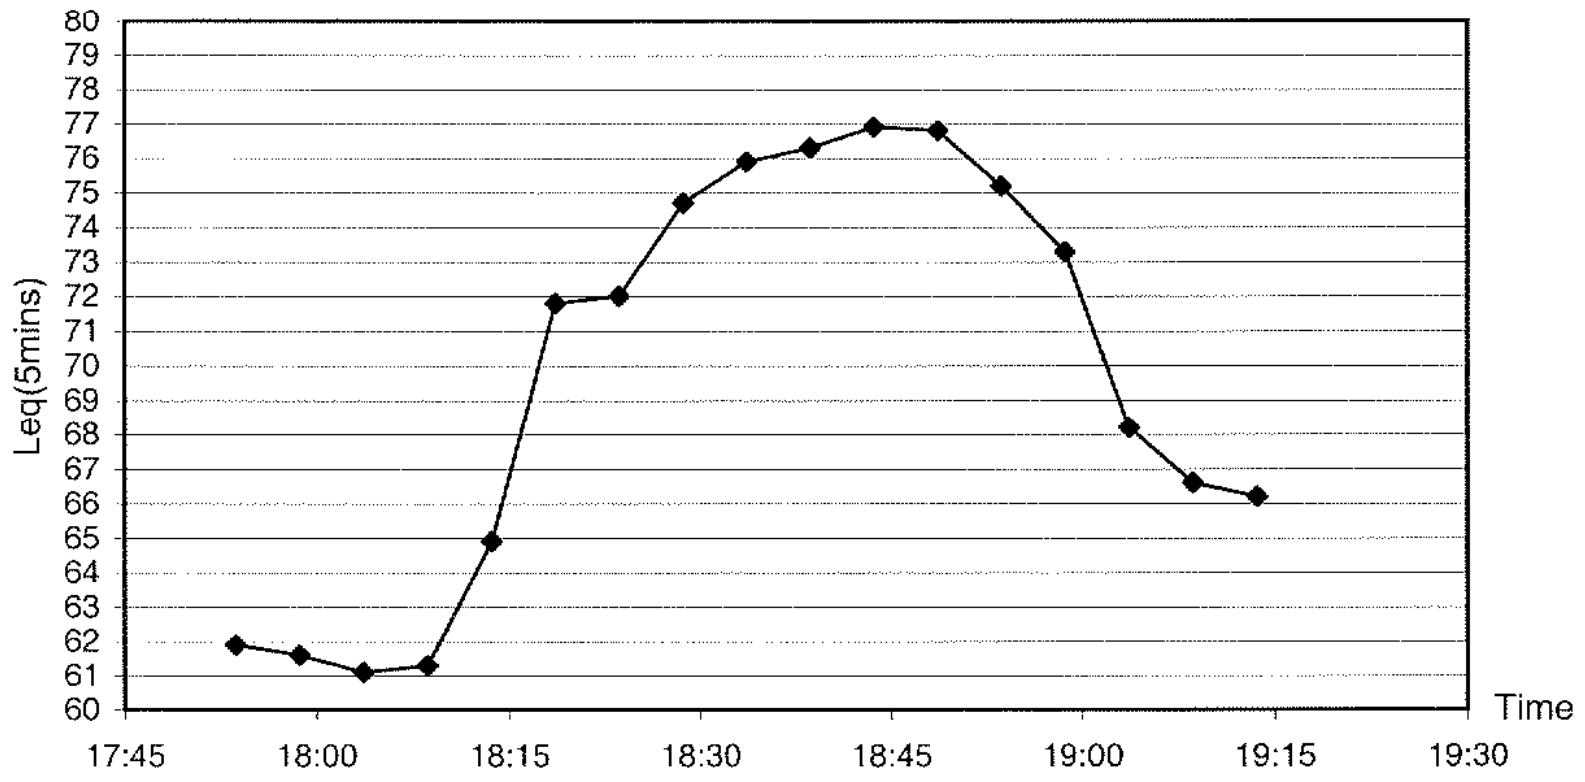
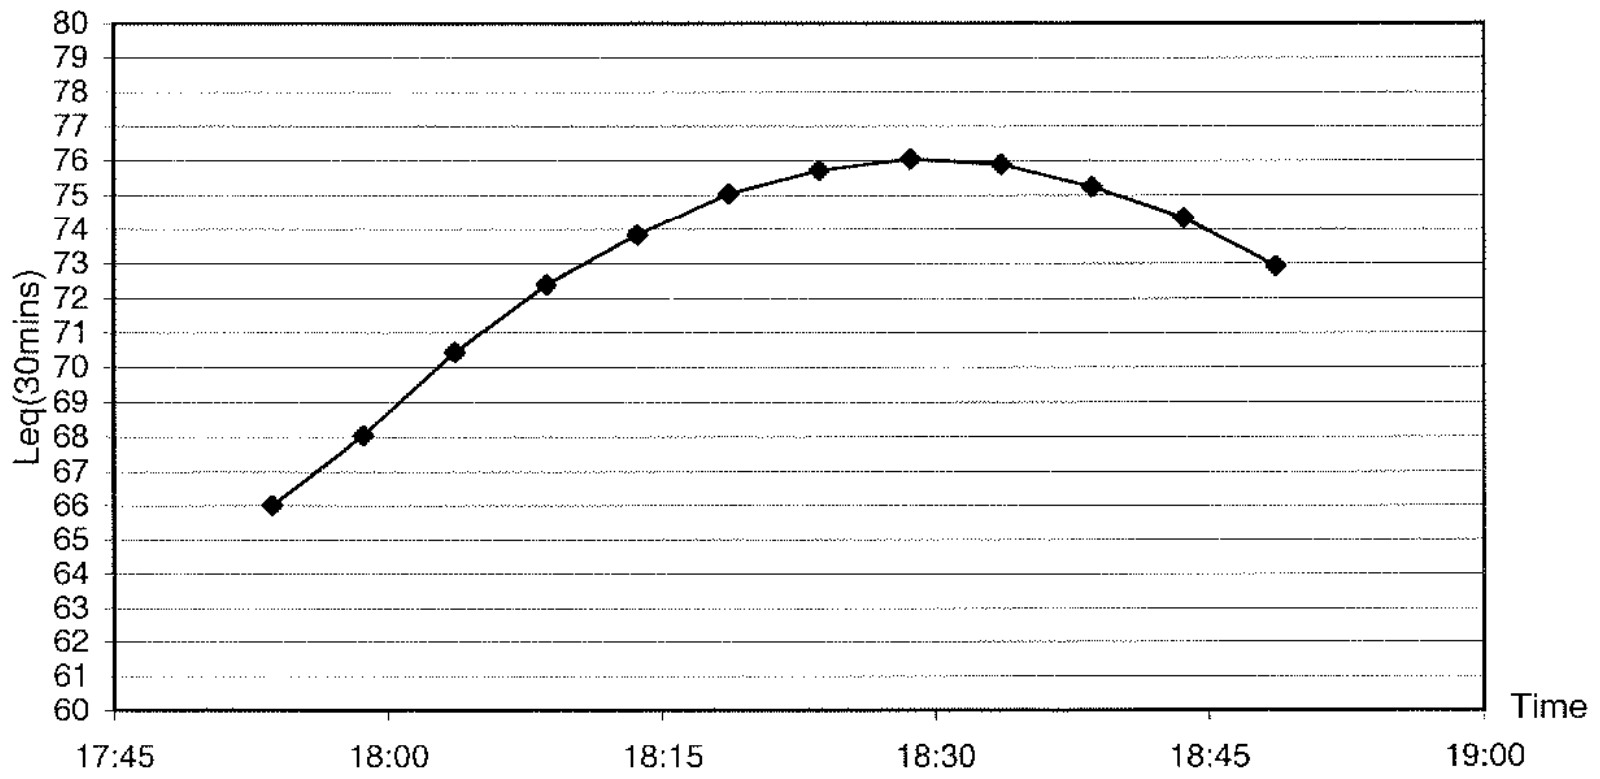
Background noise measurement results at 29/F Sea Hawk Hotel,
Fukuoka on 23Feb2001

The measurement results were meaningful for period before 18:30 while measurement conditions were still acceptable. Results are summarised as follows:

Monitoring Location	Time	Leq (5min)	Lmax (5min)	Lmin (5min)	L10 (5min)	L90 (5min)
M1-L	18:12 – 18:27	59.2 - 63.4 Avg: 61.8	73.5 – 74.8	53.6 – 57.8	60.6 – 66.5	56.7 – 59.4
M1-HE	17:54 – 18:19	61.9 – 64.9 Avg: 62.4	65.3 – 75.3	58.3 – 59.2	62.1 – 67.7	59.8 – 61.5

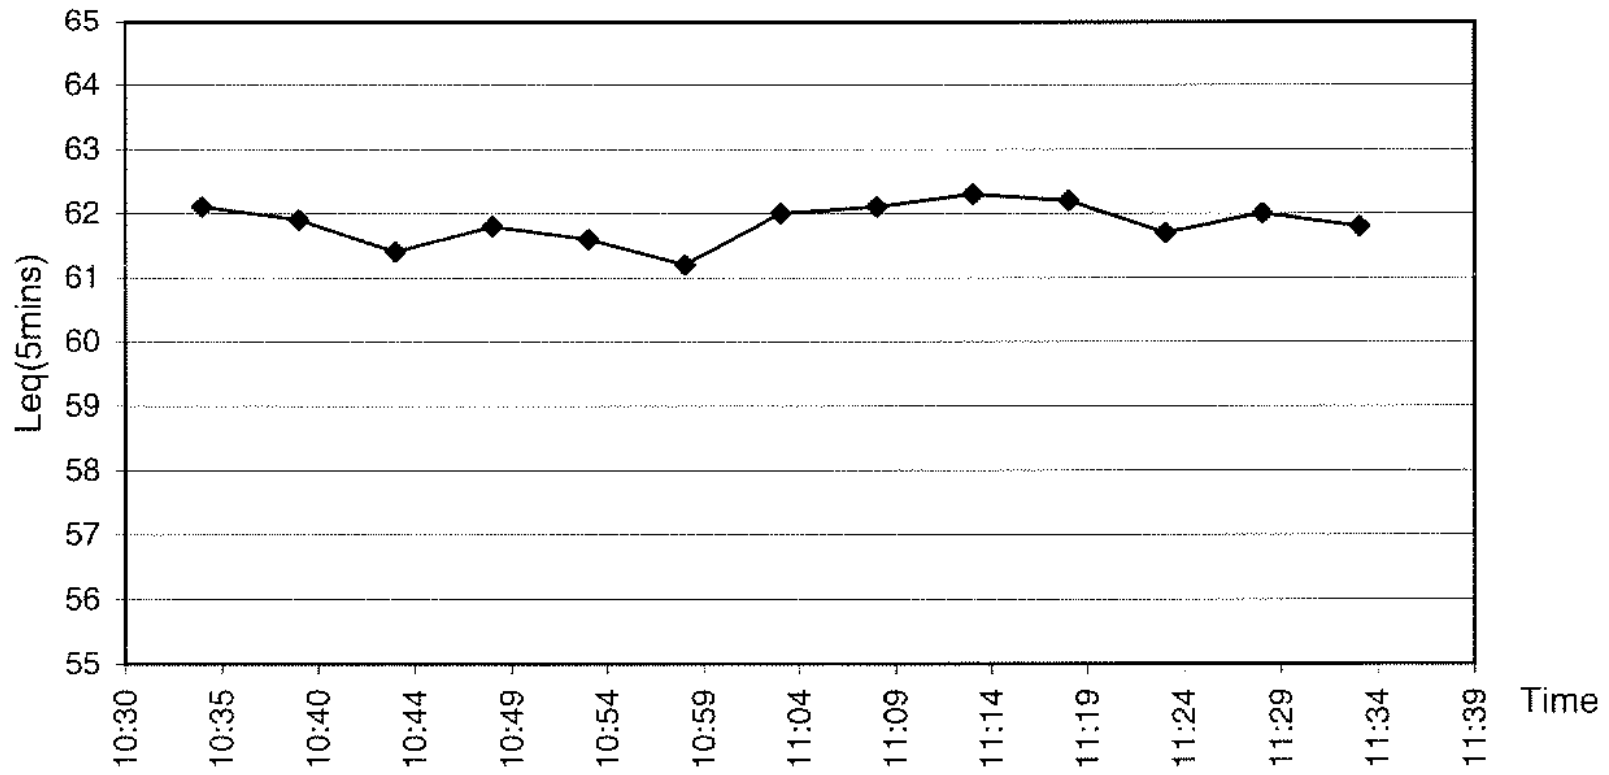
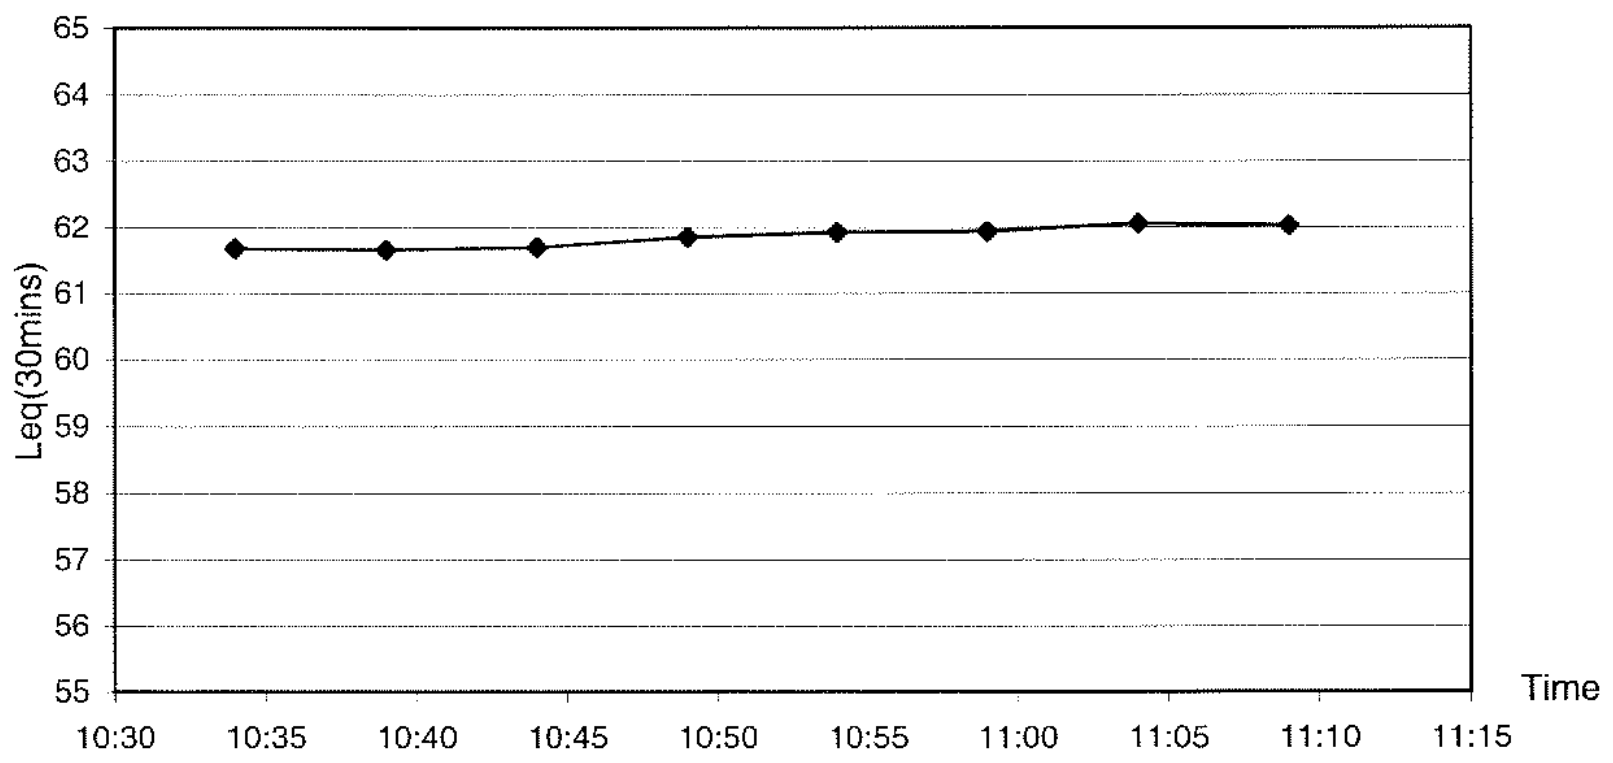
Background noise results at M1-HS, Fukuoka on 24Feb2001

Monitoring Location	Time	Leq (5min)	Lmax (5min)	Lmin (5min)	L10 (5min)	L90 (5min)
M1-HS	10:34 – 11:39	61.4 – 62.3 Avg: 61.9	65.9 – 70.3	57.2 – 59.6	62.4 – 63.8	59.9 – 60.8

It was observed that the dominant noise was from the road traffic of Fukuoka City Highway and local roads. During the period, the traffic count at the Highway was around 174 veh/5min with 9% heavy vehicles. For the nearest local road, it was about 85 veh/5min with 11% heavy vehicles mainly buses.

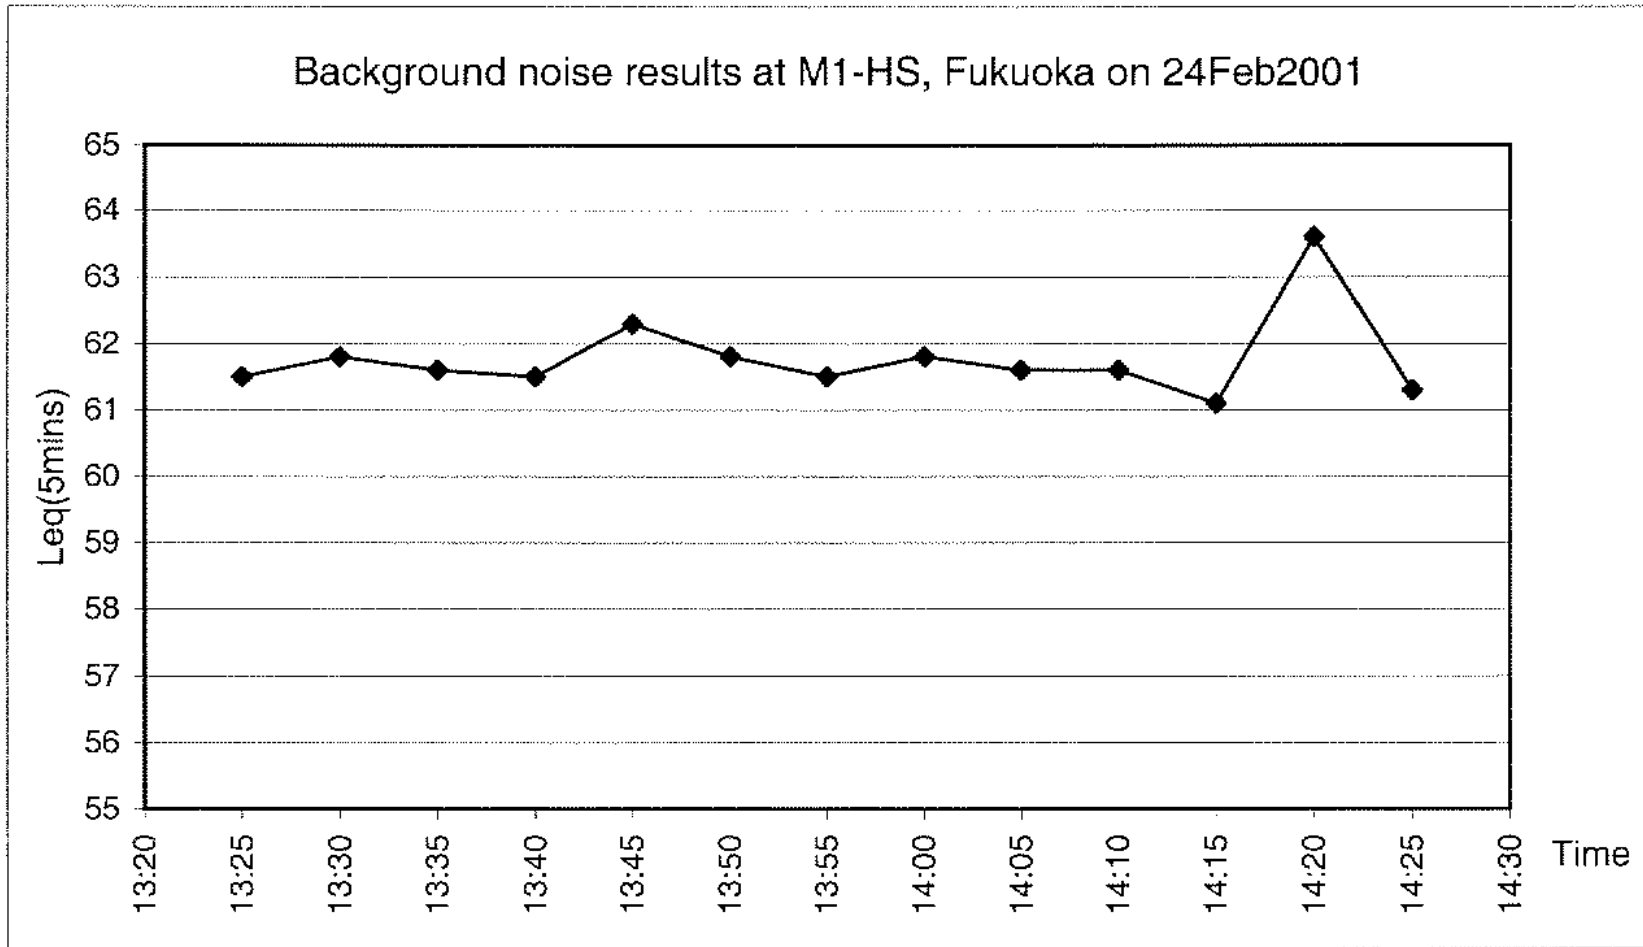
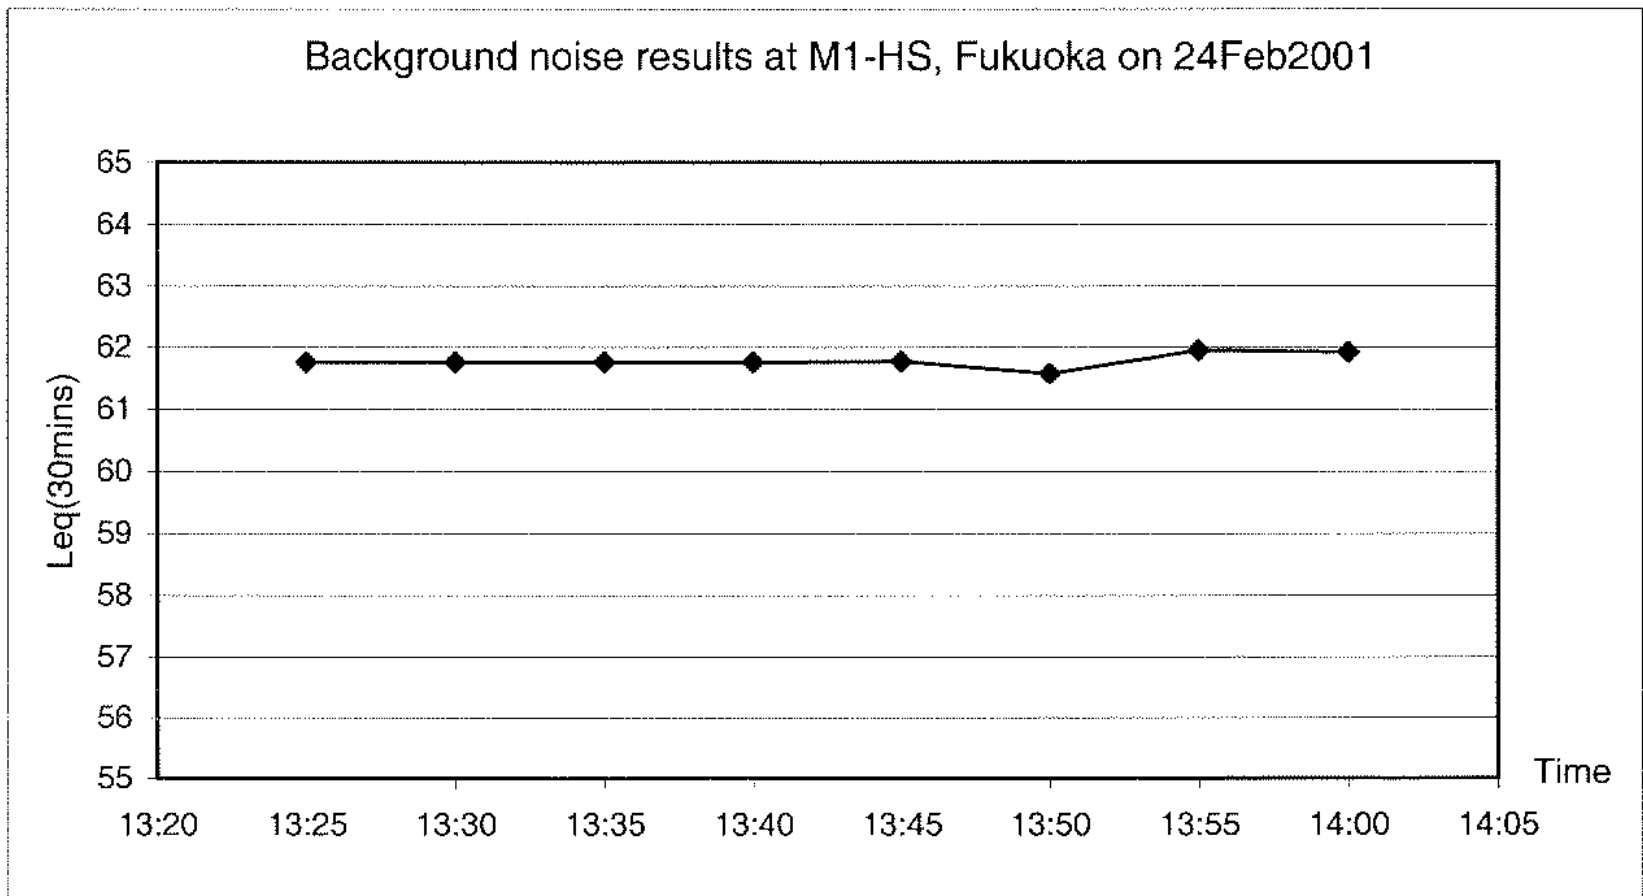
SEKDFS
STADIUM NOISE MONITORING
FEB 2001
Location M1-HS
24 February 2001 pm

Monitoring Location	Time	Leq (5min)	Lmax (5min)	Lmin (5min)	L10 (5min)	L90 (5min)
MI-HS	13:25 – 14:30	61.3 – 63.6 Avg: 61.8	66.7 – 84.2	58.3 – 59.3	62.3 – 64.7	59.9 – 60.5

It was observed that the dominant noise was from the road traffic of Fukuoka City Highway and local roads. During the period, the traffic count at the Highway was around 160 veh/5min with 13% heavy vehicles. For the nearest local road, it was about 111 veh/5min with 10% heavy vehicles mainly buses. There was a queue forming leading to the Dome (probably the carpark). Slight increase in noise level was due to car horn.

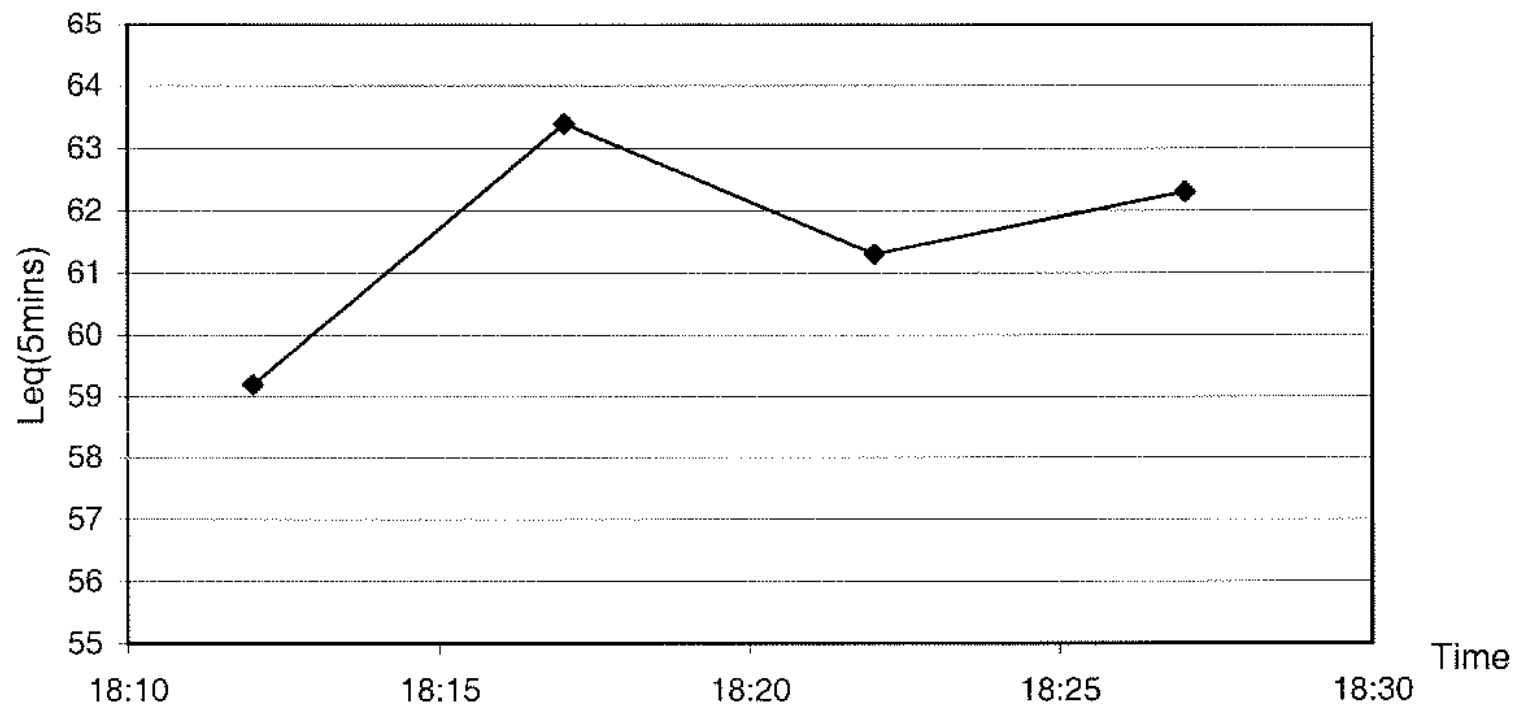
Background noise results at 7/F Sea Hawk Hotel, Fukuoka on
23Feb2001

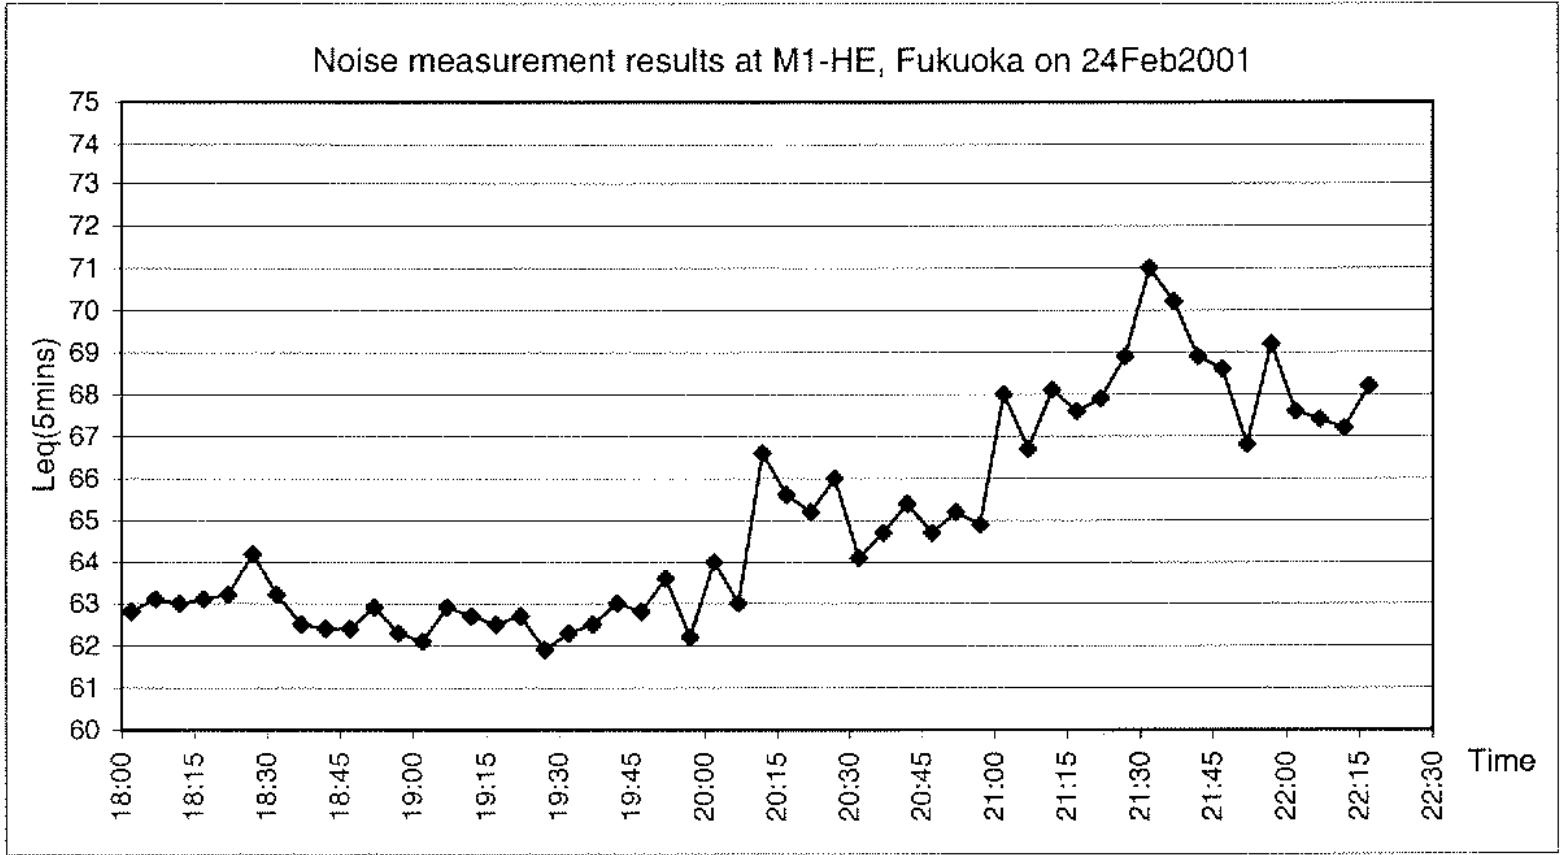
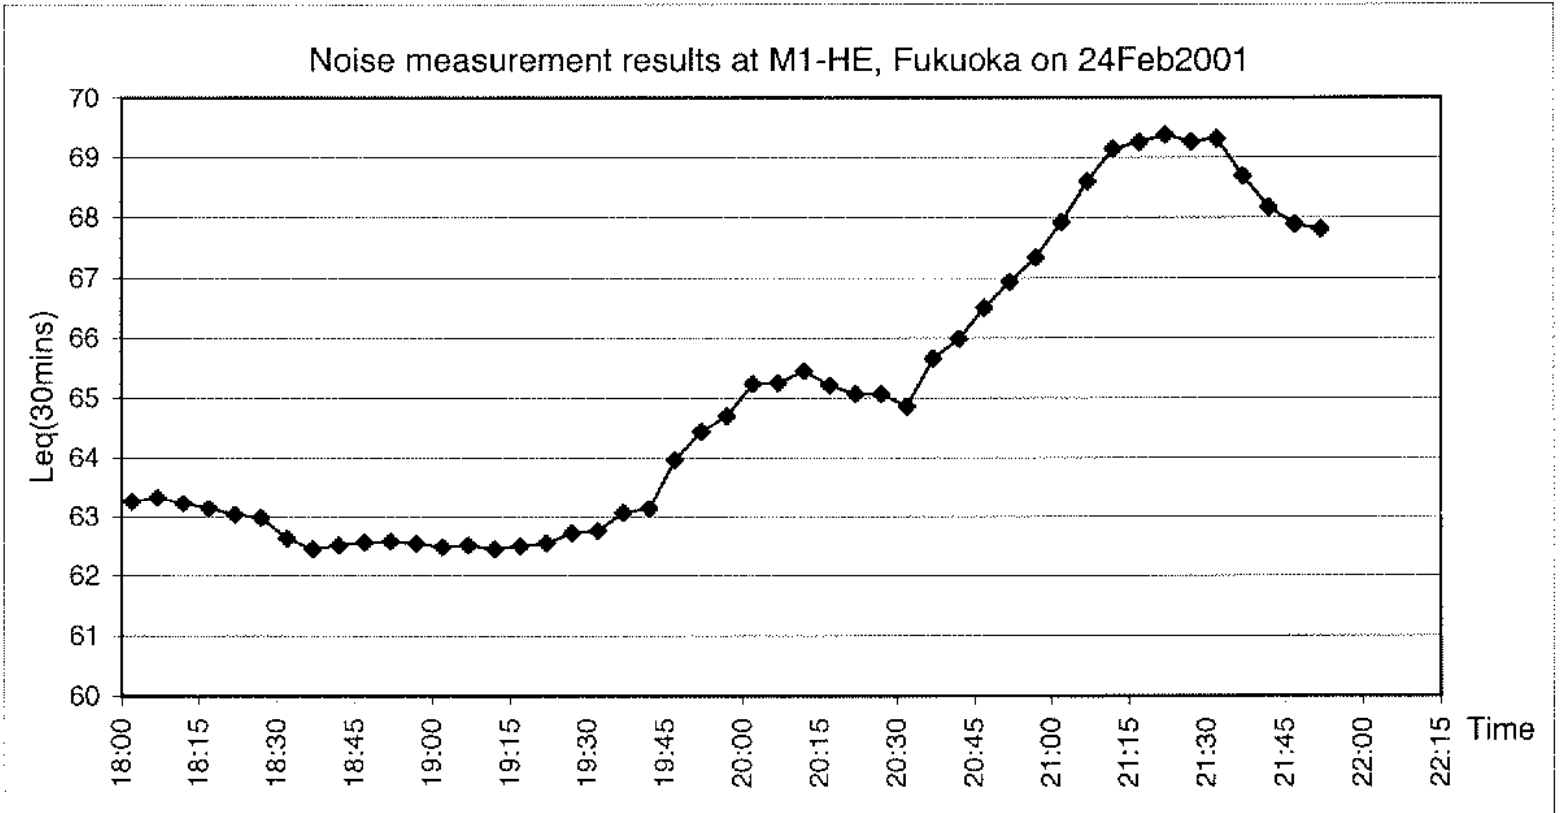
SEKDFS
STADIUM NOISE MONITORING
FEB 2001
Location M1-HE
24 February 2001 Concert Period

*Noise measurement affected by strong wind >5m/s, some record noise was due to wind, results not reliable.

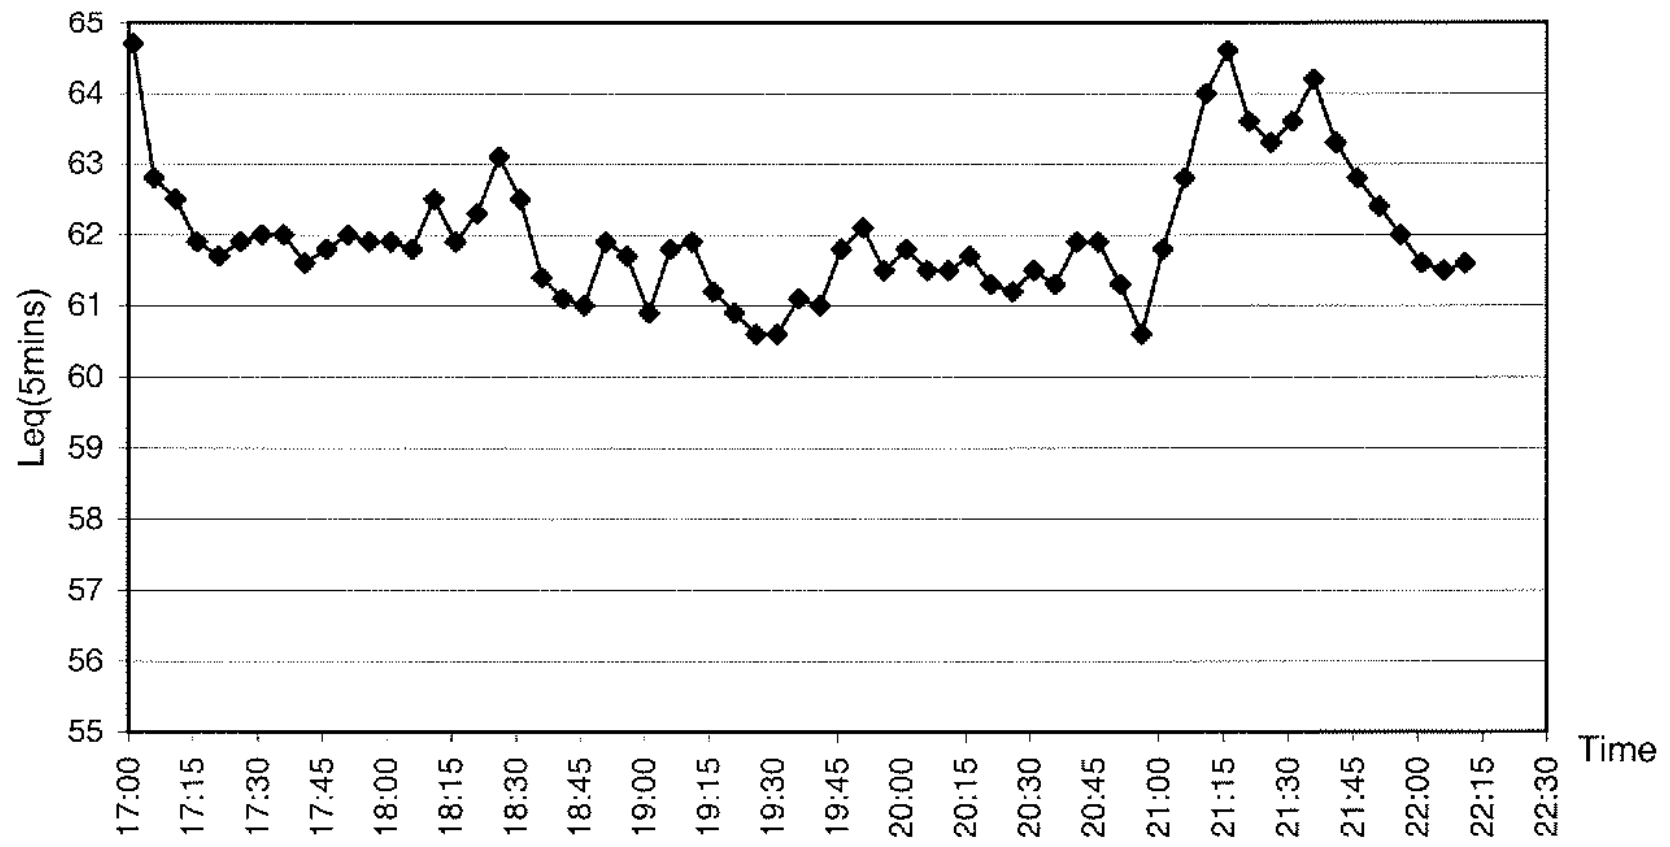
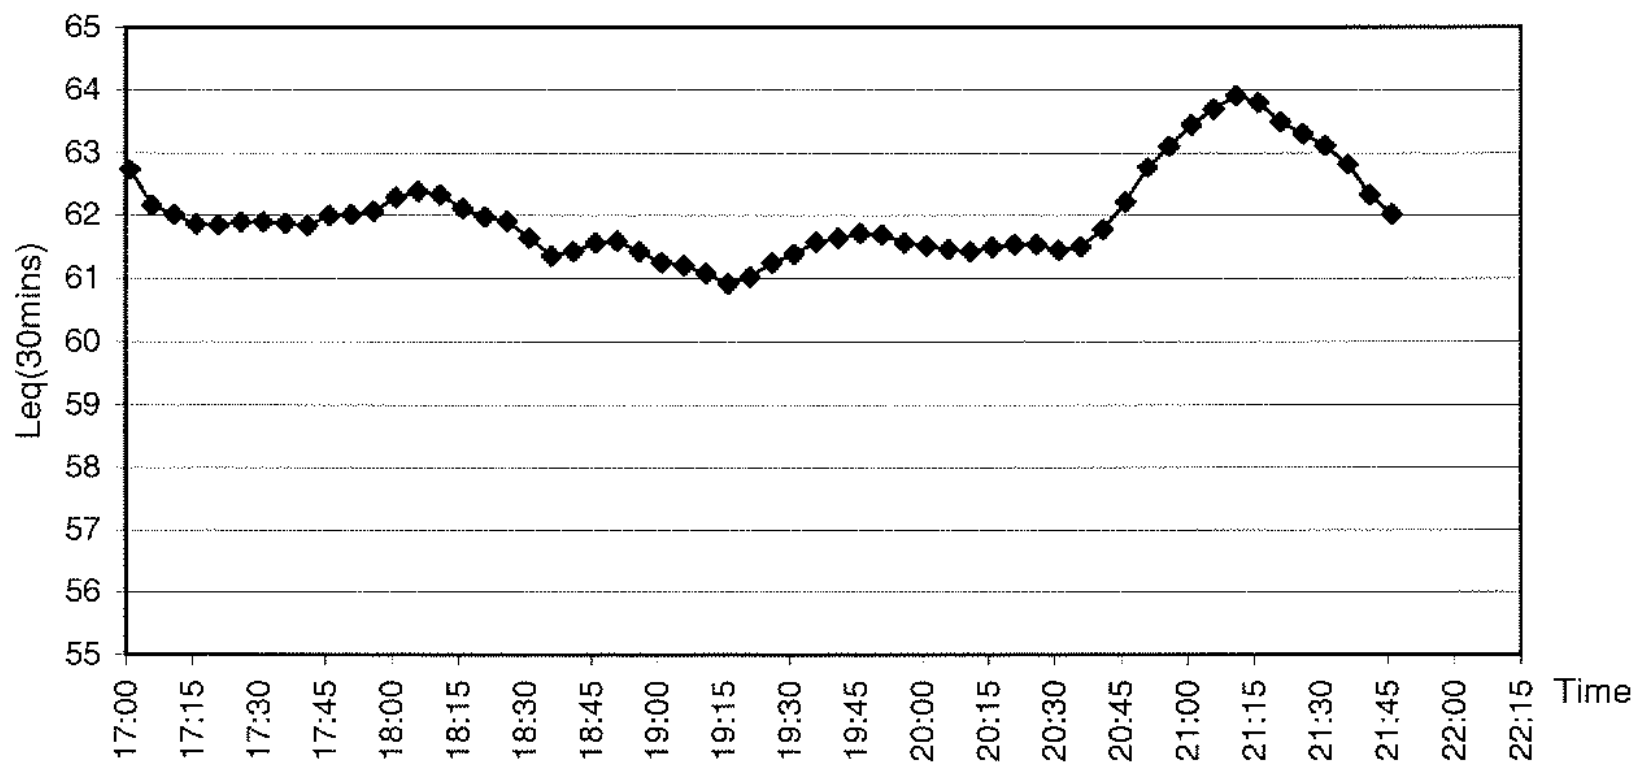
Noise measurement results at M1-HS, Fukuoka on 24Feb2001

Comparing the monitoring results at M1-HS, the noise level during the concert was L_{eq} 61.5 dB(A) overall during the entire concert period. (Please also see the Appendix A for noise variations during different periods.) This is similar to background readings obtained so far, L_{eq} 61.9 dB(A) on 24/2 am, L_{eq} 61.8 on 24/2 pm, L_{eq} 62.2 dB(A) before the concert, L_{eq} 63.1 db(A) after the concert.

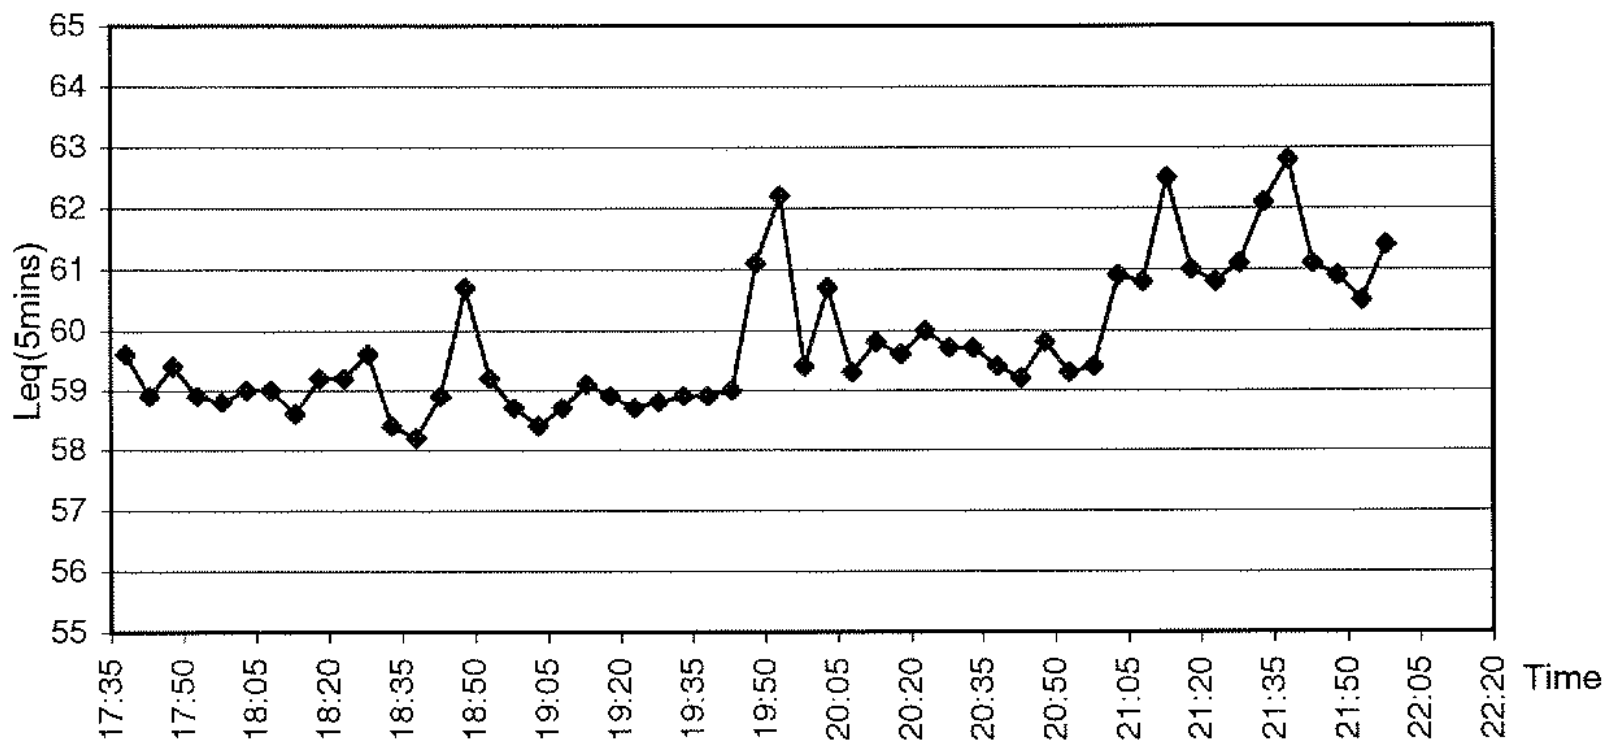
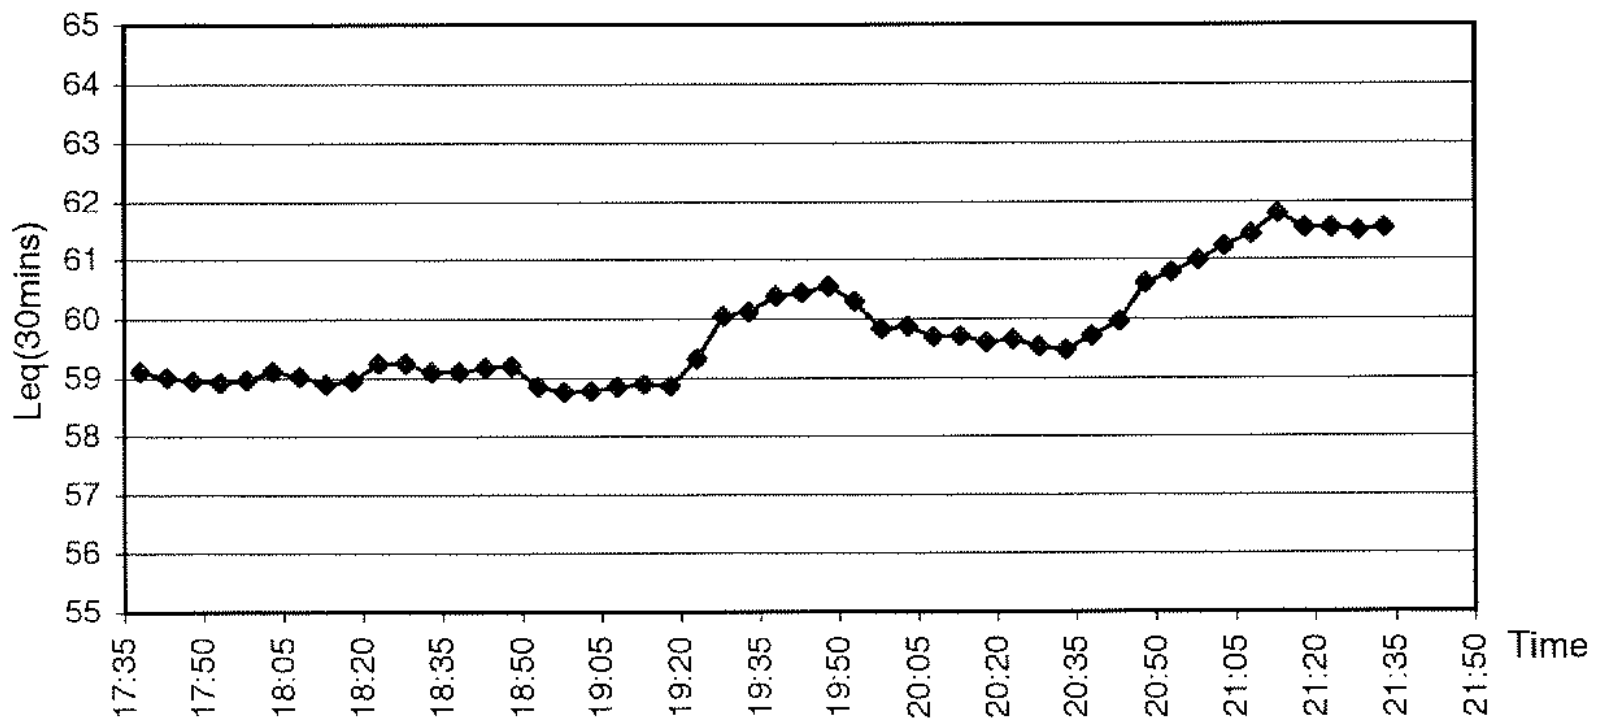
Noise measurement results at 7/F Sea Hawk Hotel, Fukuoka on 24Feb2001

Comparing the monitoring results at M1-L, the noise level during the concert was L_{eq} 59.6 dB(A) overall during the entire concert period (Please also see the Appendix A for noise variations during different periods.) The position was closed to the Dome but was slightly lower than the retractable roof portion and was relatively shielded from traffic noise. Similar noise levels were obtained compared to measurement results without the concert. Noise from concert was not noticed during the monitoring period as revealed by the monitoring team.

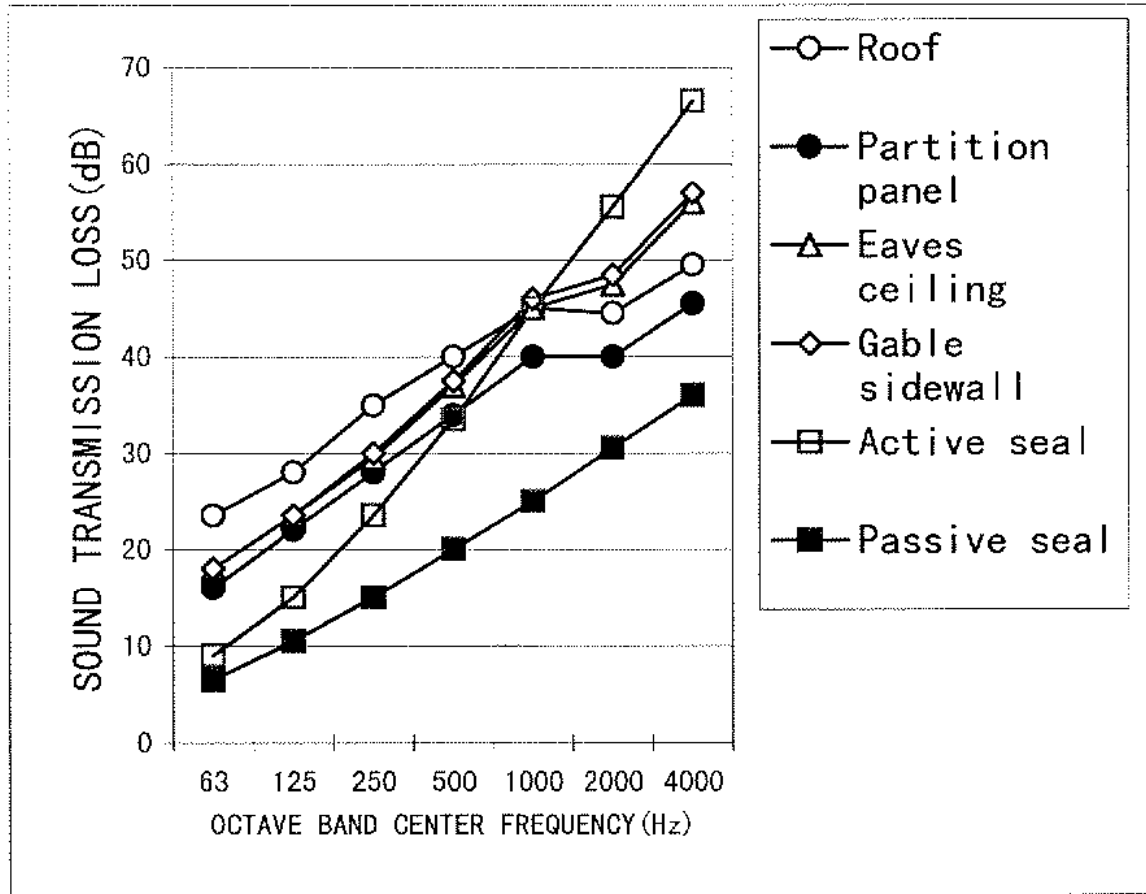
Fig.1 Sound transmission loss of each part of Fukuoka dome roof

Regarding the retractable roof, the sound transmission loss information revealed that the transmission loss was ranged from 37.5 dB to 66.9 dB for materials roof, partition panel, eaves ceiling, gable sidewall, active seal, passive seal. Such estimated level of sound transmission loss was anticipated able to reduce the noise from the Dome for rock concert. A point to note is that the transmission loss is low for low frequencies noise compared to high frequencies noise.

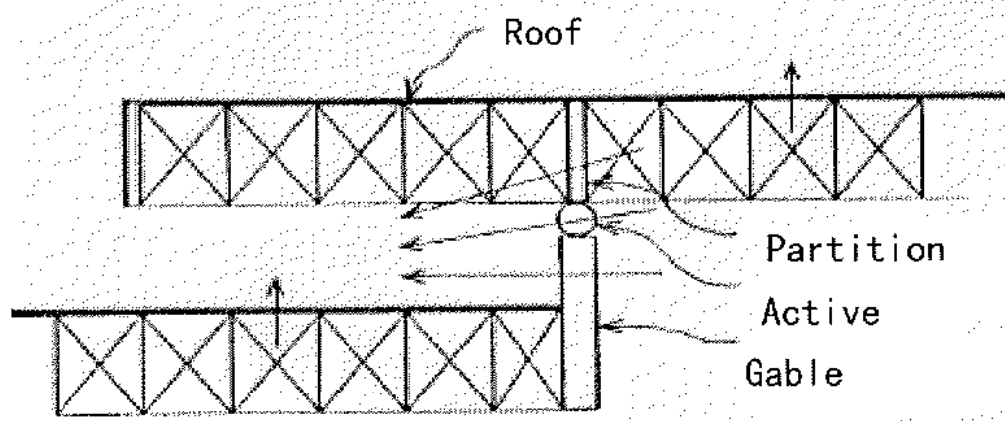
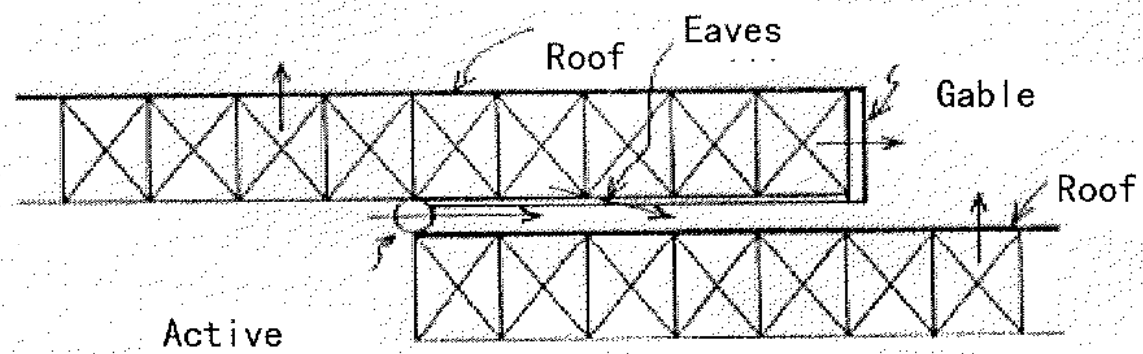
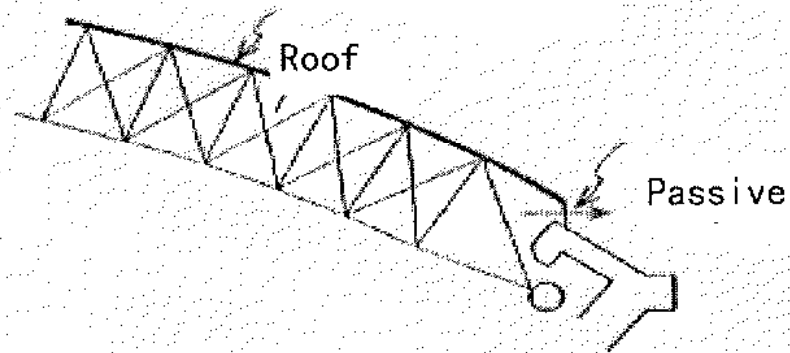
Fig. 2 Model of transmission

Each part	Section specification
Roof	Titanium 0.3mm+excelsior-board25mm(25kg/m ²) +air space100mm +fiber glass50mm(48kg/m ³)
Partition panel	Excelsior-board25mm(25kg/m ²)
Eaves ceiling	Stainless steel0.8mm+air space15mm+excelsior board25mm(25kg/m ²)
Gable sidewall	Stainless steel0.8mm+air space25mm+excelsior board25mm(25kg/m ²)
Active seal	Upper part;Chloroprene rubber3mm+air space300+chloroprene rubber3mm Lower part;Chloroprene rubber5mm+air space400+chloroprene rubber5mm
Passive seal	Chloroprene rubber5mm

a) Junction of upper roof and lower roof

b) Junction of middle roof and lower

c) Roof

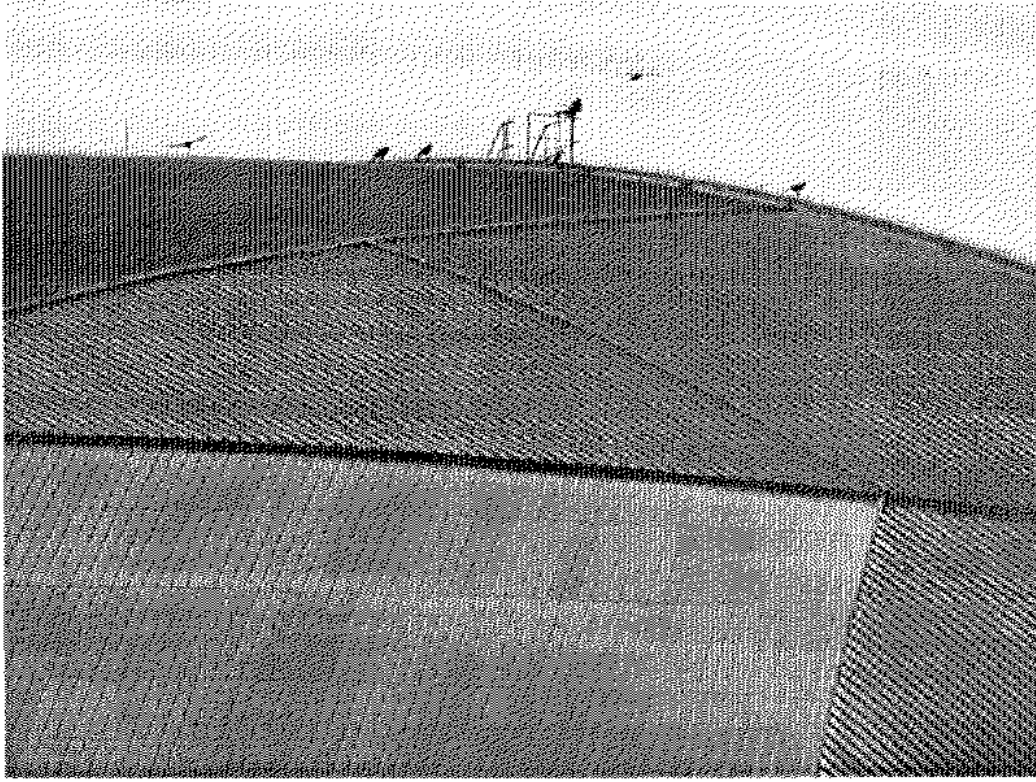
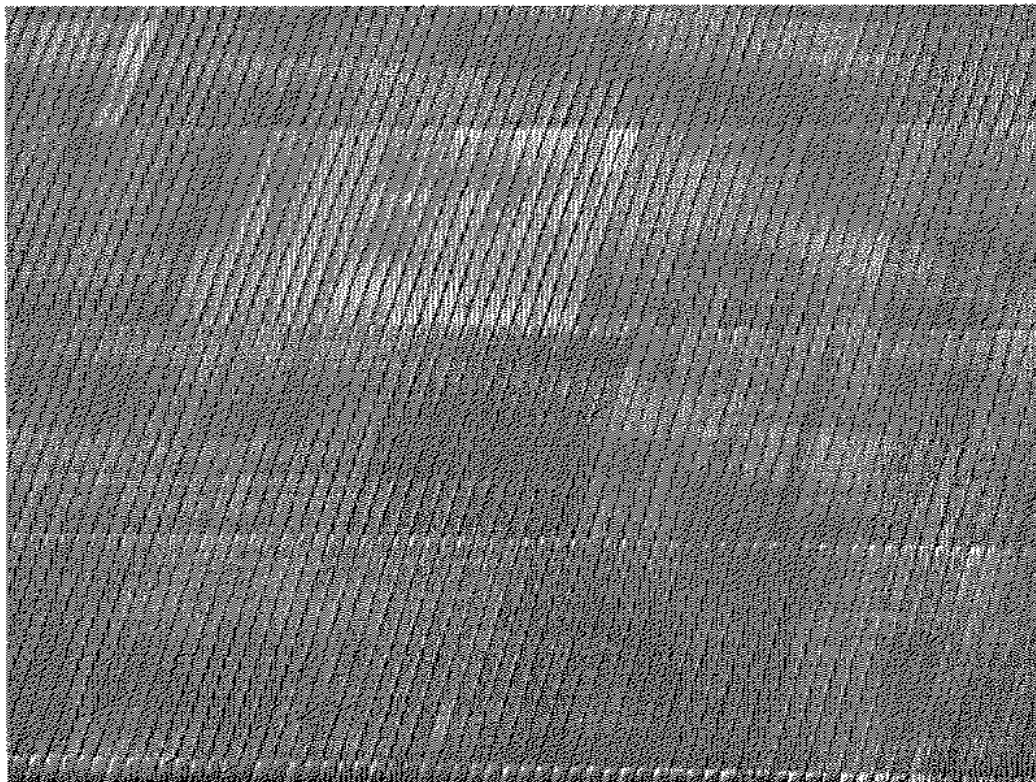
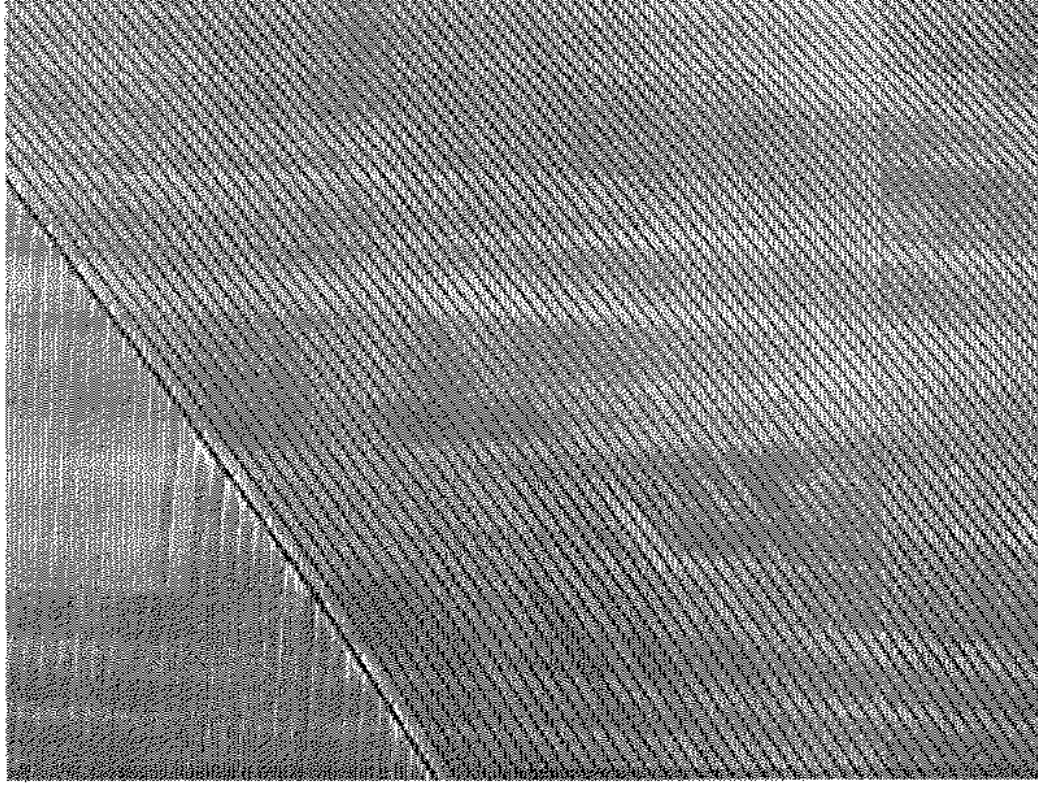
Photo 3 – Roofing material of Fukuoka Dome

Photo 4 – Roofing material of Fukuoka Dome

Photo 5 – Roofing material of Fukuoka Dome
