APPENDIX 3D

DETAILS OF STADIUM NOISE IMPACT ASSESSMENT

APPENDIX A3.4

REPORT ON STADIUM NOISE MONITORING

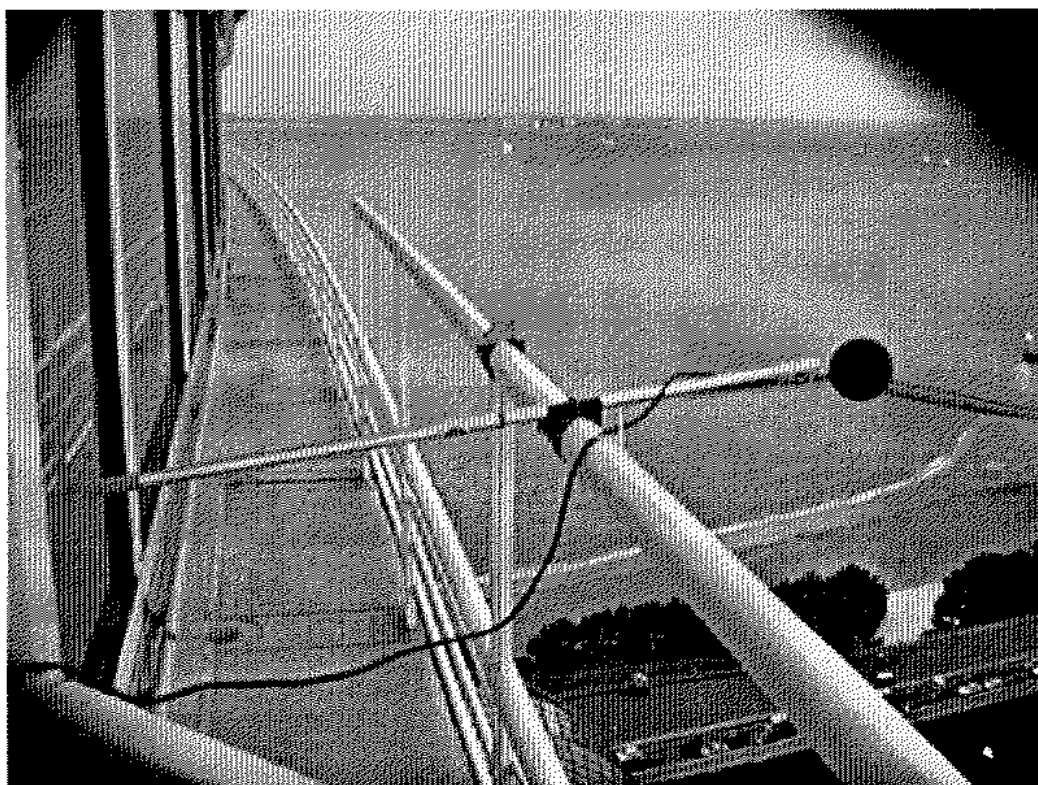
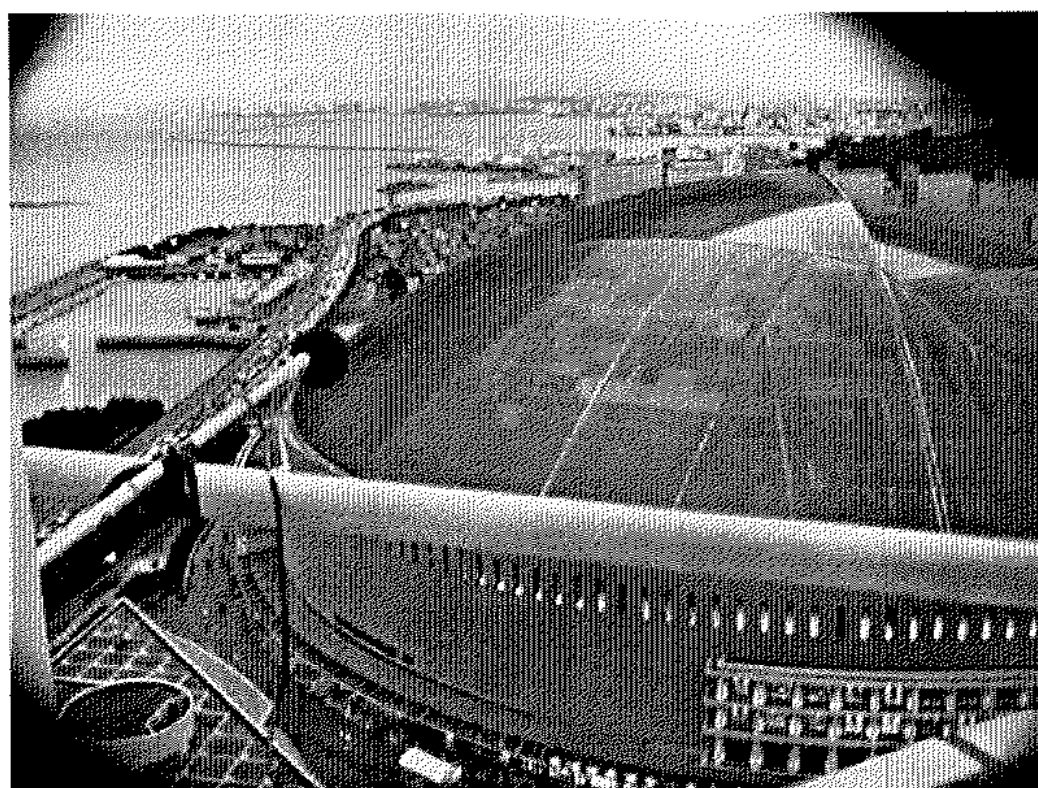
Photo 9 – Location of M1-HE at balcony of 29/F of Sea Hawk Hotel

Photo 10 – Location of M1-HE at balcony of 29/F of Sea Hawk Hotel

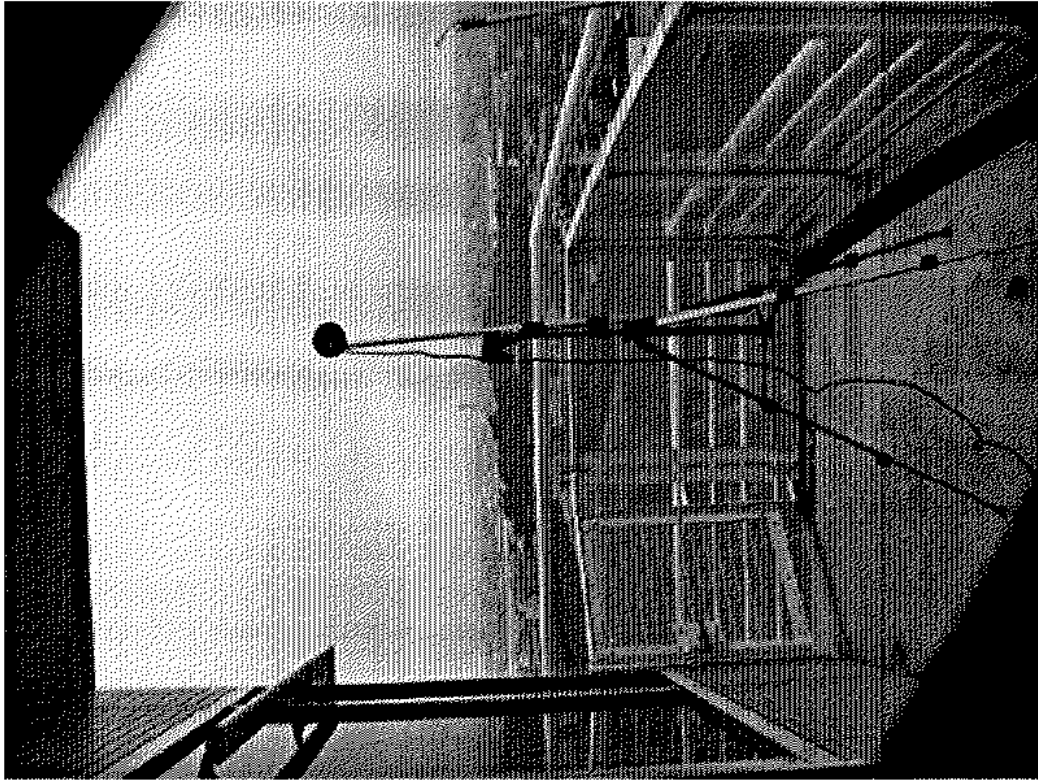
Photo 11 – Location of M1-HS at 29/F of Sea Hawk Hotel

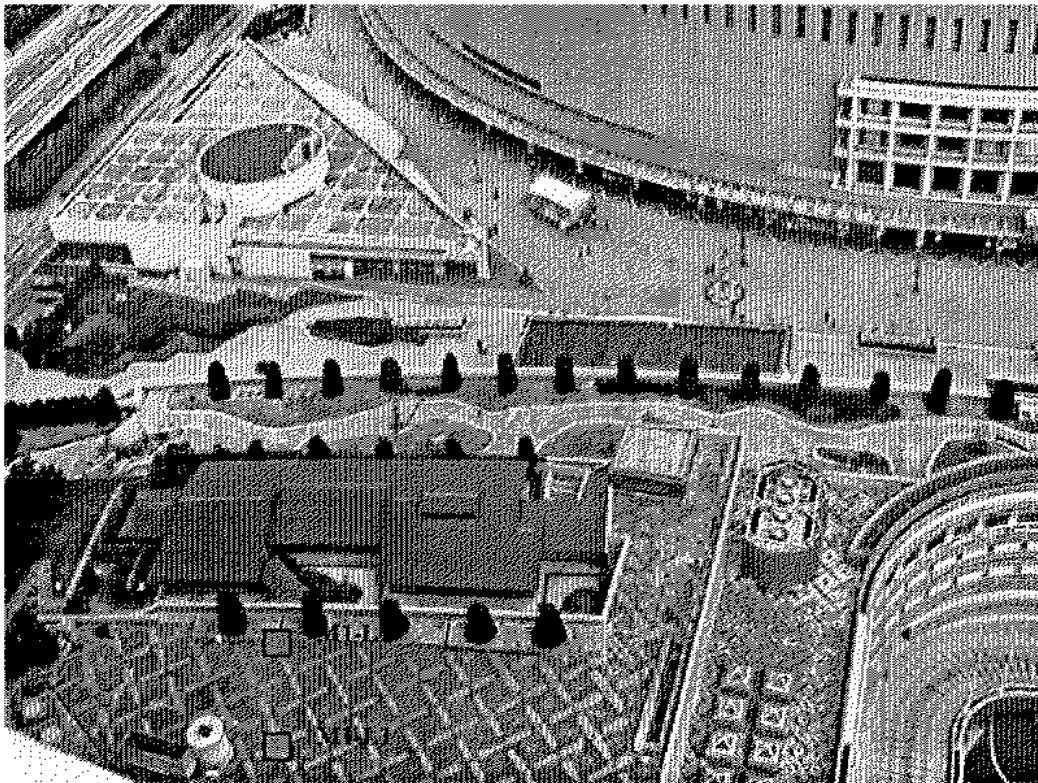
Photo 12 – Location of M1-L1 & M1-L2 at 7/F podium of Sea Hawk Hotel

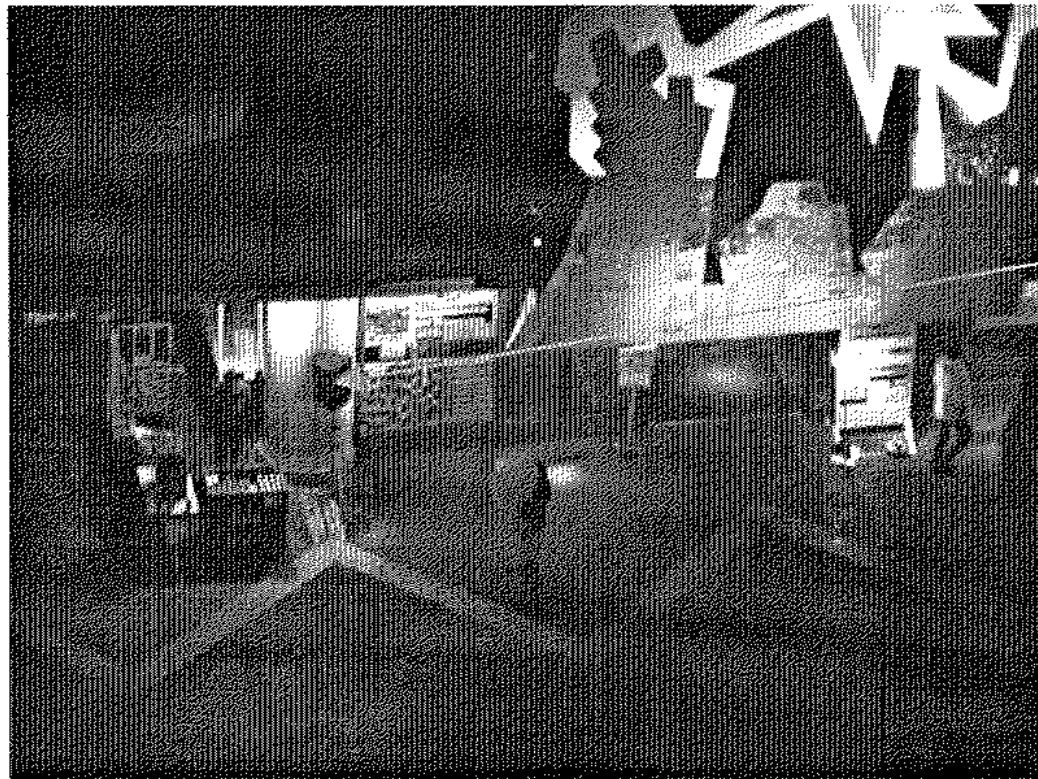
This loudspeaker broadcasting music which was heard at 29/F at M1-H

Photo 20 – Loudspeaker at the entrance of Fukuoka Dome, outside a pub

The monitoring team also carried out checking around Dome. It was observed that the door of the gate entrance was acoustically sealed. Noise from the concert was not noticed outside. Only some music from the loudspeakers hanging around the entrance level was noted.
