Scale: NTS	Project: Contamination Assessment Plan for Yau Tong Bay

EHS CONSULTANTS LIMITED
Figure:		
Title: Location of Activities Identified at the Subject Site During Preliminary Assessment

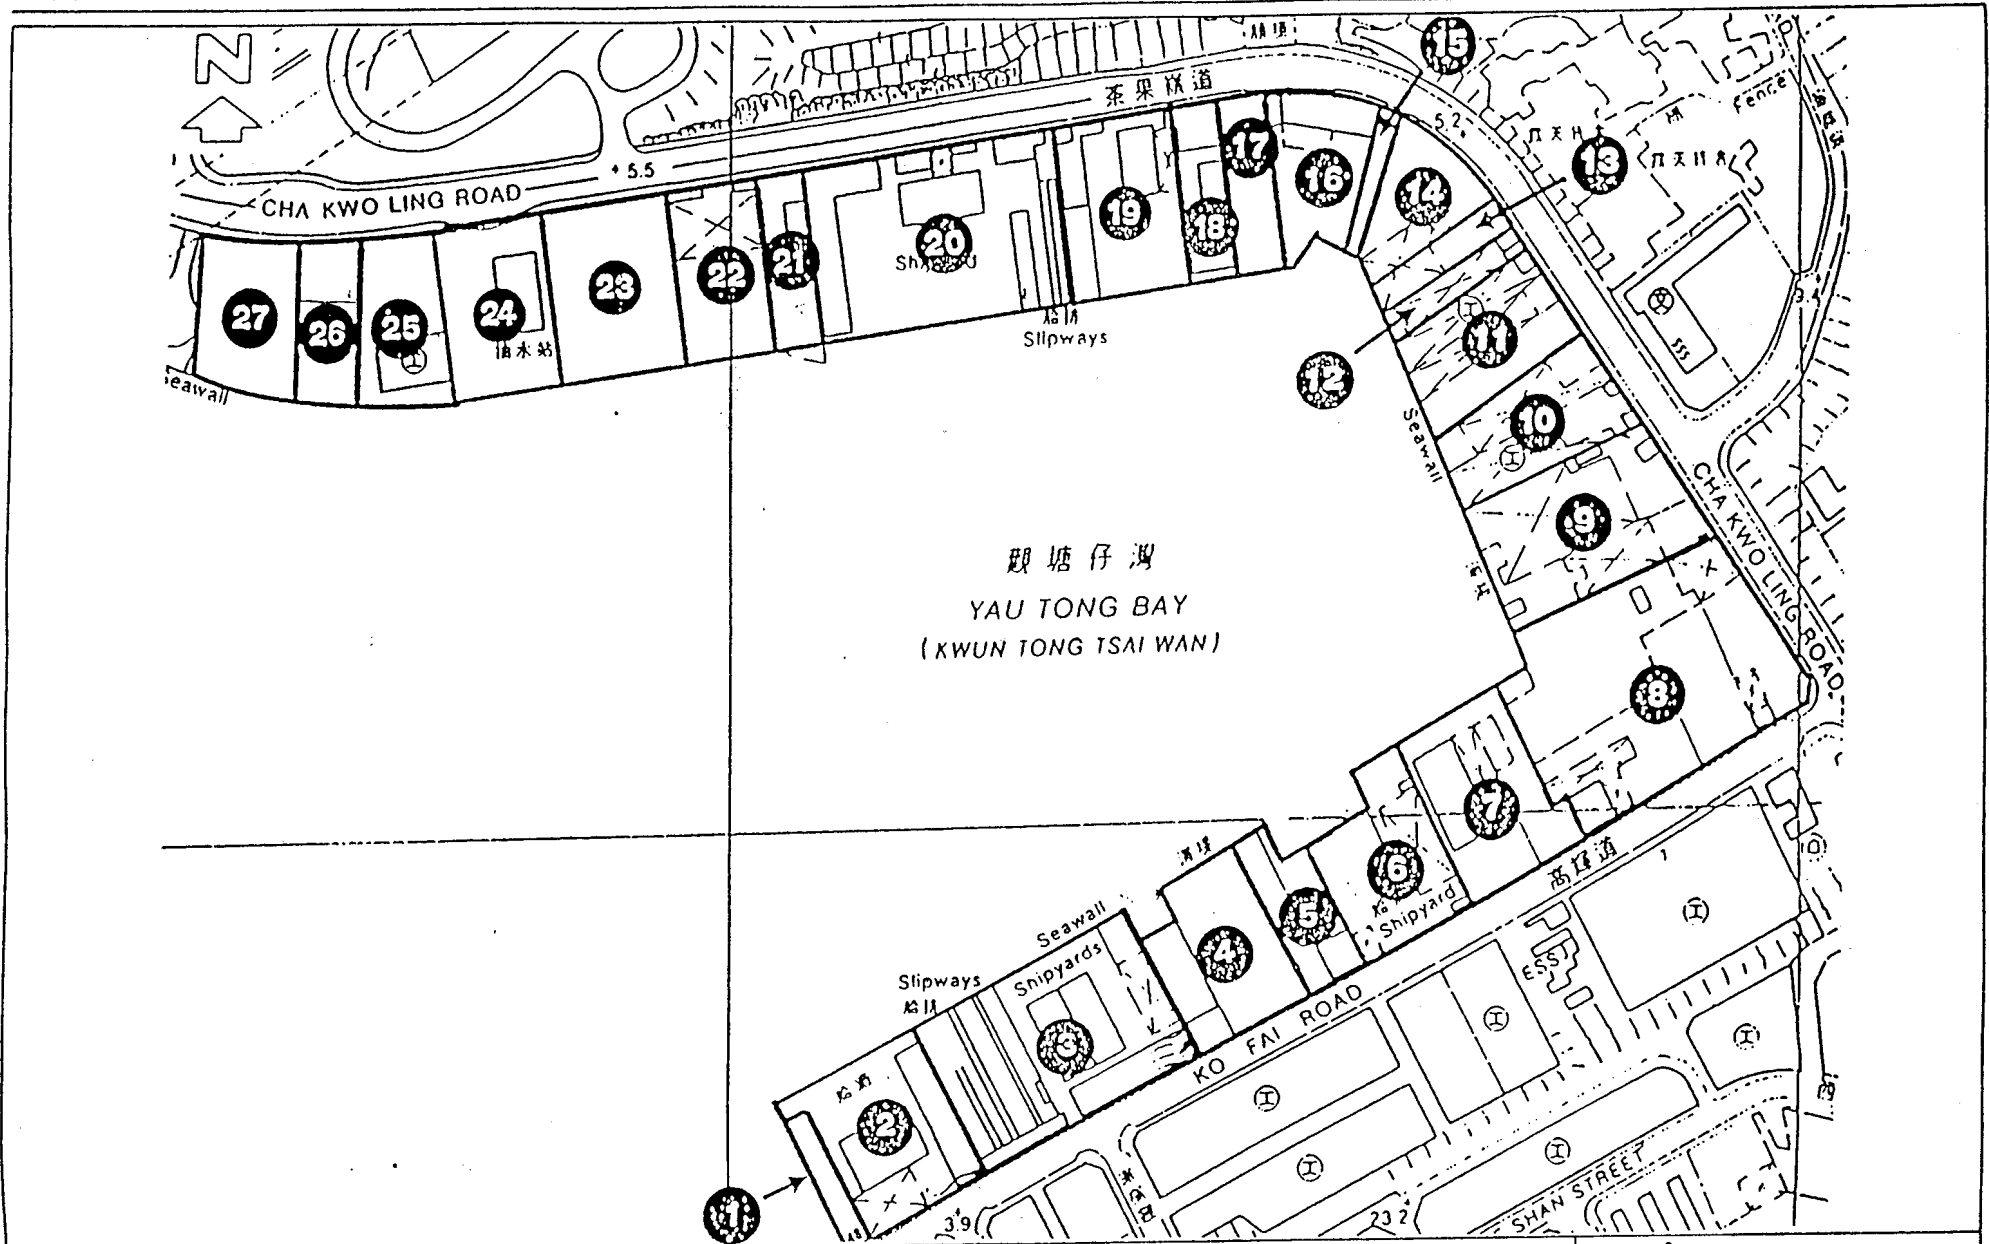
Reference No. in Figure1-1	Company Name	Description	Possible Contaminants
1	Bonanza Saw-Mill Ltd.	Saw-mill, wood storage	Less significant
2	Universal Dockyard Ltd.	Shipyards	Petroleum hydrocarbon, heavy metals
3	Yau Wing Co. Ltd.	Ship repair workshop, in-house DG store	Petroleum hydrocarbon, heavy metals
4	Redland Cement Ltd.	Cement manufacturing	Less significant
5	Hong Kong Dredging Ltd.	Office, workshop	Petroleum hydrocarbon, heavy metals
6	Man Wah Ltd.	Bricks and cement packaging	Less significant
7	Kwok Wing Ltd.	Vacant	Insufficient information
8	Hop Fat Metals Tin Wai Warehouse	Vacant	Insufficient information
9	Wing Tai Cheong Saw-Mill	Saw-mill, wood storage	Less significant
10	EI Freight (HK) Ltd.	Cargo storage	Less significant
11	Bonanza Saw-Mill Ltd.	Saw-mill, wood storage	Less significant
12-1	Kei Yip Car Repair	Car repair workshop	Petroleum hydrocarbon, heavy metals
12-2	Kwok Luen	Tyre supplier	Less significant

13	Sing Tai Saw-Mill	Saw-mill, wood storage	Less significant
14	N.A.	Vacant	Insufficient information
15	Rainbow Transportation and Warehouse Ltd.	Warehouse, no DG storage	Less significant
16	Wai Sing Car Repair	Car repair workshop	Petroleum hydrocarbon, heavy metals
17	Wing Wui Co. Ltd.	Cement and bricks manufacturing (ship repair in the past)	Petroleum hydrocarbon, heavy metals
18	Brigantine Services Ltd.	Machine repair workshop	Petroleum hydrocarbon, heavy metals
19	Sam Woo Ship Building Ltd. Sam Woo Engineering Equipment Ltd.	Machine workshop	Petroleum hydrocarbon, heavy metals
20	N.A.	Vacant, abandoned land, signs of uncontrolled waste dumping	Insufficient information
21	Goltens Hong Kong Ltd.	Ship repair workshop	Petroleum hydrocarbon, heavy metals
22	Kwong Hing Cement	Cement manufacturing	Less significant
23	Agincourt Industrial Building	Multi-storey industrial building	Insufficient information
