Designed By <b>ECO</b>	  <b>路政署</b> <b>HIGHWAYS DEPARTMENT</b> 主要工程管理處 Major Works Project Management Office	Consultant <b>ARUP</b> 奧雅納工程顧問 Ove Arup & Partners Hong Kong Limited	Project Title <b>Shenzhen Western Corridor Investigation &amp; Planning</b>	Drawing Title <b>Lotus Bridge in Macau SAR showing mudflats and mangrove plantations</b>	Client Filename	Client Date	
		Drawn By <b>YML</b>		Supported By: Environmental Management Ltd. BMT Asia Pacific Ltd. Urbis Ltd.			Scale N/A		
		Checked By <b>TDD</b>					Drawing No. <b>Figure 9.13</b>		
		In Charge <b>TDD</b>					Drawing Status	Rev. <b>0</b>	
		Date <b>15 Apr 02</b>							
Mark	Date	By	Rev.

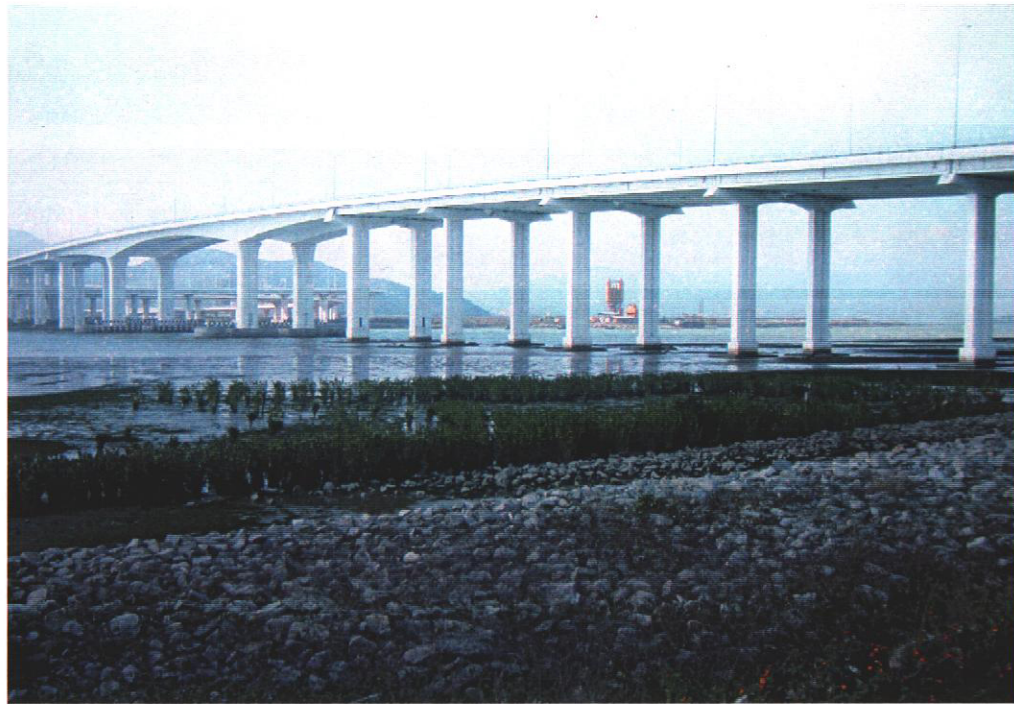
(a) Lotus Bridge viewed from southeast, showing arched sections over navigation channel, 35m pier spacing, mangrove plantation on mudflat (foreground), and inundated mudflat (behind mangrove).

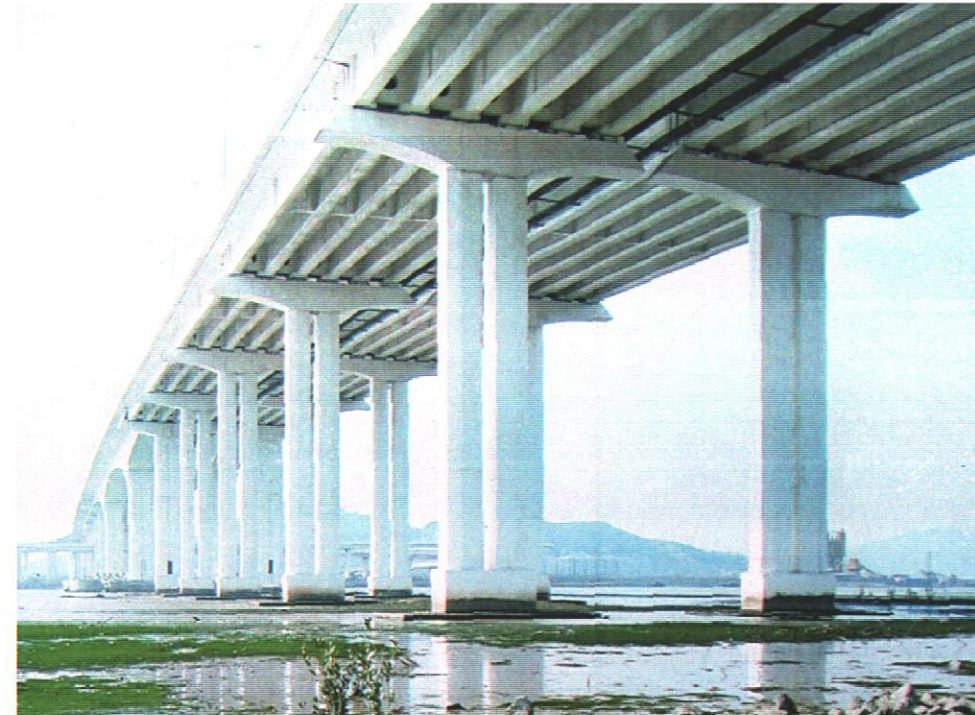
(b) Lotus Bridge seen from below, showing pairs of piers, pile caps above mud surface, and slope-covered mudflat.

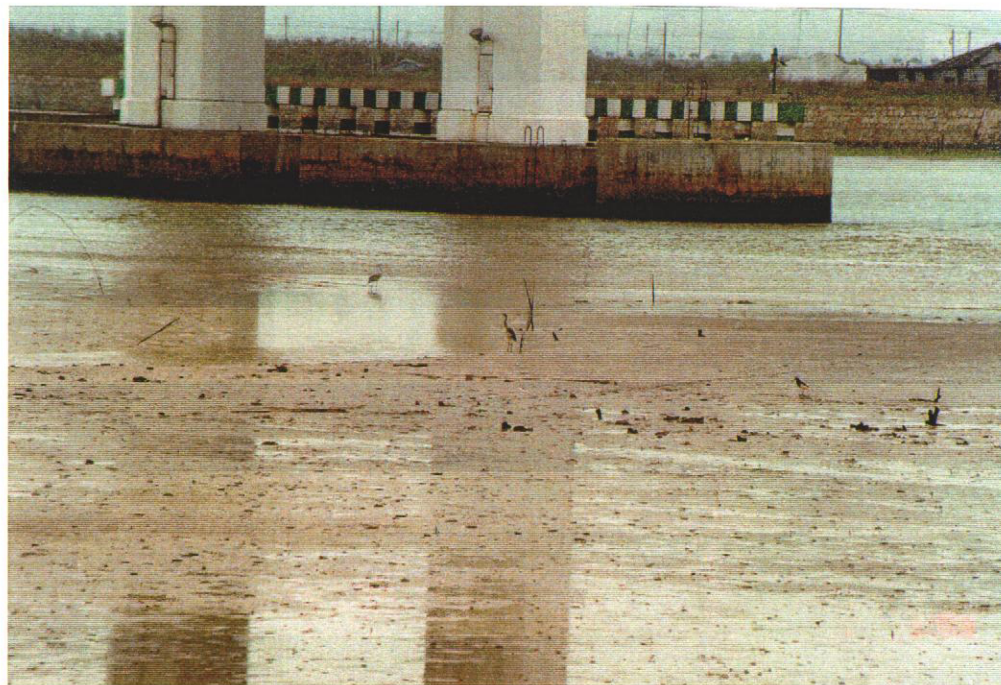
(c) Mudflat beneath Lotus Bridge showing Grey Herons and Chinese Pond Heron foraging near navigation channel.

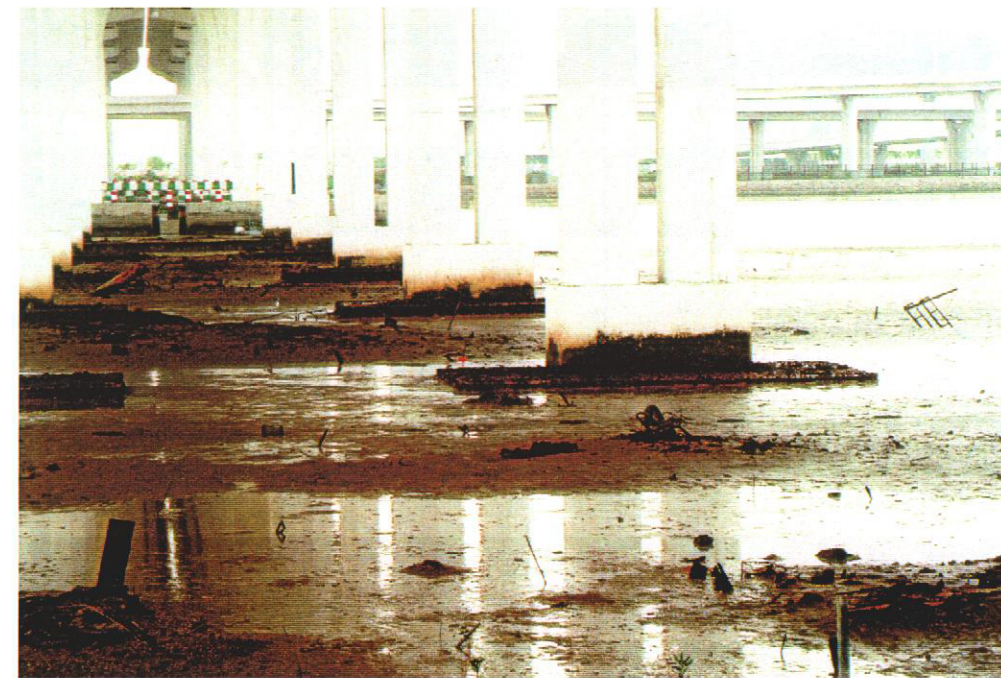
(d) View of poor quality mudflat restoration beneath Lotus Bridge, showing construction debris (wheel barrow, trolley, pipe), uneven mud surface, and pile caps above mud surface.
