Agreement No.CE 6 / 2002 (DS)
Drainage Improvement in Northern New Territories Package C Investigation, Design and Construction
MUP 03 , 04A/B & 05 -Visually Sensitive Receivers - VSR 05 & 06

Figure No. 8.4A-iii

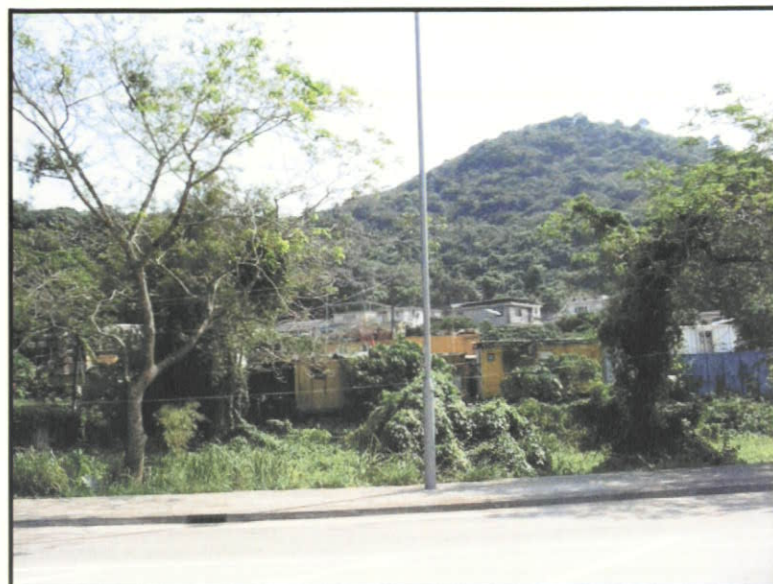
(MUP 03 , 04A/B ,05) VSR 05

Visually Sensitive Receivers - VSR	Description of Visually Sensitive Receivers	Number of Individuals (Many/ Fair/ Few/ Very Few)	Quality of Existing View (Good / Fair / Poor)	Minimum Distance between VSRs & Impact Source	Degree of Visibility (Full /Partial /Glimpse)	Frequency of View (Very Frequent / Frequent / Occasional / Rare)	Sensitivity to Change (High/Medium /Low)
VSR 5	Residents @ toe of Princess Hill (Individual Village houses/ Rural Fringe area)	Few	Fair	Approx. 80m	Glimpse	Rare	Low

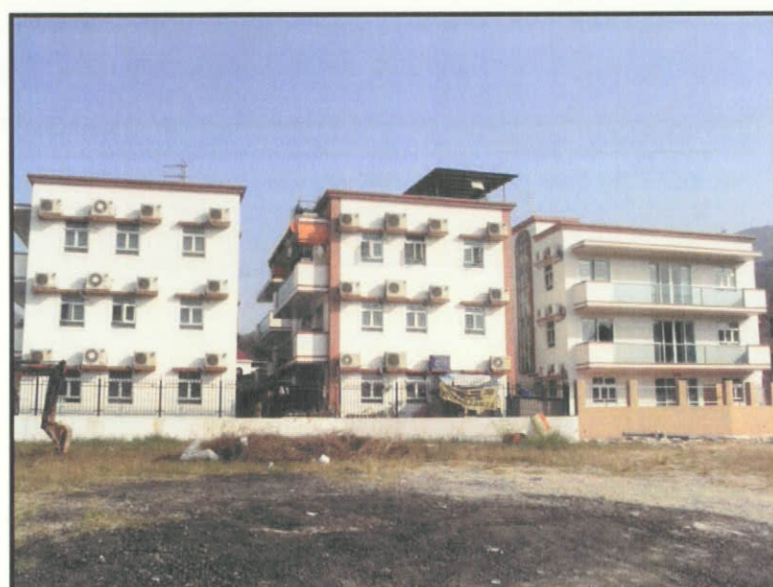
(MUP 03 , 04A/B ,05) VSR 06

Visually Sensitive Receivers - VSR	Description of Visually Sensitive Receivers	Number of Individuals (Many/ Fair/ Few/ Very Few)	Quality of Existing View (Good / Fair / Poor)	Minimum Distance between VSRs & Impact Source	Degree of Visibility (Full /Partial /Glimpse)	Frequency of View (Very Frequent / Frequent / Occasional / Rare)	Sensitivity to Change (High/Medium /Low)
VSR 6	Residents @ Loi Tung (Individual Village houses/ Rural Fringe area)	Many	Fair	Approx 50m	Full	Frequent	Medium
