Agreement No.CE 6 / 2002 (DS)

Drainage Improvement in Northern New Territories Package C Investigation, Design and Construction

MUP 03 , 04A/B & 05 -Visually Sensitive Receivers - VSR 13 & 14

Figure No. 8.4A-vii

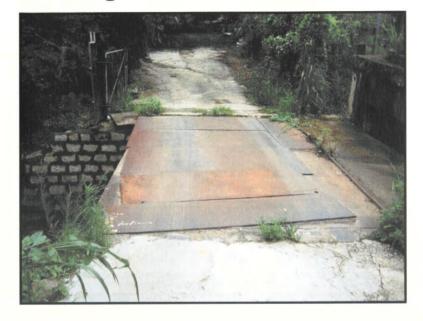
(MUP 03 , 04A/B ,05) VSR 13

Existing View

Visually Sensitive Receivers - VSR	Description of Visually Sensitive Receivers	Number of Individuals (Many/ Fair/ Few/ Very Few)	Quality of Existing View (Good / Fair / Poor)	Minimum Distance between VSRs & Impact Source	Degree of Visibility (Full /Partial /Glimpse)	Frequency of View (Very Frequent / Frequent / Occasional / Rare)	Sensitivity to Change (High/Medium /Low)
VSR 13	Road Users of Sha Tao kok Road-Wo Hang (Along the road near MUP03A)	Many	Fair	< 30m	Full	Very Frequent	Low

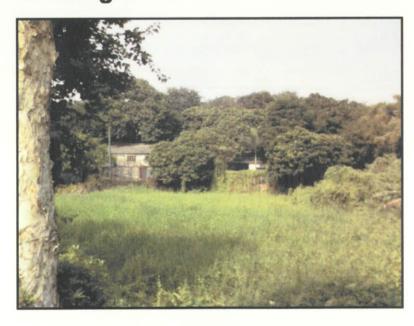
(MUP 03 , 04A/B ,05) VSR 14

Existing View

Visually Sensitive Receivers - VSR	Description of Visually Sensitive Receivers	Number of Individuals (Many/ Fair/ Few/ Very Few)	Quality of Existing View (Good / Fair / Poor)	Minimum Distance between VSRs & Impact Source	Degree of Visibility (Full /Partial /Glimpse)		Sensitivity to Change (High/Medium /Low)
VSR 14	Residents @ toe of small hill next to MUP01 (Individual Village houses/ Rural Fringe area)	Many	Fair	Approx 25m	Full	Frequent	Low
