Agreement No.CE 6 / 2002 (DS)
Drainage Improvement in Northern New Territories Package C Investigation, Design and Construction

Residual Visual Impact - LMH 01 (VSR 07)

Figure No. 8.8B

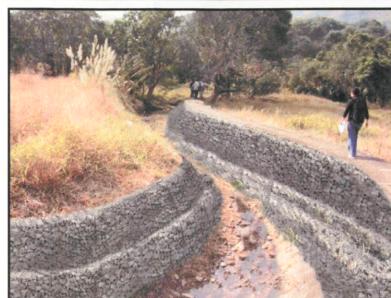
Day 1 Unmitigated View

LMH 01 (VSR 07) - Visual Impact Unmitigated

Visually Sensitive Receivers - VSR	Description of Visually Sensitive Receivers	Minimum Distance between VSRs & Impact Source	Magnitude of Change	Sensitivity to Change	Significance Threshold - Landscape Impact
VSR 7	Residents near the temple @ Lin Ma Hang (Low Rise Housing Development)	Approx. 35m	Small	Medium	Slight Impact

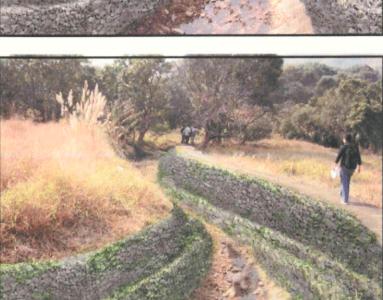
Day 1 Mitigated View

LMH 01 (VSR 07) - Visual Impact After Mitigation

Visually Sensitive Receivers - VSR	Description of Visually Sensitive Receivers	Magnitude of Change	Sensitivity to Change	Landscape Mitigation Measures	Significance Threshold - Landscape Impact
VSR 7	Residents near the temple @ Lin Ma Hang (Low Rise Housing Development)	Small	Medium	LMM 1	Negligible
