Project: Harbour Area Treatment Scheme (HATS) Stage 2A: Built Heritage Impact Assessment – Investigation	Location: Fortress Hill	Ref # HATS-01
Originally Recorded: 14/05/07	Updated On: N/A	
Original Usage: Former club house of the Royal Hong Kong Yacht Club	Current Usage: Governm	ent
Orientation: North	Map Reference: #12 Oil S	treet
Construction Date: Early part of the 20 th Century	Ownership: Government	
Setting: Urban commercial district	Historical Associations: N	one
Condition: Good	Degree of Modification: Low	
Architectural Significance: High	Cultural Significance: Moderate

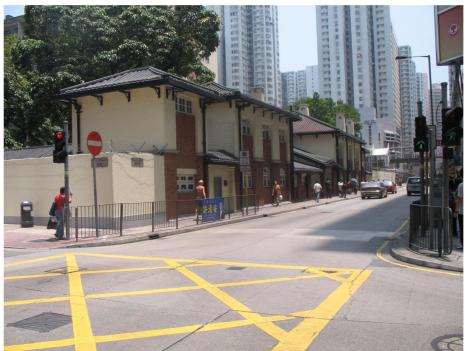
Description: Red brick building with covering over some upper sections. Two large rectangular two storey buildings with single storey middle section, side buildings also single storey. Tile roof with black covered chunam rolls. Roofs of the two strory sections of the building are supported by wooden brackets. The area in front of the building has mature trees.

View of the Former Yacht Club House(前香港皇家遊艇會會所) at Electric Road (HATS-01)

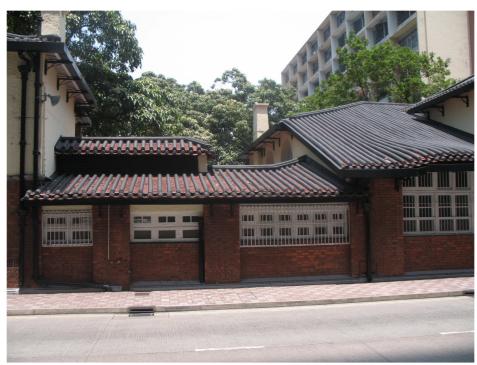
Close up of central rear section of the former Yacht Club House (前香港皇家遊艇會會所) at Electric Road (HATS-01)

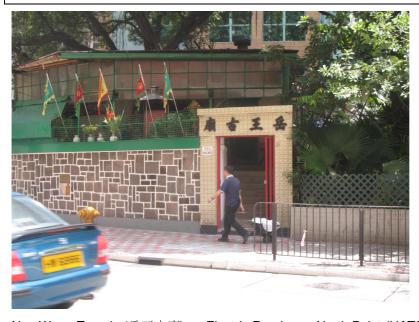
Description: Metal and glasss building with granite wall along roadside. Area in the compound has trees. Modern gate with inscription leading into the compound.

Ngo Wong Temple (岳王古廟) on Electric Road near North Point (HATS -02)

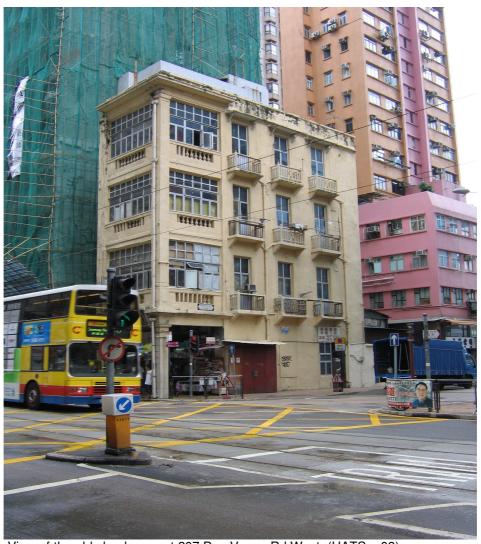
Description: Four storey rectangular concrete structure with flat roof. The ground floor has retained the original architectural style of shop in central and back section of the building with a covered area over pavement supported by two pillars. The three upper stories each have rooms above the front section. The front section of the building has windows over urn style balusters. The eastern side of the building (upper 3 floors) have three decorative balconies each with four paned window above. The building is painted cream in colour.

View of the old shophouse at 207 Des Veoux Rd West (HATS-03) 中環德輔道西 207 號

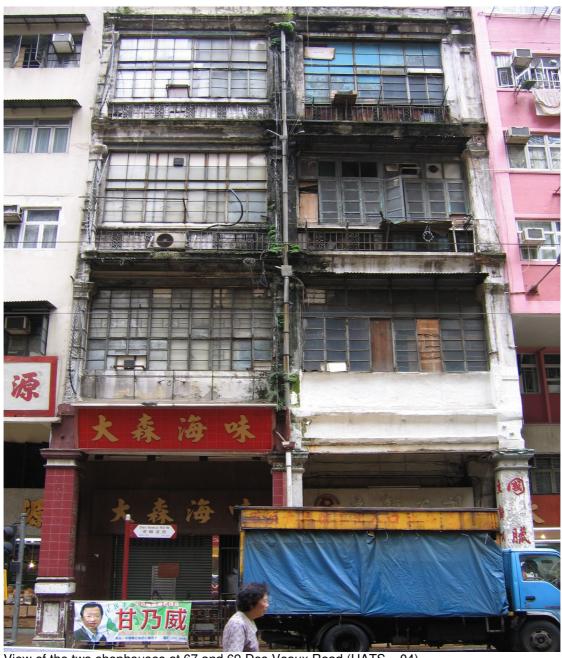
View of the two shophouses at 67 and 69 Des Veoux Road (HATS – 04) 中環德輔道西 67, 69 號

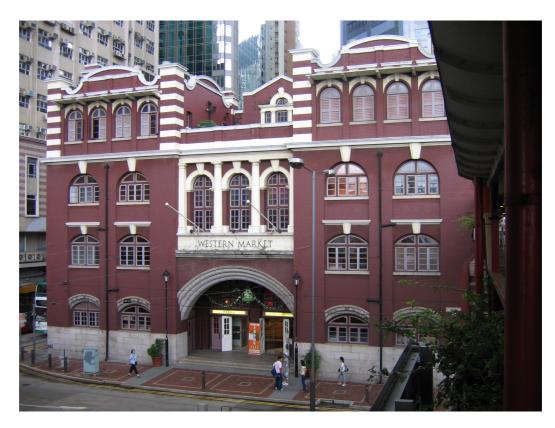
Description: Edwardian style brick structure. The exterior of the building has been painted. The building has three floors with four corner towers. Decorative features include rounded arches and bandaged brickwork

View of Western Market (HATS-05) 前上環街市 (西港城)

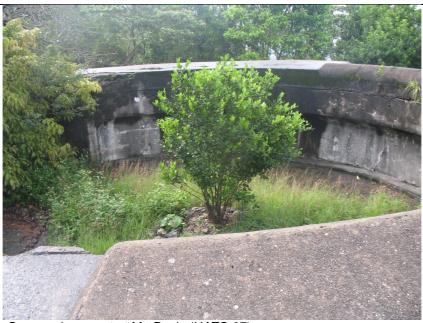
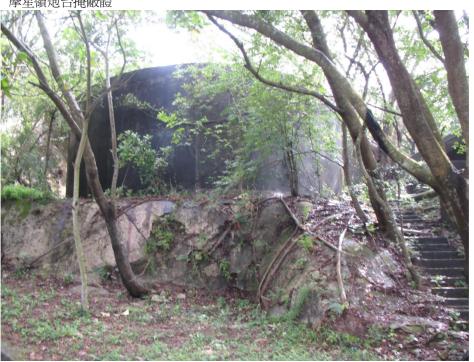
Description: Series of battery buildings and a series of 9.2 inch gun emplacements. The site was attacked by the Japanese during the Second World War and part sustained heavy damage. A site near the summit of Mount Davis is also the site as the Western Fire Command Headquarters

Gun emplacement at Mt. Davis (HATS-07) 摩星嶺炮台炮床

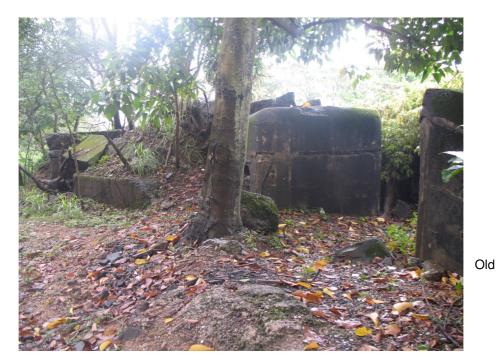
bunker at Mt. Davis (HATS-07) 摩星嶺炮台掩蔽體

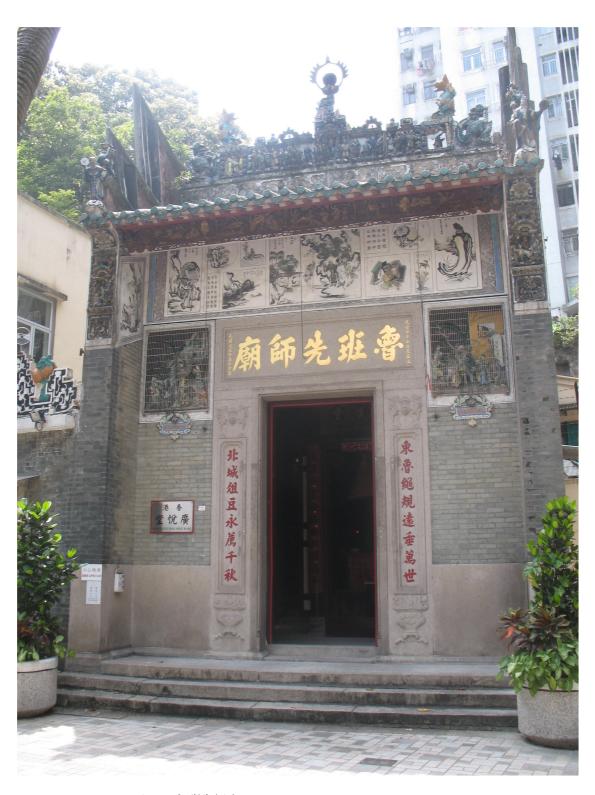
Description: Green brick structure with elaborate decorative features. Façade with piers at either end and three cut granite steps across the entire length of the façade. Decorative frieze panels across the top of the façade and also two panels with ceramic figures on either side of the entrance. Entranceway has cut granite frame with carved stone. Golden inscription above the door and red painted inscriptions on either side of the door. Stylised wok yee gables and decorative frieze panels.

Lo Pan Temple (HATS-08) 魯班先師廟

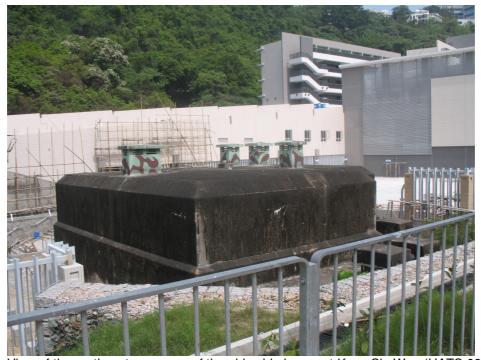
View of the northeastern corner of the old cable house at Kong Sin Wan (HATS-09) 鋼線灣前大東電報局電報站

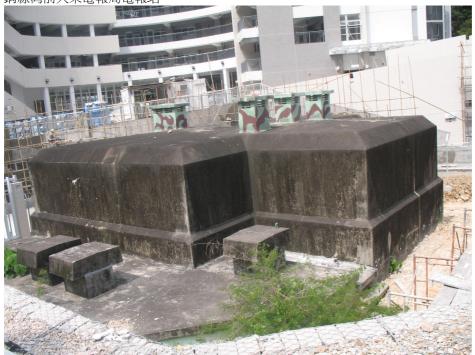
View of the southeastern corner of the old cable house at Kong Sin Wan (HATS-09) 鋼線灣前大東電報局電報站

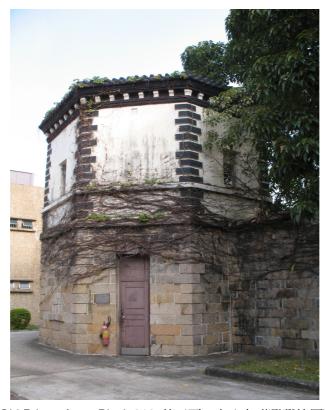
Block 318: Octagonal two storey structure. The ground floor is constructed of granite masonry blocks with quoins at the corners. There are small slit like openings in the stone work. The upper floor of the building has an exterior covered in render with quoins on all of the corners and a cornice (with dentil style decoration). The roof is Chinese style with round chunam covered end tiles. There is a modern wooden door on the ground floor at ground level and directly onto the pavement. There are modern glass windows in the upper storey.

Old Prison Area, Block 318 第三百一十八座(舊監獄範圍)

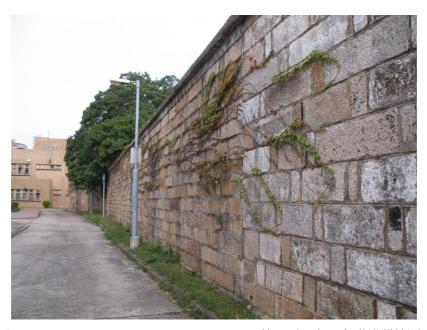
Old Prison Area, wall attached to Block 318 第三百一十八座(舊監獄範圍)

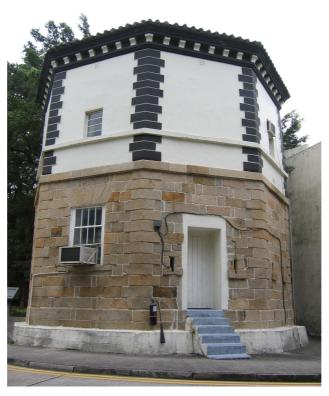
Block 319: Octagonal tower with two stories. Ground floor has a concrete foundation with cut granite block walls. There are two doors the first faces in a northerly direction and is situated above the current ground level and is reached by a set of concrete steps. The door is made of vertical wooden boards and painted white. The other door faces in a southerly and is set at ground level. There are four projecting granite brackets over the doorway. The exterior of the first floor of the building is covered in render and painted white with black trim, painted quoins and cornice with dentil pattern decoration. There are small slit windows on the ground floor. The roof of the building is similar to that of Block 318 with chunam covered round end tiles.

Old Prison Area, Block 319 (front view)第三百一十九座(舊監獄範圍)

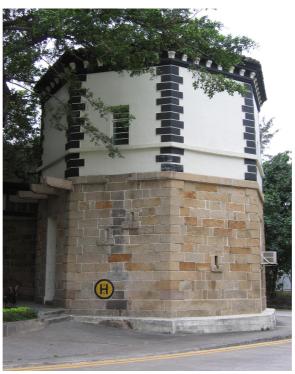
Old Prison Area, Block 319 (side view)第三百一十九座(舊監獄範圍)

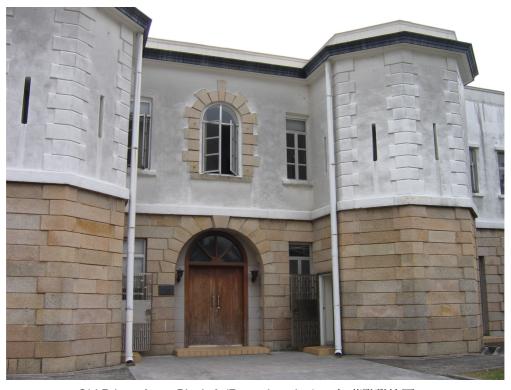
Rectangular two storey building with cut granite masonry ground floor exterior and render covered first floor exterior walls. The northwest facing wall has two projecting bays (5 sided) on either side of the doorway (modern wooden door set in niche; rounded roman style arch with keystone). The window above the doorway on the first floor has similar flat arch around it. The windows in the bays are on the first floor only and consist of narrow slits. The other parts of the building have modern windows and doors.

Old Prison Area, Block A (Rear elevation) A 座(舊監獄範圍)

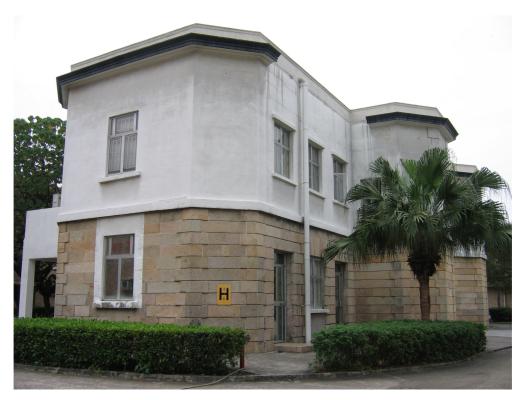
The bay sections have quoins, the other corners of the building are undecorated. The first floor is painted white and has cornice with black painted trim. Details of the roof were not possible to discern from the ground, apart from the fact that it was flat.

Old Prison Area, Block A (Side elevation) A 座(舊監獄範圍)

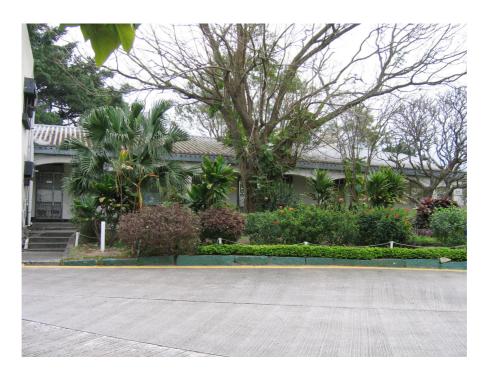
View of the setting of Block 322 (Old Prison Area)第三百二十二座(舊監獄範圍)

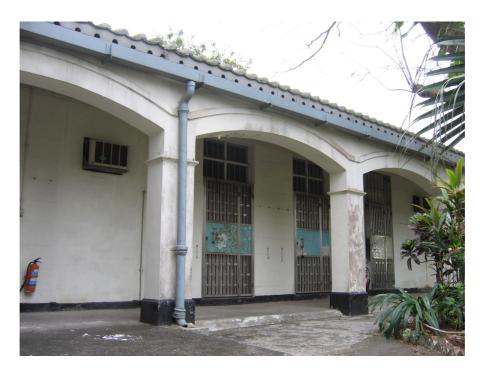
Block 322 (Old Prison Area) View of the façade 第三百二十二座(舊監獄範圍)

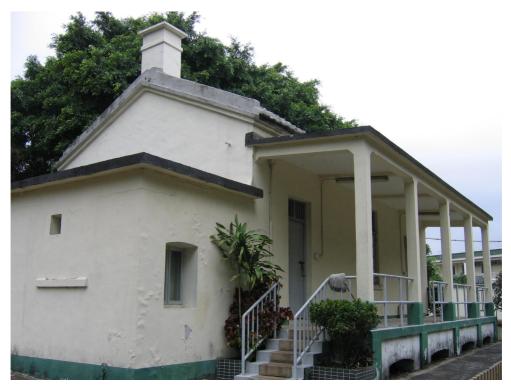
Description: A single storey rectangular concrete structure with small annex on southern end. The main building has a pitched roof with chimney at southern end and the annex a flat roof. There is a raised porch at the front of the main section of the building, flat roof supported by square columns. The building has been painted a cream colour with black trim around the roof edges.

Side view of Block 29 (Old West Battery) 第二十九座(舊西炮台)

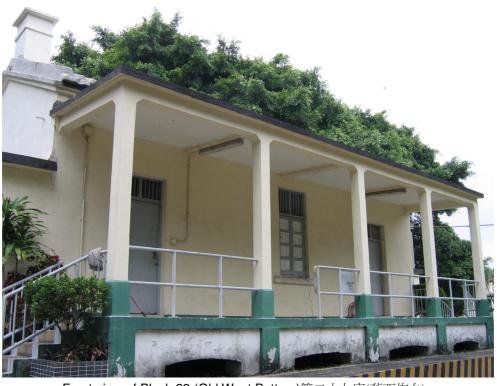
Front view of Block 29 (Old West Battery)第二十九座(舊西炮台)

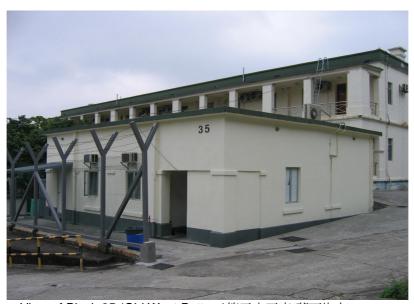
View of Block 35 (Old West Battery)第三十五座(舊西炮台)

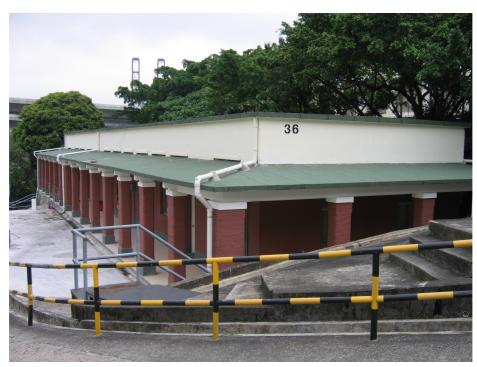
Description: A long rectangular structure with a flat roof. Walls are constructed of brick with heavy coat of ochre red paint. The main building has a colonnade all around it, supported by square brick pillars, also painted red. The building has been modified through the addition of modern windows and doors.

View of Block 36 (Old West Battery) 第三十六座(舊西炮台)

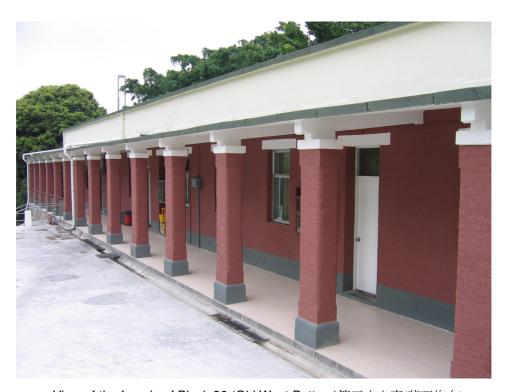
View of the façade of Block 36 (Old West Battery)第三十六座(舊西炮台)

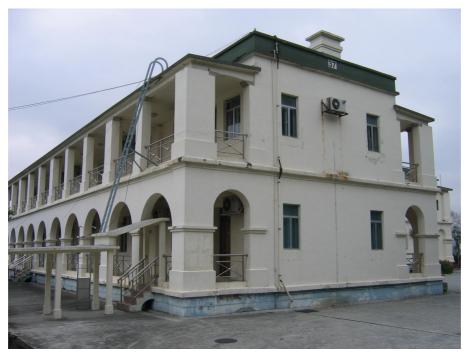
Description: Large rectangular two storey concrete building with flat roof and two storey colonnades on both lengths of the structure. The supporting columns on the ground floor have rounded arches for openings. The upper floor has square columns and openings. A modern metal balustrade has been installed on both floors, roughly similar to the traditional wrought iron style seen on colonial government structures in Hong Kong. The roof of the main structure and the colonnade are both flat.

View of the façade and south-eastern side of Block 37 (Old West Battery) 第三十七座(舊西炮台)

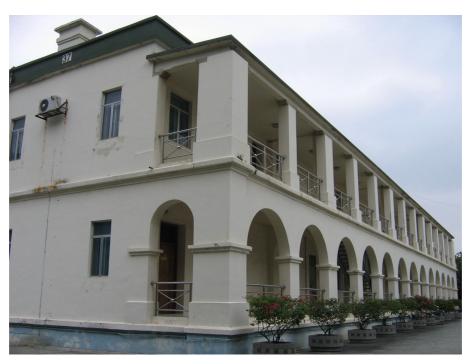
View of the rear of Block 37 (Old West Battery)

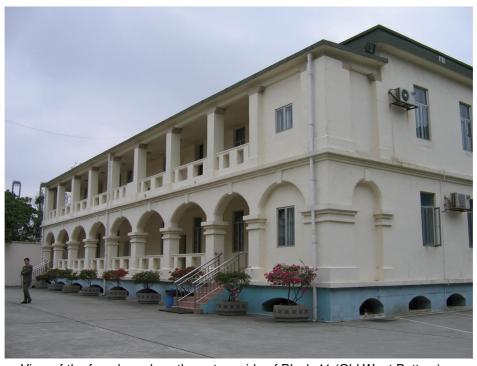
Description: Large rectangular two storey concrete building with flat roof and two storey colonnades on both lengths of the structure. The supporting columns on the ground floor have rounded arches for openings. The upper floor has square columns and openings. Some of the arches on the ground floor have been filled in. The roof of the main structure and the colonnade are both flat. Modern windows and air-conditioning have been added to the building.

View of the façade and south-eastern side of Block 41 (Old West Battery) 第四十一座(舊西炮台)

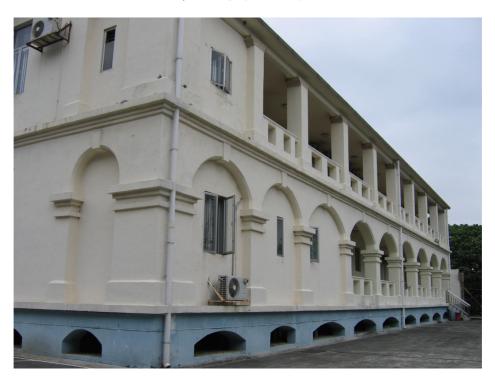
View of the rear of Block 41 (Old West Battery)

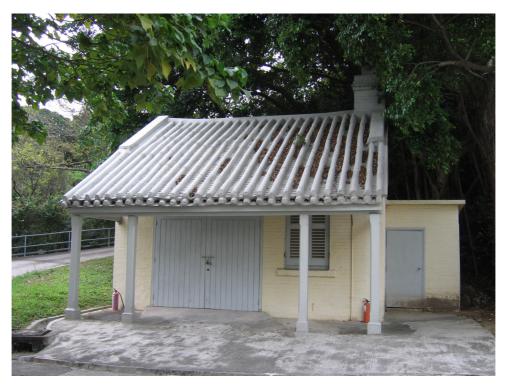
Description: Rectangular shaped single story brick structure with small annex to the side. The building has been painted a cream colour on the exterior. The roof is covered in chunam, cylinders with plain ends and plain roof ridge. There is a chimney at the southwestern corner of the building next to the annex. The roof projects over the façade of the building creating a covered area in front of the building. The roof is supported at the front by four pillars and cross-beams at the ends.

Front elevation of Block 43 (Old West Battery)第四十三座(舊西炮台)

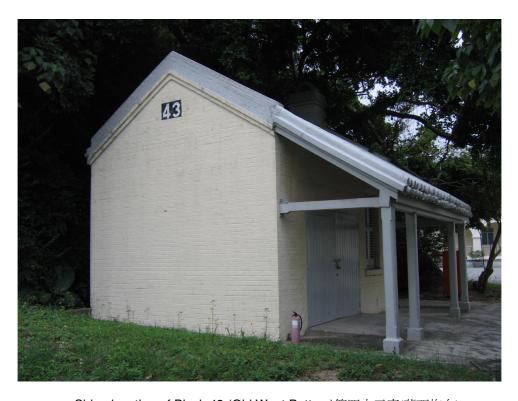
Side elevation of Block 43 (Old West Battery)第四十三座(舊西炮台)

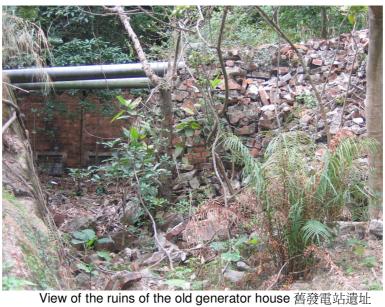
Description: The structure is in extremely ruinous condition with most of the building collapsed and just consisting of piles of bricks. There are some red brick walls still remaining, heavily overgrown.

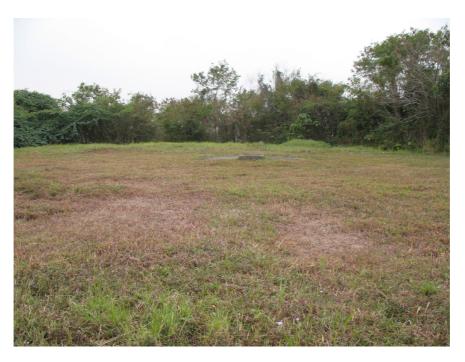
The gun emplacement is overgrown by grassy vegetation, but not as heavily overgrown as at the Central Battery. The gun emplacement is reached by a set of cut granite steps. There is a brick building in very poor condition at the level directly below the gun emplacement. Below this level there are numerous magazine structures cut into the hillside with cut stone exteriors.

The former gun emplacement at the ruins of the West Battery 前西炮台炮床遺址

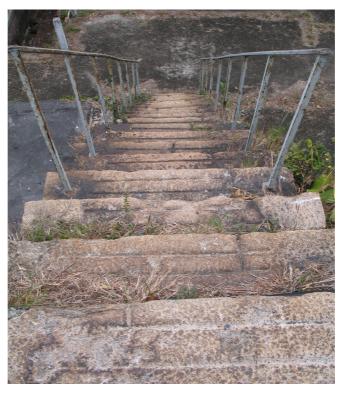
Photograph of the steps leading up to the gun Emplacement at the former West Battery 通往前西炮台炮床遺址的石階

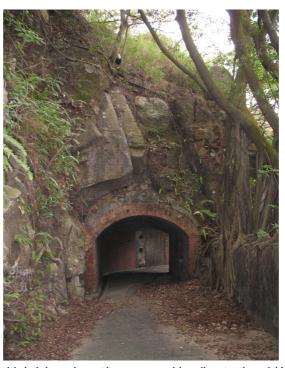
The gun road leading up to the gun emplacement still retains features such as tunnels and transport rings for hauling the guns and heavy equipment up to the battery and gun position.,

View tunnel with brick arch on the gun road leading to the old West Battery 設置在運送槍炮往前西炮台的通道之磚砌拱門隧道

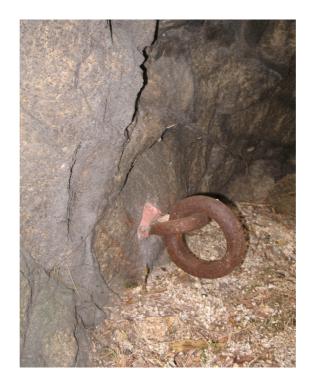
View of metal ring used for transporting of guns and equipment to the old West Battery 用作運送槍炮及裝備往前西炮台的鐵環

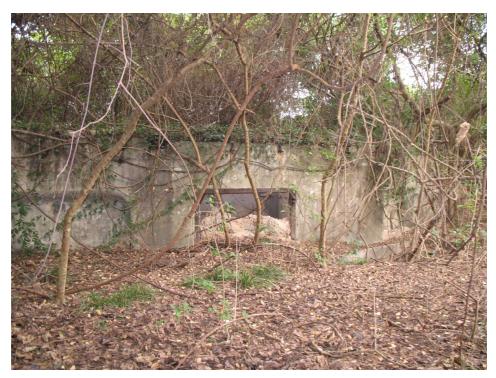
The hilltop is very overgrown and it was difficult to make out details of the former structures associated with the site. The flat circular gun emplacement is covered by vegetation and the concrete platform could not be discerned. There were concrete structures around the hill top in very poor condition. The structures were concrete shells with rectangular openings and no roof coverings.

View of the magazines associated with the old Central Battery 中炮台舊軍火庫遺址

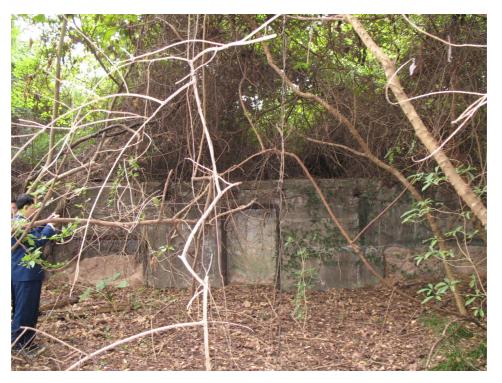
View of magazines associated with the old Central Battery 中炮台舊軍火庫遺址

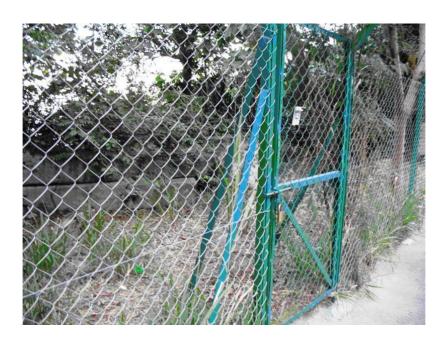
Description: A series of military installations including tunnels, search light positions, battery buildings, gun emplacements. Very overgrown.

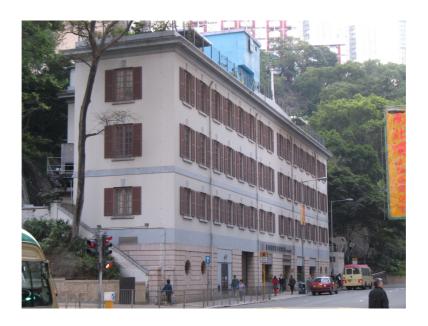
Description: Rectangular structure with cut granite foundation and three stories above with rows of windows with shutters.

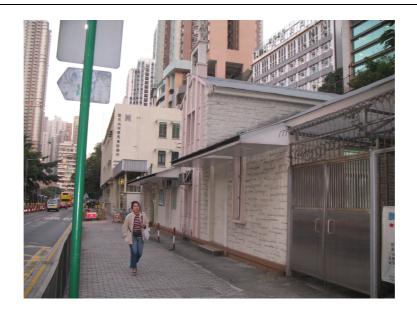
Description: Stone building single storey with central higher section, peaked roof with bell tower and cross on top. Pitched roof on the central section and flat roof on the side sections. Building is currently painted pink.

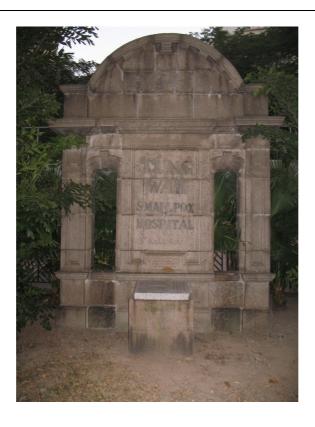
Description: Cut granite blocks arch with side pillars and rounded top. Inscription on front.

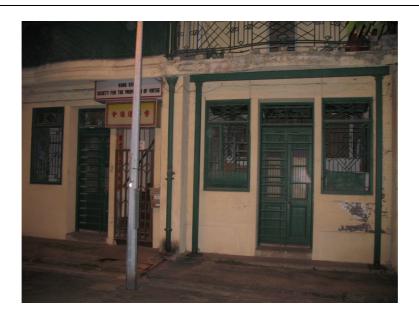
Description: Five storey Chinese tenement buildings, with balconies on each floor enclosed with iron balconies or glassed fronts. The ground floor entrances have barred gates.
