The Hong Kong Section of Guangzhou-Shenzhen-Hong Kong Express Rail Link (the Project) is approximately 26 km long, in a dedicated underground railway from the boundary at Huanggang to West Kowloon Terminus.

Dredging works will be required to construct the berthing area for Lung Kwu Sheung Tan barging point. In order to evaluate the archaeological potential of the dredging area, a Marine Archaeological Impact Assessment (MIA) was conducted by ENSR Asia (HK) Ltd.

1 INTRODUCTION

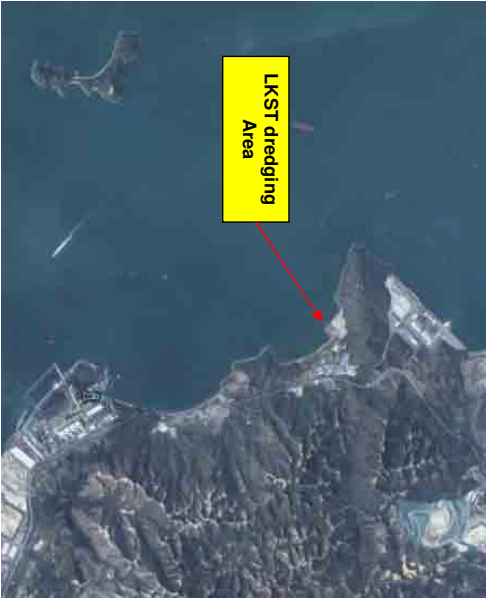
Figure 1: Aerial photograph of the study area.

- 3.2.1 The MAI covers the dredging area in Lung Kwu Sheung Tan. The location of the study area and adjacent shoreline are marked in **Figures 1 and 2**. The dredging area is approximately 6,600m² (i.e. 60m x 110m) as shown on **Figure 2**. Baseline review, marine geophysical survey and dive survey was conducted at this dredging area.

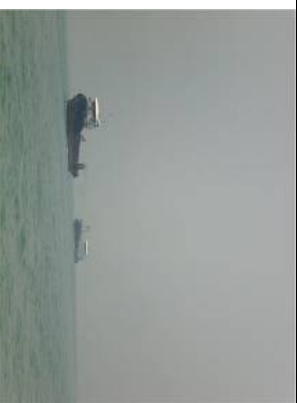
Figure 7: Marine traffic during the survey.

5.1.1 The dredging site is located at Lung Kwu Sheung Tan and close to the Black Point Power station. A high volume of marine traffic was observed during the survey (Figures 7 to 9). A number of boats were anchored nearby and there were regular cargo ships crossing. A discharge outfall running parallel to the surveying corridor was located south of it and was visible at the sea surface.

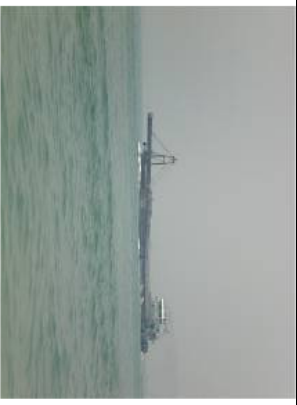
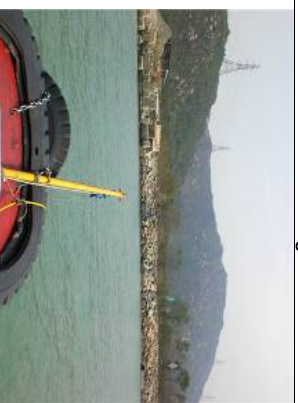
Figure 8: Rubble mound seawall at the coast.

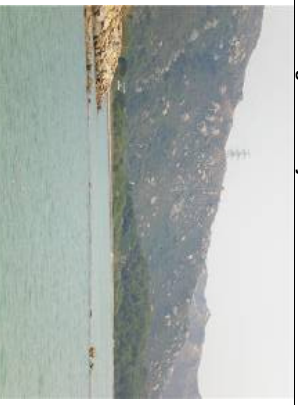
5.3.2 The Marine Geophysical Survey data provided 100% coverage of the seabed with side scan sonar data and approximately 80% with seismic profiler data. The data quality was high with the exception of the masked areas which were probably caused by discharges from the nearby sewage outfall.

Figure 9: The discharge outfall covered by dumped rock.

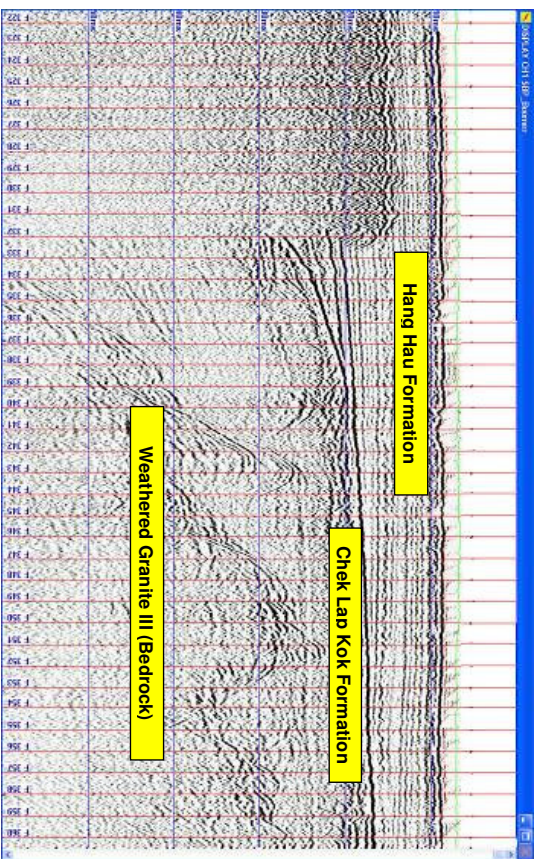
Figure 10: Seismic record annotated to show geological stratigraphy.

5.2.3 In places, one or more of the main geological units may be missing, for example, where marine deposits pinch out against the underlying Alluvium and rock, close to the shorelines.

5.2.5 From an archaeological perspective, the Hang Hau Formation has the greatest archaeological potential. The formation consists of relatively homogenous very soft to soft, greenish grey silty clay and has high moisture content. Therefore, the Hang Hau Formation sediments potentially provide an excellent substrate for the preservation of archaeological material.

5.2.6 Additionally, the soft nature of the sediments would make it possible for archaeological material to be buried within the formation, where it would have greater protection than if it were exposed on the seabed. The contoured level at the base of marine deposits is presented in Figure 10. Below this unit lies Grade IV/V weathered rock in any state of decomposition and Grade III presumed moderately decomposed rock. There are two areas where masking is observed and no interpretation could be done.

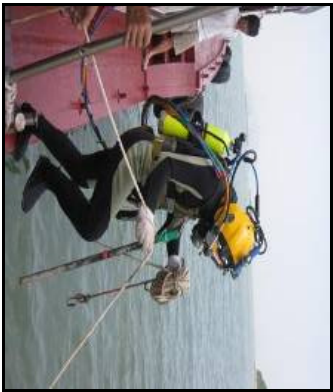
Figure 13: Diver entering water with hand held probe and rope for circular search.
