Shatin to Central Link -
Consultancy Agreement No. NEX/2213

**Environmental Impact Assessment
(EIA) of Cross Harbour Section
(Phase I – Mong Kok East to Hung Hom)**

Contamination Assessment Plan
Sep 2009

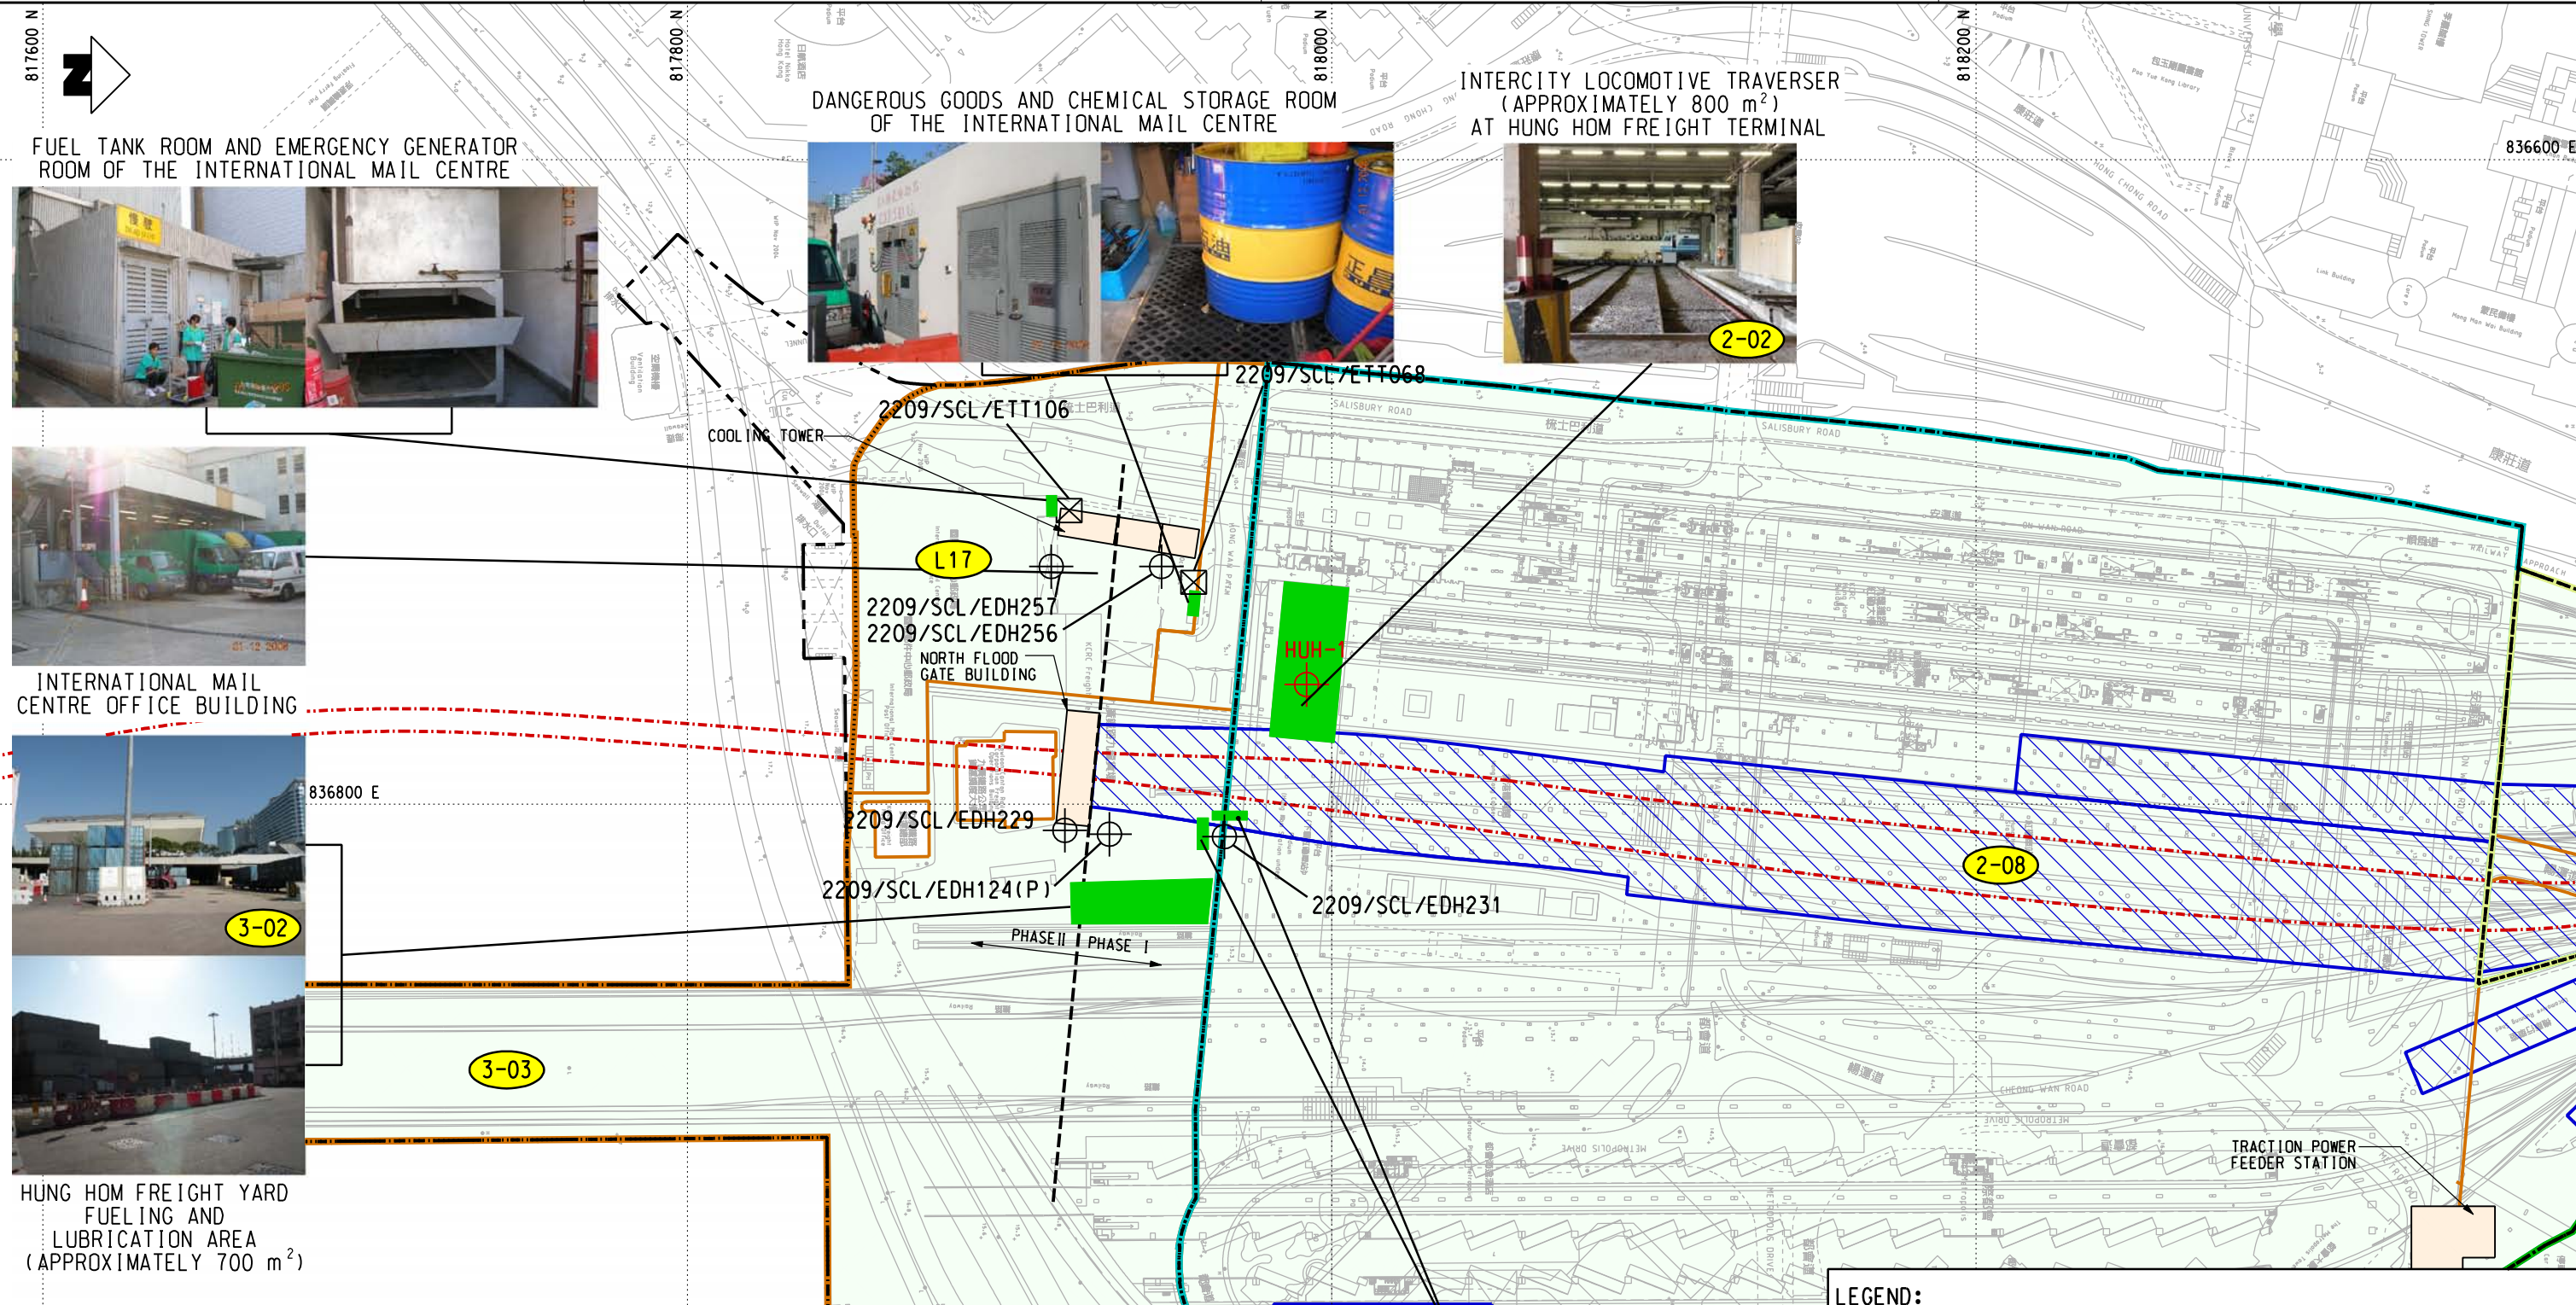
FUEL TANK ROOM AND EMERGENCY GENERATOR ROOM OF THE INTERNATIONAL MAIL CENTRE

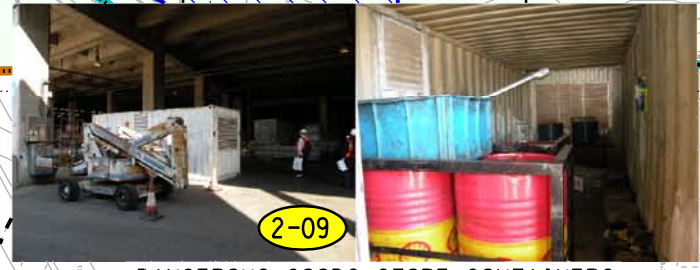
DANGEROUS GOODS STORE CONTAINERS (APPROXIMATELY 20 m²)

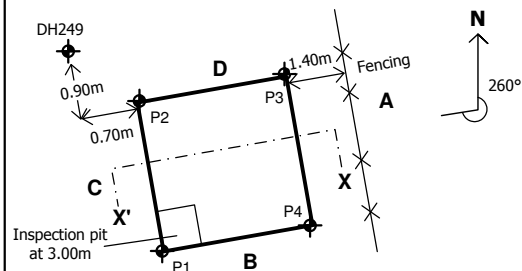
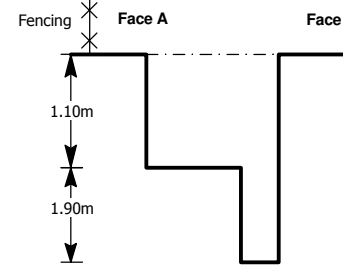
1. No shoring.
2. No seepage observed.
Co-ordinates:
P1 : 818601.35 N 836786.69 E G.L. 4.23 m.P.D.
P2 : 818602.37 N 836786.55 E G.L. 4.24 m.P.D.
P3 : 818602.49 N 836787.59 E G.L. 4.25 m.P.D.
P4 : 818601.50 N 836787.75 E G.L. 4.24 m.P.D.

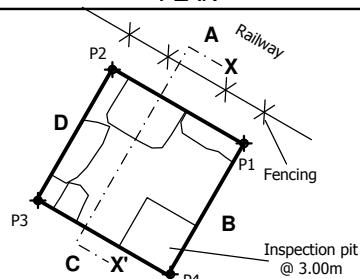
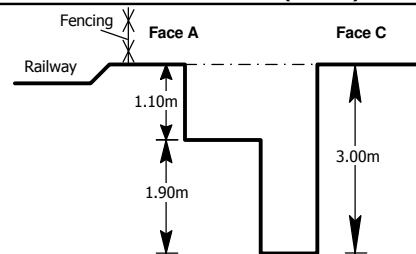
1. No shoring.
2. Seepage observed at 2.40m depth.
3. Inspection pit (0.40m x 0.40m) was dug to 3.00m below ground level.
4. Small disturbed samples were taken at 0.50m, 1.50m and 3.00m depths.

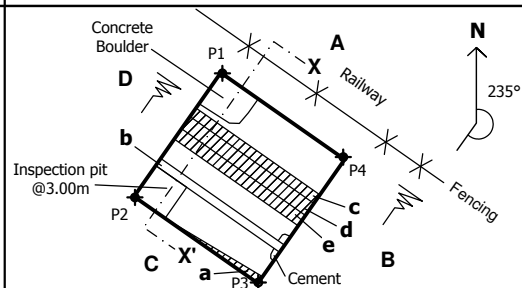
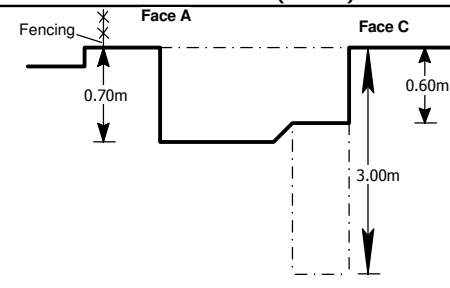
1. No shoring.
2. Water level at 2.00m depth.
3. Inspection pit (0.30m x 0.30m) was dug to 3.00m below ground level.
4. Small disturbed samples were taken at 0.50m (2 nos.), 1.50m (2 nos.) and 3.00m (2 nos.) depths.
