Shatin to Central Link

Detailed Design for Kai Tak Station and Associated Tunnels

Working Paper – Pile Integrity Test to Former Kowloon City Pier

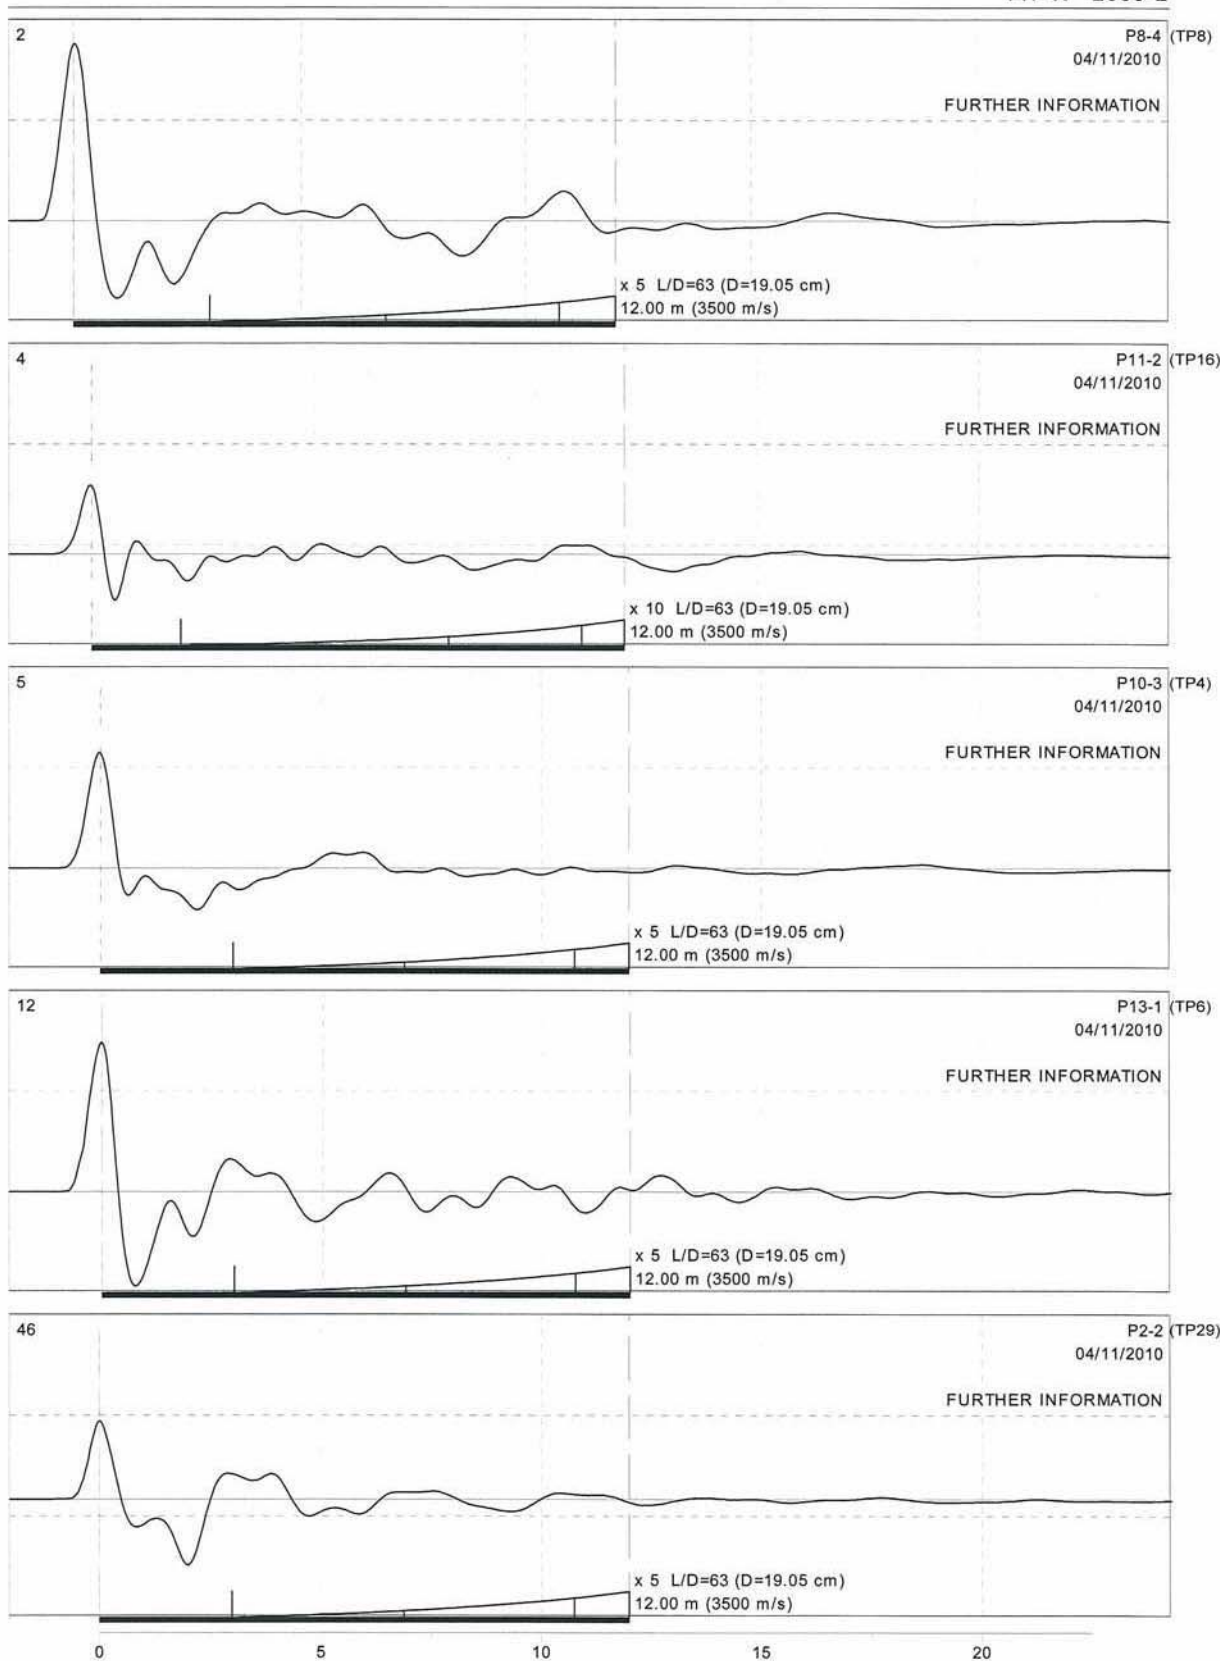
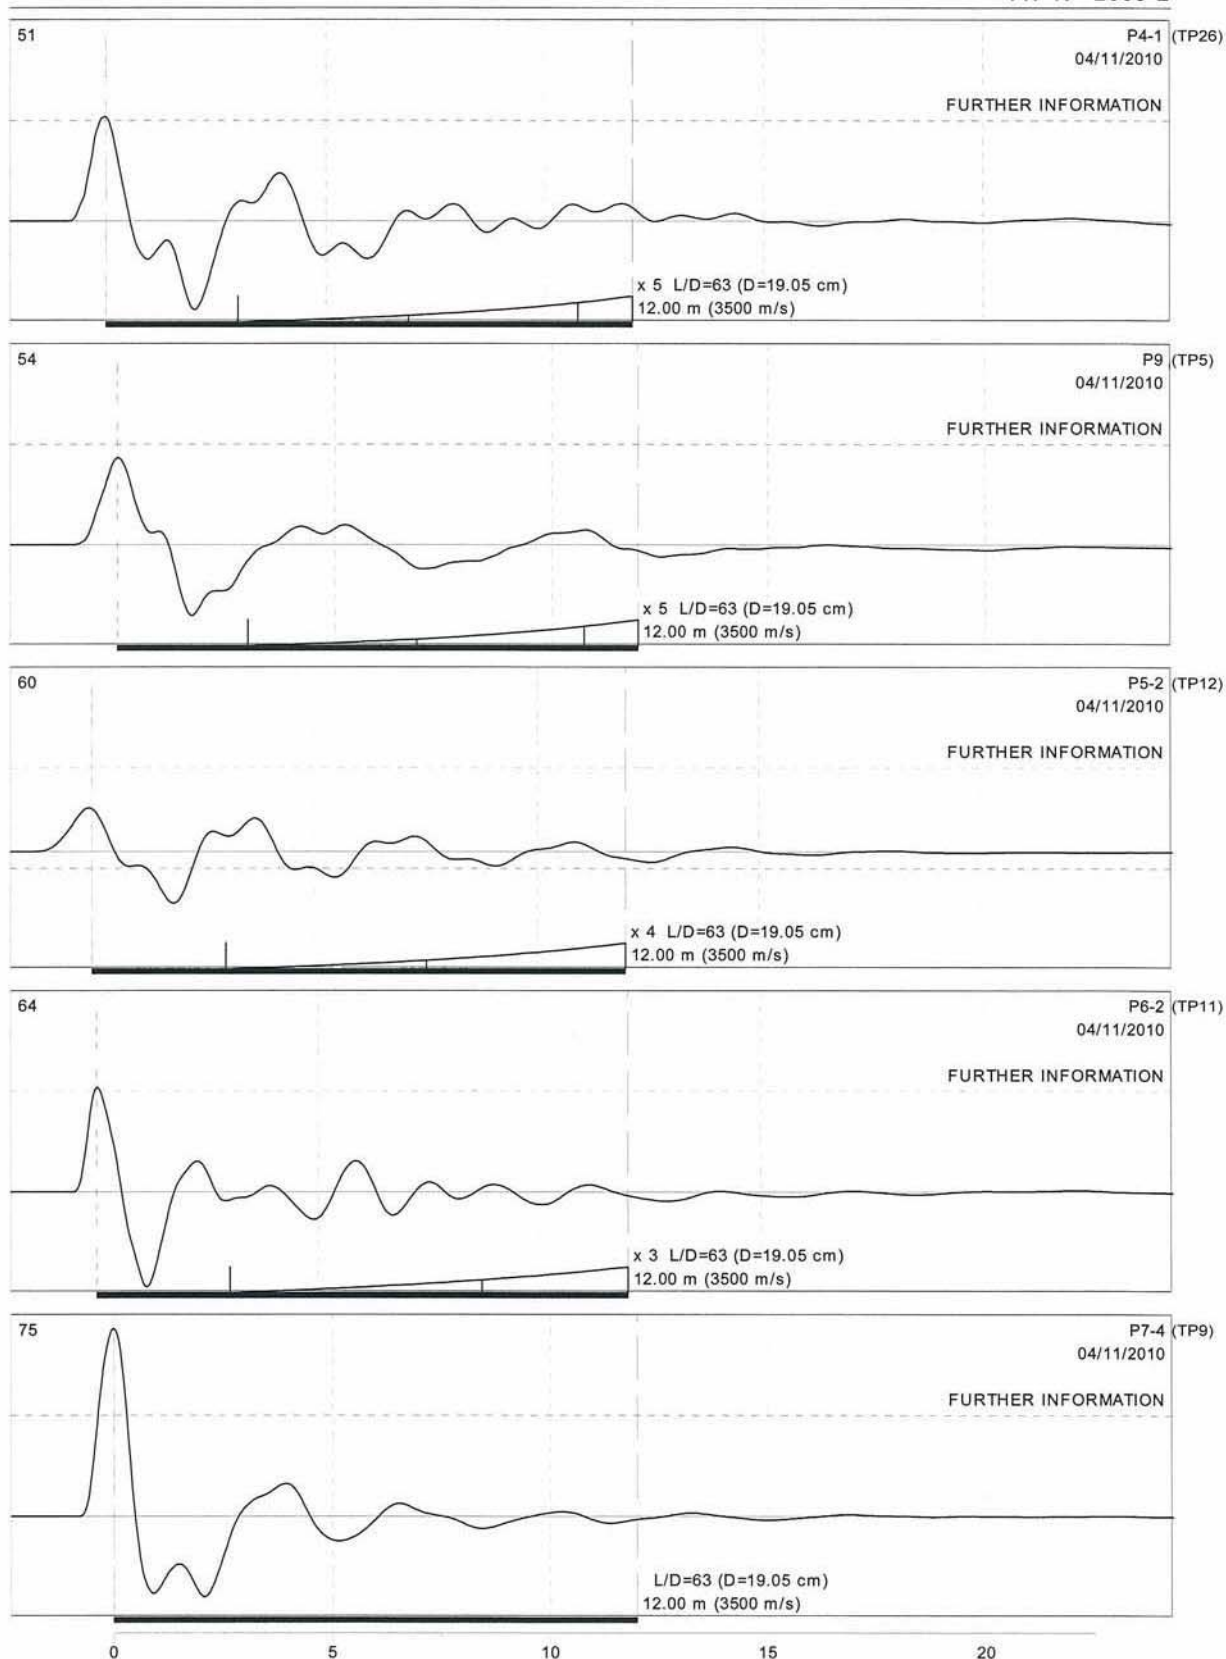
6.0 Test Results

The printouts of representative blow for pile no. TP4, TP5, TP6, TP8, TP9, TP11, TP12, TP16, TP26 and TP29 are presented below; the interpretation on these piles refer to Part B Section 9.0.

From the test results, a strong reflection of transmitted signal was observed from 1.7m to 2.2m below the pillar top level at 8 of the pillars (i.e., TP4, TP5, TP6, TP9, TP12, TP16, TP26 and TP29). For TP11, reflected signal was detected at about 2m below pillar top, similar to the results at the 8 pillars as mentioned above. However, additional signal reflections were also noted from 8.66m to 10.80m below the pillar top. For TP11, multiple reflections of transmitted signal were observed. The location at which the transmitted signal is reflected is related to various parameters, including the variance of pillar's cross-sectional area, elastic modulus and stress wave propagation speed and change of soil stratum. The test results are enclosed in **Appendix C** for reference.

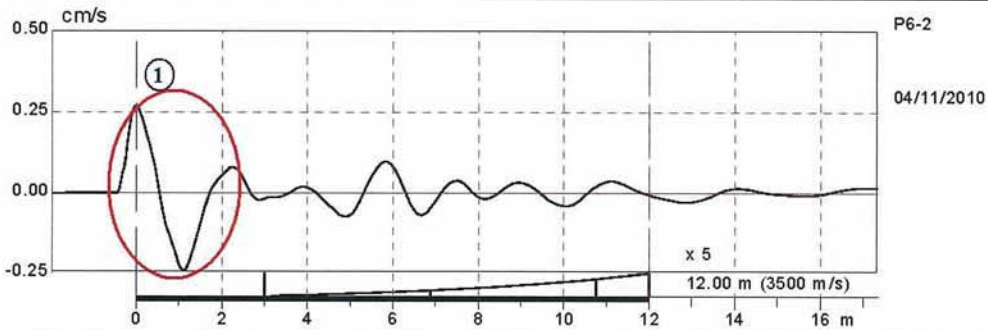
File No.	Pile No.	Reflectogram	Remarks ¹
P6	TP11

① Significant reflection near pile top.
P7	TP9

The data is inconclusive for TP11. Multiple reflections are noted probably because of poor pile top quality, low concrete strength or major impedance changes near pile top which block signals to travel through the shaft.

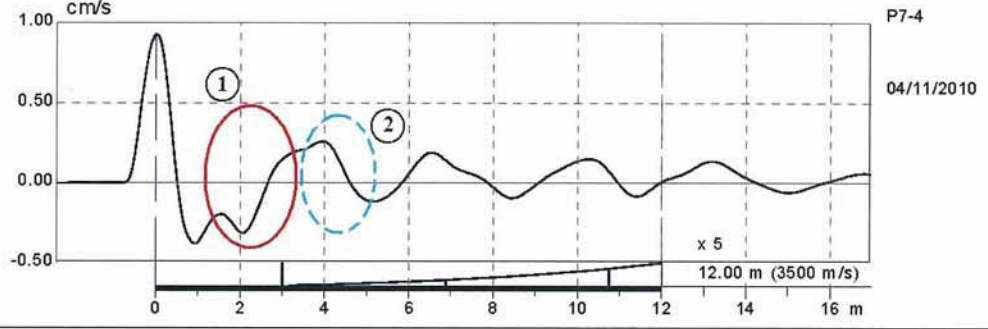
① Local increase of impedance is detected at approx. 2.02m below pile top. ② Second reflection of ① at approx. 4.01m.
P8	TP8

Similar pattern is noted from the pile integrity results of pile nos. TP4, TP5, TP6, TP9, TP12, TP16, TP26, TP29. A strong reflection of an impedance increases from range between 1.7m to 2.2 below pile top level, this may due to an increase of cross sectional area such as bulging, change in structural forms or soil strata change. This major reflection causes the following multiple reflections and toe reflection is not apparent.

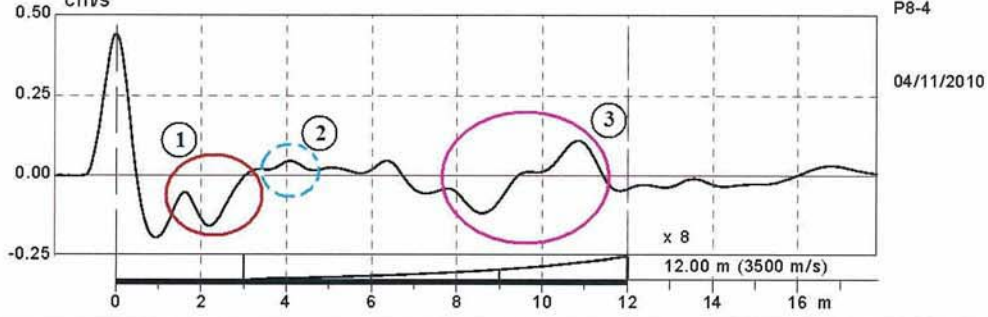
① Increase of impedance is detected at approx. 2.12m below pile top. ② Second reflection of ① at approx. 4.16m. ③ Local increase of impedance is detected at approx. 8.66m.

As mentioned in Section 1.1, the estimated pillar length is between 9.0m to 9.5m according to the results of PIT in 2009. This concurred with the reflected signals observed at TP8 (from 8.66m to 10.80m), which might be due to encountering the pillar toe.

Alike other piles, TP8 has reflection at approx. 2.12m. Moreover, an additional reflection is noted between 8.66m and 10.80m, which may be due to a local increase of cross sectional area such as bulging, soil strata change or pile toe reflection.

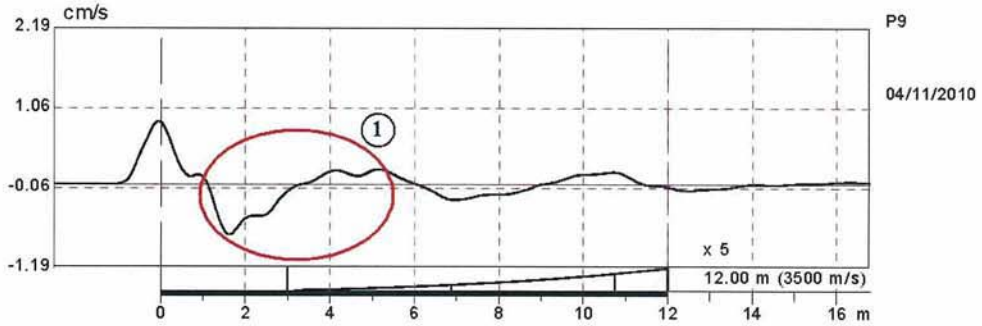
File No.	Pile No.	Reflectogram	Remarks ¹
P9	TP5

① Increase of impedance is detected at approx. 1.71m & 2.58m below pile top.
P10	TP4

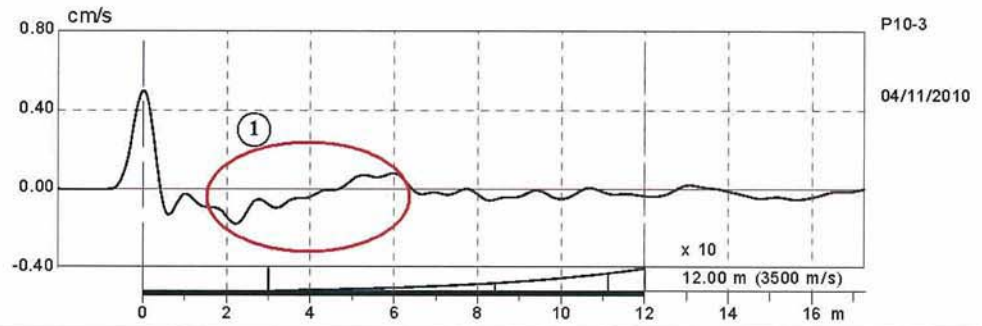
① Increase of impedance is detected at approx. 2.21m & 3.26m below pile top.
P11	TP16

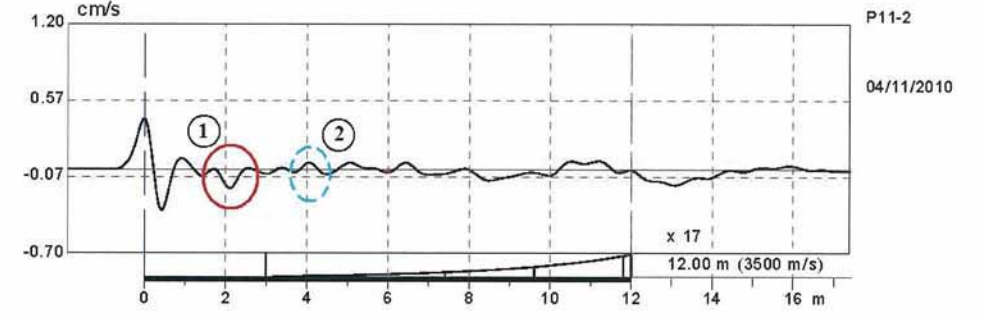
① Increase of impedance is detected at approx. 2.10m below pile top. ② Second reflection of ① at approx. 4.00m.

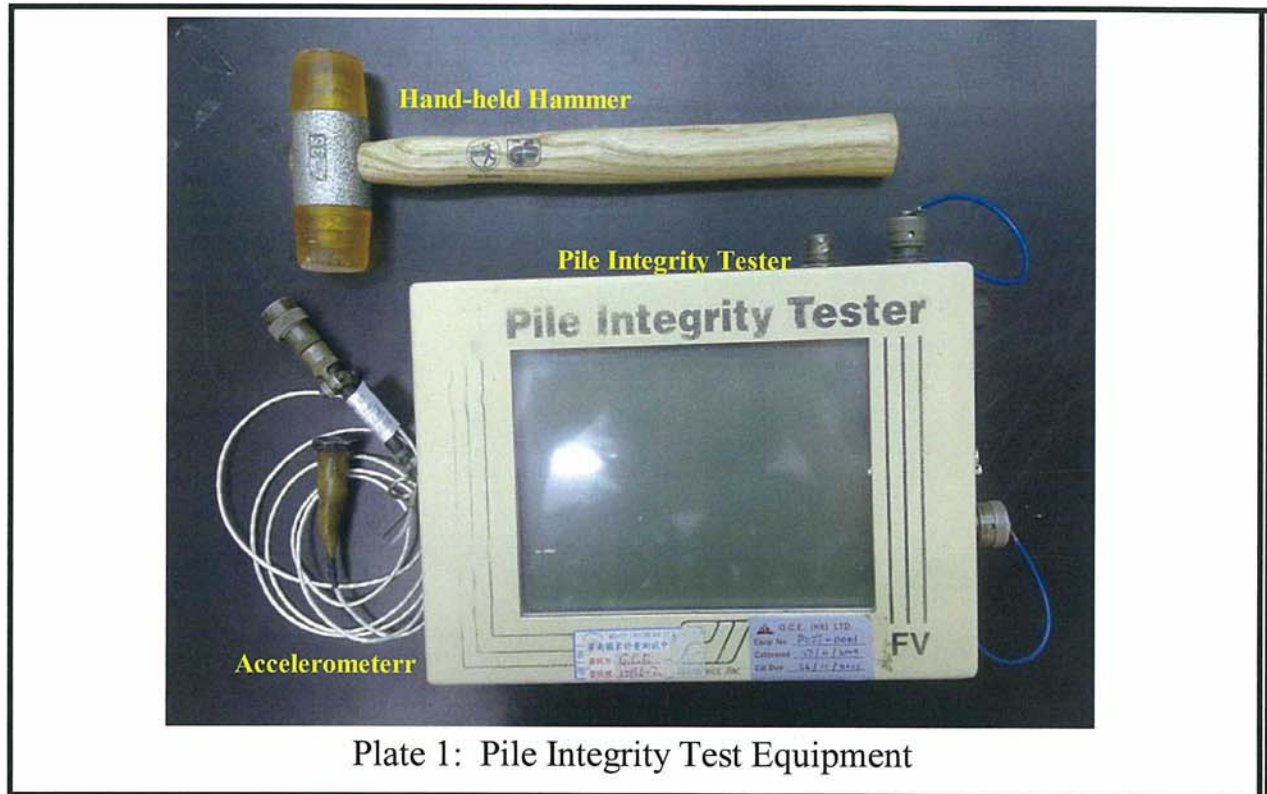
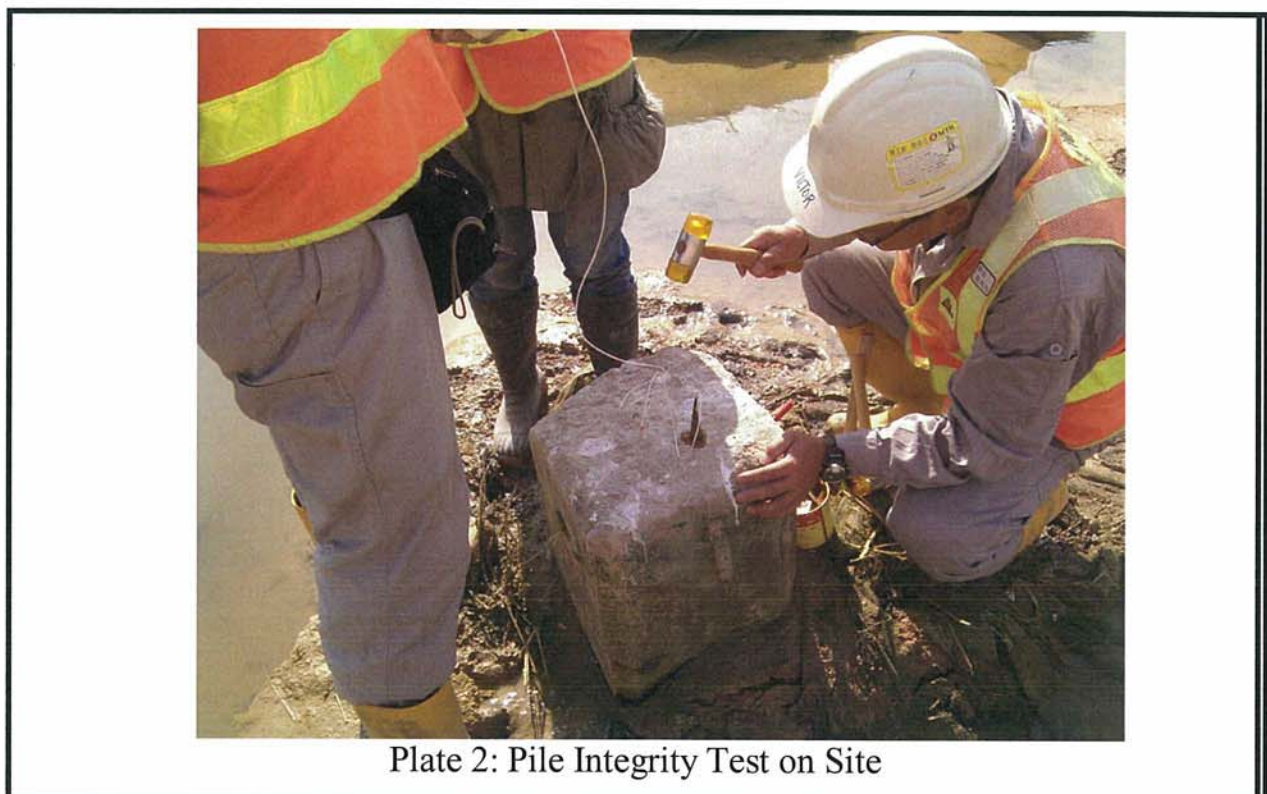
Test Equipment & Field Test Photo

Manufactured by Pile Dynamic Inc., USA. The Pile Integrity Tester is a hand Battery powered signal data acquisition unit capable of providing signals conditioning, digital signal processing, digital signal storage and, for output, an LCD screen. The system is completed with an instrument hand held hammer with an integral plastic tip and an accelerometer.

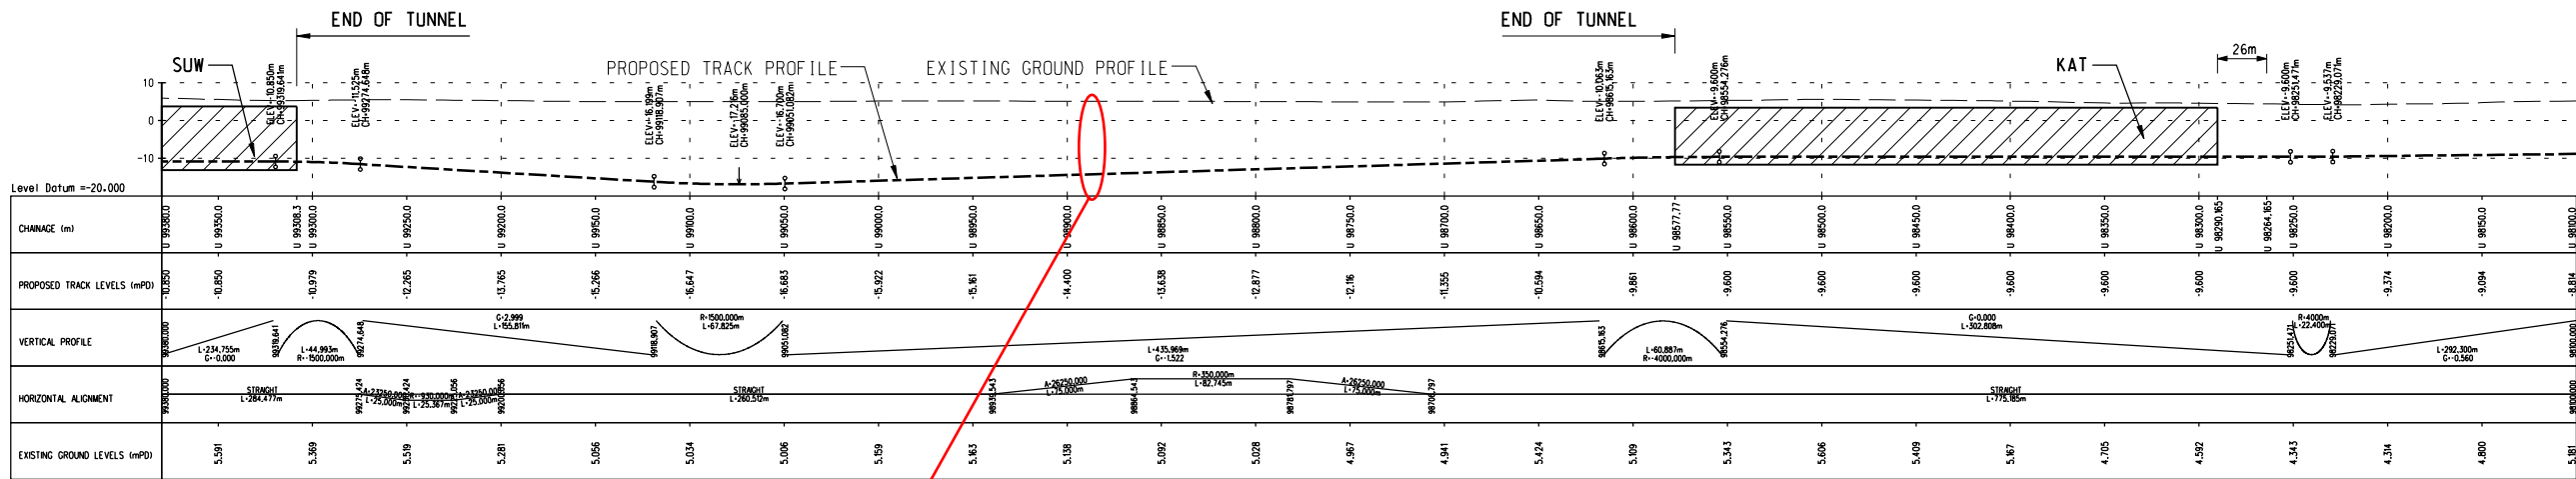
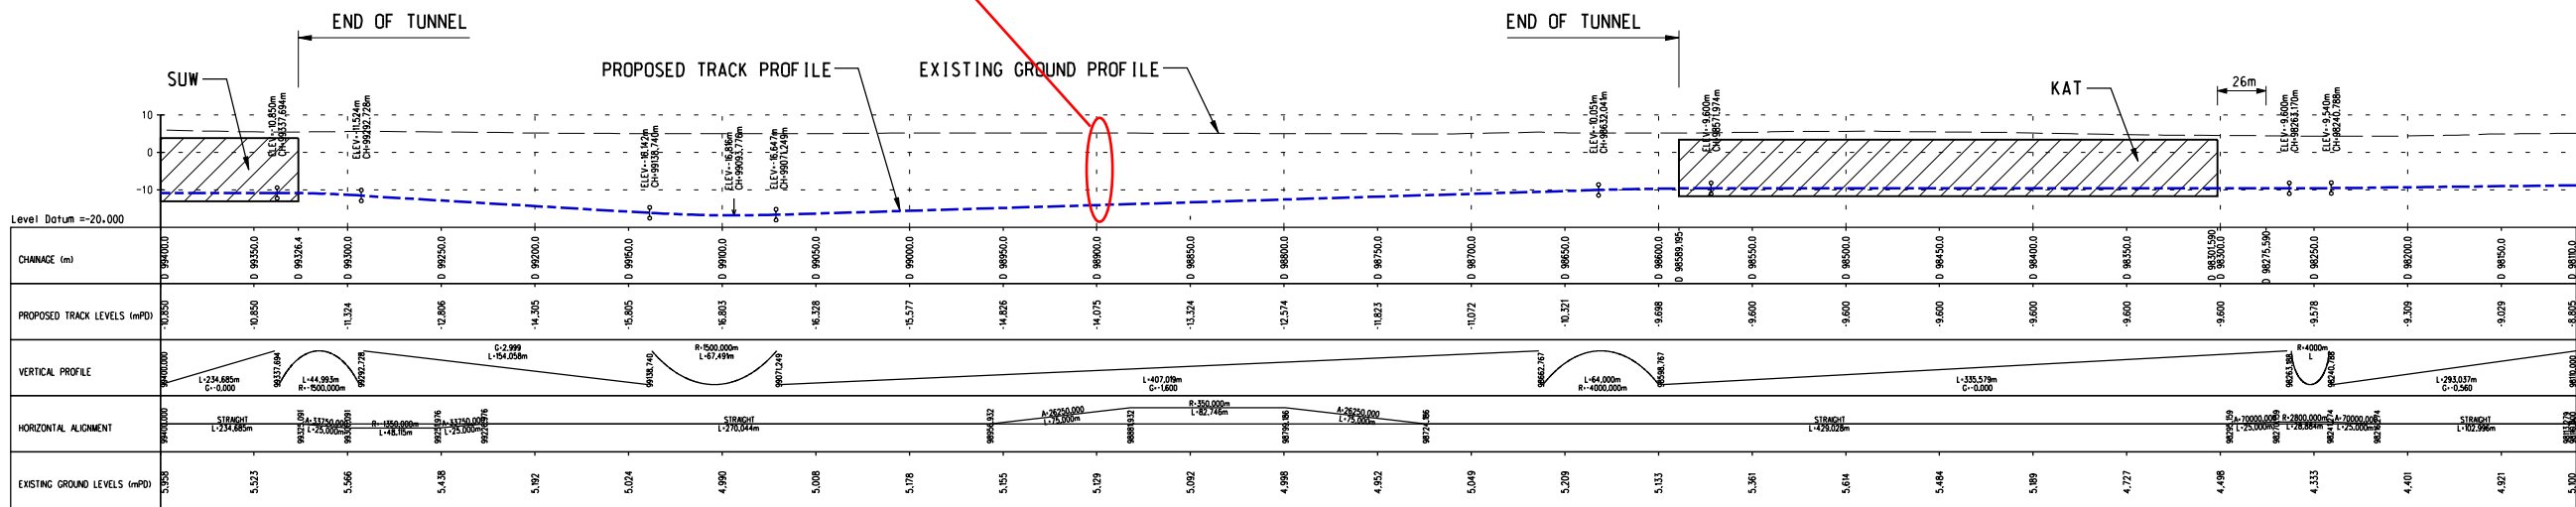
Appendix D - Tunnel Alignment (Preliminary Design and Current Proposal)

TITLE		NEX/2201 - TAW TO HUH SECTION PRELIMINARY DESIGN PLAN AND PROFILE (NORTHBOUND) SHEET 7 OF 18	
SCALE	1 : 2000 (A3)	FIGURE NO.	4.007
REV.	A

Approximate Interface location between
FKCP and proposed tunnels

VERTICAL PROFILE (UPTRACK)
HORI. 1 : 2000 (A1)
VERT. 1 : 1000 (A1)

VERTICAL PROFILE (DOWNTRACK)
HORI. 1 : 2000 (A1)
VERT. 1 : 1000 (A1)

In addition, the tunnel profile is lowered with rail track level at around -14.135mPD in the vicinity of the FKCP (-12.654mPD in preliminary design alignment) so that there will be around 1.8m to 2.2m clearance between the concrete pillars' tip at FKCP and the proposed tunnels. The proposed tunnels are founded on Alluvium, which is a stiffer material than Marine Sand Deposit. The construction of mined tunnel should post no direct impact to the FKCP structure.

The tunnel alignment for preliminary design and current proposal are shown in **Appendix D** for easy reference. In addition, a tunnel section through the FKCP is attached in **Appendix E** for reference.

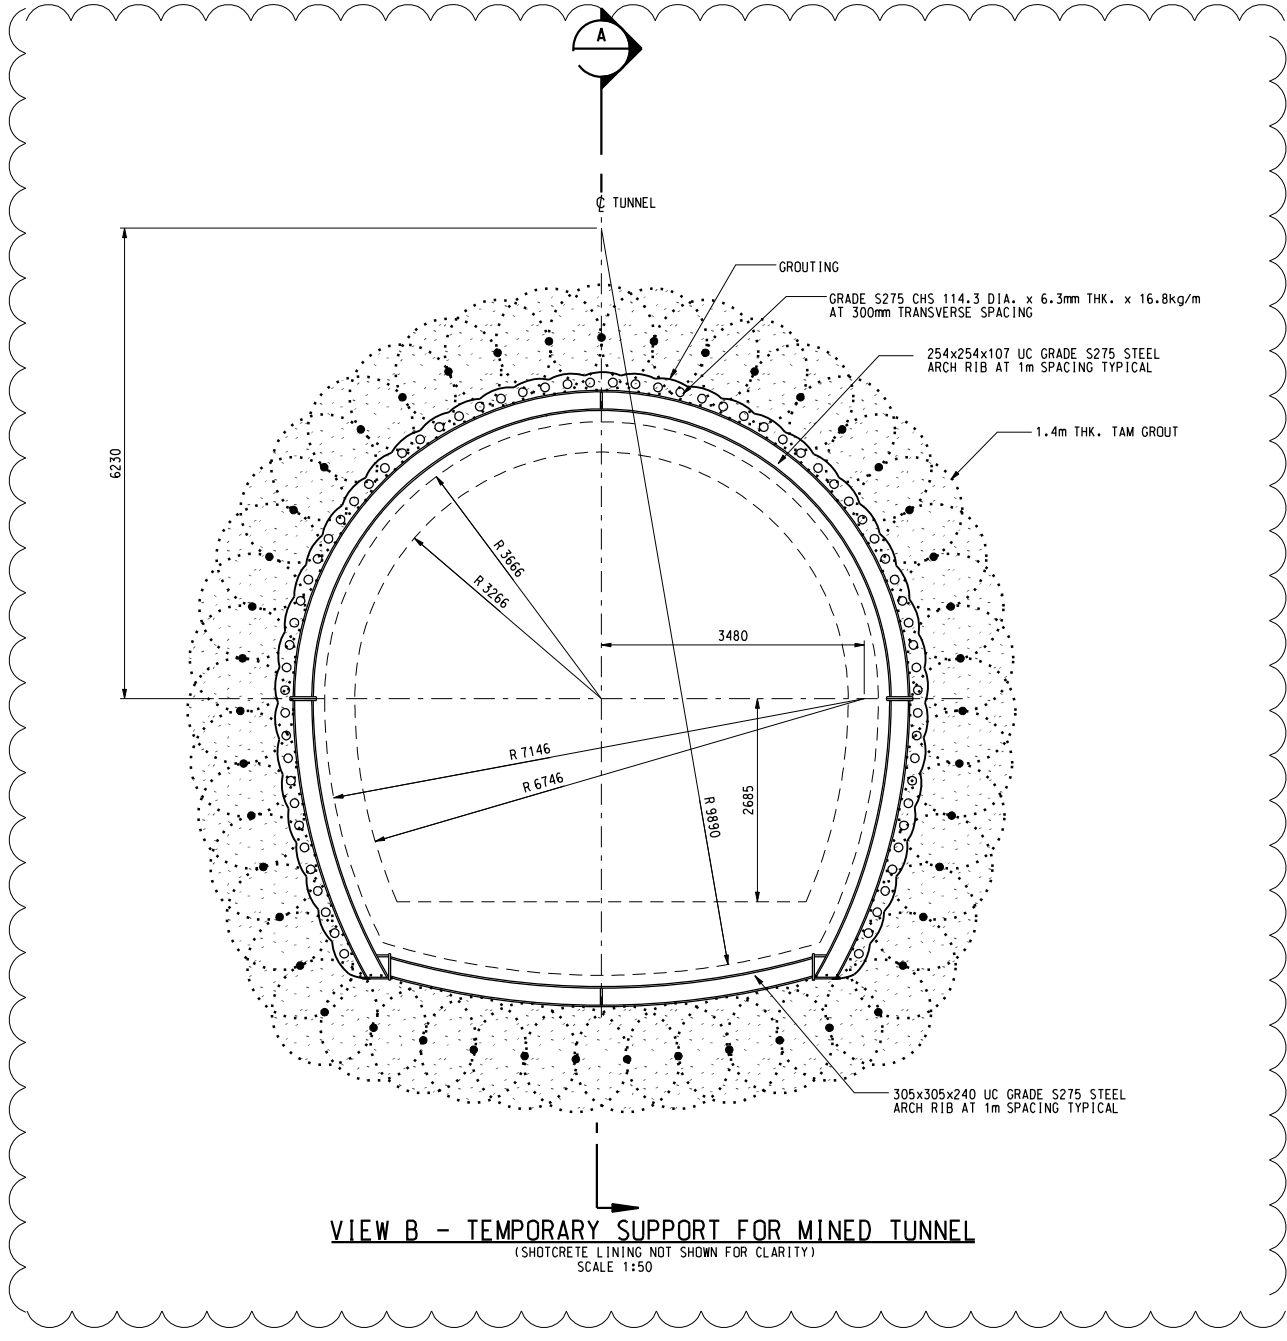
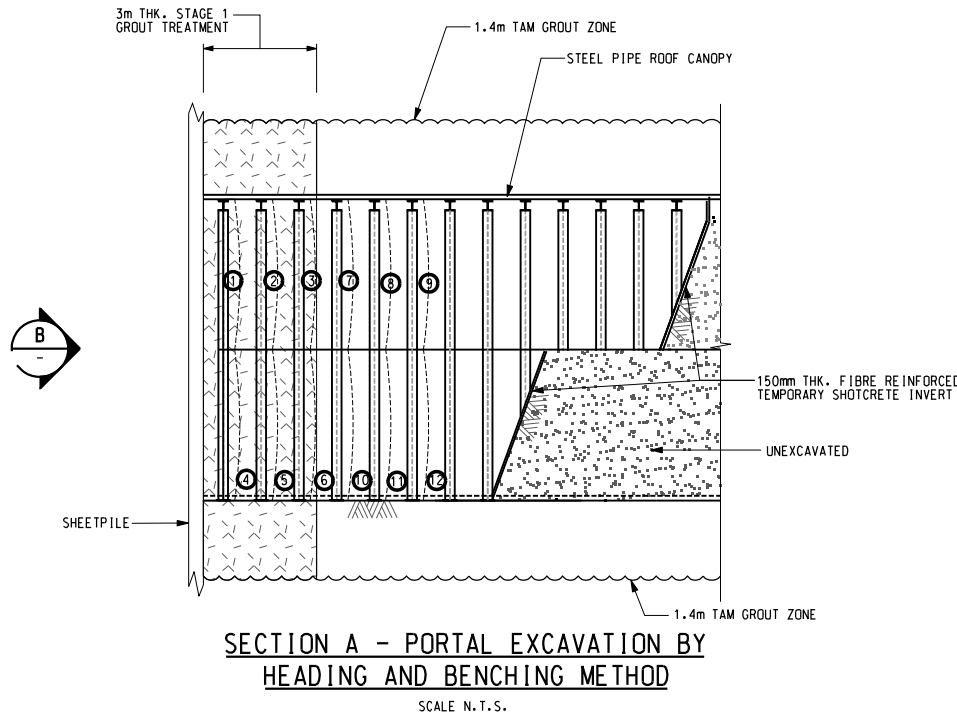
- NOTES :
1. THIS DRAWING SHOWS THE DETAILS OF TYPICAL TEMPORARY SUPPORT FOR THE SOFT GROUND MINED TUNNEL.
 2. THE CONTRACTOR SHALL SUBMIT MILL CERTIFICATES TO THE ENGINEER FOR RECORD.

- LEGEND :
- PRE-SUPPORT STEEL PIPE
 - TAM GROUT PIPE

In order not to disturb the FKCP, the tunnel face is excavated in stages under cover of improved ground condition by jack-grouting and horizontal canopy tube. The exposed ground will be supported by steel arches and sprayed concrete. Each excavation stage (1.5m typically) is coordinated to ensure movements in the tunnel and at surrounding ground surface are within the limit. This method will be adopted for the critical tunnel section and length of about 40m.

The construction sequence of mined tunnel is attached in **Appendix G**.
