Appendix D

**Summary of Surveyed  
Sites**

Job Title  
**Agreement No. CE 61/2007 (CE) North East New Territories New Development Areas Planning and Engineering Study - Investigation**

Drawing Title  
**Locations of Surveyed Sites - FLB**

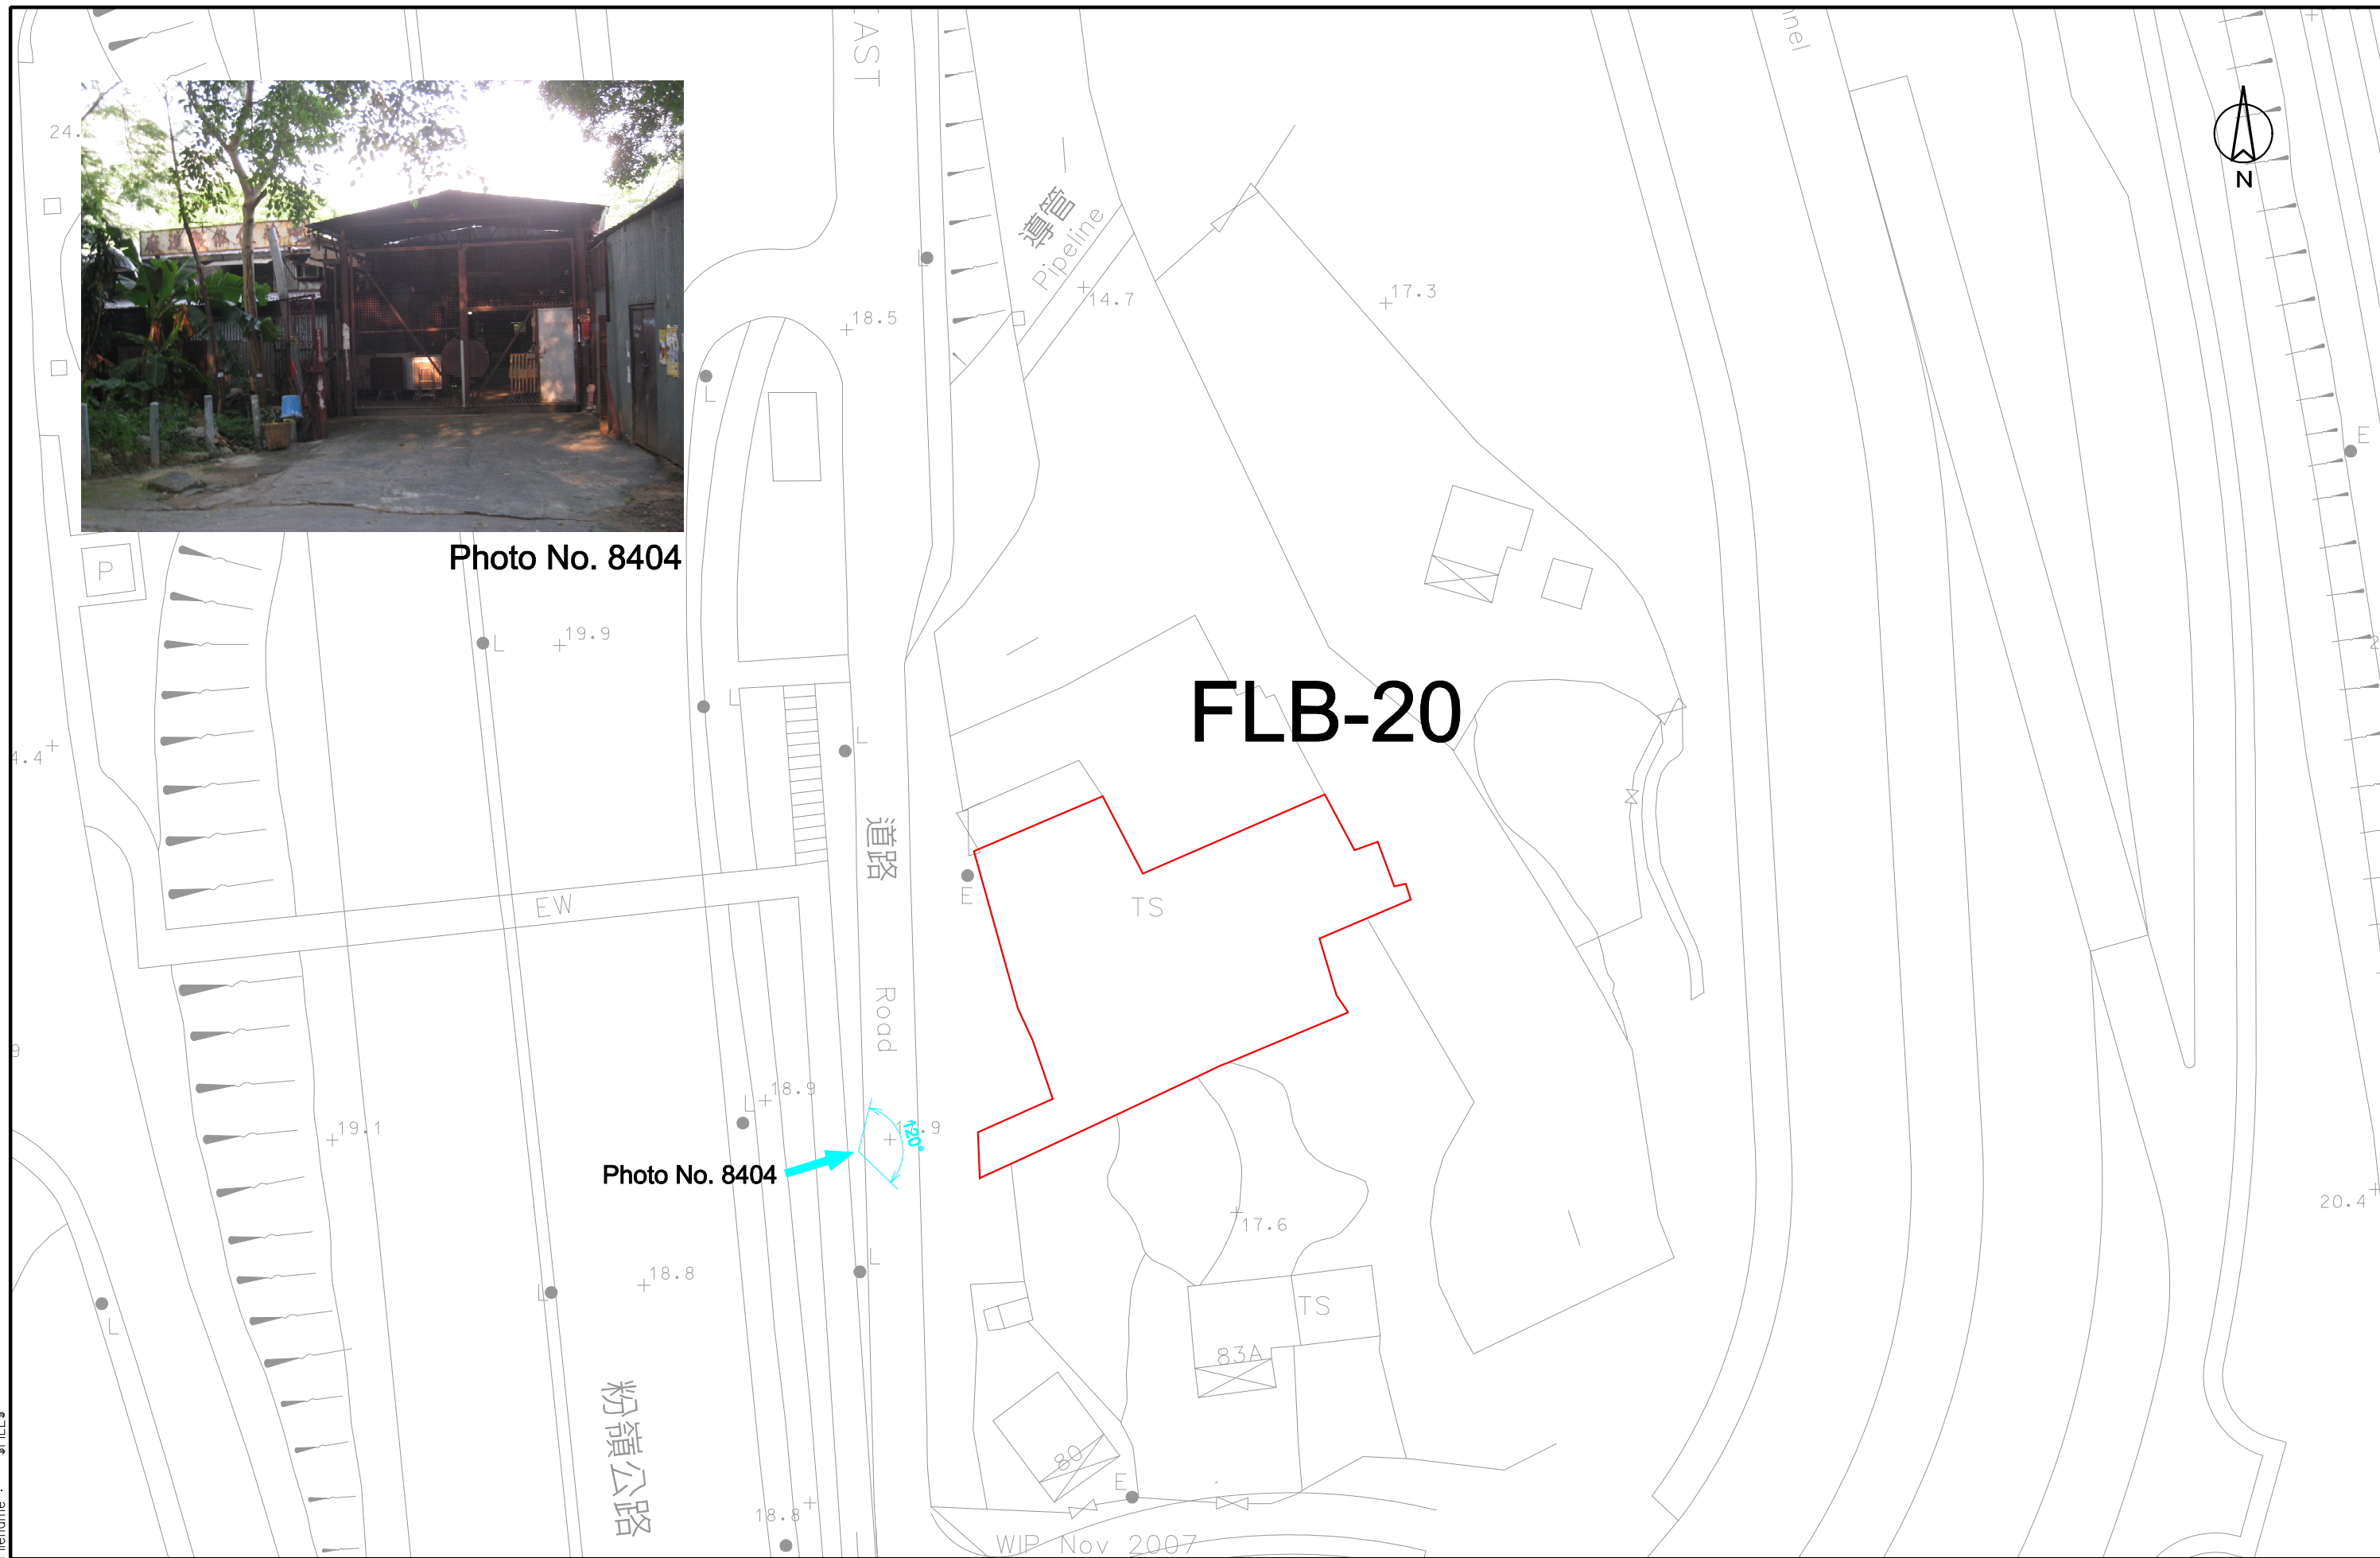
Drawing No.	<b>AD-FLB-20</b>
Rev.	-

Desktop Review	
Ref. No. in TP13:	Not found in TP13
Past Land Use in TP13	Not found in TP13
Review of Outline Zoning Plan	Roads - Fanling Highway & Tai Wo Service Road West
Review of Geological Survey Map	JTM
Site History (Review of Historical Aerial Photos)	<ul style="list-style-type: none"> <li>• 1963: Agricultural lands.</li> <li>• 1972: No significant change observed.</li> <li>• 1982: The site was occupied by a building.</li> <li>• 1993: A storage warehouse was built.</li> <li>• 2001: Several temporary structures were built.</li> <li>• 2008: No significant change observed.</li> </ul>
Lot No.	DD9 583 C-RP, STW326/TAT/61 STW, STT382 STT
Land Ownership Status	Private

Site Survey Information and Recommendation	
Date of Survey:	Sep-11
Conducted by:	Thomas Chan and Lawrence Kan
Site Observation & Potentially Sources of Contamination:	Storage of furniture. Access limited. Visual inspection limited.
Preliminary Contamination Rating *	U
Recommended No. of Boreholes **	N/A
Future Landuse	Road network (FLB)
RBRGs	Lower of Industrial or Public Park
Remarks	-

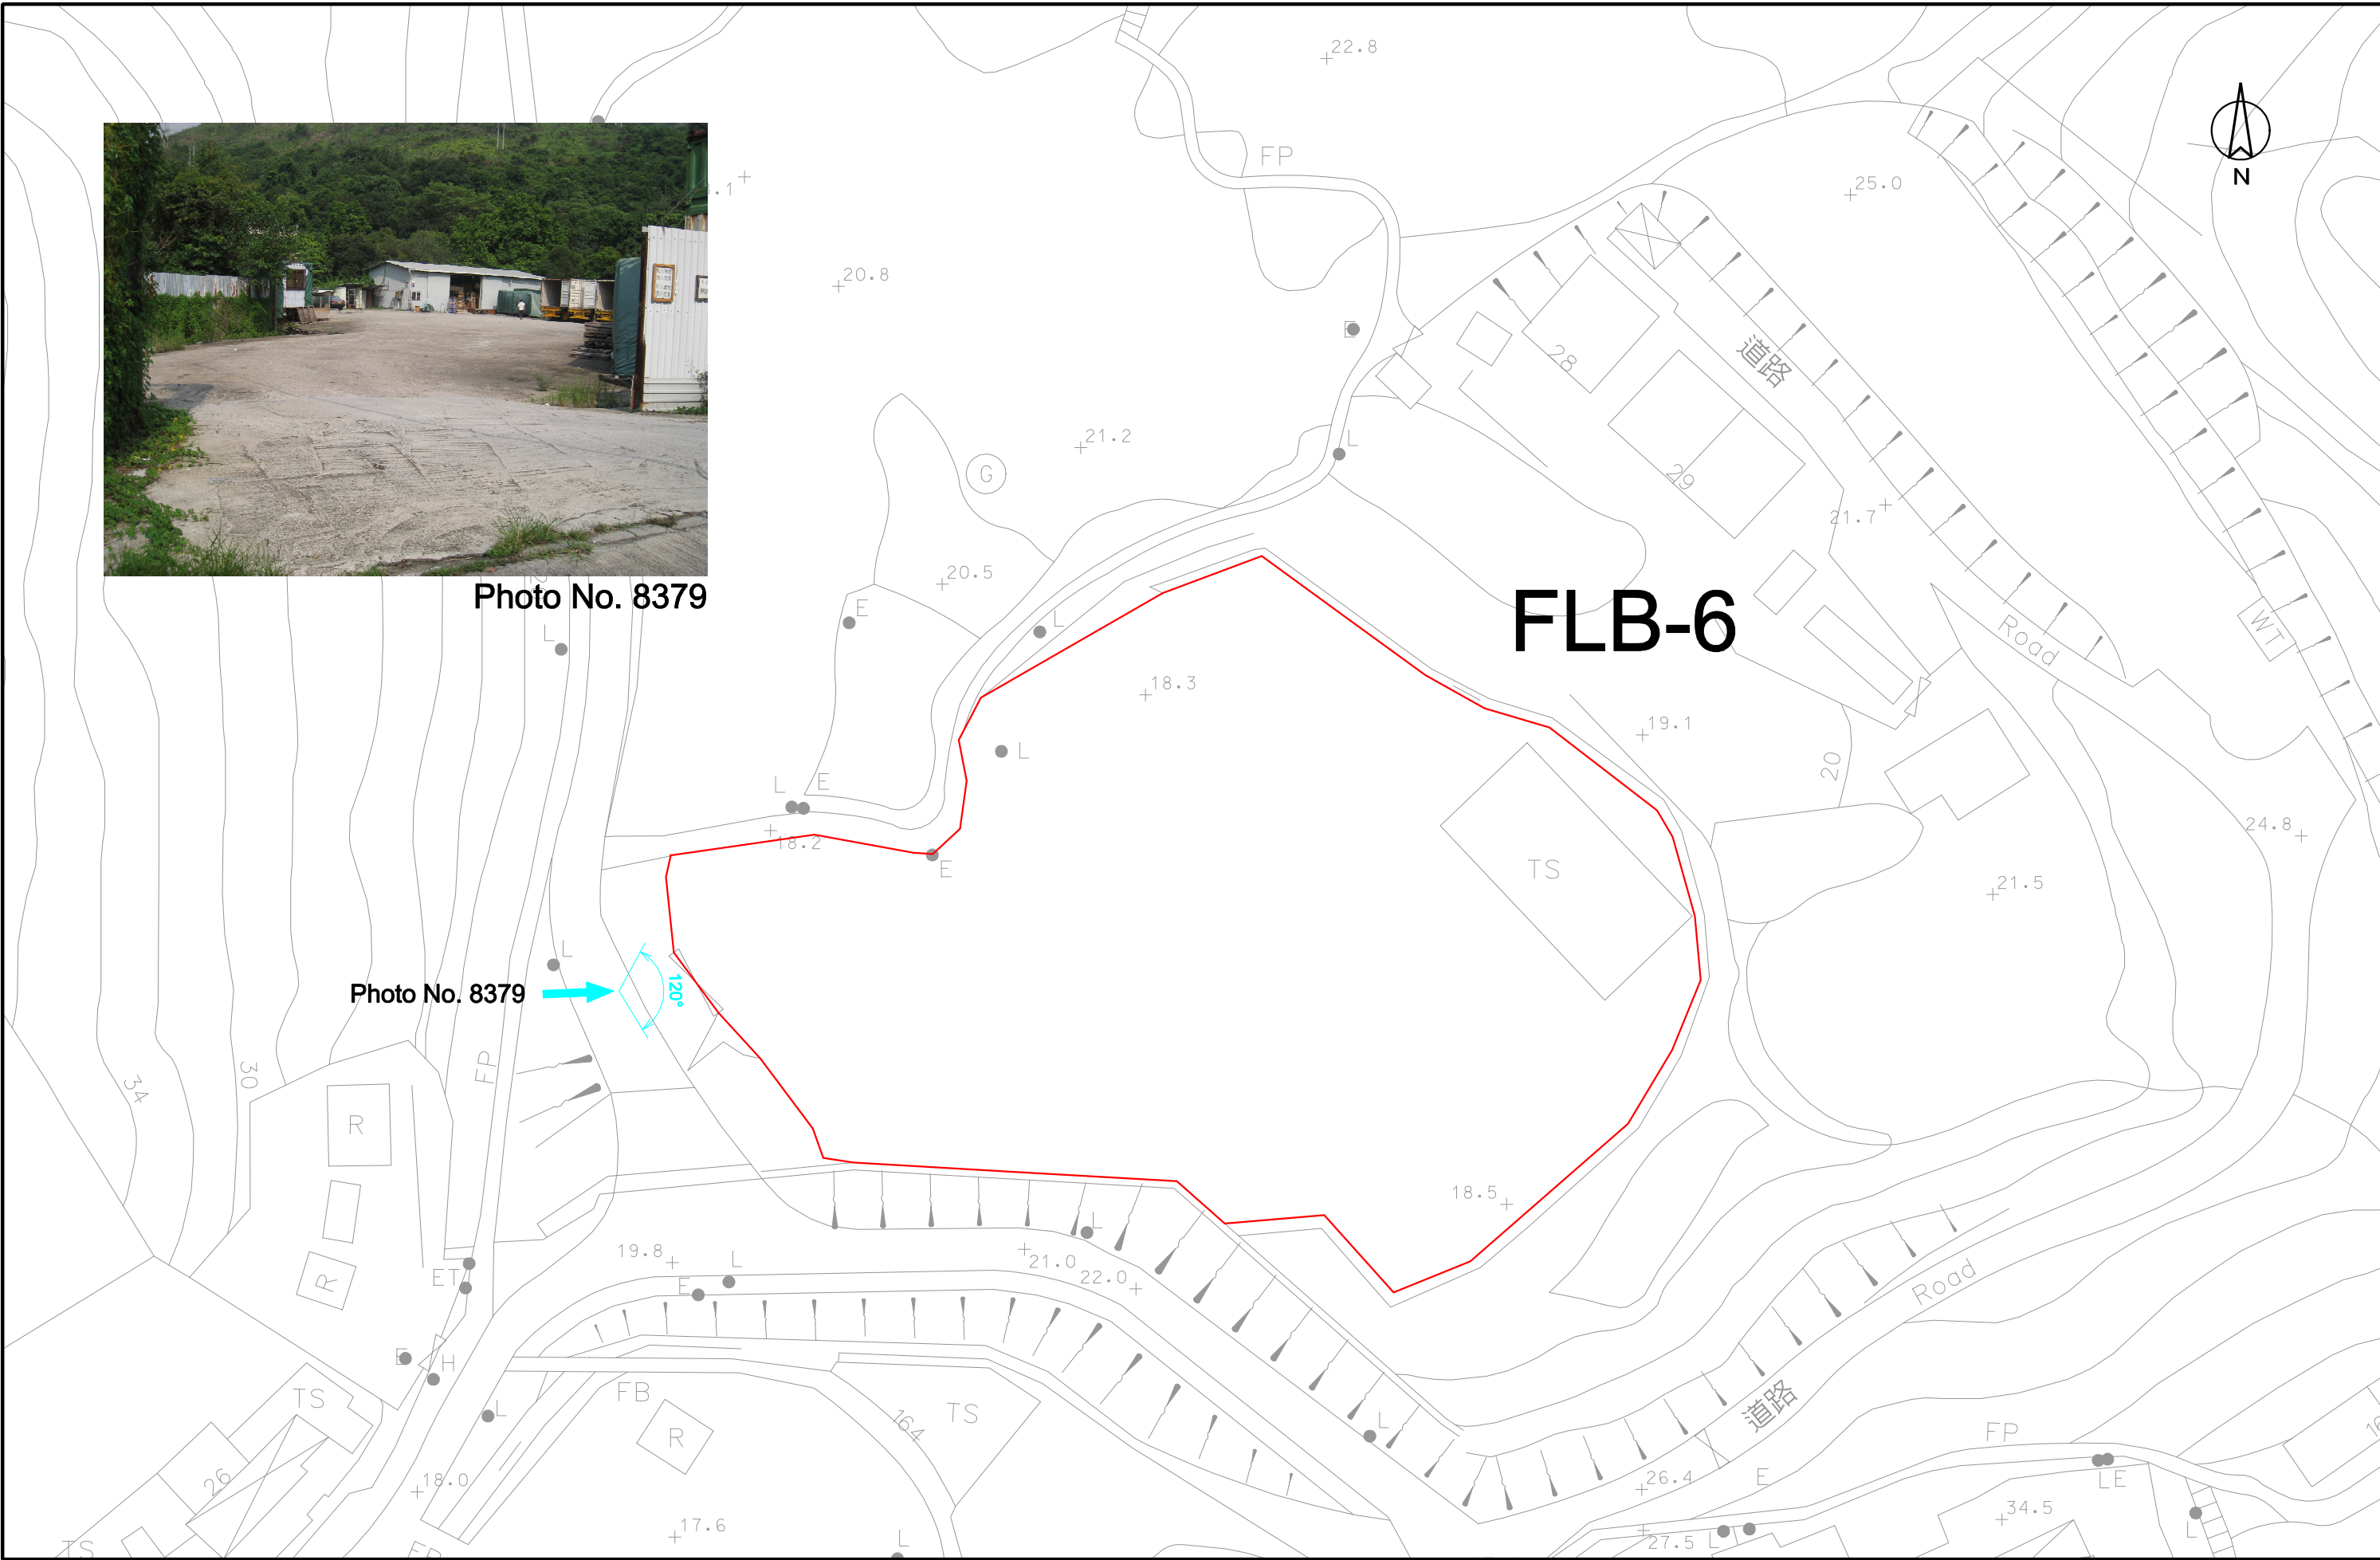
Drawing No.  
**AD-FLB-6**  
Rev.

Desktop Review	
Ref. No. in TP13:	Table A4 - Site No.6
Past Land Use in TP13	Open storage
Review of Outline Zoning Plan	AGR
Review of Geological Survey Map	Qpd
Site History (Review of Historical Aerial Photos)	<ul style="list-style-type: none"> <li>• 1963: Agricultural lands.</li> <li>• 1972: No significant change observed.</li> <li>• 1982: Part of the fields were replaced by grassland and shrubland.</li> <li>• 1993: Part of the site was cleared and became hard standing ground. Few warehouses were built.</li> <li>• 2001: The whole area was cleared and became hard standing ground with a warehouse built.</li> <li>• 2008: The site was used for trailer parking.</li> </ul>
Lot No.	DD51 2808B, 2808C, 2808D, 2808E, 2808RP
Land Ownership Status	Government

Site Survey Information and Recommendation	
Date of Survey:	Sep-11
Conducted by:	Thomas Chan and Lawrence Kan
Site Observation & Potentially Sources of Contamination:	Few trucks parked. Access limited.
Preliminary Contamination Rating *	B
Recommended No. of Boreholes **	N/A
Future Landuse	Road network (FLB)
RBRGs	Lower of Industrial or Public Park
Remarks	-

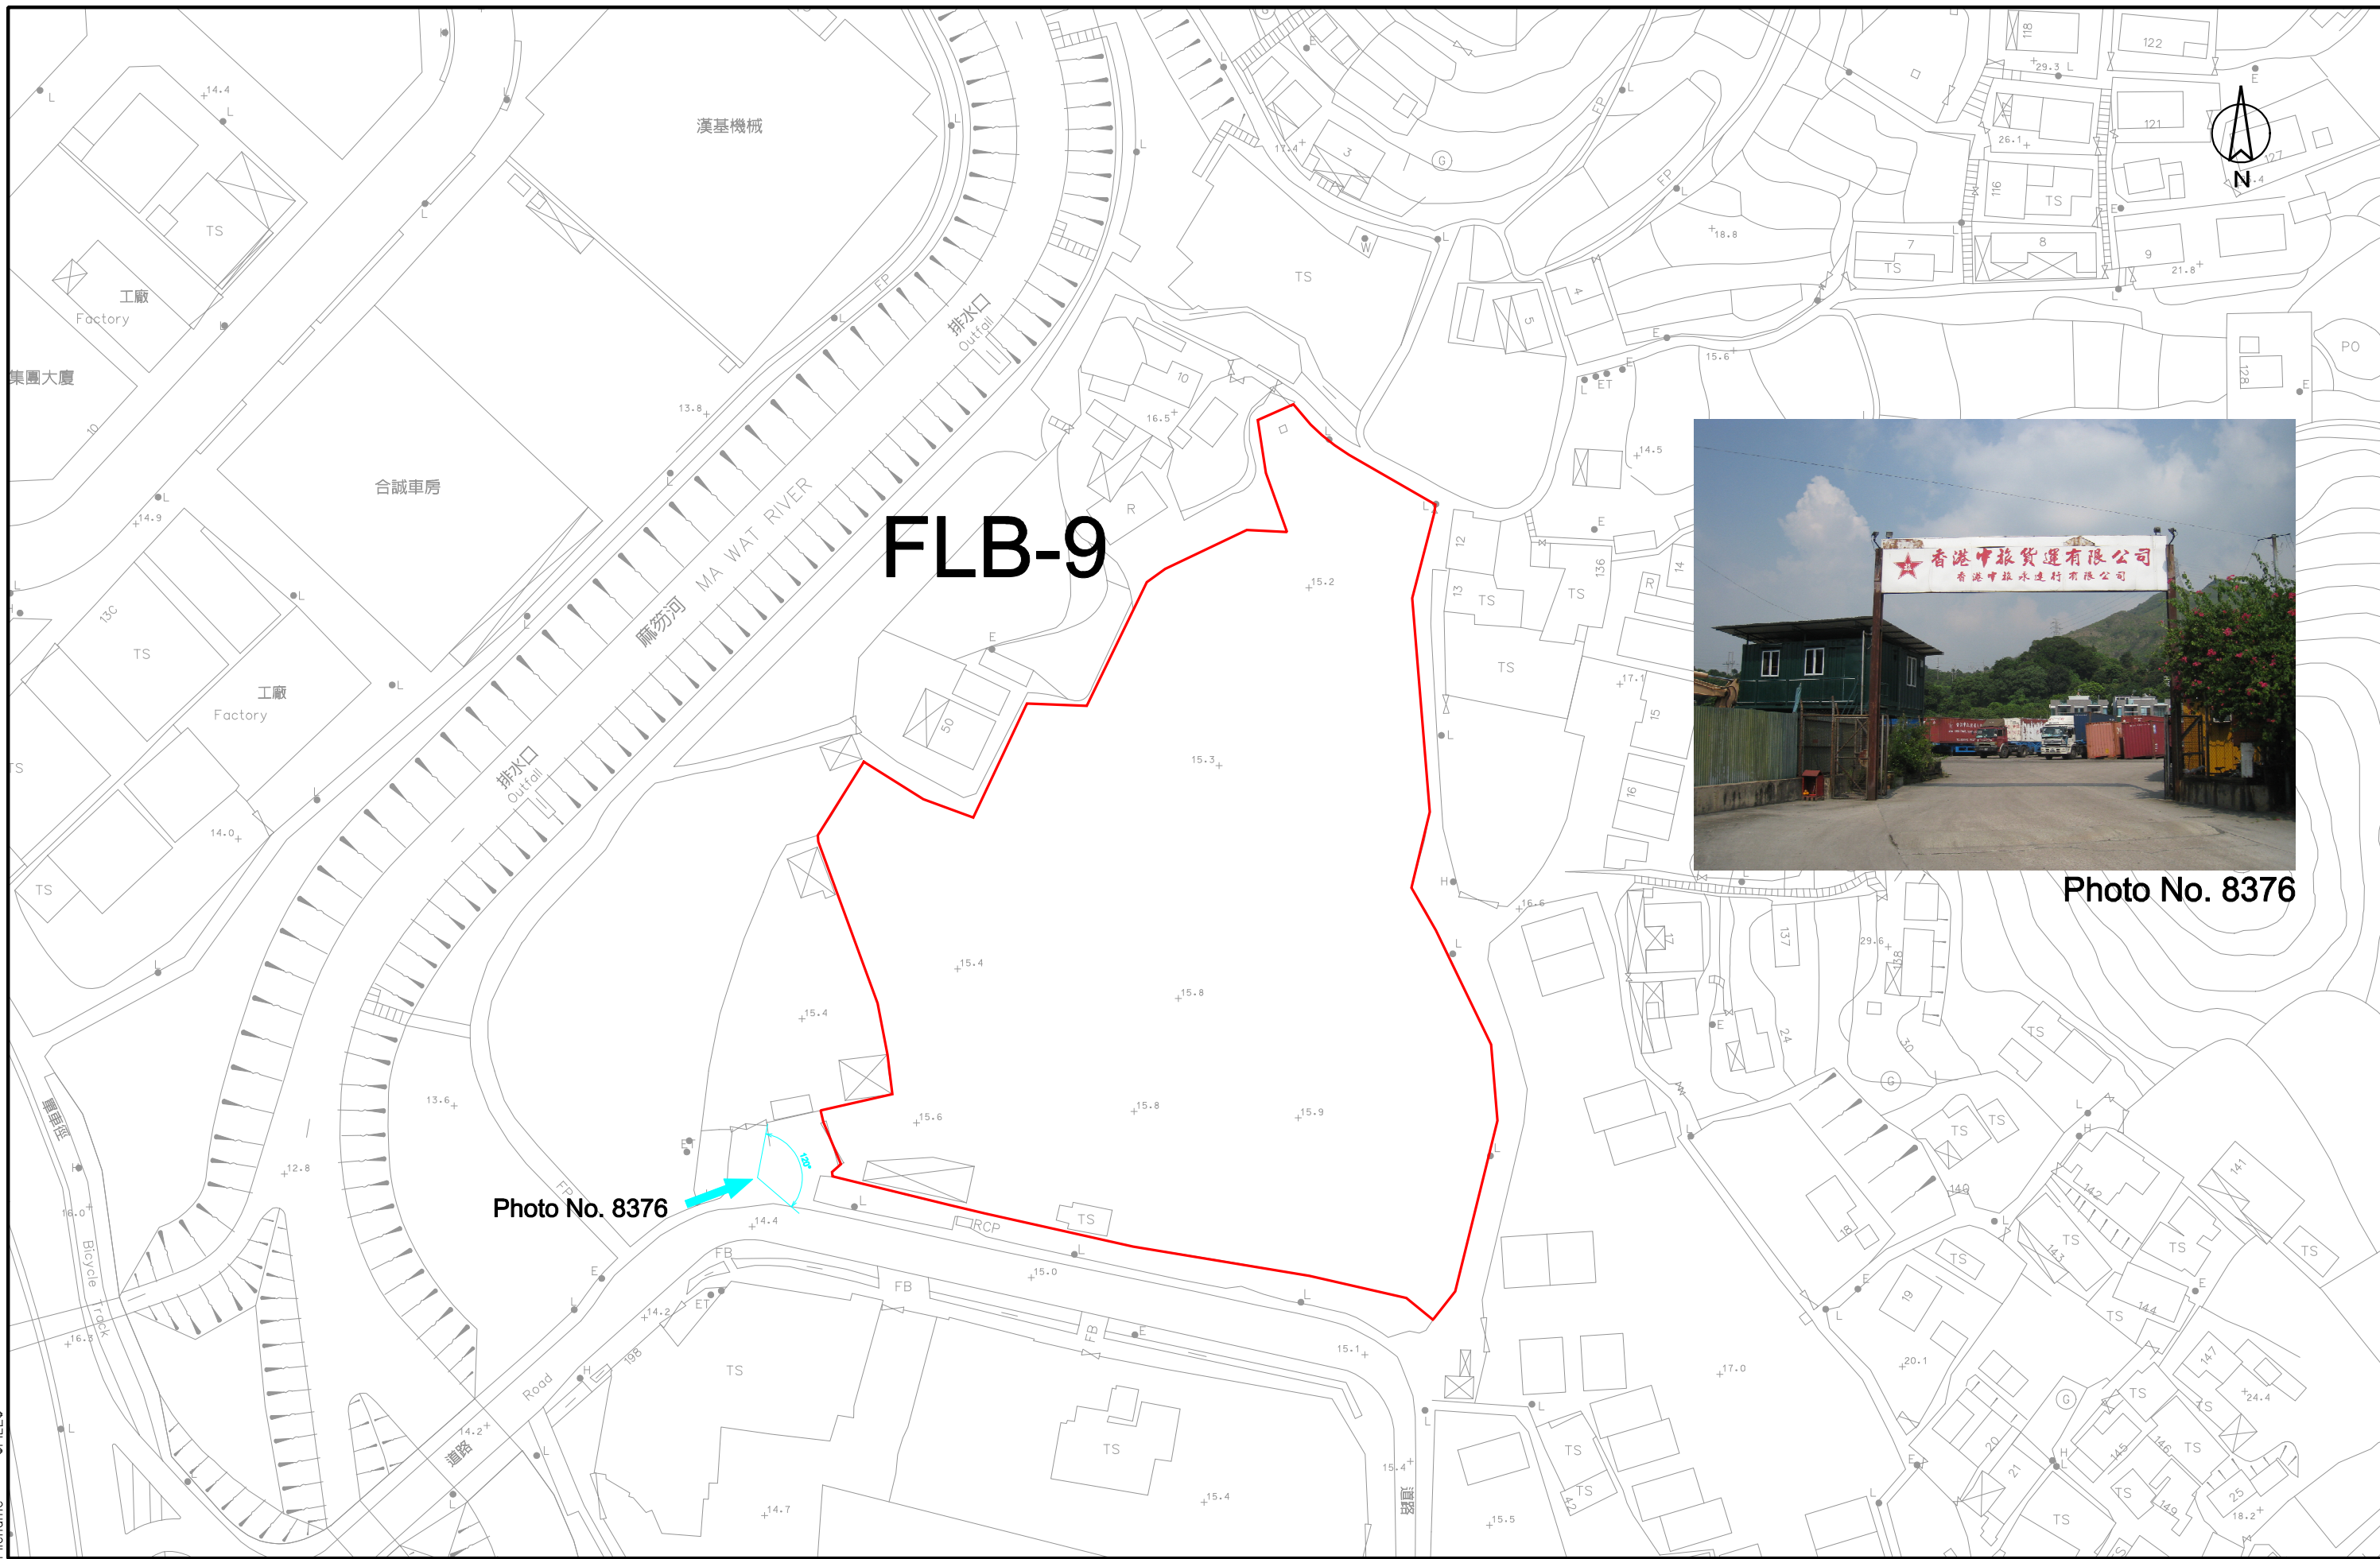
Drawing No.  
**AD-FLB-9**  
Rev.

Desktop Review	
Ref. No. in TP13:	Table A4 - Site No.9
Past Land Use in TP13	Hong Kong China Travel and Transportation Company Ltd
Review of Outline Zoning Plan	REC
Review of Geological Survey Map	Qpa+Qpd+Qa
Site History (Review of Historical Aerial Photos)	<ul style="list-style-type: none"> <li>• 1963: Agricultural fields</li> <li>• 1972: No significant change observed.</li> <li>• 1982: Increased portion of associated buildings.</li> <li>• 1993: The entire area was cleared and became hard standing ground for trailer storage.</li> <li>• 2001: Some temporary structures were built.</li> <li>• 2008: The site was used for storage.</li> </ul>
Lot No.	DD51 2836RP, 2837, 2838, 2840, 2846, 2847
Land Ownership Status	Private

Site Survey Information and Recommendation	
Date of Survey:	Sep-11
Conducted by:	Thomas Chan and Lawrence Kan
Site Observation & Potentially Sources of Contamination:	Warehouses. Trailers parked.
Preliminary Contamination Rating *	B
Recommended No. of Boreholes **	N/A
Future Landuse	Road network (FLB)
RBRGs	Lower of Industrial or Public Park
Remarks	-
