**Agreement No. CE 18/2012 (CE)  
Development of Anderson Road Quarry – Investigation**

**Final Contamination Assessment Plan  
(Rpt Ref. 227724-REP-020-02)**

Final | 13 August 2013

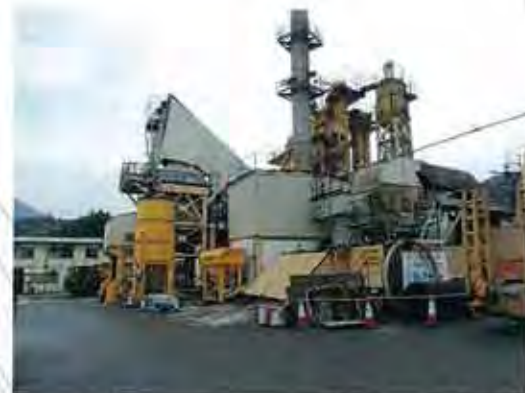
Photo no. : P02-1

| Sub-Section ID | Company | Figure No. | Site Observation | Potentially Contamination Sources | Photo No. | Potentially Contaminated |
|---|---|---|--|---|--|---|
| ARQ-02 | K. Wah Asphalt Plant | 227724/E/5008 | <ul style="list-style-type: none"> <li>The asphalt production machines (<b>Photo P02-1</b>) were in operation and the area is concrete paved and intact. No oil stain was observed;</li> <li>As advised by the operator, asphalt residual would be generated during the production and would be disposed to Public Fill Facilities as this asphalt residual is an inert material. Potential land contamination issue at the asphalt production facilities was not observed;</li> <li>Diesel pump (<b>Photo P02-2</b>) was observed in the centre of the site.</li> </ul> | <ul style="list-style-type: none"> <li>Diesel pump</li> <li>Underground diesel tank with fuel station</li> <li>Site vehicles repairing and maintenance workshop</li> </ul> | <ul style="list-style-type: none"> <li>P02-2</li> <li>P02-3</li> <li>P02-4</li> </ul> | Yes |

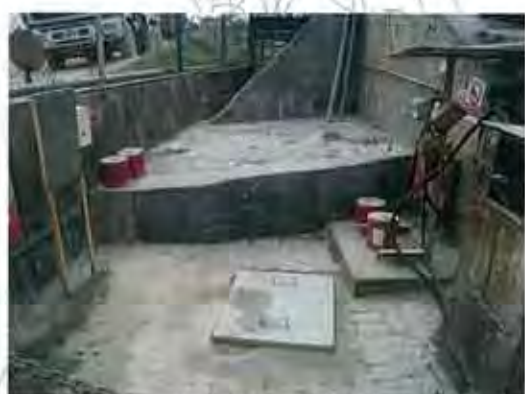
Photo no. : P02-3

| Sub-Section ID | Company | Figure No. | Site Observation | Potentially Contamination Sources | Photo No. | Potentially Contaminated |
|---|---|---|--|---|--|---|
| ARQ-03 | K. Wah Construction Products Ltd. | 227724/E/5009 | <ul style="list-style-type: none"> <li>No oil stain was observed;</li> <li>The fuel station (<b>Photo P02-3</b>) with underground diesel tank (capacity 45,460L) was located in the eastern part. No oil stain was observed;</li> <li>Maintenance workshop (<b>Photos 02-4</b>) was located in the temporary structure at the southern part. The workshop was concrete paved and intact;</li> <li>As advised by the operator, the maintenance activities involved the site vehicle (e.g. truck, asphalt paver, road roller and fork lifter) and equipments (e.g. asphalt production machines) maintenance;</li> <li>The area next to the workshop was used for chemical and chemical waste storage area (<b>Photo P02-5</b>). Bunding filled with sand was used in this area.</li> </ul> | <ul style="list-style-type: none"> <li>Chemical and chemical waste storage room</li> </ul> | <ul style="list-style-type: none"> <li>P02-5</li> </ul> | |

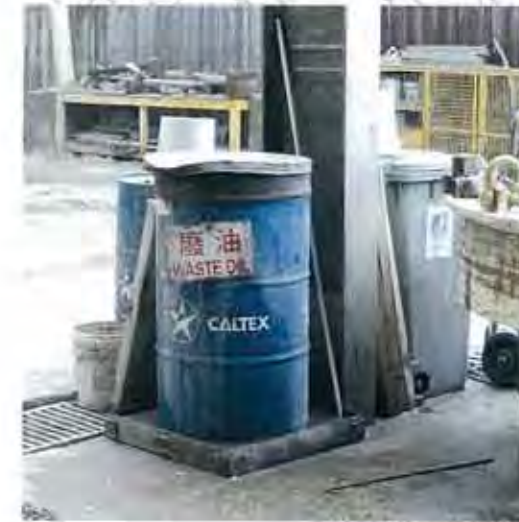
Photo no. : P04-4

| Photo No | Description |
|---|---|
| P04-4 | Chemical waste containers |

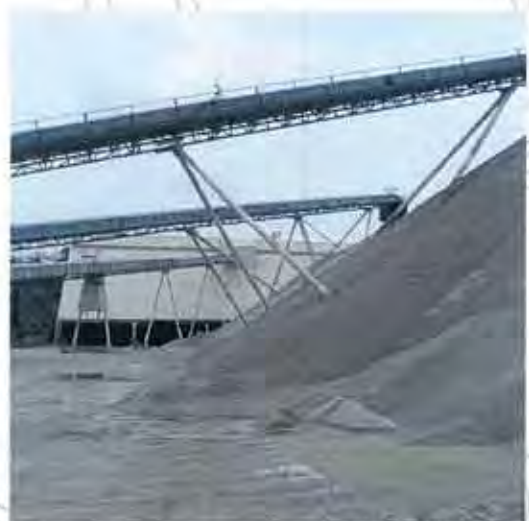
Photo no. : P04-2

| Sub-Section ID | Company | Figure No. | Site Observation | Potentially Contamination Sources | Photo No. | Potentially Contaminated |
|---|---|---|---|---|--|---|
| | Co. Ltd. | | <ul style="list-style-type: none"> <li>The temporary structure located in the western part was used for stockpiling the rocks after crushing from crushing plants. <b>(Photo P04-2)</b>.</li> <li>Maintenance workshop <b>(Photo P04-3)</b> for equipments maintenance was located next to the crushing plant. The workshop was concrete paved and intact. No oil stain was observed;</li> <li>Four 200L drum <b>(Photo P04-4)</b> placed outside the workshop were used for chemical waste storage.</li> </ul> | <ul style="list-style-type: none"> <li>Chemical waste storage area</li> </ul> | <ul style="list-style-type: none"> <li>P04-4</li> </ul> | |

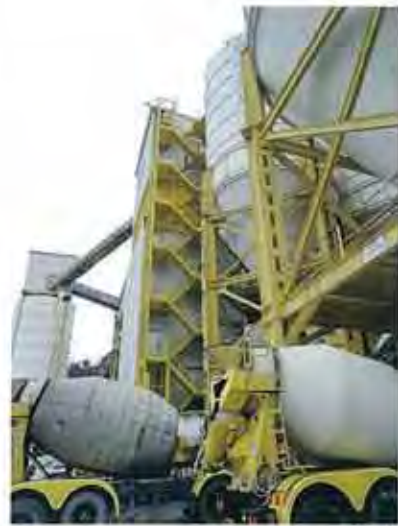
Photo no. : P05-1

| Sub-Section ID | Company | Figure No. | Site Observation | Potentially Contamination Sources | Photo No. | Potentially Contaminated |
|---|---|---|---|---|--|---|
| ARQ-05 | K. Wah Concrete Plant | 227724/E/5011 | <ul style="list-style-type: none"> <li>The concrete production facilities <b>(Photo P05-1)</b> including several silo and raw materials stockpiling area are located in the northern part of the site. The whole area was concrete paved and intact. No oil stain was observed;</li> <li>As advised by the operator, the main activities is mixing the sand, rock, cement and water in the production facilities, and then unloading to the concrete mixing truck. A concrete residual would be generated during the production and would be disposed to Public Fill Facilities as this concrete residual is an inert material. Potential land contamination issue at the concrete production facilities was not observed;</li> <li>Maintenance workshop <b>(Photo P05-2)</b> was identified in the southern part. As advised by the operator, only equipment maintenance (i.e. concrete mixer) was carried out in the workshop. The workshop was concrete paved and intact;</li> <li>Chemical waste storage area <b>(Photo P05-3)</b> was identified in the maintenance workshop.</li> </ul> | <ul style="list-style-type: none"> <li>Maintenance workshop</li> <li>Chemical waste storage area</li> </ul> | <ul style="list-style-type: none"> <li>P05-2</li> <li>P05-3</li> </ul> | Yes |

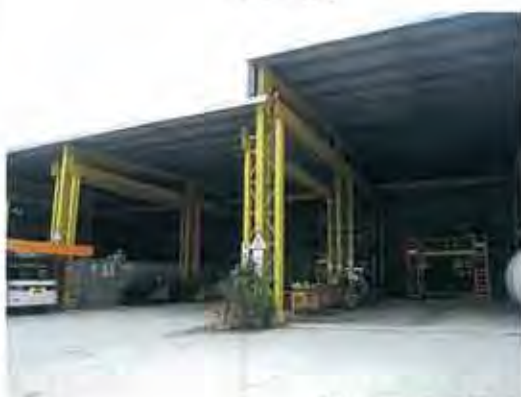
Photo no. : P05-2

| Photo No | Description |
|---|---|
| P05-2 | Maintenance workshop |

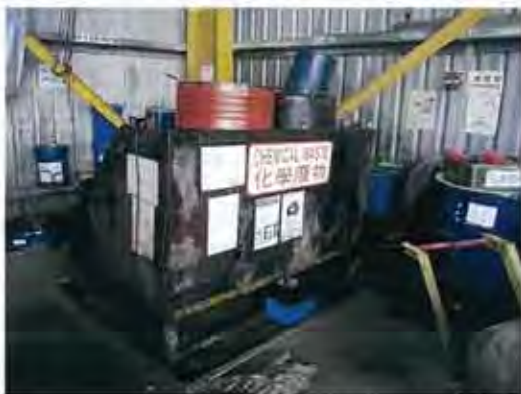
Photo no. : P05-3

| Photo No | Description |
|---|---|
| P05-3 | Chemical waste storage area |

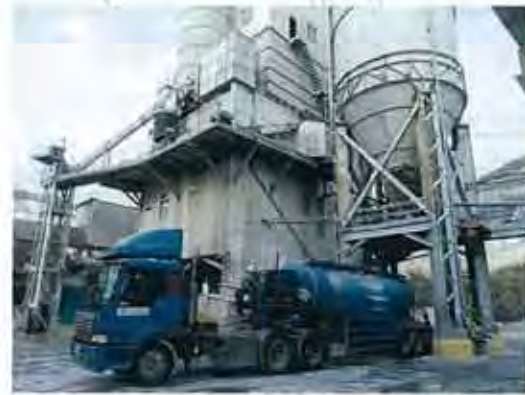
Photo no. : P06-1

| Sub-Section ID | Company | Figure No. | Site Observation | Potentially Contamination Sources | Photo No. | Potentially Contaminated |
|---|---|---|---|---|--|---|
| ARQ-06 | Anderson Concrete Ltd. | 227724/E/5012 | <ul style="list-style-type: none"> <li>The concrete production facilities <b>(Photo P06-1)</b> and <b>Photo 06-2)</b> including several silo and raw materials stockpiling area are located in the northern part of the site. The whole area was concrete paved and intact. No oil stain was observed;</li> <li>As advised by the operator, the main activities is mixing the sand, rock, cement and water in the production facilities, and then unloading to the concrete mixing truck. A concrete residual would be generated during the production and would be disposed to Public Fill Facilities as this concrete residual is an inert material. Potential land</li> </ul> | <ul style="list-style-type: none"> <li>Chemical storage area</li> <li>Diesel drums storage room</li> </ul> | <ul style="list-style-type: none"> <li>P06-3</li> <li>P06-4</li> </ul> | Yes |

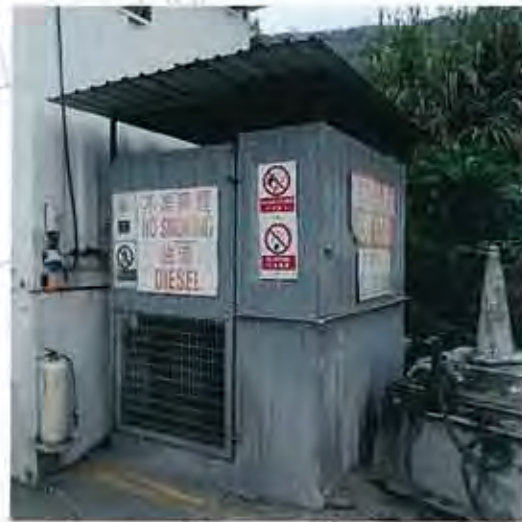
Photo no. : P06-4

| Sub-Section ID | Company | Figure No. | Site Observation | Potentially Contamination Sources | Photo No. | Potentially Contaminated |
|---|---|---|--|---|---|---|
| | | | <p>contamination issue at the concrete production facilities was not observed;</p> <ul style="list-style-type: none"> <li>One chemical storage cabinet <b>(Photo P06-3)</b> for lubricant oil storage was located in the centre area;</li> <li>A small temporary structure located in the southeast boundary was used for diesel storage with maximum 3 no. of 200L diesel drums <b>(Photo P06-4)</b>.</li> </ul> | | | |

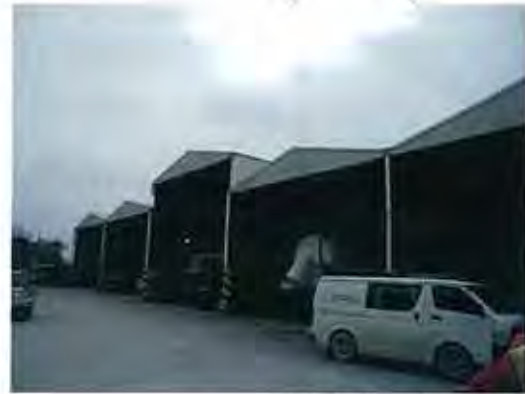
Photo no. : P07-1

| Sub-Section ID | Company | Figure No. | Site Observation | Potentially Contamination Sources | Photo No. | Potentially Contaminated |
|---|---|---|--|---|---|---|
| ARQ-07 | Anderson Concrete Ltd. | 227724/E/5013 | <ul style="list-style-type: none"> <li>The majority of the site is maintenance workshop <b>(Photo P07-1)</b>. The whole area was concrete paved and intact;</li> <li>As advised by the operator, the maintenance activities involved the site vehicle (e.g. truck, concrete mixing truck) and equipments (e.g. concrete production machines) maintenance;</li> <li>Chemical waste storage area <b>(Photo P07-2)</b> was observed in the workshop;</li> <li>Two temporary structures located at the northern area were used for materials storage <b>(Photo P07-3)</b> and site office <b>(Photo P07-4)</b>.</li> </ul> | <ul style="list-style-type: none"> <li>Site vehicles repairing and maintenance workshop</li> <li>Chemical waste storage area</li> </ul> | <ul style="list-style-type: none"> <li>P07-1</li> <li>P07-2</li> </ul> | Yes |

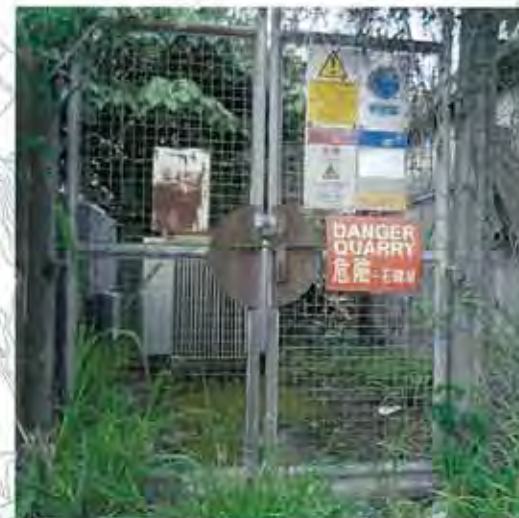
Photo no. : P08-8

| Sub-Section ID | Company | Figure No. | Site Observation | Potentially Contamination Sources | Photo No. | Potentially Contaminated |
|---|---|---|--|---|---|---|
| ARQ-09 | Anderson Concrete Ltd. | 227724/E/5015 | unlikely;<br><ul style="list-style-type: none"> <li>Electric sub-station (ESS-05) (Photo P08-8) was located next to the maintenance workshop. Transformer was observed in the sub-station.</li> <li>Open car park for concrete mixing vehicle (Photo P09-1 and Photo P09-2);</li> <li>The whole area was unpaved but clean and no oil stain was observed.</li> </ul> | <ul style="list-style-type: none"> <li>Electric sub-station (ESS-05)</li> </ul> | <ul style="list-style-type: none"> <li>P08-8</li> </ul> | No |

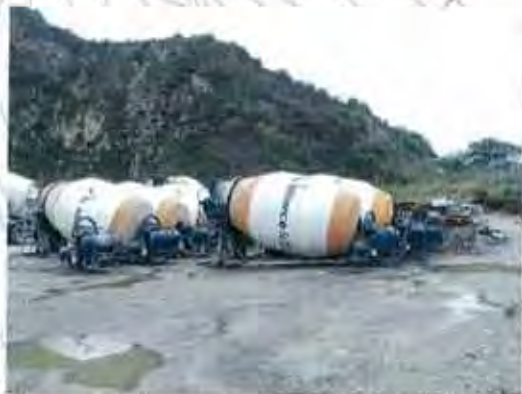
Photo no. : P09-2

| Photo No | Description |
|---|---|
| P09-2 | Car park |

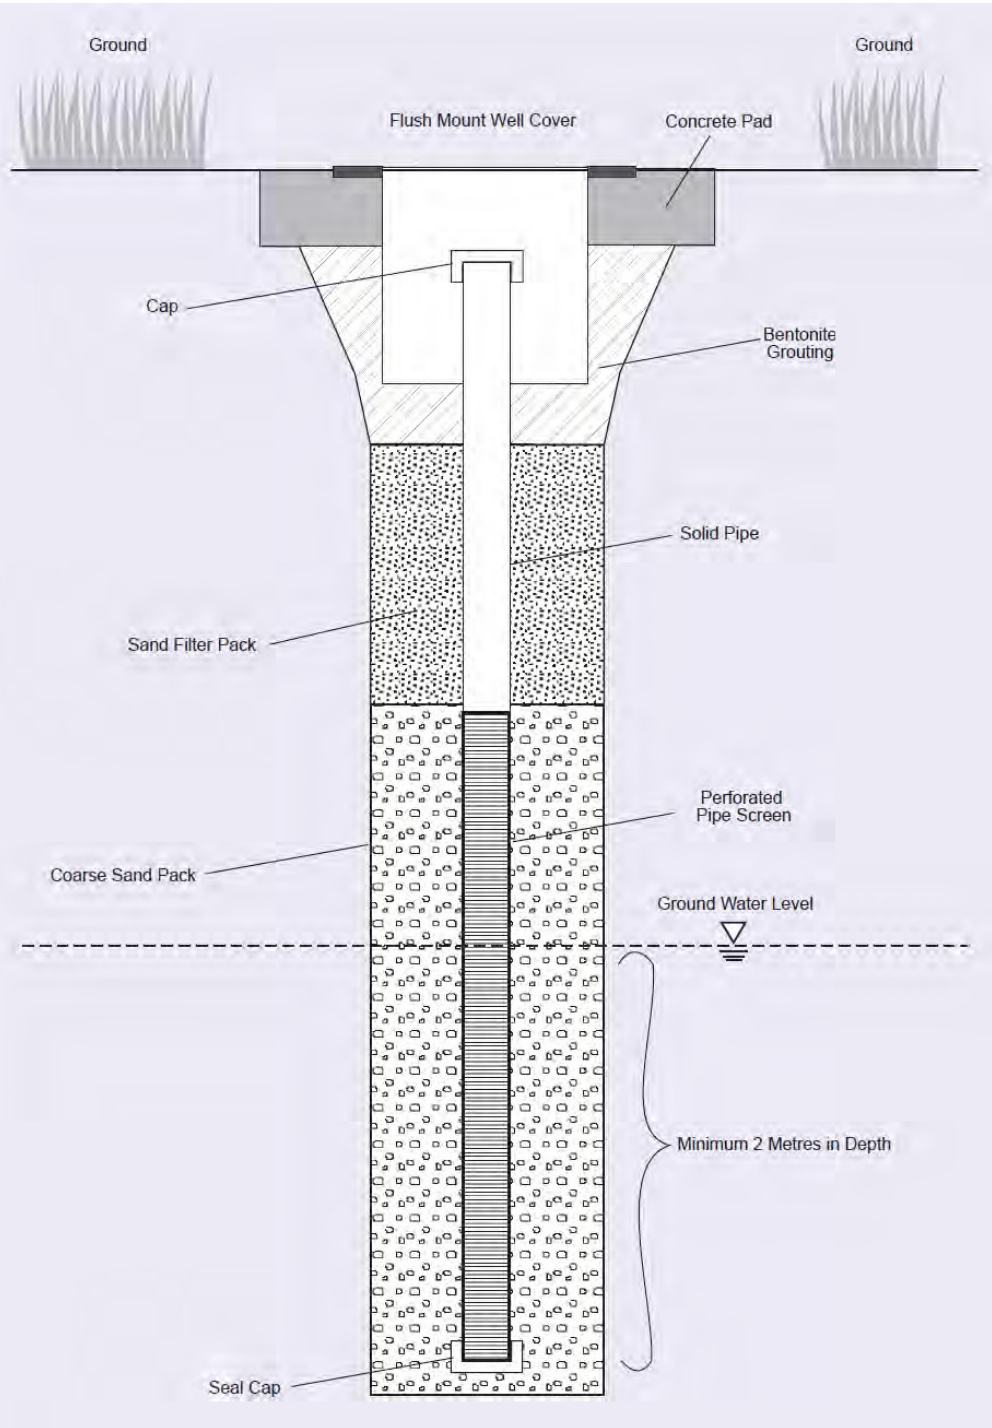
Schematic drawing of groundwater monitoring well

**Groundwater Monitoring Well**
