Contract title  
DESALINATION PLANT AT TSEUNG KWAN O - FEASIBILITY STUDY

Drawing title  
ILLUSTRATIONS OF POTENTIAL SLOPE MITIGATION WORKS

Drawing no. FIGURE 11.13c	Revision
------------------------------	----------

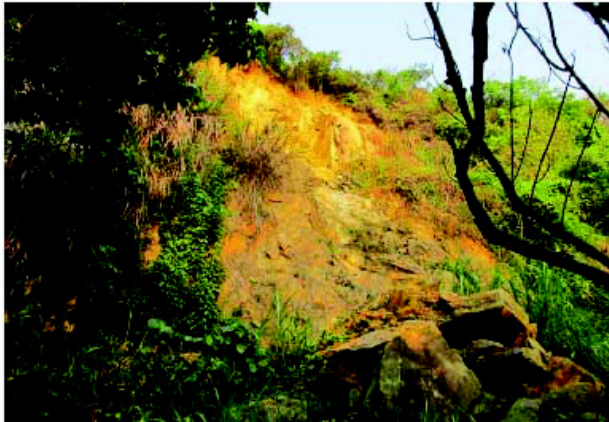
Existing conditions

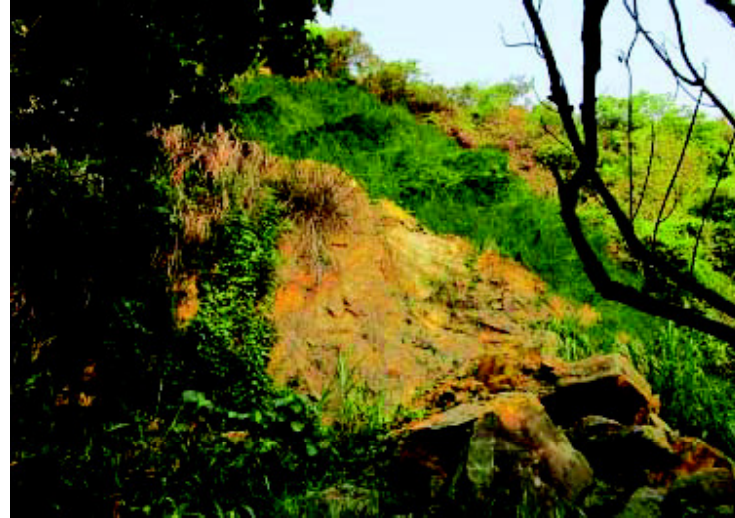
Indicative photomontage of view after installation of soil nails on slope portion immediately above rock slope at toe of natural slope. Affected soil slope restored with hydroseeding and planting

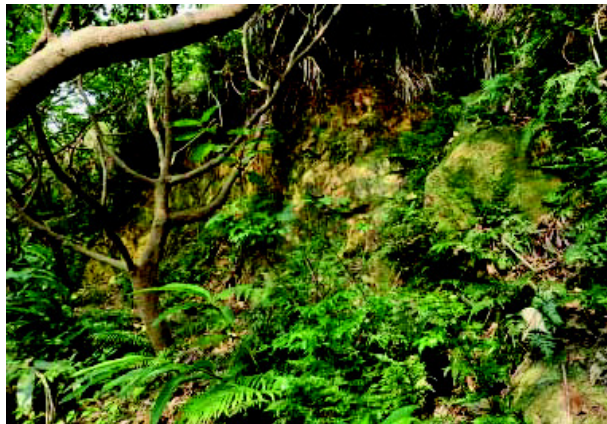
Existing conditions

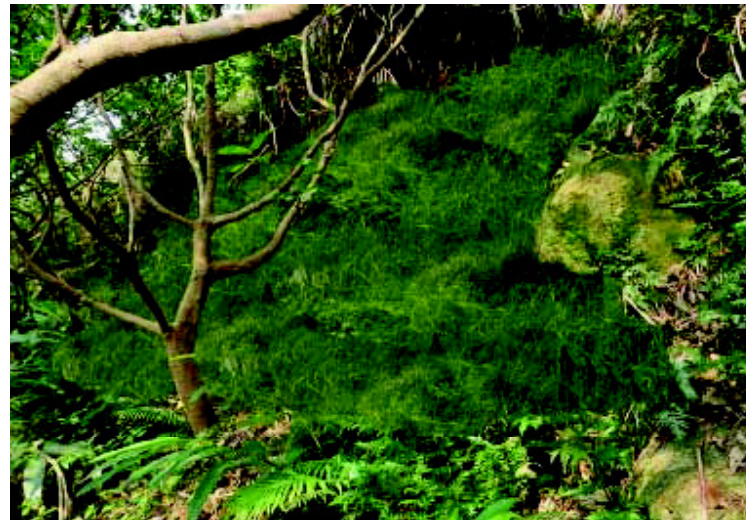
Indicative photomontage of view after installation of soil nails on soil slope at the toe of natural slope. Affected soil slope restored with hydroseeding and planting
