# Slope Stabilization

Contract title	DESALINATION PLANT AT TSEUNG KWAN O - FEASIBILITY STUDY
----------------	---

Drawing title	ILLUSTRATIONS OF POTENTIAL SLOPE MITIGATION WORKS
---------------	---

Drawing no.	FIGURE 3.3c	Revision	
-------------	-------------	----------	--

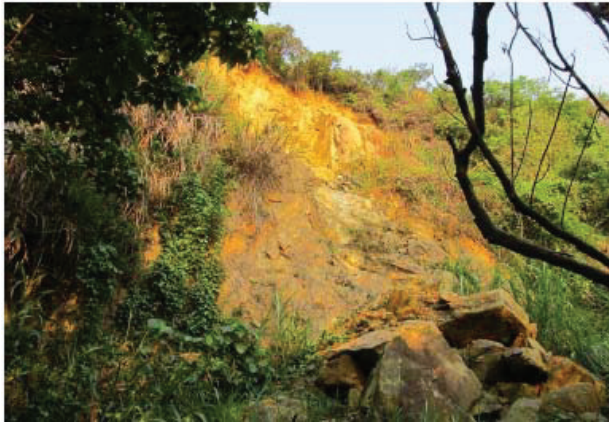
Existing conditions

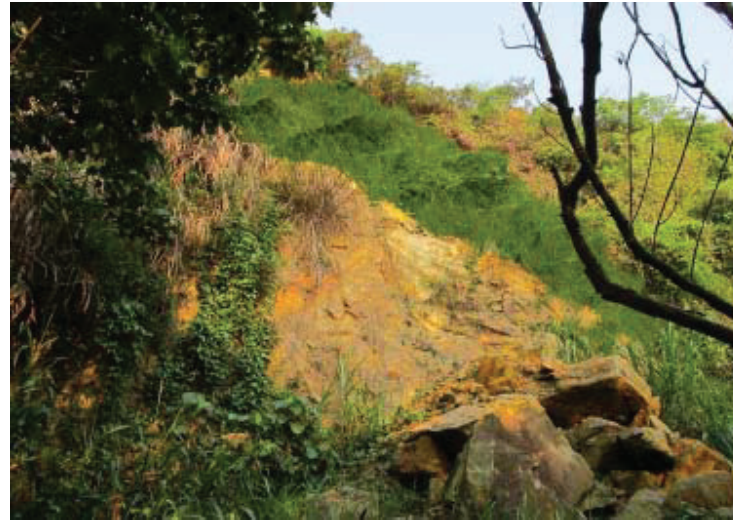
Indicative photomontage of view after installation of soil nails on slope portion immediately above rock slope at toe of natural slope. Affected soil slope restored with hydroseeding and planting

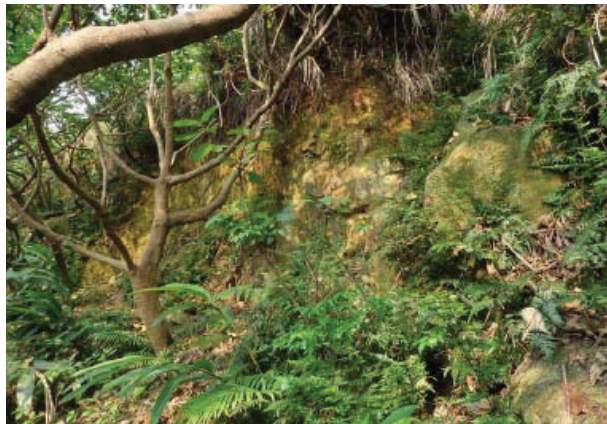
Existing conditions

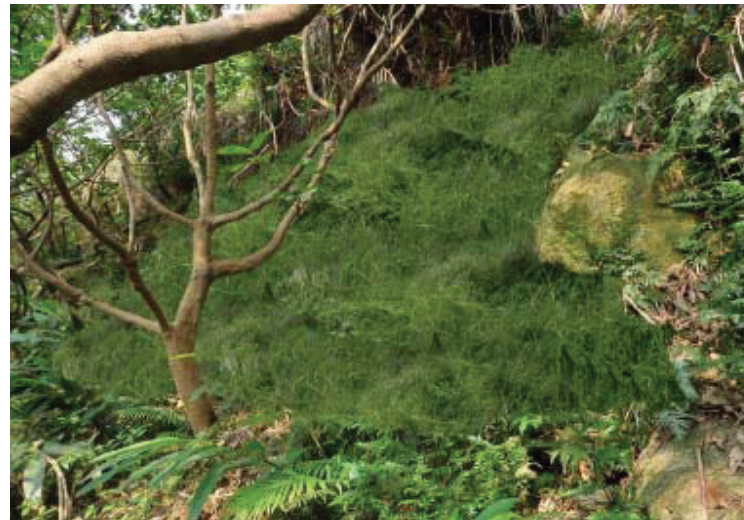
Indicative photomontage of view after installation of soil nails on soil slope at the toe of natural slope. Affected soil slope restored with hydroseeding and planting
