**Advisory Council on the Environment
Nature Conservation Subcommittee**

Restoration of Tung Chung Stream

This paper reports the findings of the monitoring programme on ecological recovery of Tung Chung Stream.

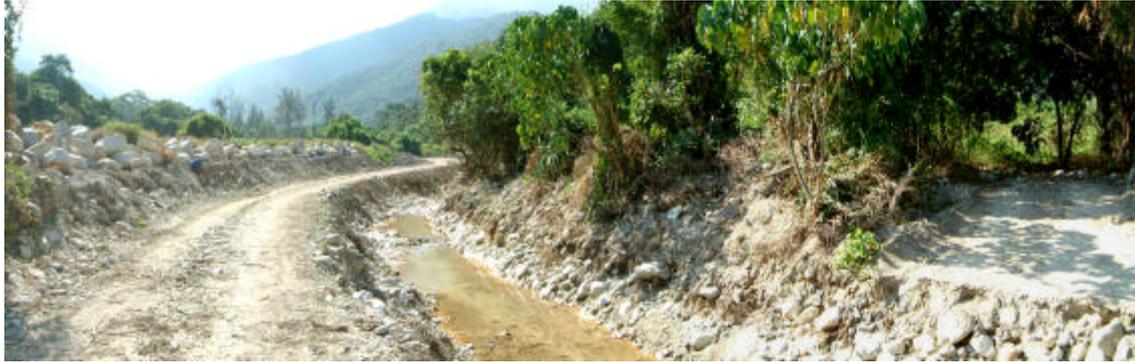
Figure 3(a): The damaged section of Tung Chung Stream (photo taken on 7 Nov 2003)

2. Tung Chung Stream is about three kilometres long. A section of about 330 metres at the lower course of the stream was found damaged by unauthorised works in late 2003. The streambed was excavated and boulders and pebbles on the streambed were removed and stockpiled along the stream bank. An access road along the stream bank and several temporary dams were formed. There were also earth filling activities reducing the stream width to 2-3 metres. The stream flow was impeded and the remaining flow was filled with sediments. It was considered that the stream section and riparian habitats were damaged severely. The incidence was reported to the Advisory Council on the Environment (ACE) in December 2003 (ACE Paper 37/2003).

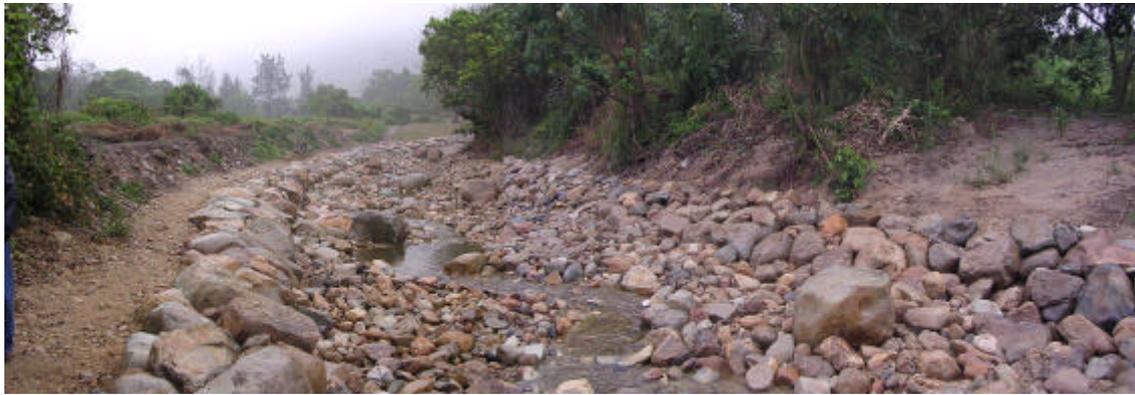
Figure 3(b): After reinstatement (photo taken on 30 April 2004)

14. A series of photographs of the reinstated section of the stream showing the progress of restoration is given in **figure 3** and a photo of the undisturbed reference site is given in **figure 4** for reference.

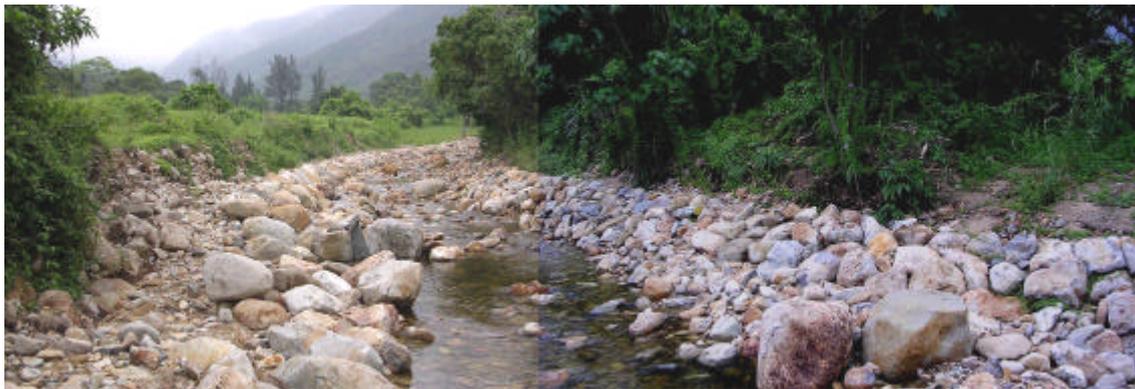
Figure 3(c): After heavy rainstorm (photo taken on 21 May 2004)

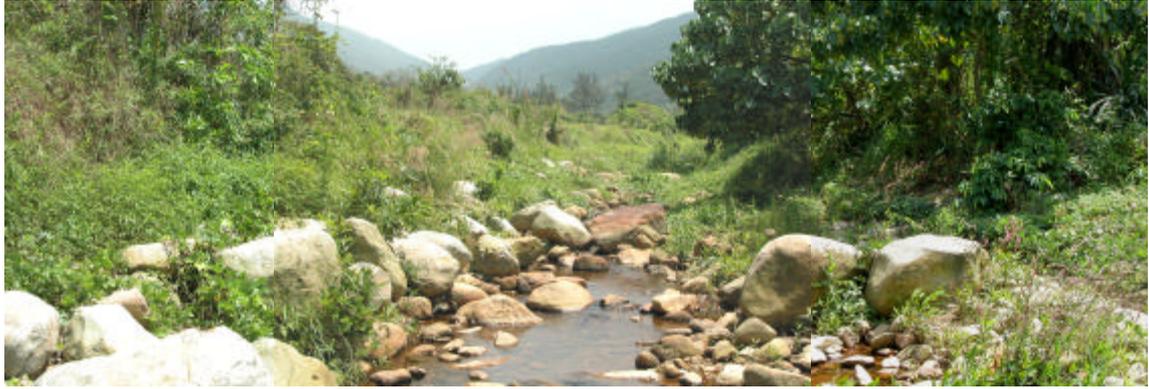
Figure 3(d): The recent situation of the reinstated section (photo taken on 21 April 2006)

15. Based on the findings of the monitoring programme described above, the ecological recovery of Tung Chung Stream is considered successful. The reinstated section has largely recovered and no further enhancement works are required. Members are invited to note the findings of the ecological monitoring programme.

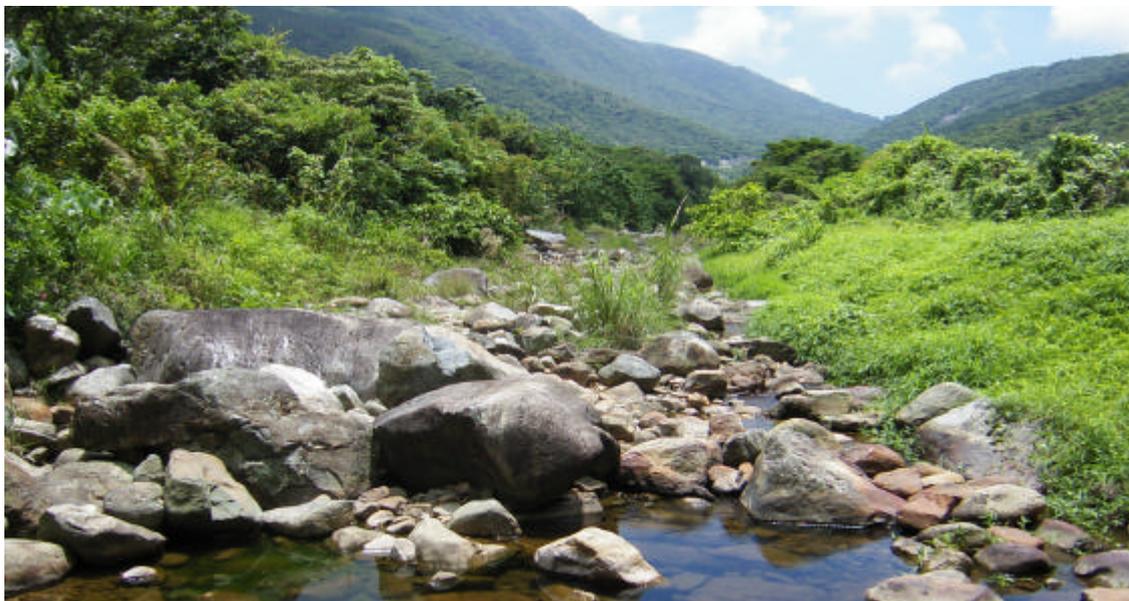
Figure 4: The undisturbed reference section of Tung Chung Stream
