Graded/Proposed Graded Historic Building

Site Code: G201	Site Name: MacIntosh Fort (Pak Fu Shan)
Full Address: At hilltop of Pak Fu Shan	Figure No.: Figure 11.4
Orientation: North	Category: Built Structure (Government Building)
Age of Structure: Constructed between 1949 and 1953	Grading Status : Grade 2 (confirmed on 18 December 2009)

Site Code: G202	Site Name: MacIntosh Fort (Ngau Yiu)
Full Address: At hilltop of Lo Shue Ling	Figure No.: Figure 11.11
Orientation: North	Category: Built Structure (Government Building)
Age of Structure: Constructed between 1949 and 1953	Grading Status : Grade 2 (confirmed on 18 December 2009)

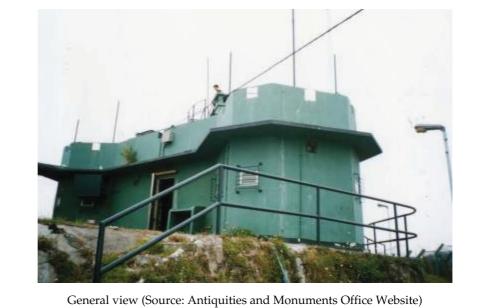
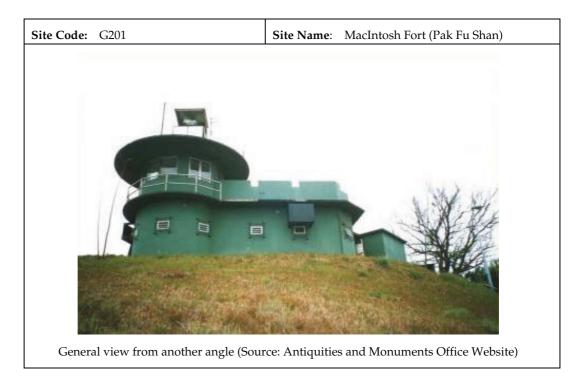
Photographic Records:

This fort at Pak Fu Shan is two-storey high and was constructed with a rounded central portion and two side wings on the ground floor. One wing was generally used for sleeping quarters for up to eight people and the other for cooking. The ground floor of the central area served as communication or command room and the second floor as an observation tower. Both floors are constructed with ramparts and gun-slot iron openings. There are double iron doors at the entrance of the fort

Existing Condition: Good

Notes on any Modifications: Original appearance can be retained except some minor alterations

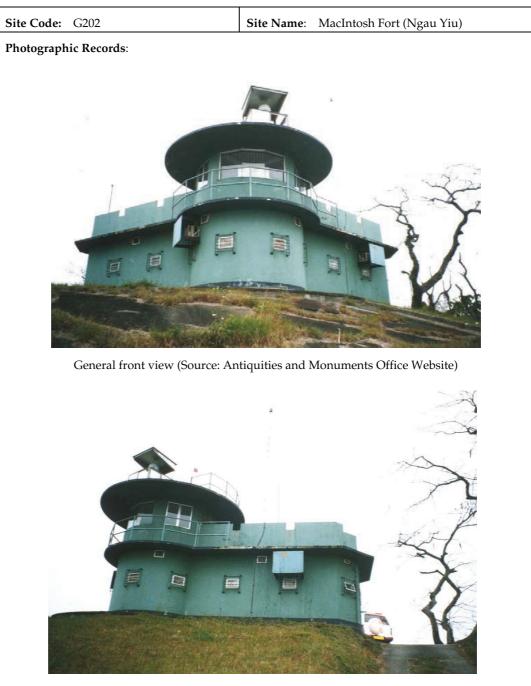
Right elevation (Source: Antiquities and Monuments Office Website)

Similar to MacIntosh Fort at Pak Fu Shan, this fort at Ngau Yiu is two-storey high and was constructed with a rounded central portion and two single-storey side wings on the ground floor. One wing was generally used for sleeping quarters for up to eight people and the other for cooking. The ground floor of the central area served as communication or command room and the second floor as an observation tower. Both floors are constructed with ramparts and gunslot iron openings. There are double iron doors at the entrance of the fort. The major difference of this fort from other MacIntosh Forts is that this fort has a circular shaped flat roof, instead of an octagonal shaped roof adopted by other forts.

Existing Condition: Good

Notes on any Modifications: MacIntosh Fort (Ngau Yiu) is regarded as having minimal amount of alterations.
