Figure 3 Development of a Bathing Beach at Lung Mei, Tai Po (發展大埔龍尾泳灘)

圖三 Indicative Arrangement of Standing Type Silt Curtain - 直立式隔泥幕指示布置

EP-388/2010

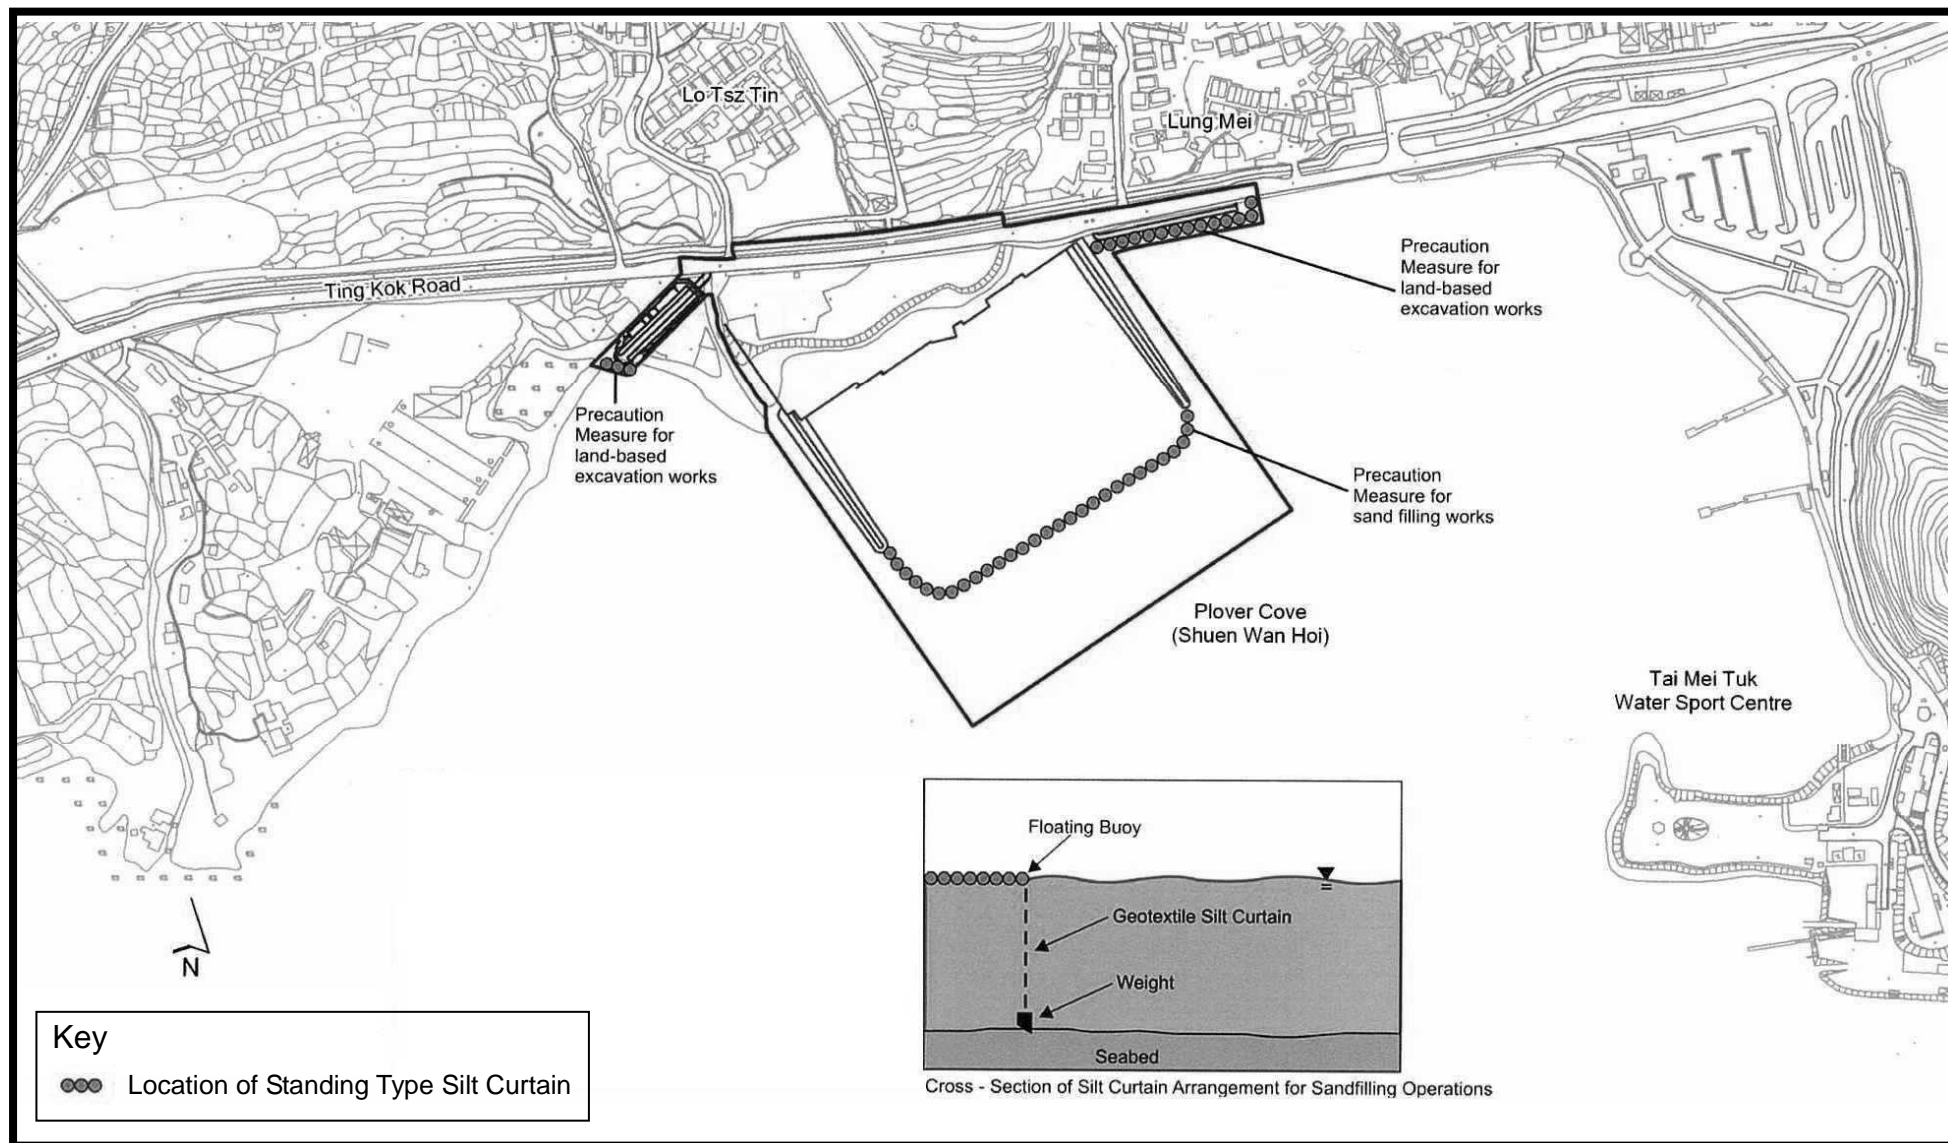
This figure was prepared based on Figure no. 6.21 of the EIA Report (No.: AEIAR-123/2008)
 本圖是根據環境影響評估報告(編號: AEIAR-123/2008)圖 6.21 編制
