Removal of Temporary Rock Bund from Existing Seabed at Ha Pak Nai

Project Profile

May 1999

Civil Engineering Department

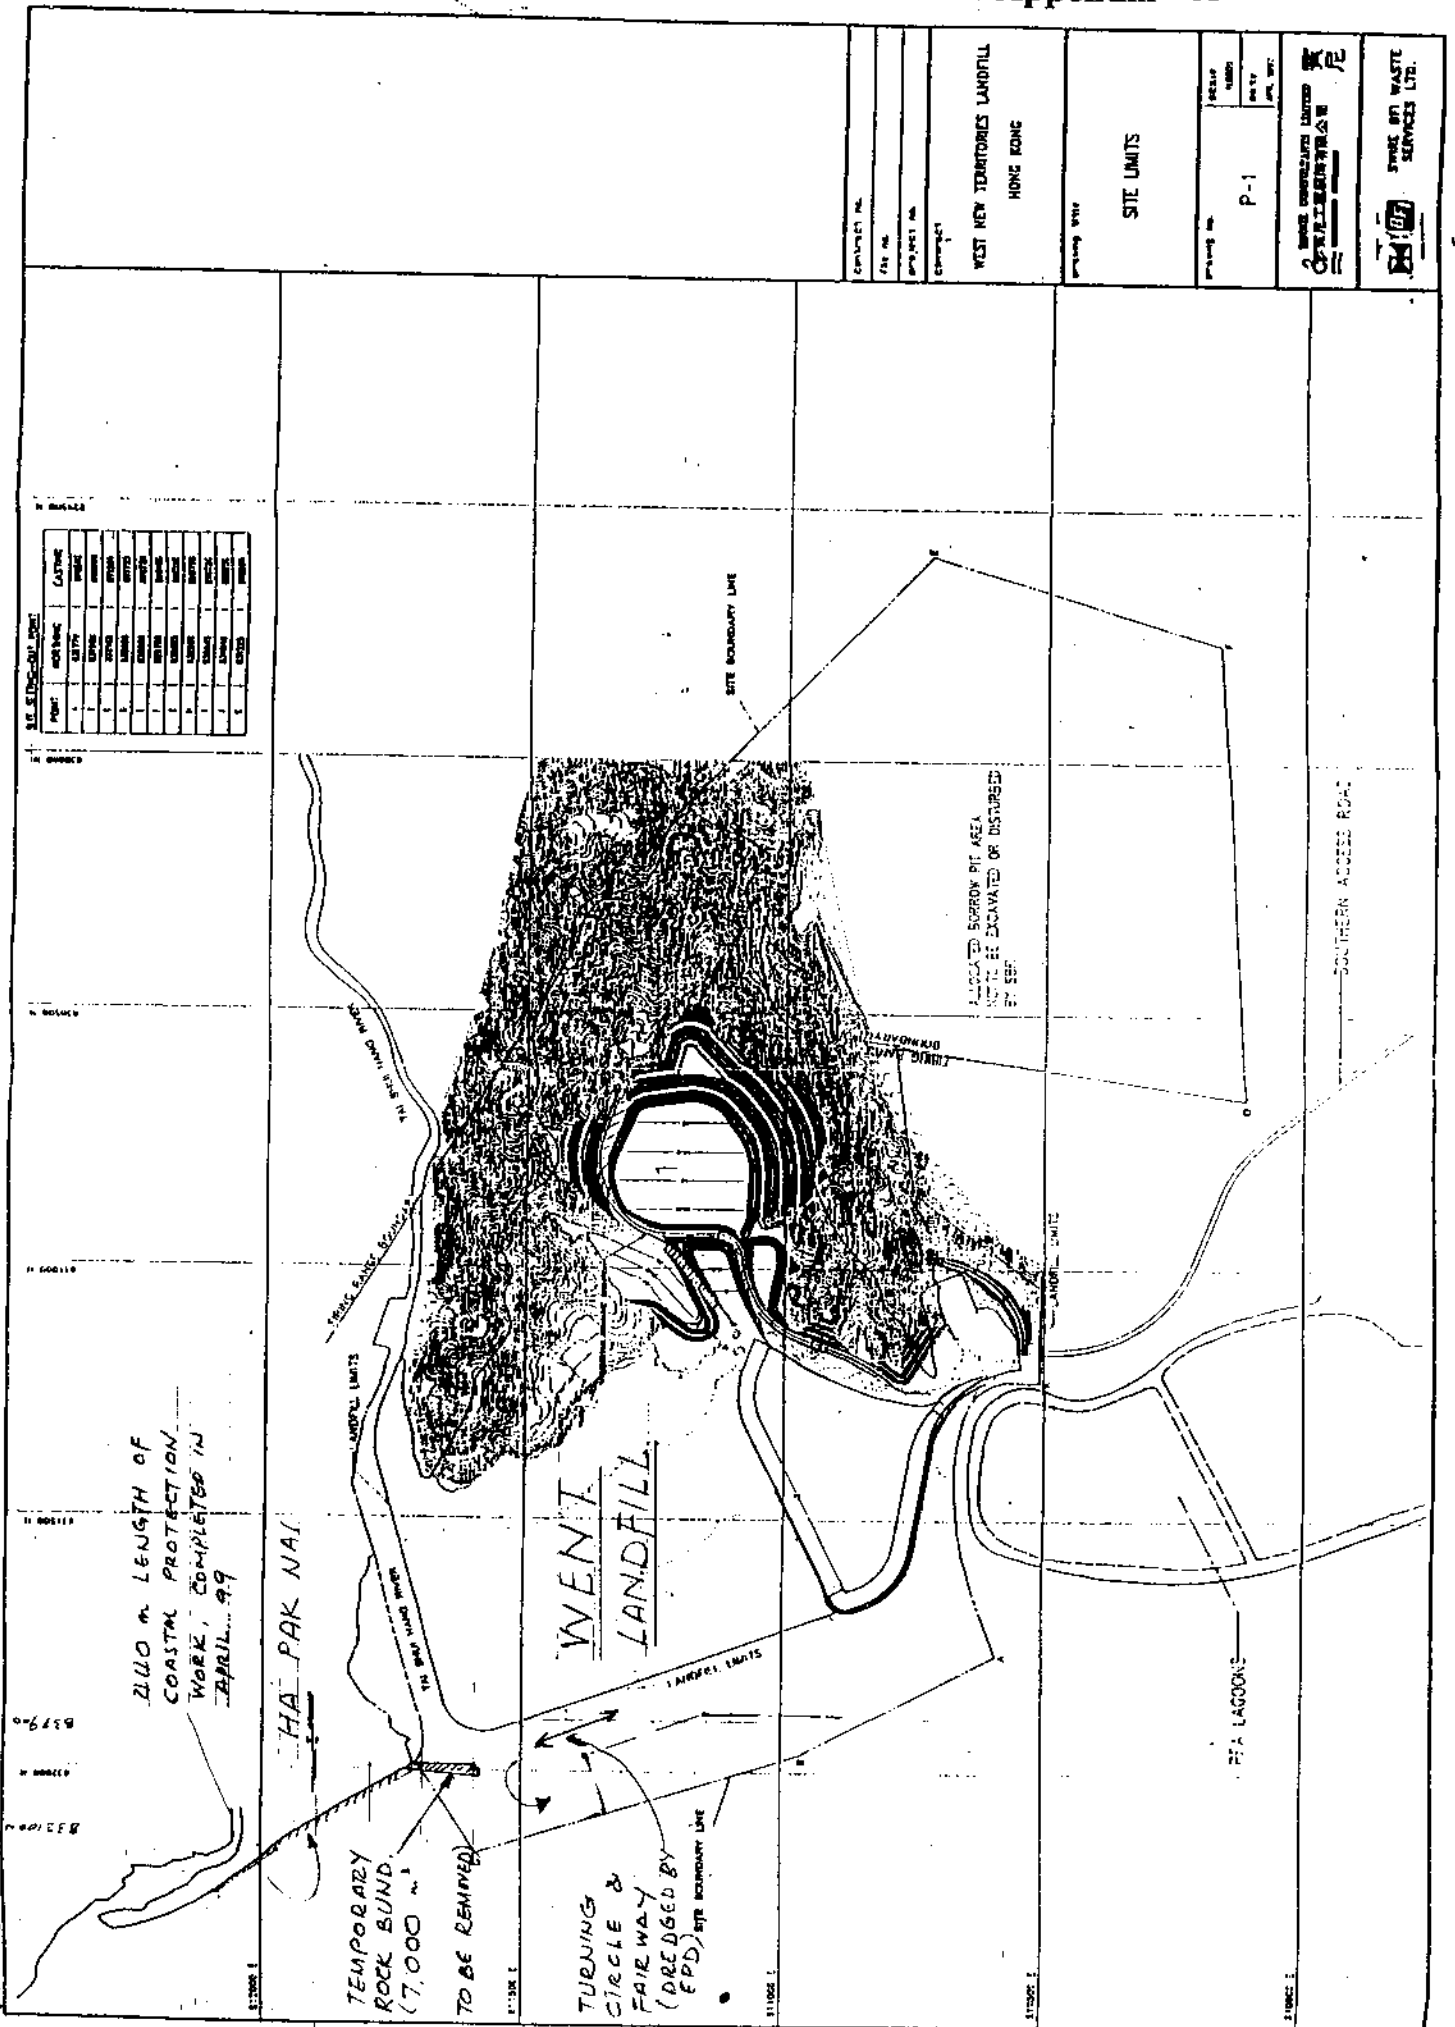
- A. Site Limits Plan (P-17) of WENT Landfill showing the location of the shore Protection works, Rock Bund, the fairway and turning circle near Ha Pak Nai.
- B. Part of Plan No. S/YL-PN/1 dated 1994-06-10 of Outline Zoning Plan of Ha Pak Nai showing the original coastline before 1994 and mark-up showing the change of coastline due to the development of the WENT Landfill.
- C. Dredging Plan (P-15, May 92) showing the dredging area and the original seabed level.
- D. Aerial Photos showing the village of Ha Pak Nai and the change due to WENT Landfill between 1963 to 98. (3 sheets)
- E. Sounding survey of the seabed conducted in October 1999 before the placement of the rock bund.
- F. Marine Works—Dredging Plan (W-00.00-0001-1, 29-03-93) showing the dredging for the navigation channel, turning circle for marine vessels, seawall foundation.

The temporary rock bund made of rockfill is located offshore the village of Ha Pak Nai. The village is next to the WENT Landfill site. See Appendix A for the location of the WENT Landfill, the village of Ha Pak Nai, the area of coastal protection works carried out in this year and the bund. The bund is about 130 m x 30 m. The footprint of the bund lies on a tidal flat with water depth ranging from -2.0 mPD to +0.8 mPD. The top of the bund is at +2.5 mPD. The entire bund is within the site limit of the WENT Landfill.

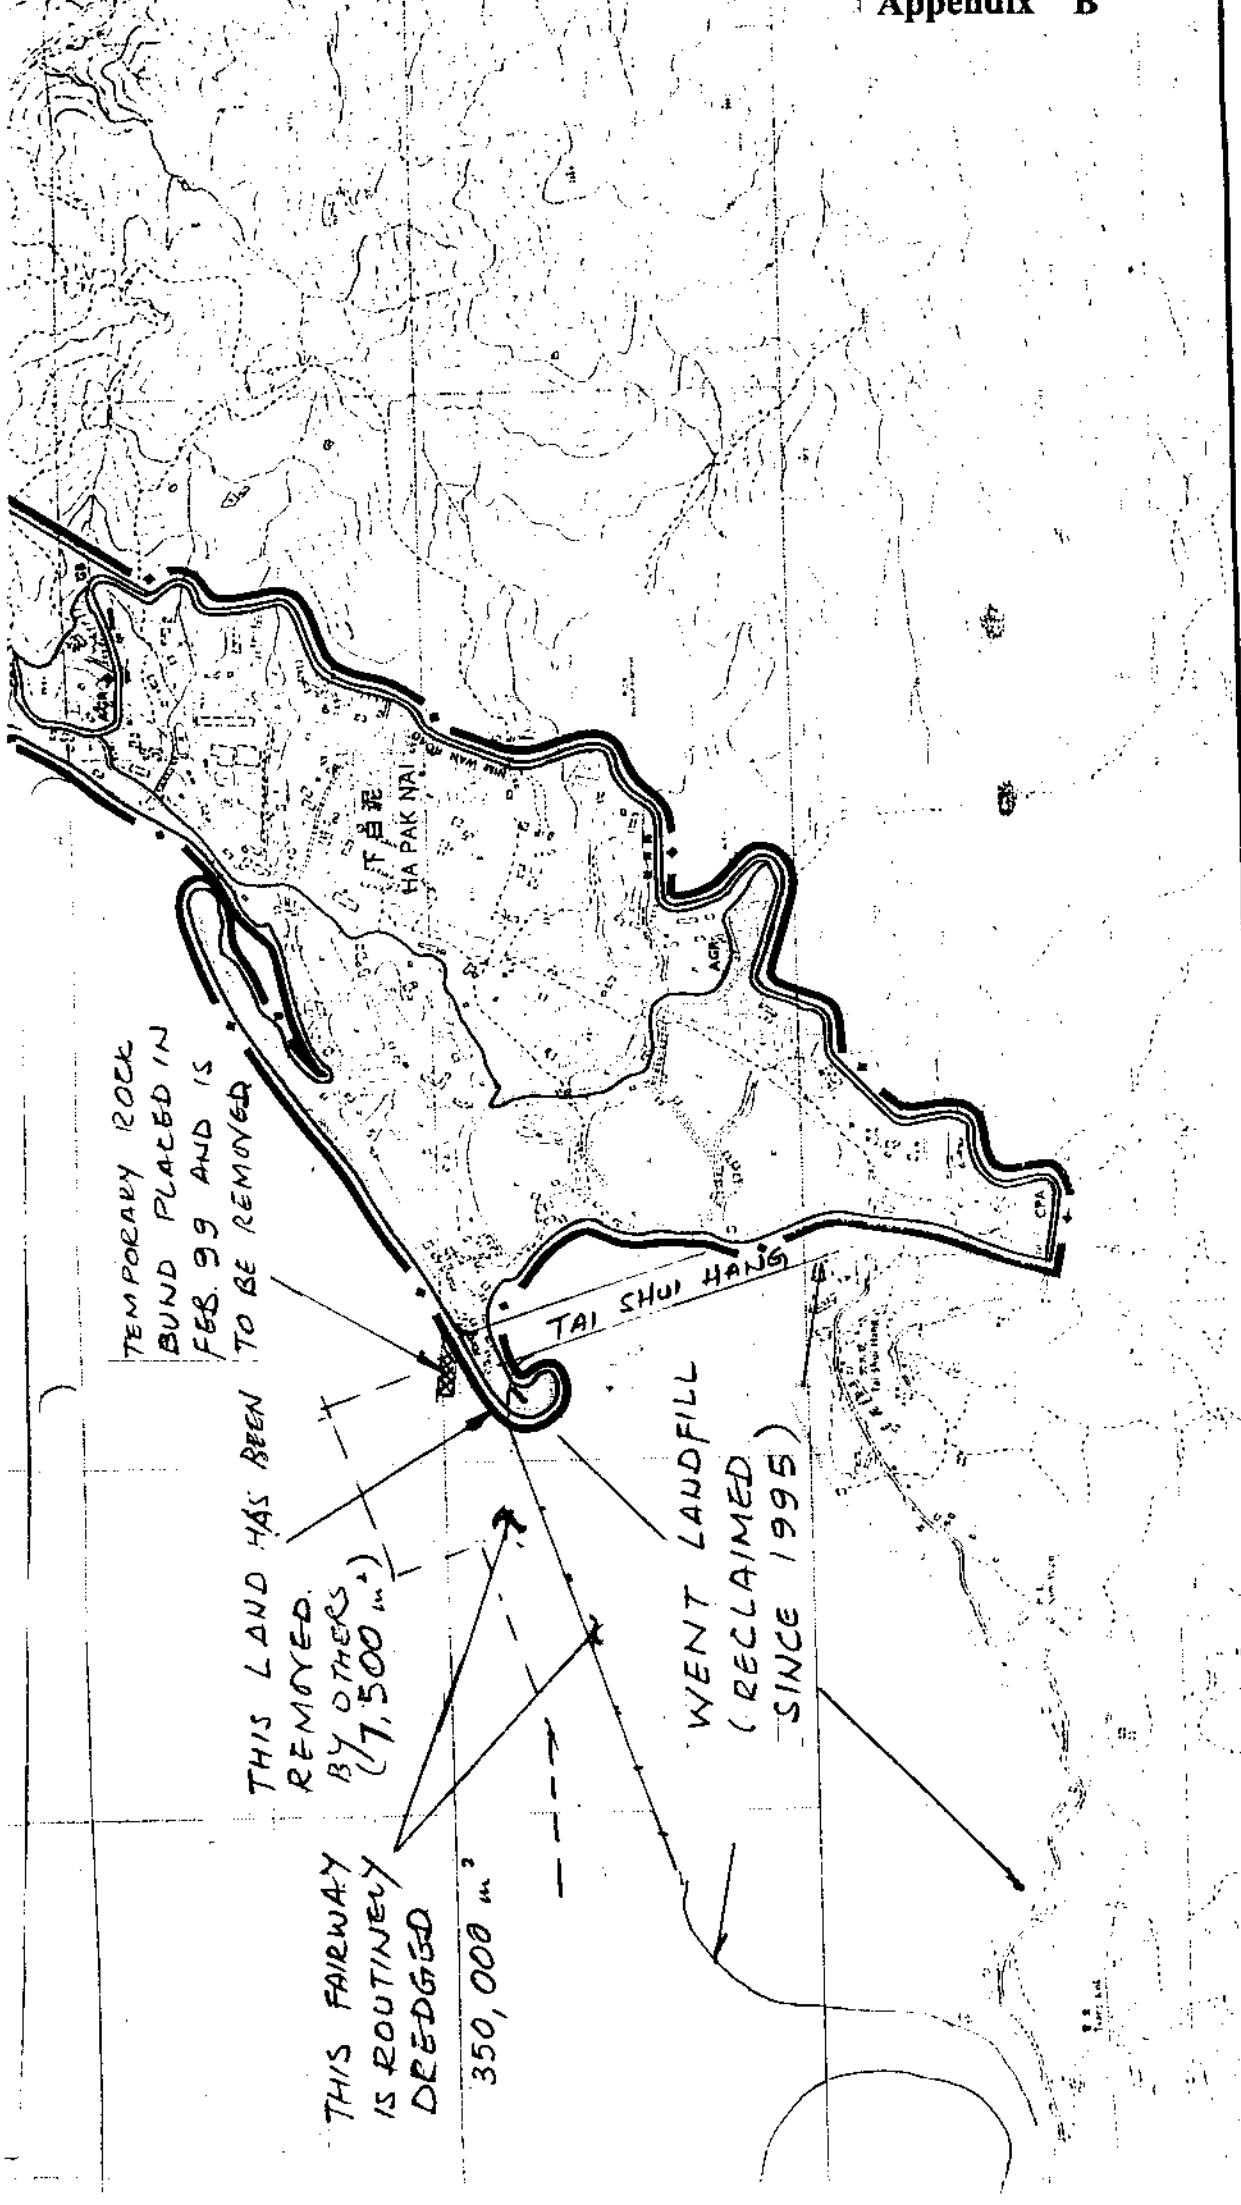
PART OF PLAN
 No. S/YL-PN/1

香港城市規劃委員會依據城市規劃條例第
 TOWN PLANNING ORDINANCE, HONG KONG
 SHEUNG PAK NAI & HA PAK NAI

1994年6月10日按照城市規劃條例第5條
 的規定公佈展示的草圖。
 DRAFT PLAN EXHIBITED UNDER SECTION 5 OF THE
 TOWN PLANNING ORDINANCE ON THE 10th DAY
 OF JUNE 1994

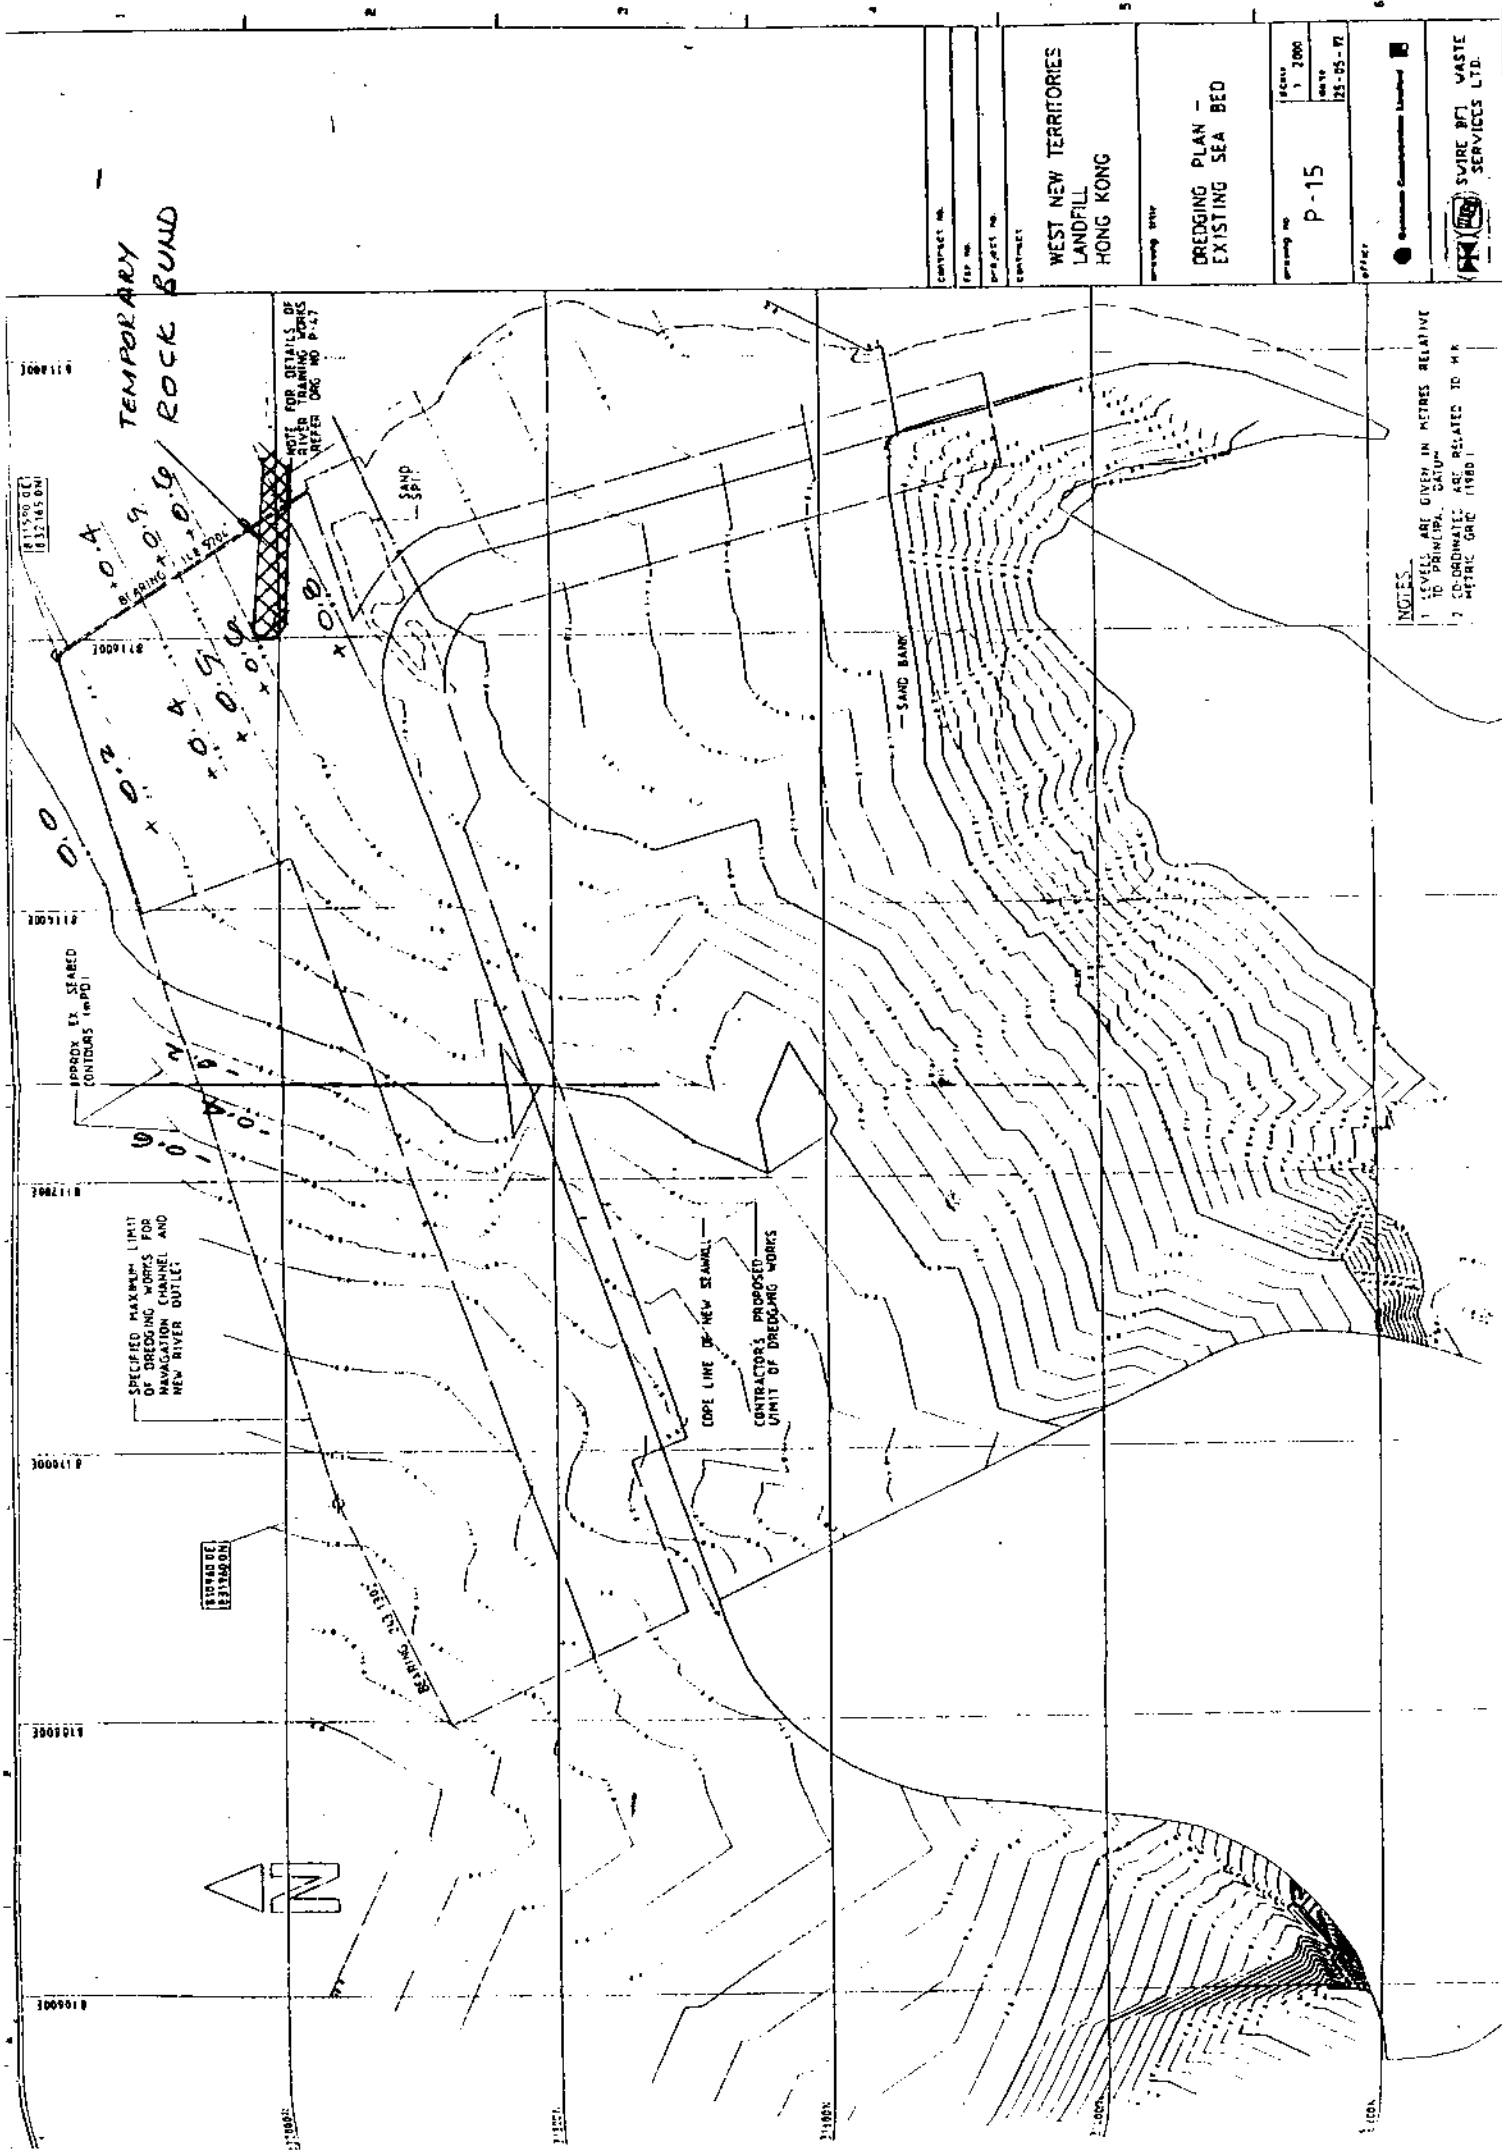
DREDGING PLAN -
 EXISTING SEA BED

WEST NEW TERRITORIES
 LANDFILL
 HONG KONG

TEMPORARY
 ROCK BUND

APPROX EX SEABED
 CONTOURS (mPD)

SPECIFIED MAXIMUM LIMIT
 OF DREDGING WORKS FOR
 NAVIGATION CHANNEL AND
 NEW RIVER OUTLET

This temporary rock bund is presently situated on a mud flat at the estuary of the Tai Shui Hang within the site boundary of the WENT Landfill. The bund was sited just outside of a sea area of turning circle for the marine vessels. The existing seabed was dredged and a portion of land, a sand spit, was removed for the river training for Tai Shui Hang River and for the construction of seawall for the WENT Landfill between 1993 and 1995. Please refer to Appendix B for the Outline Zoning Plan S/YL-PN/1 dated 10.06.94 showing the original coastline before the WENT Landfill development. Appendix C shows the original seabed level at about 1991 before the removal of the sand spit and the dredging for the turning circle for marine vessels. See also the aerial photos of the area since 1963 to 1998 and note the change of coastline between 1993 and 1995 in Appendix D1 to D3. Dredging of the seabed was also carried out to deepen the seabed to -4.5 mPD to maintain adequate water depth in the fairway and turning circle for the marine vessels for the WENT Landfill operation in 1997. The dredged area is shown in Appendix F.

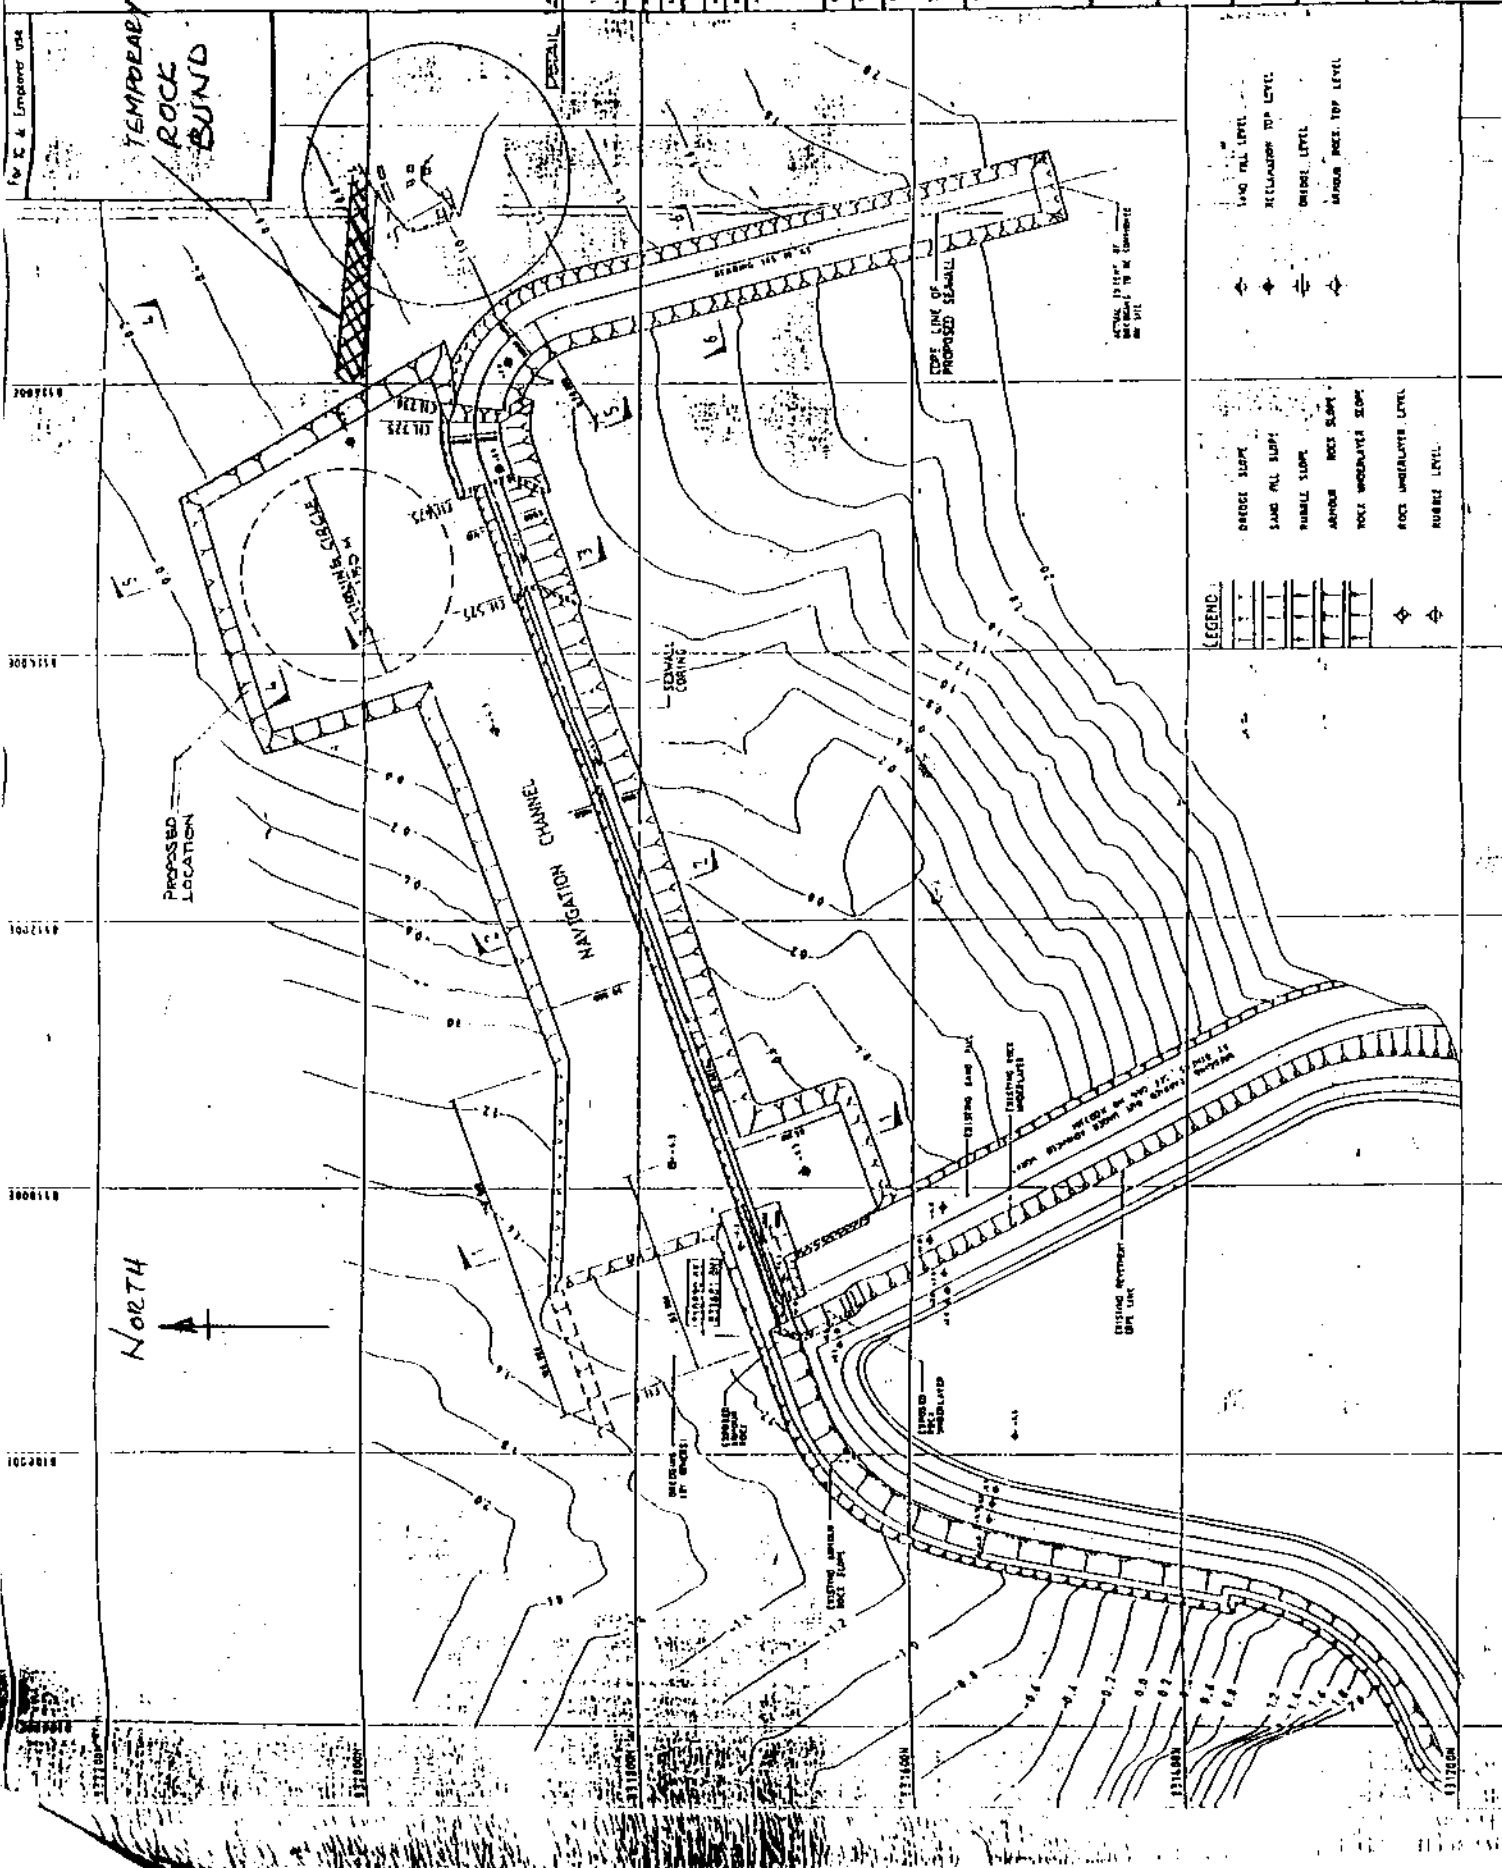
TEMPERARY ROCK BUND

PROPOSED LOCATION

NAVIGATION CHANNEL

DREDGING AREAS
