位於大嶼山南岸塘福第 328 號約第 591SA 地段之北亞海底光纖通訊電纜系統遠程通訊設施及相關之電纜登岸工程。

此《工程簡介》涵蓋根據“Level 3”所提供的概念規劃藍圖及各項預計的施工和運作活動資料，對電纜登岸機樓和海底遠程通訊電纜系統在施工和運作期間，對環境可能造成的影響作出之評估（詳見附件 A 至 I）。

北亞海底光纖通訊電纜系統

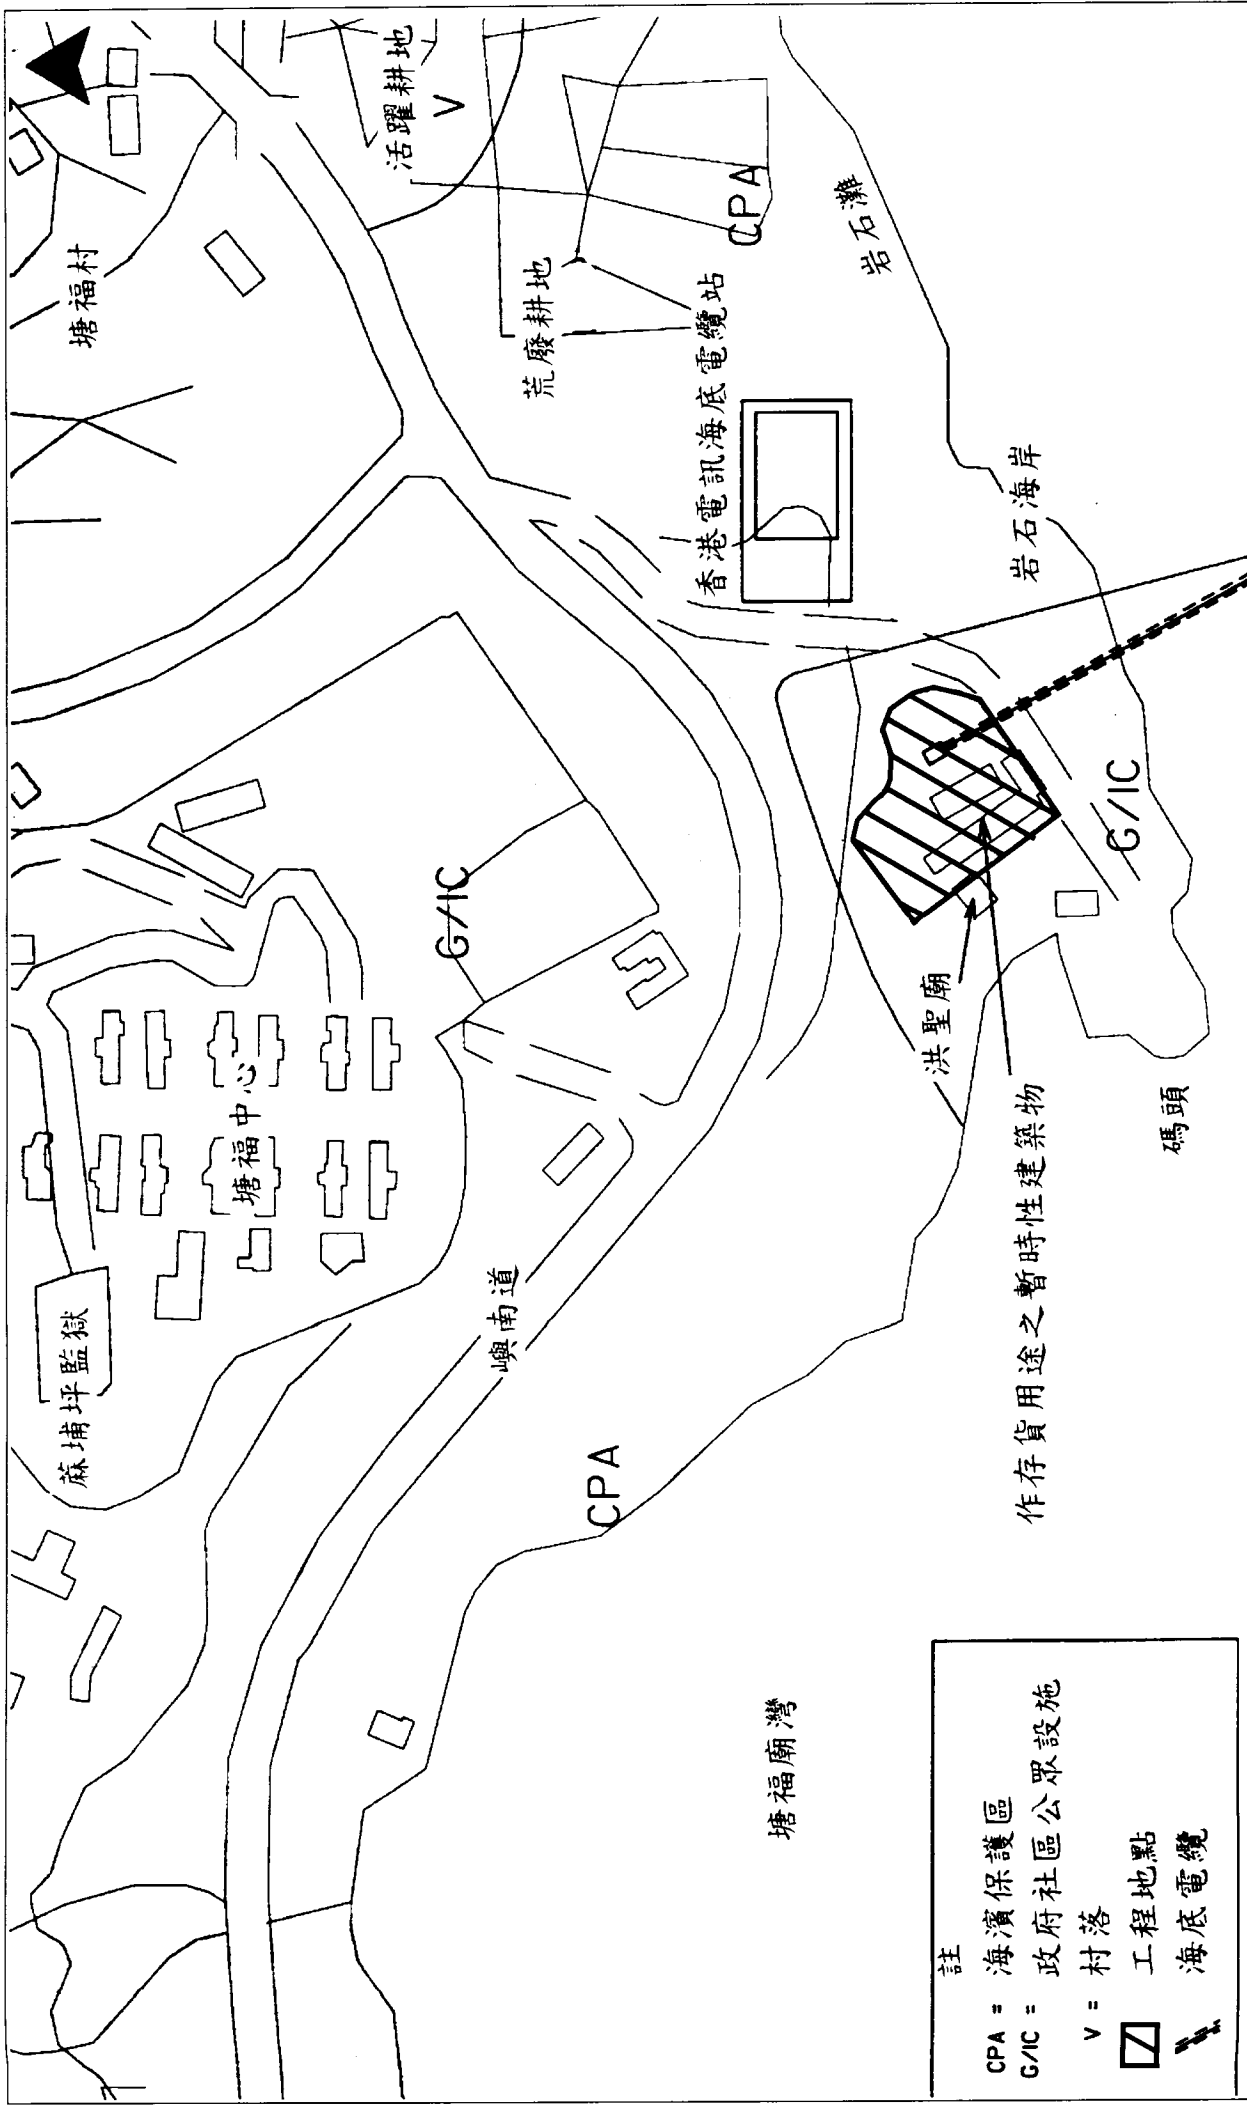
圖 1.4a

工程地點及地區規劃藍圖

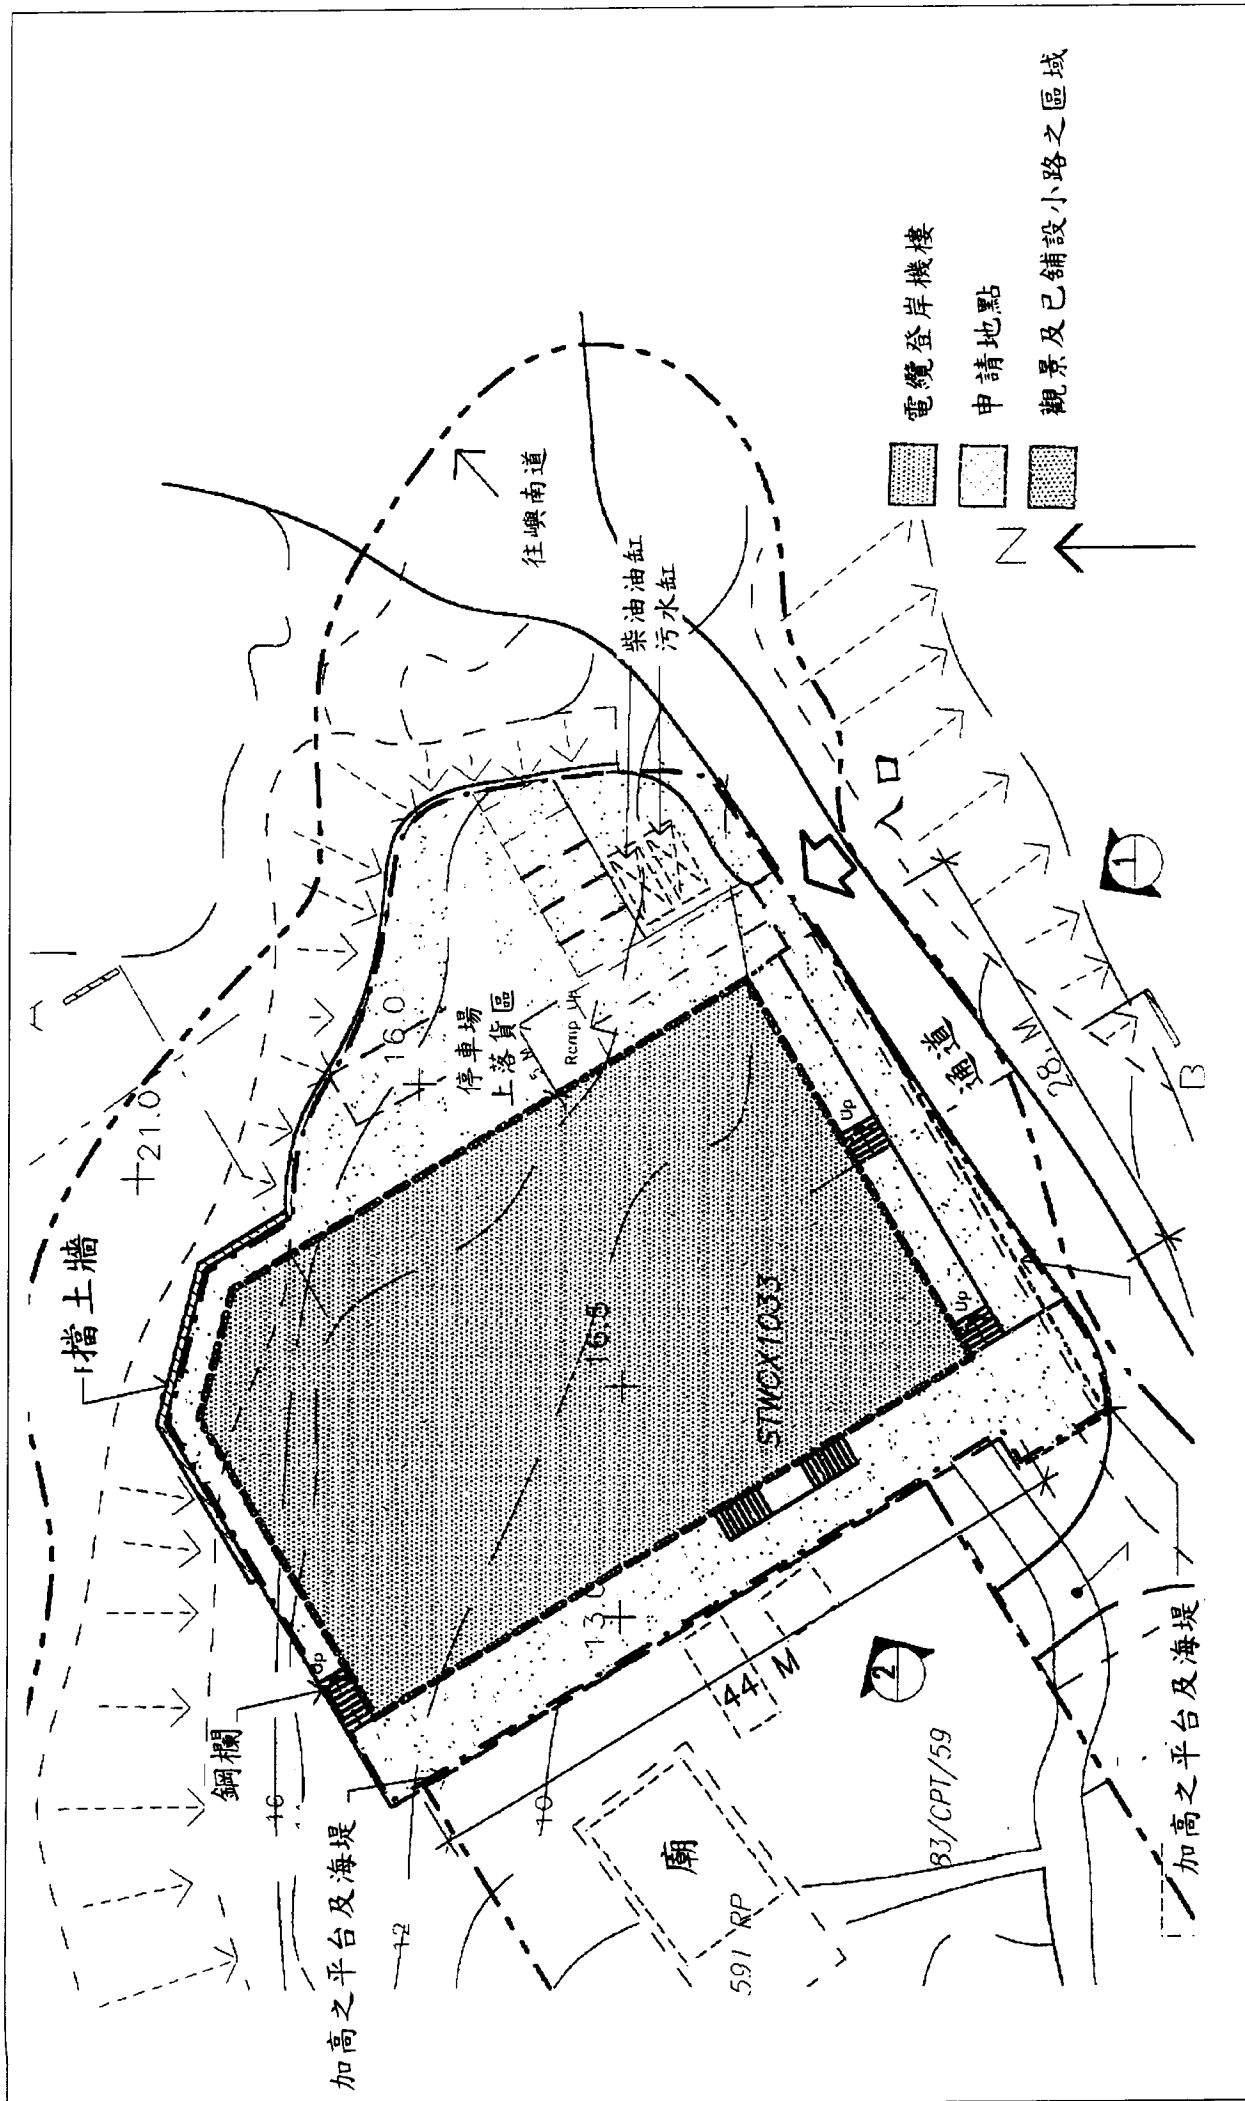
擬興建之建築物圖則

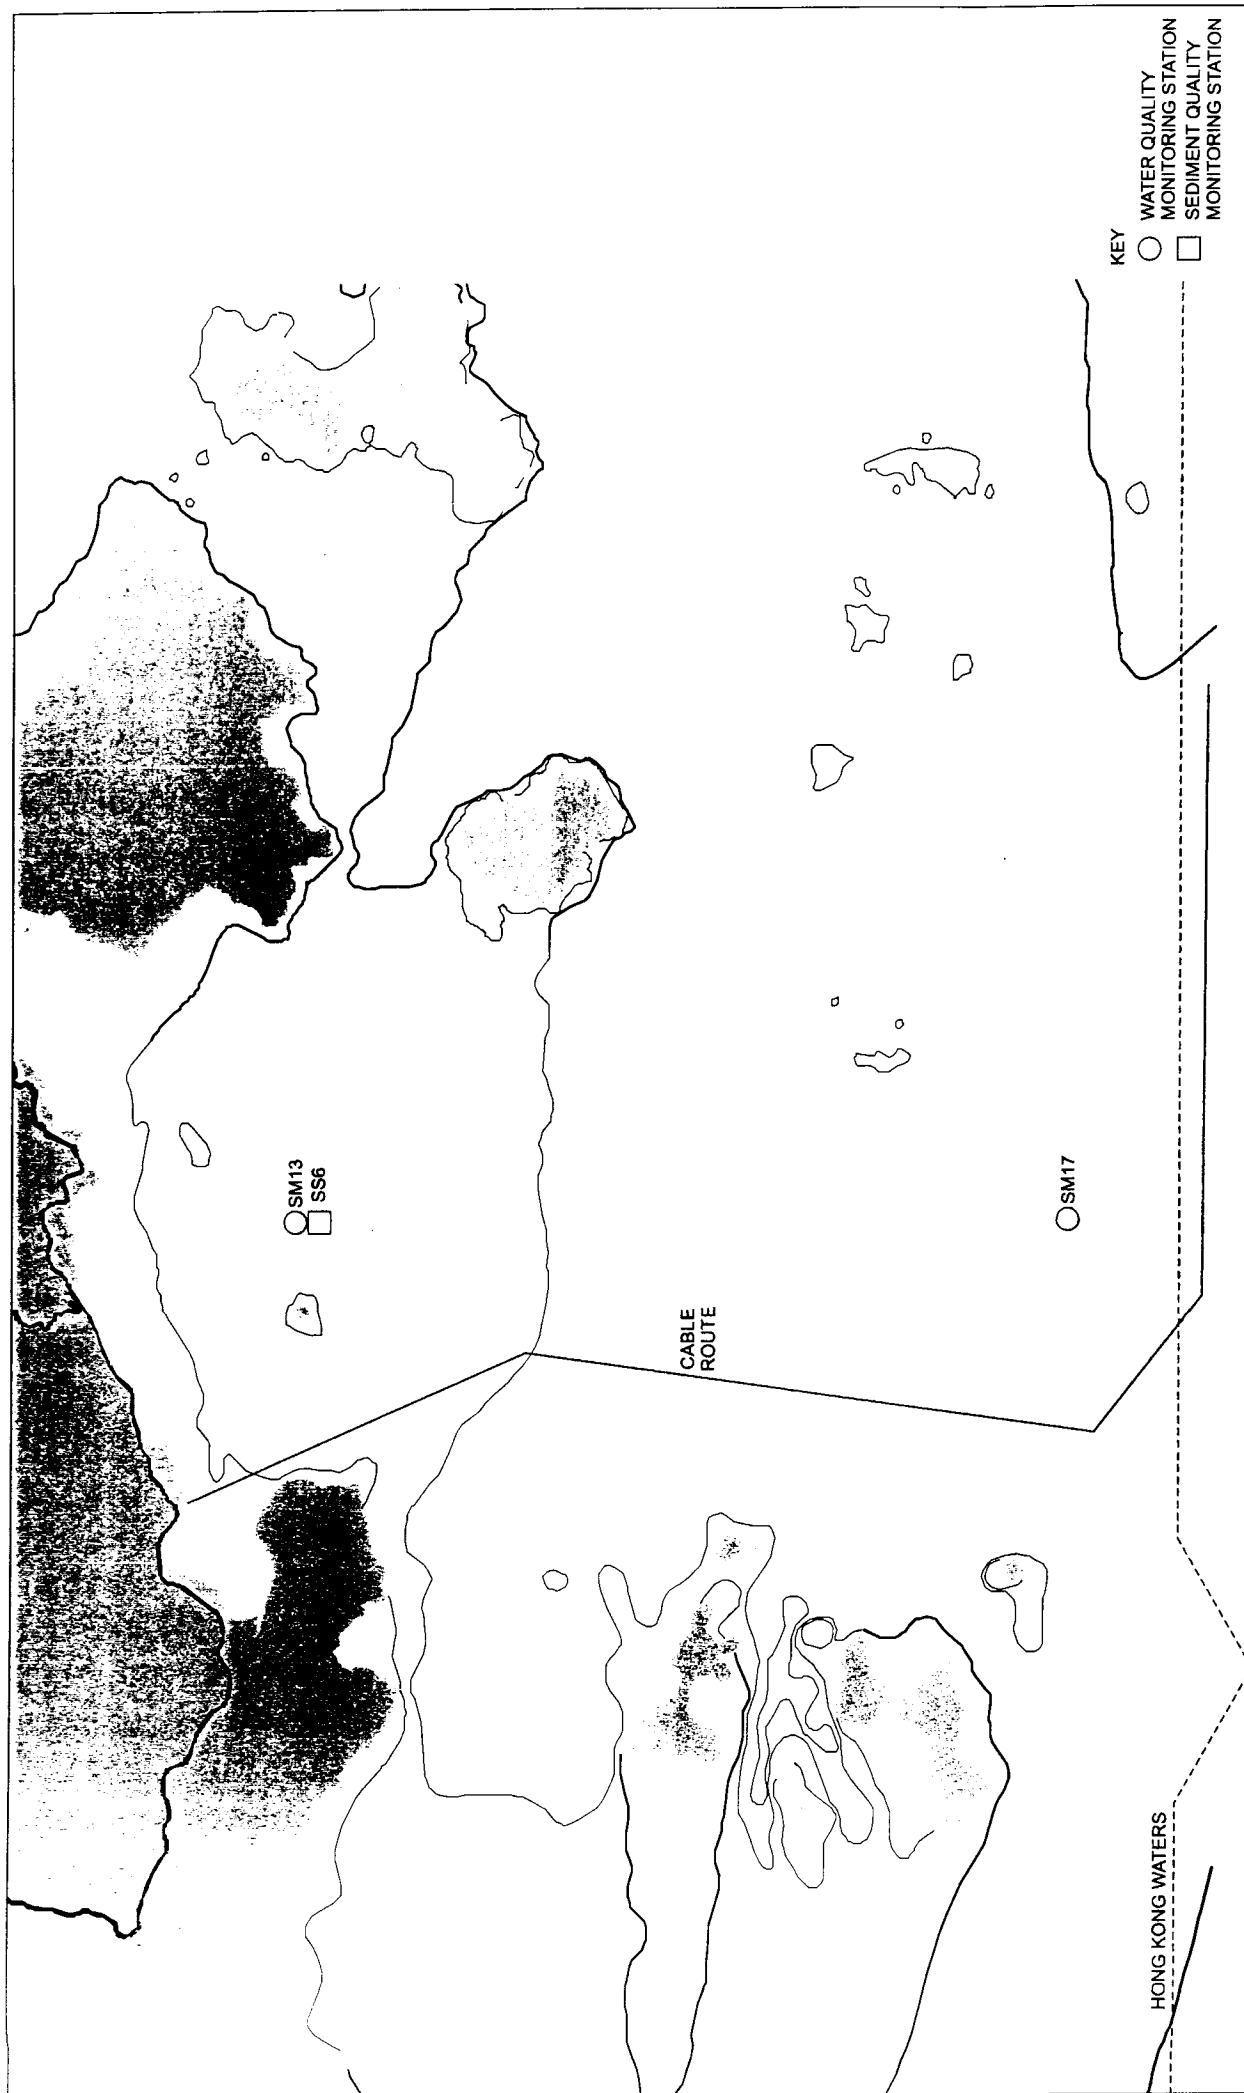
FIGURE C3a

LOCATIONS OF EPD ROUTINE WATER AND SEDIMENT QUALITY MONITORING STATIONS

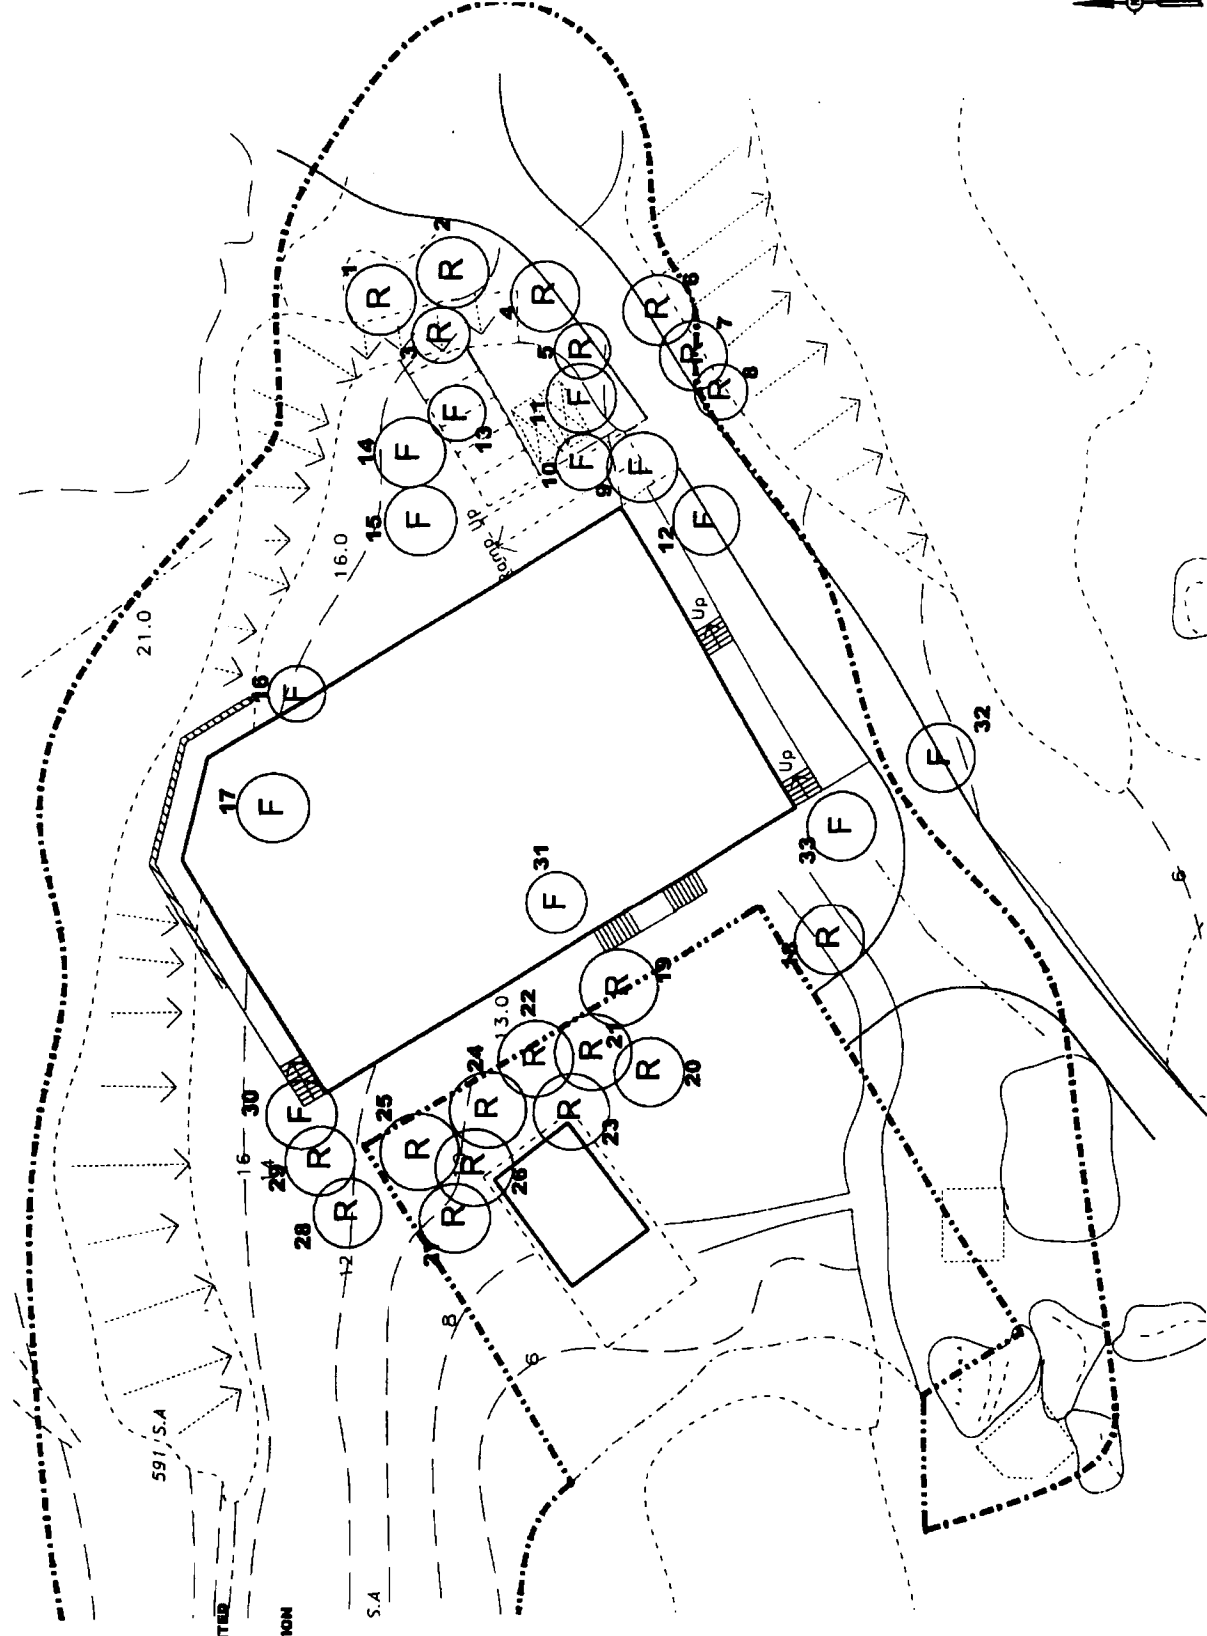
FIGURE E5a

- R** EXISTING TREE TO BE RETAINED
- F** EXISTING TREE TO BE FELLED
- T** EXISTING TREE TO BE TRANSPLANTED
- T** TREE IDENTIFICATION NUMBER

**LANDSCAPE AND VISUAL IMPACT STUDY
TREE SURVEY PLAN**

A tree survey was undertaken to ascertain the numbers of trees affected (see *Attachments E1 and E2*) and to assess the amenity value of the trees to be felled. It was found that 11 trees would need to be felled, while the remaining trees would be retained and protected during construction. The concept landscape design allows for the reprovision of two trees for every tree felled and the planting of approximately 500 m² of compensatory planting around the periphery of the new development.

<i>Tree number</i>	Identification number for each tree and indicated on <i>Figure E5a</i>
<i>Species</i>	Botanical name of tree
<i>Trunk diameter</i>	In metres, taken at 1000 mm height above ground level (multi-trunks tree will be measured with the biggest sized trunk)
<i>Height</i>	In metres, taken from ground level to the top of tree
<i>Crown spread</i>	In metres
<i>Health and condition</i>	Graded as Good, Fair, or Poor
<i>Form and style</i>	Graded as Good, Fair, or Poor
<i>Amenity value</i>	Graded as High, Medium, or Low
<i>Conflict with development</i>	Graded as Yes (affected by development) or No (not affected by development)
<i>Transplantability</i>	Graded as Yes (should be transplanted if affected by the development) or No (should be felled if affected by the development).
<i>Proposed treatment</i>	Recommendation for tree's future status, graded as Retain, Fell or Transplant
<i>Brief comments</i>	Brief description on tree such as "Leaning trunk", rotting trunk" etc. Tree with more than one trunk will be described as double trunks, triple trunks so and so forth.

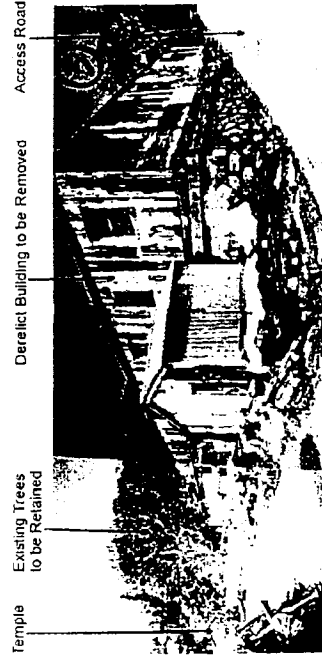
Viewpoint 1 - Looking at the site from the south-east

Viewpoint 2 - Looking at the site from the south-east next to the temple

Viewpoint 3 - Looking at the site from the existing access road from the south

Viewpoint 4 - Looking at the site from the west from the existing access road

Viewpoint 5 - Looking at the site from the west from the existing access road. Note the screening effects of the existing woodland.

Viewpoint 6 - Looking at the site from the footpath on south Lantau Road. The site is completely screened

This figure illustrates the existing landscape and visual resources of the site.

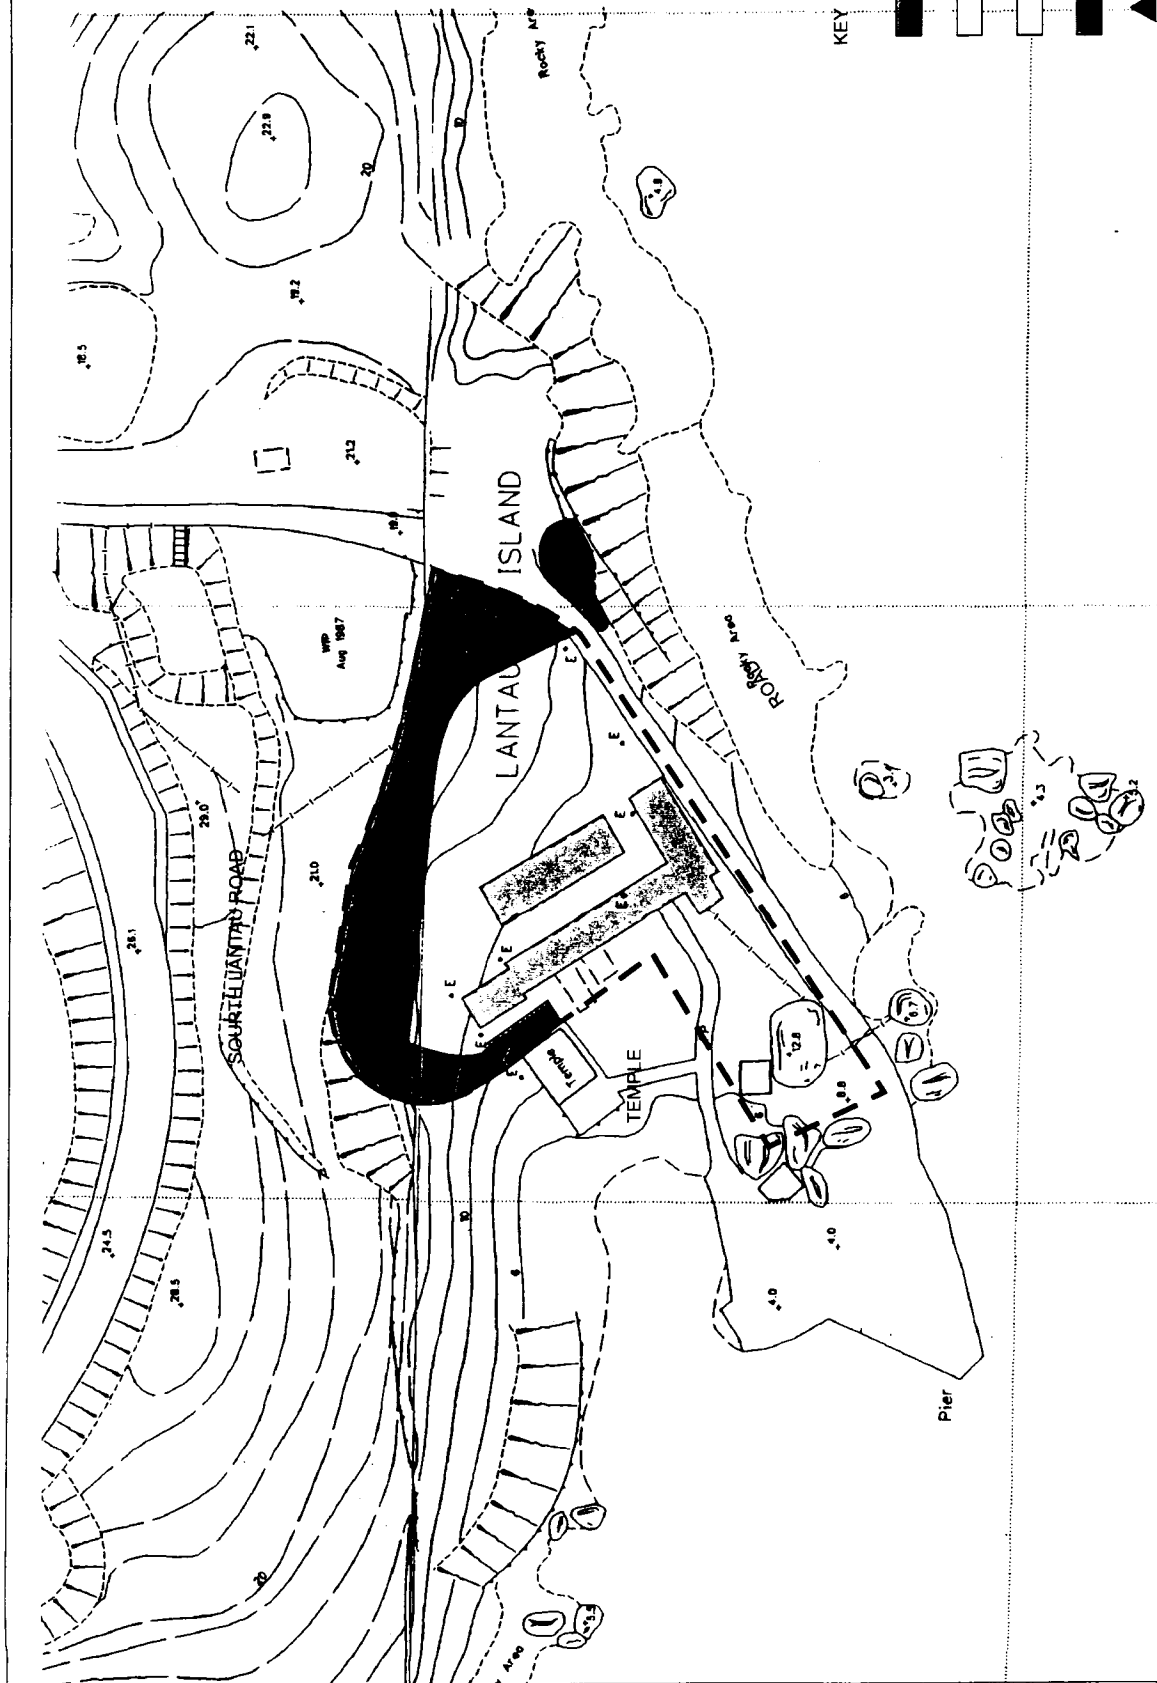
FIGURE G3a

HABITAT MAP OF PROPOSED PROJECT SITE AT TONG FOK, LANTAU

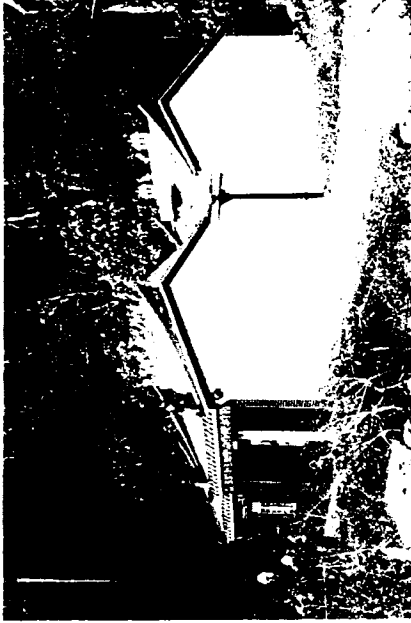
Photo 7. A view of the temple close to the proposed site at Tong Fok, Lantau.

A large area within the proposed development site is occupied by an abandoned building (Figure G3c Photo 6). A small temple is located to the west (Figure G3c Photo 7). A few large trees, i.e. *Celtis sinensis*, *Delonix regia*, *Ficus variegata*, *Viburnum odoratissimum* and *Bischofia javanica*, were observed growing between the boundary of the proposed site and the temple site (Figure G3c Photo 8). An abandoned nest of a Magpie or raptatory bird was found on one of the large trees.

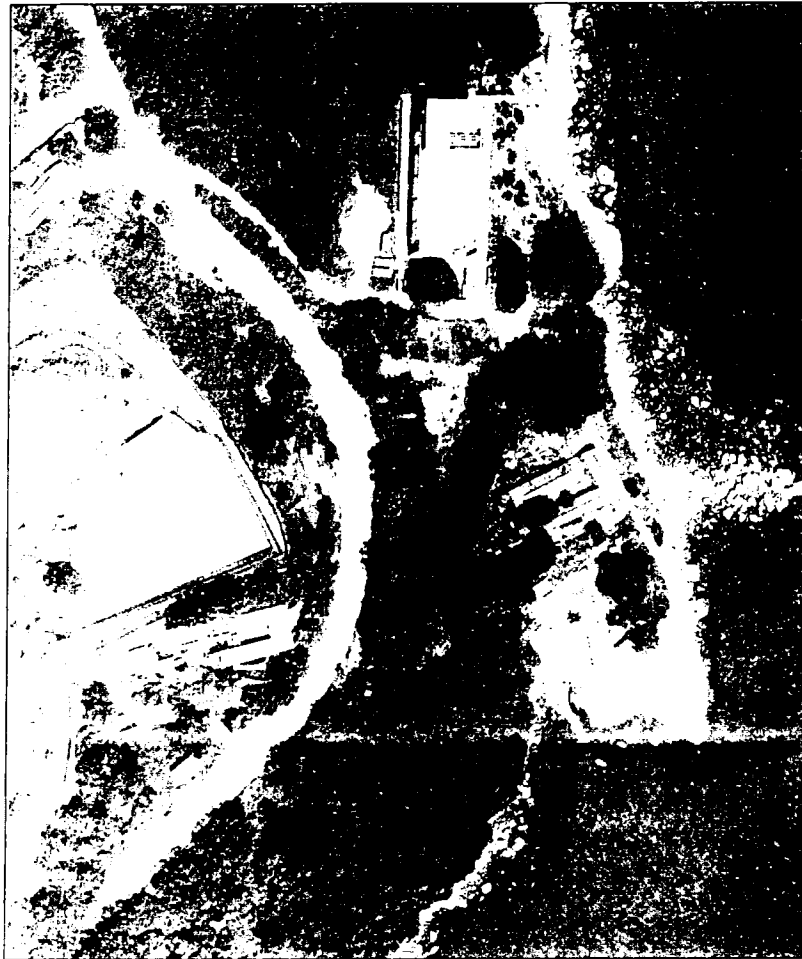
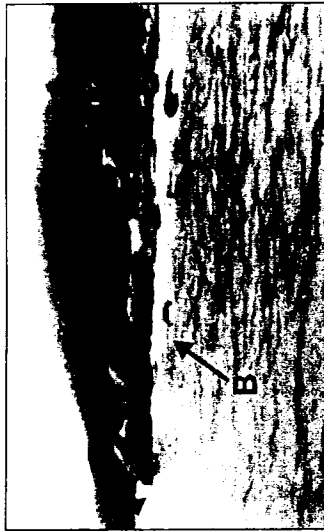
FIGURE H1b

SURVEY AREA

AREAS IDENTIFIED AS SUPPORTING GORGONIAN SEA WHIPS

CORAL A: GORGONIAN SEA WHIPS

CORAL B: GORGONIAN SEA WHIP

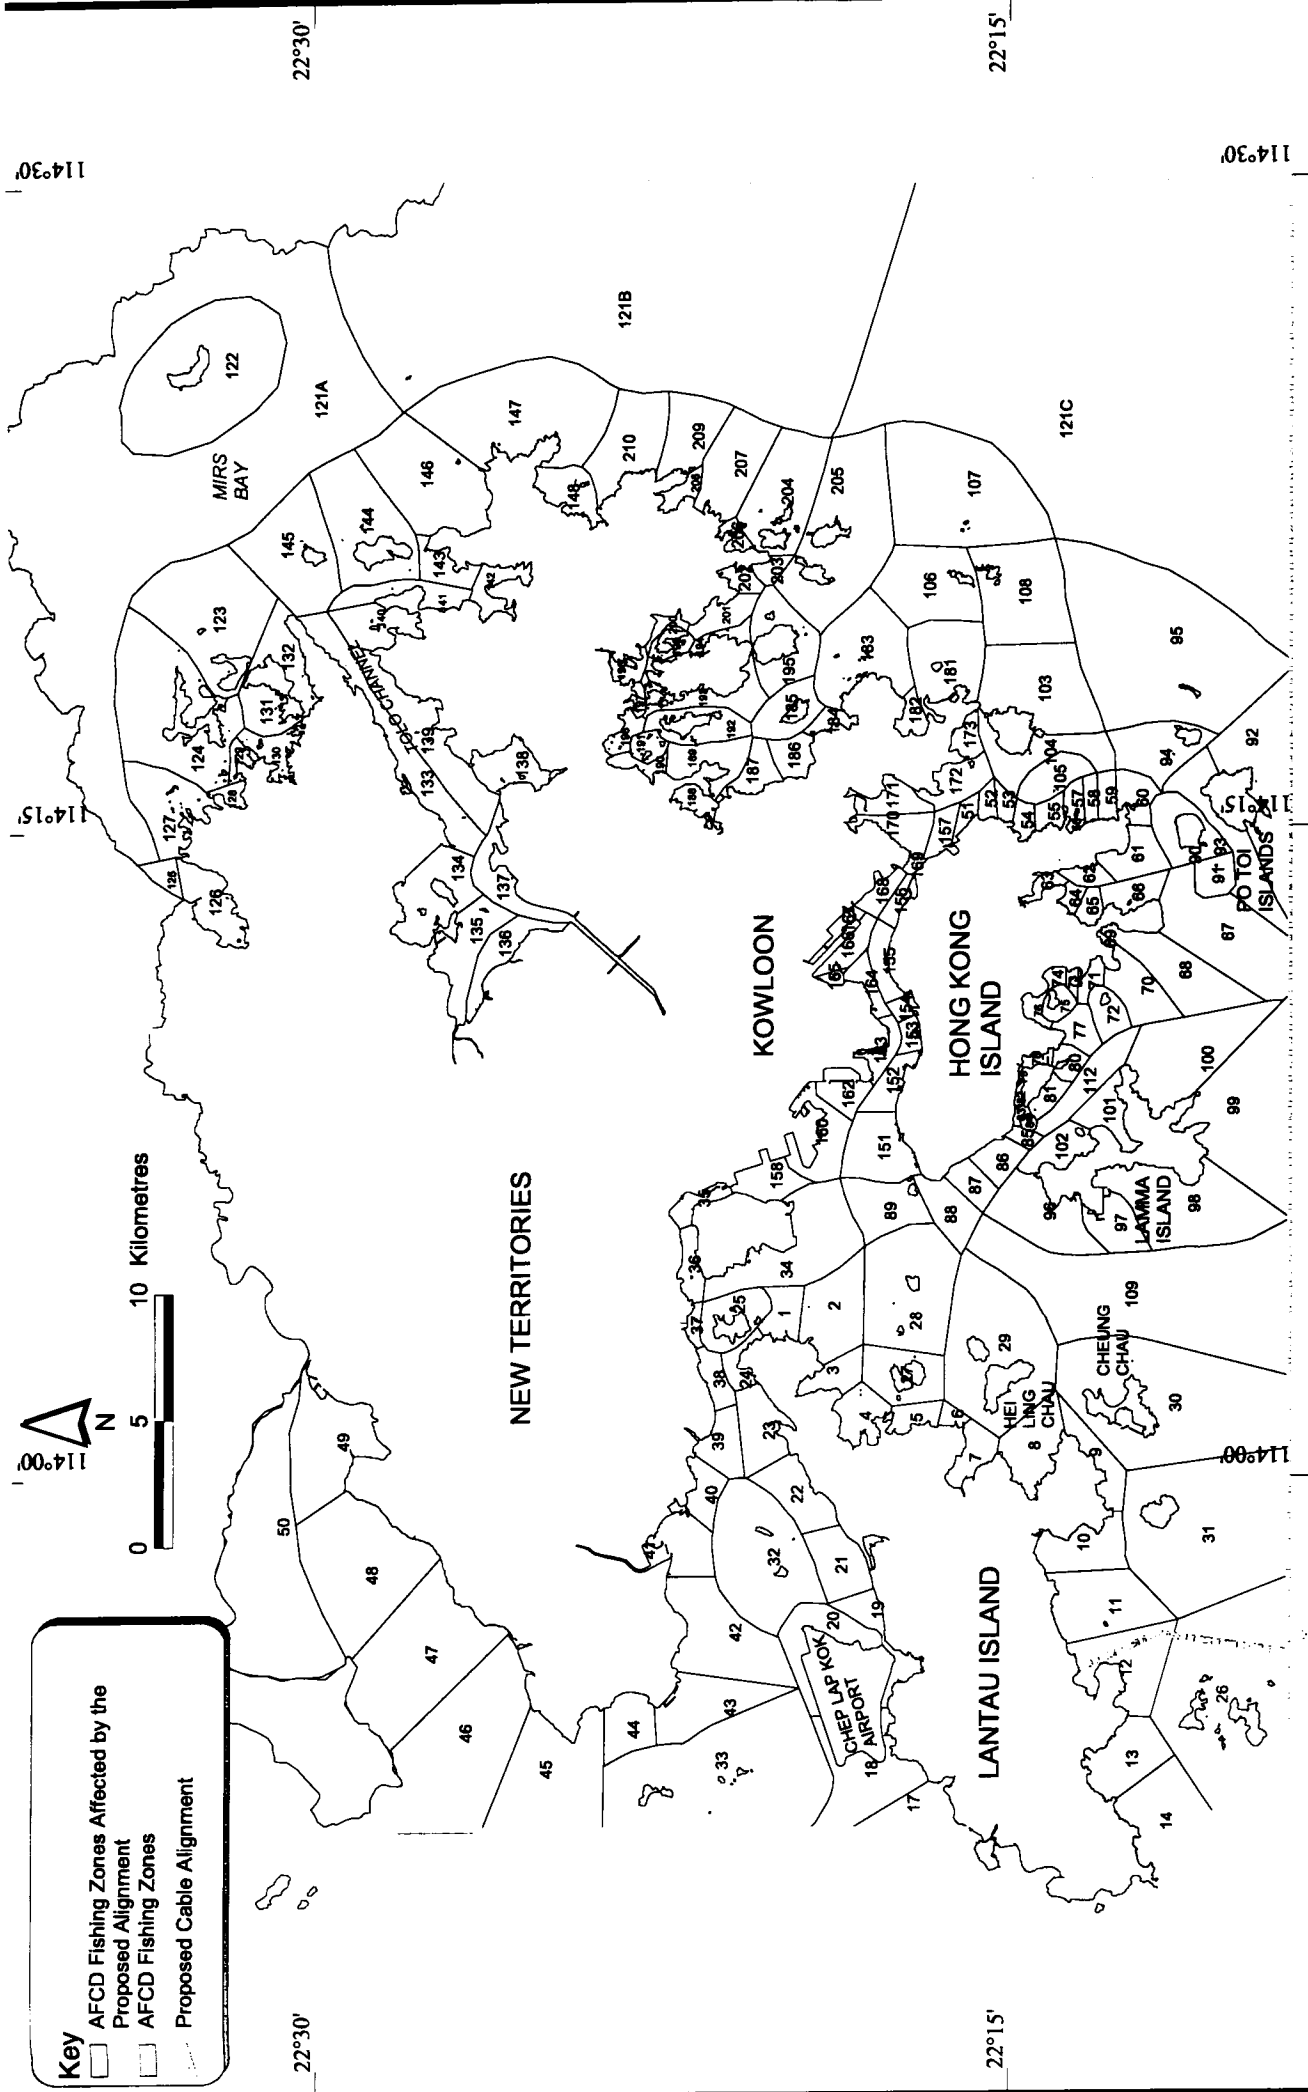
FIGURE 13a

Distribution of AFCD Fishing Zones in Hong Kong Waters and
Location of The Proposed Cable Alignment
