## 7. Ecology

7.1.1 This section provides terrestrial ecological information of the Butterfly Valley, and assesses the potential impact on the ecological resources within the Project Limit (see *Figure 2.1e*) for the West Kowloon Section of the Route 16 Alternative Alignment. Mitigation measures are recommended where necessary. Field surveys were undertaken between July 1998 and March 1999 to establish the baseline ecological conditions of the study area.

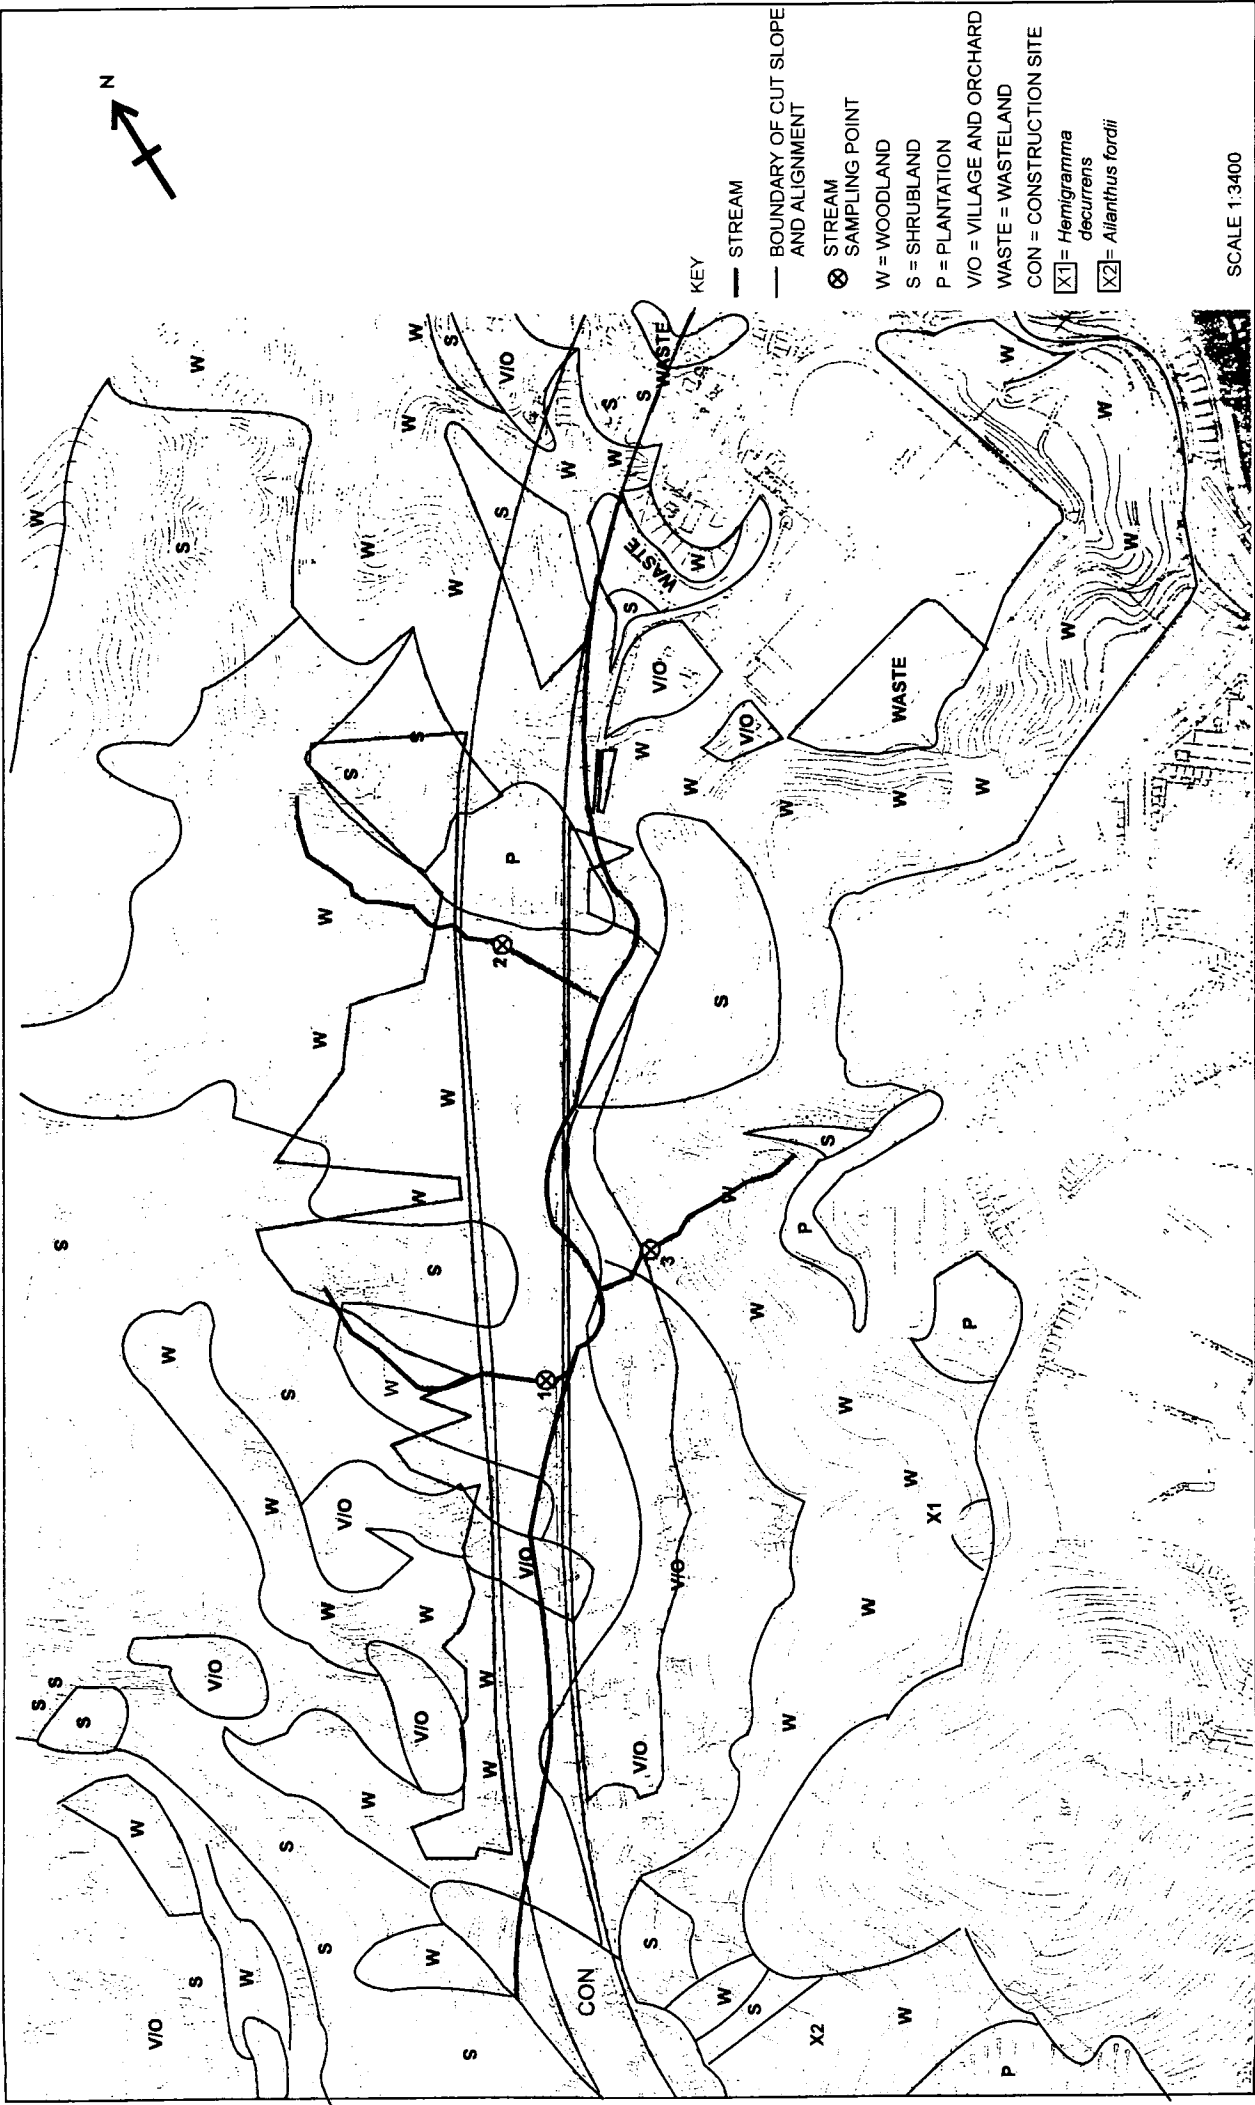
FIGURE 7.4a

HABITAT MAP FOR BUTTERFLY VALLEY

- the woodland area to be encroached upon by the development should be well-defined and minimised;
  - fences should be erected along the boundary of construction sites before the commencement of works to prevent tipping, vehicle movements, and encroachment of personnel into adjacent wooded areas, particularly near the two rare/protected plant species (location see *Figure 7.4a*);

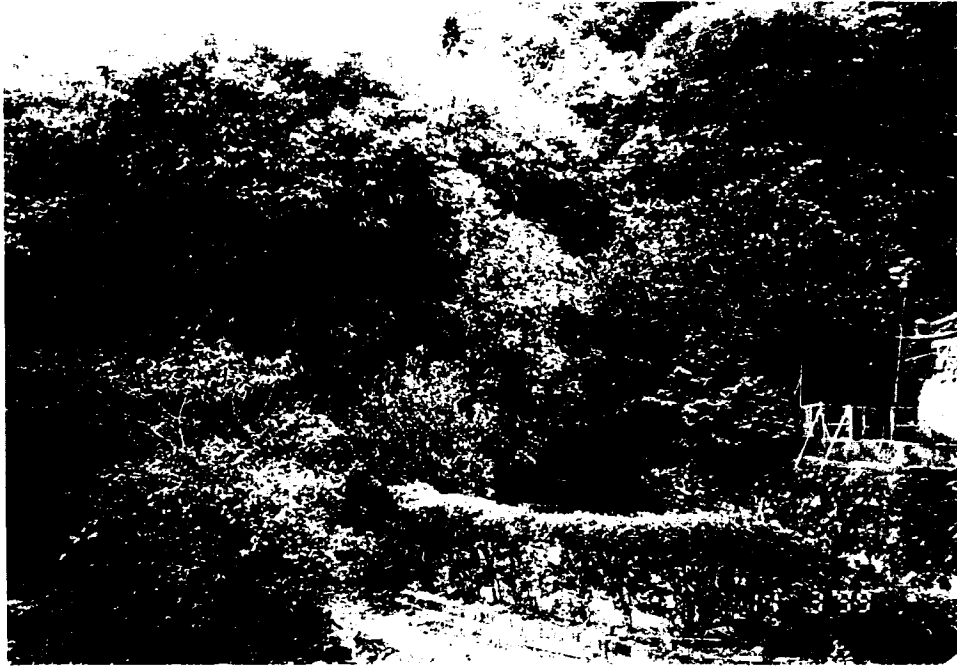
*Plate 7.4c : Orchard at Butterfly Valley*

- 7.4.1.5 Orchards among villages (*Plate 7.4c*) is one of the major components within the area to be directly affected by the proposed alignment. The vegetation community mainly comprises ornamental and introduced species such as *Dracaena* spp., *Livistonia chinensis*, *Archontopheonix alexandrae* and bamboo, as well as fruit trees such as *Clausena lansium*, *Dimocarpus longan*, *Litchi chinensis* and *Citrus maxima*. The orchard is of low species diversity and heterogeneity, and hence unlikely to support wildlife of ecological importance.

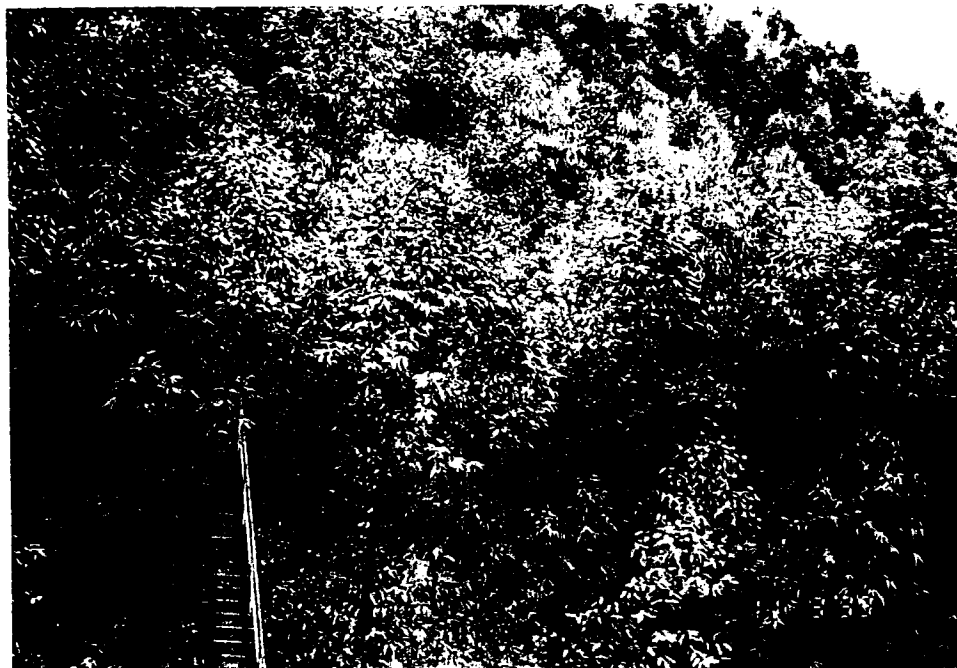
*Plate 7.4d : Platation Woodland at Butterfly Valley*

- 7.4.1.6 The plantation woodland (*Plate 7.4d*) is located in the northern section of the proposed alignment where a pylon is present. Species found were all exotic/introduced, and common to such habitat type in Hong Kong, such as *Acacia confusa*, *Eucalyptus* spp. and *Casuarina equisetifolia*. Owing to its simple species and structural diversity, the ecological value to wildlife is considered limited.

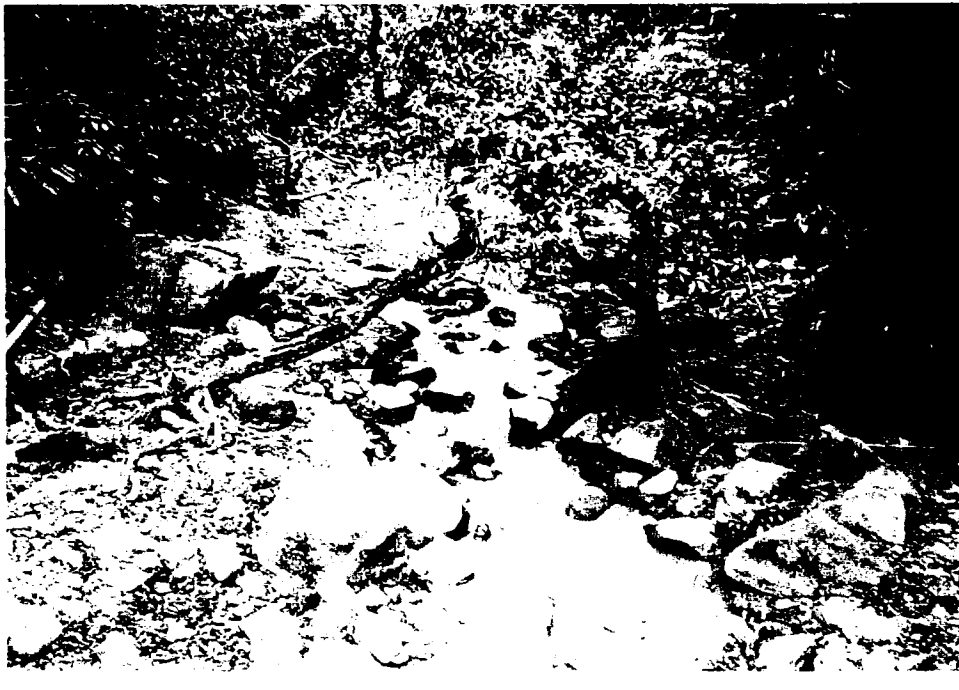
*Plate 7.4f : Main Stream (lower section) at Butterfly Valley*

- 7.4.1.8 Within the Study Area, there are five fast running seasonal streams receiving water from the Kam Shan Country Park 0.5km away, flowing into the permanent stream (*Plate 7.4f*) within Butterfly Valley. The three sampled representative seasonal streams were observed with limited flow during dry season surveys. Riparian vegetation are mainly shrubland or secondary woodland as described above, including certain common stream flora such as *Cleistocalyx operculatum*, *Diplazium esculenta*, *Scleria ciliaris*, and *Fimbristylis* sp.. Stream substratum at lower elevation (< 80 m) consists of small pebbles to small boulders, while that at higher elevation (> 80 m) comprises large boulders and rocks.

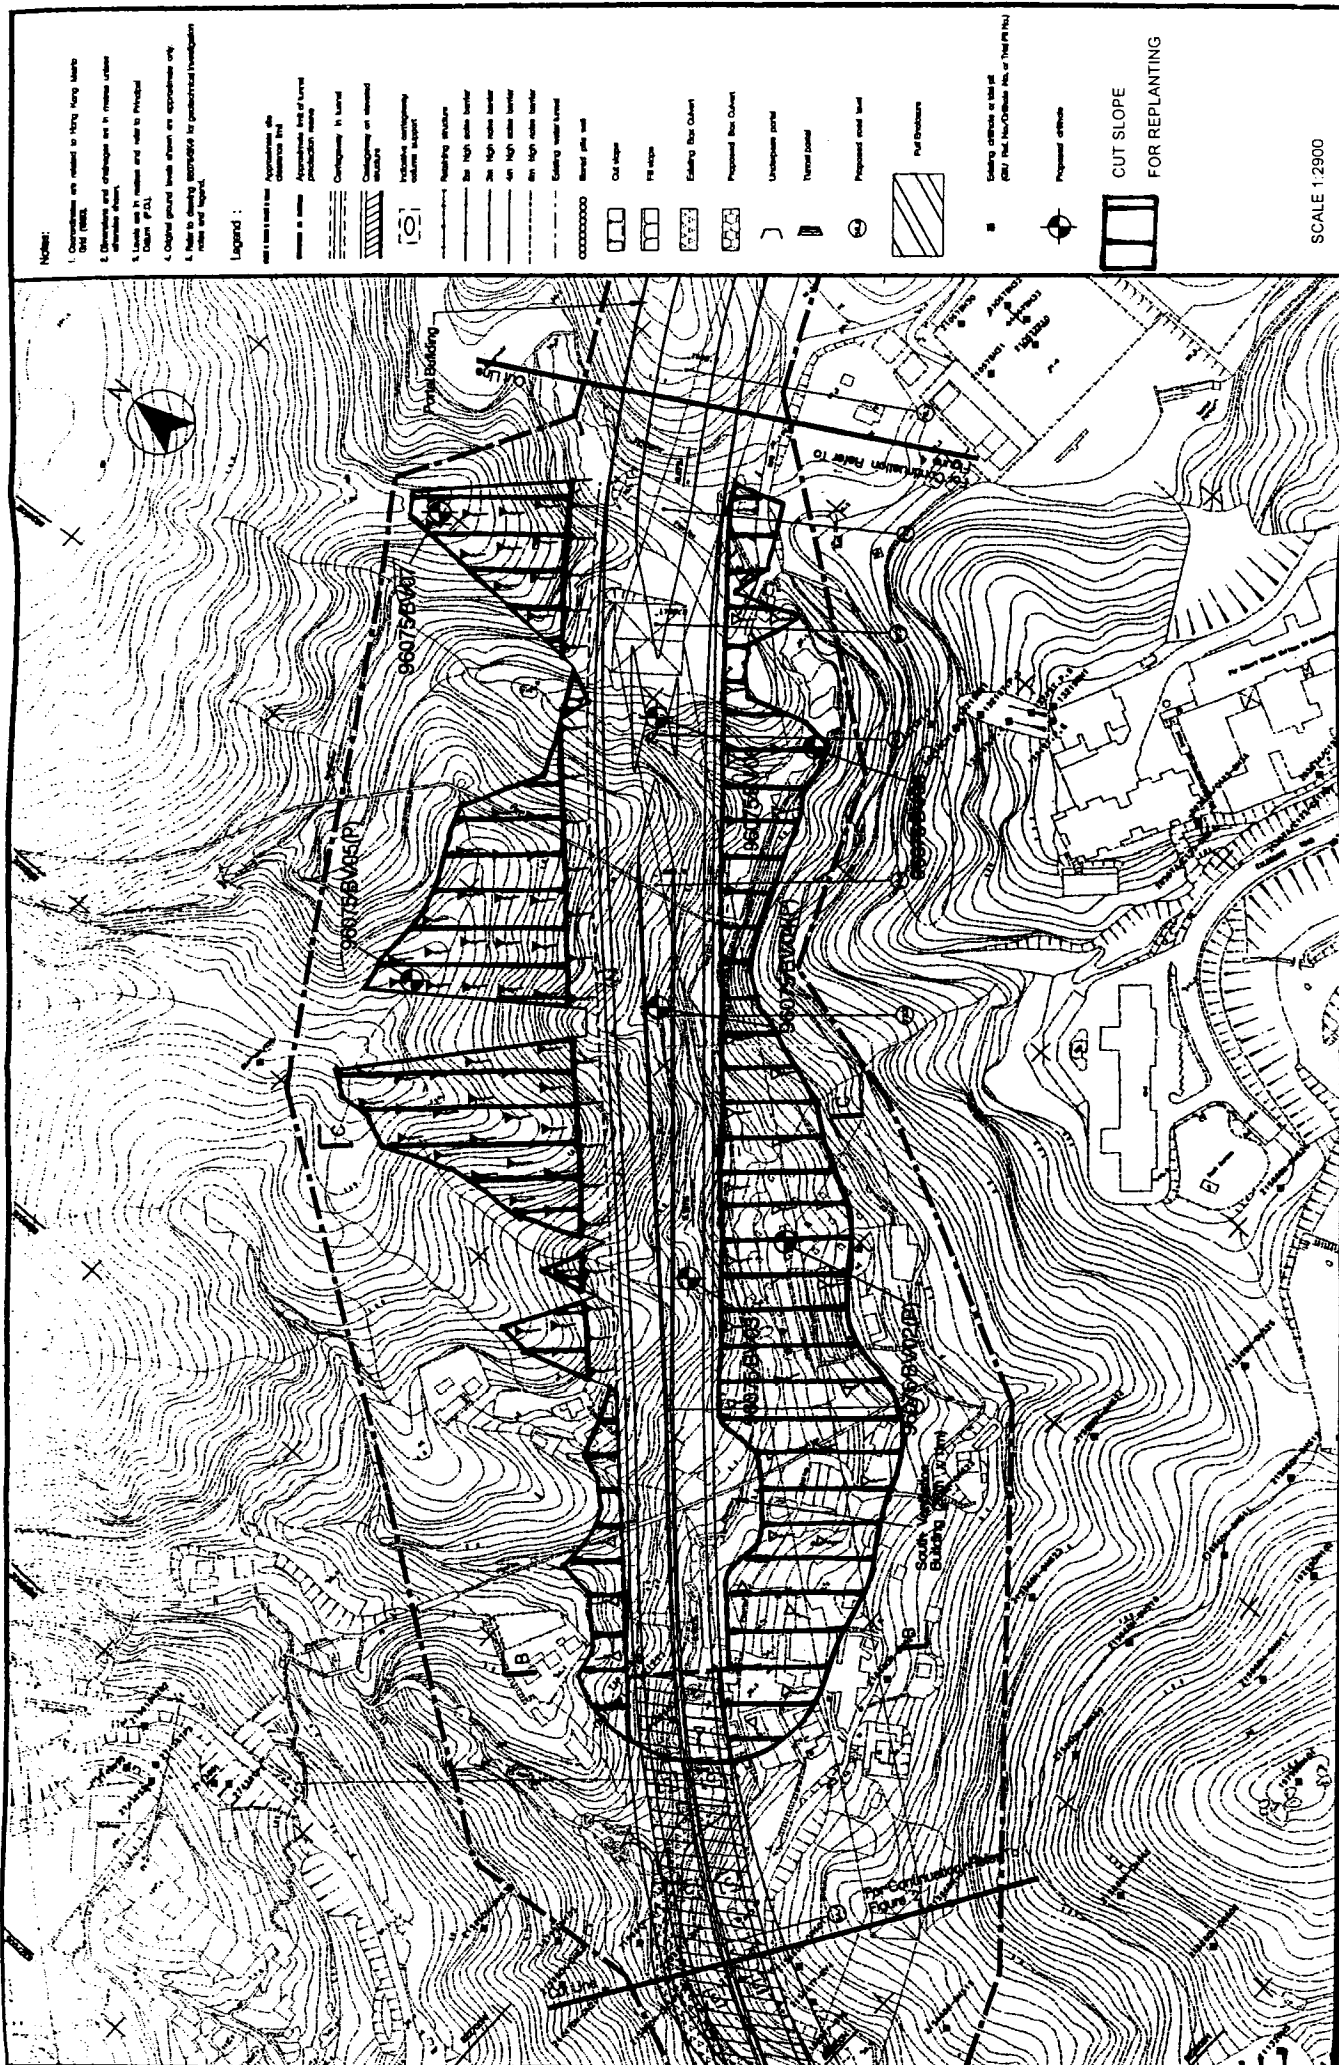
FIGURE 7.7a

LOCATION OF CUT SLOPE FOR COMPENSATORY REPLANTING

- 7.7.3 For the loss of the 3ha of secondary woodland, it is recommended that the extent of cut slope along Butterfly Valley to be investigated further at the following Design and Construct stage to explore further options to minimise the loss of secondary woodland and stream habitat. There is approximately 3 ha cut/fill slope area within the boundary of cut slope and alignment in Butterfly Valley available as shown in *Figure 7.7a* and has been recommended for compensatory tree planting (see also *Figure 9.9a*). Tree species used for planting should take reference of the species in the surrounding and, using native species as far as possible.

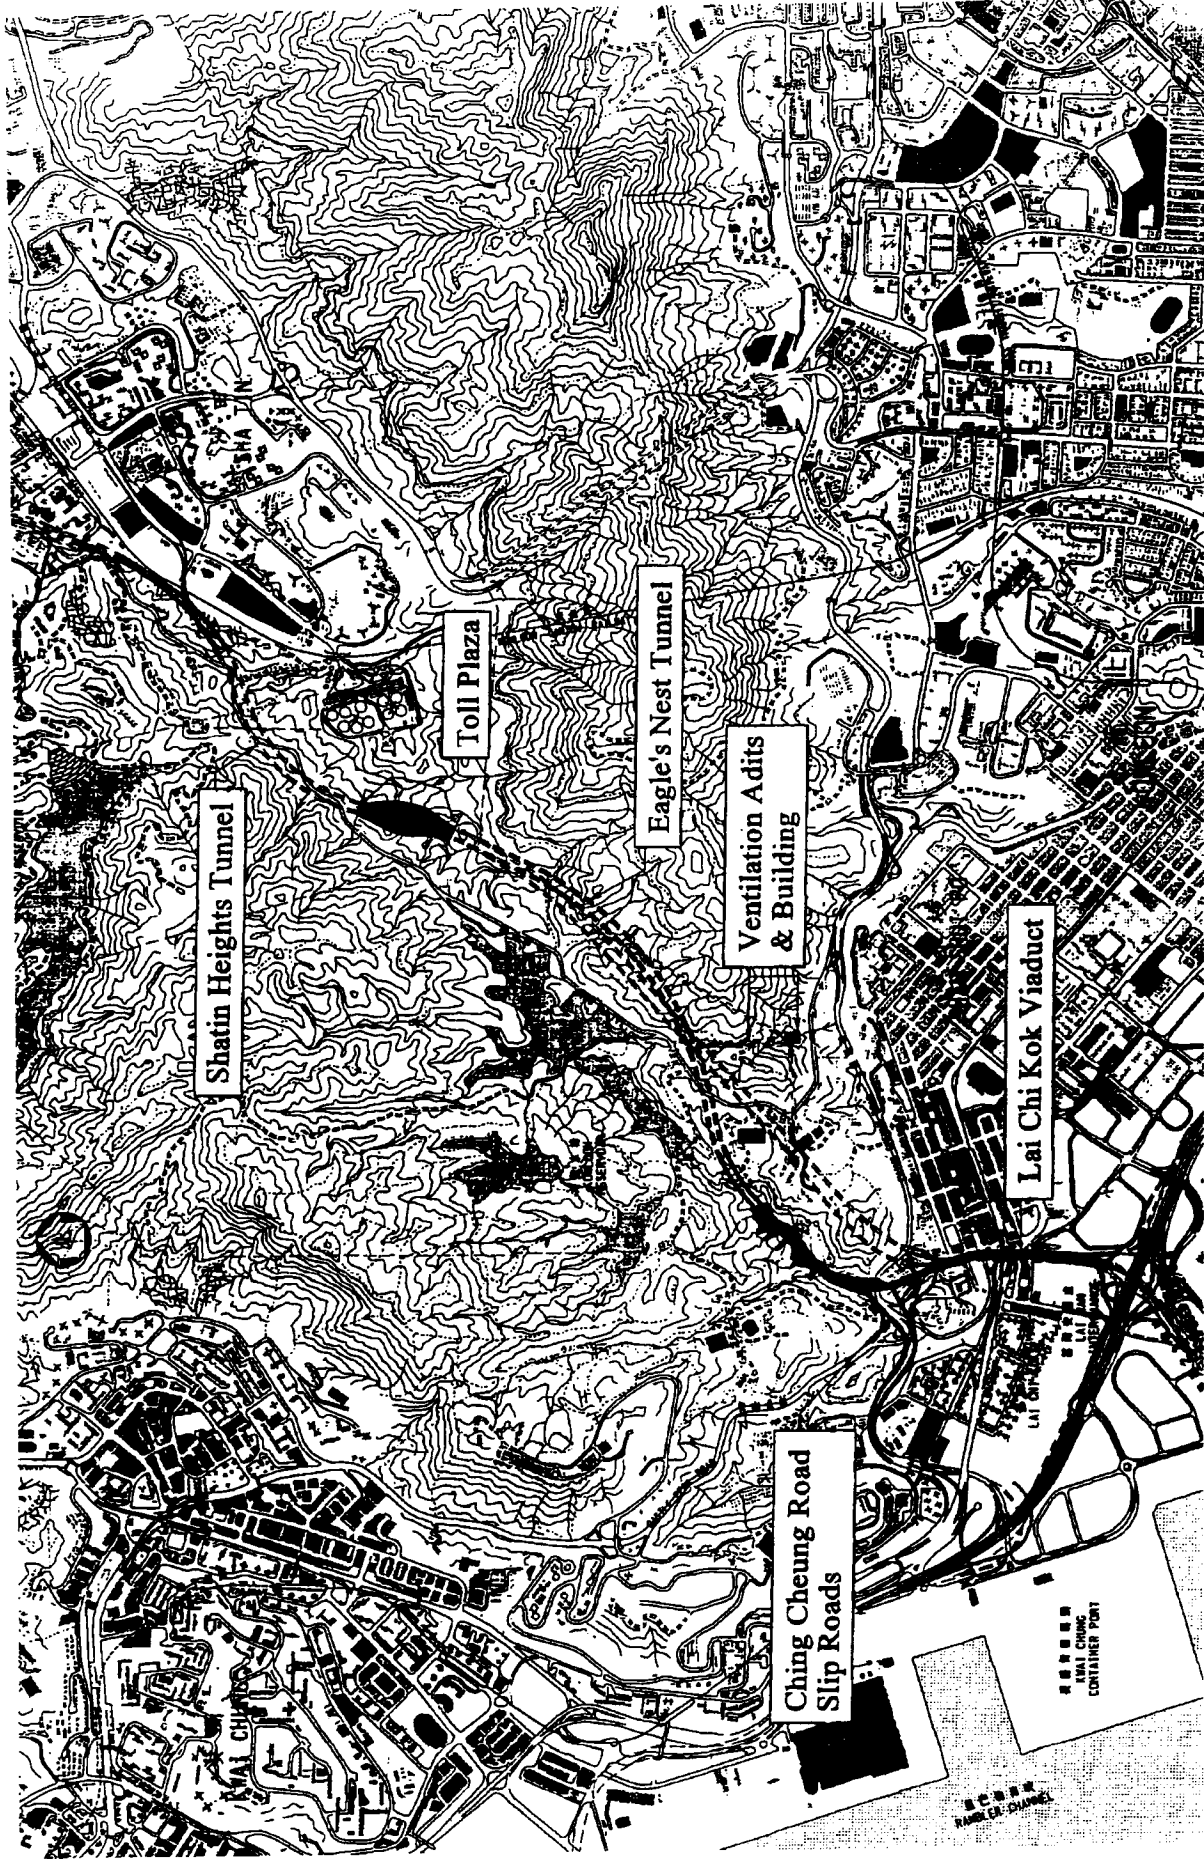
FIGURE 7.7b

INDICATIVE LOCATION OF WOODLAND LOSS FOR THE ENTIRE ROUTE 16 ALIGNMENT

- 7.7.4 Woodland loss and corresponding compensation due to the section from West Kowloon to Sha Tin of Route 16 has been stated in the previous EIA report. However, it has been confirmed with Highways Department that more area is identified available for compensatory replanting in Ching Cheung Road Interchange and Pak Shek area. For completeness, the entire Route 16 alignment is considered and the total woodland loss and compensation is summarised in *Table 7.7a*. Their locations are shown in *Figure 7.7b* and *7.7c* respectively.

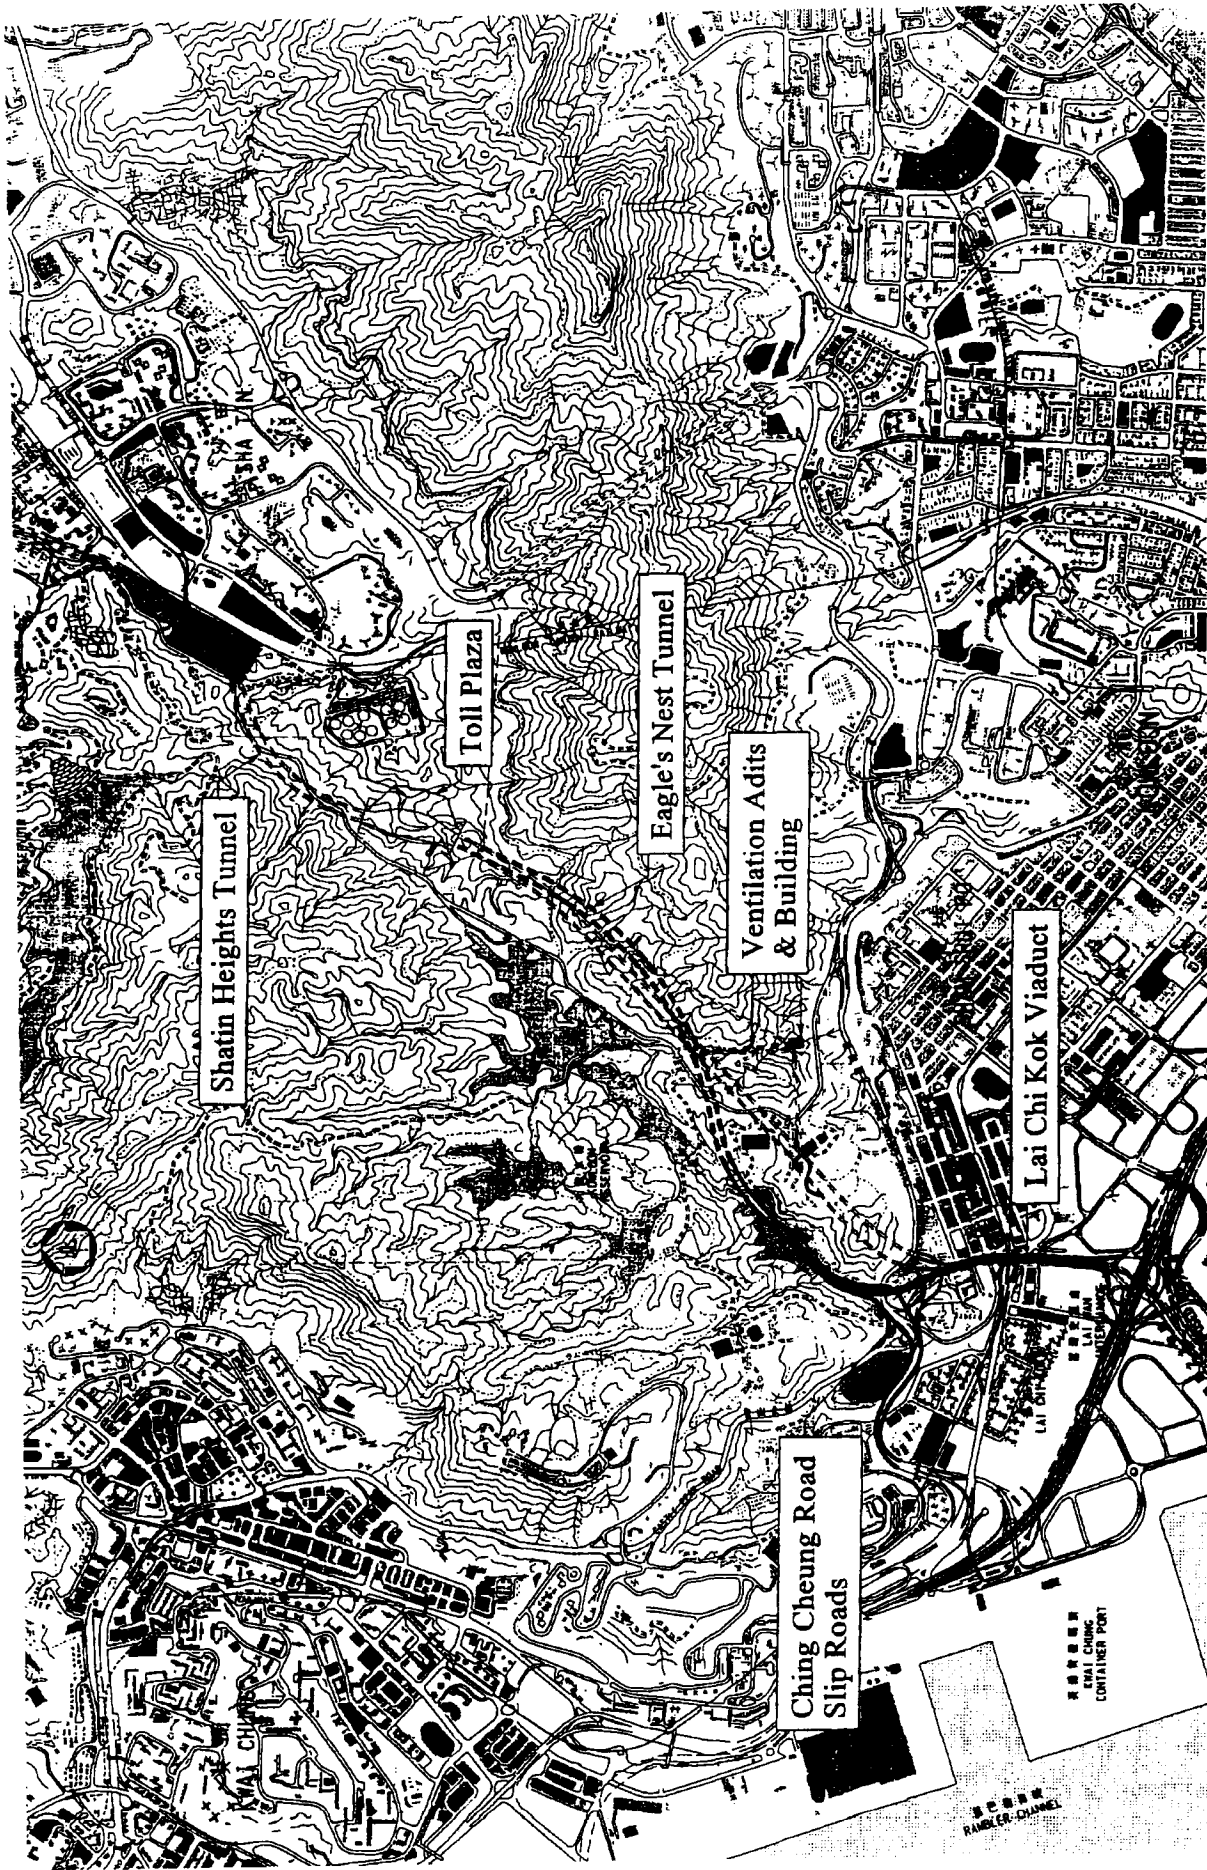
FIGURE 7.7c

INDICATIVE LOCATION OF WOODLAND COMPENSATION FOR THE ENTIRE ROUTE 16 ALIGNMENT

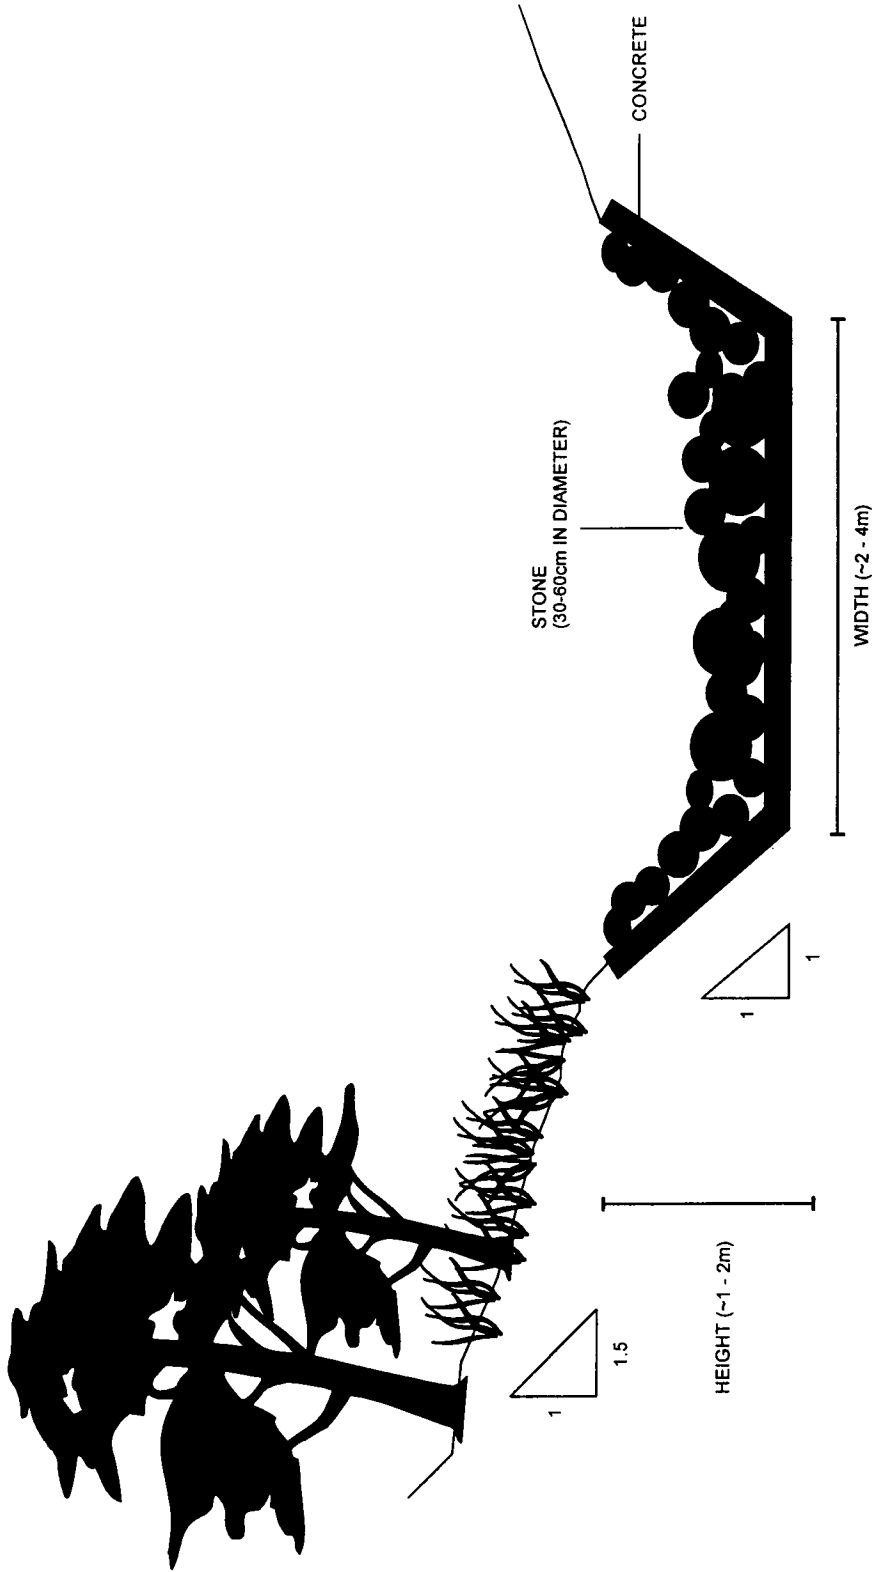
FIGURE 7.7e

NOTE: HEIGHT AND WIDTH TO BE DETERMINED AT DETAILED DESIGN STAGE TO CATER FOR THE EXPECTED FLOW

TYPICAL SCHEMATIC CROSS-SECTION OF RE-CREATED STREAM
