EcoPark Operation EM&A

Quarterly Report

February 2010 to April 2010

Report No EB000198-R16-01

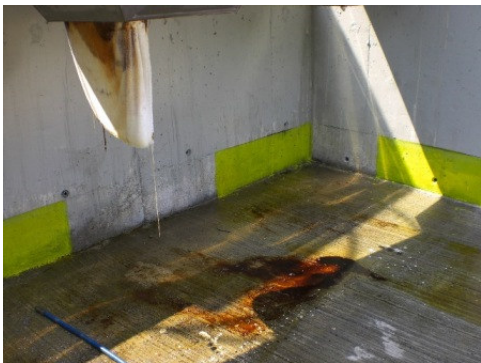
No.	Observation (Please include location and recommended remedial action)	Expected Date for Action Taken
1	<p>Oily patch was found near the drains. The tenant was reminded to clear the patch and prevent washing it into the drains.</p>

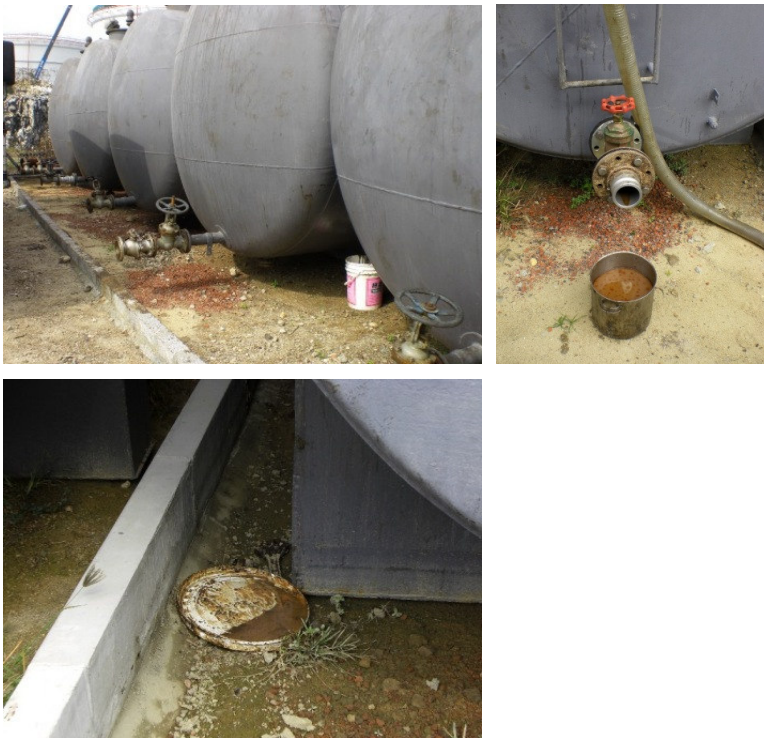
Completed
2	<p>At the reserved area for EcoPark's Wastewater Treatment Plant (WWTP), oil stain was found near the storage tanks. In addition, uncovered waste cooking oil bucket was observed on the bare ground. The tenant was reminded to remove the oil stain and dispose of the waste properly; and provide cover and drip tray / canvas underneath the buckets / storage tanks.</p>

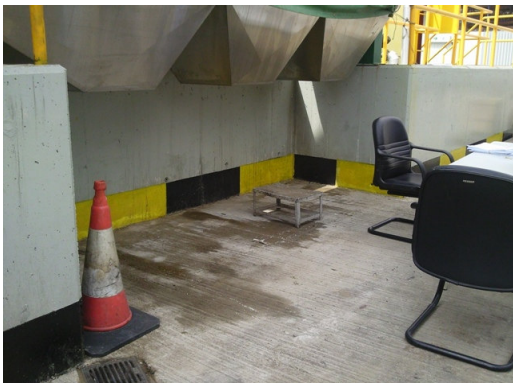
No.	Observation (Please include location and recommended remedial action)	Expected Date for Action Taken
	No major environmental deficiency was found during the site inspection.	N/A
No.	Follow-up from Previous Audit Dated <u>23 February 2010</u> (Please state date of previous audit)	Completed / Outstanding?
1	<p>Oily patch was no longer found near the drains.</p>

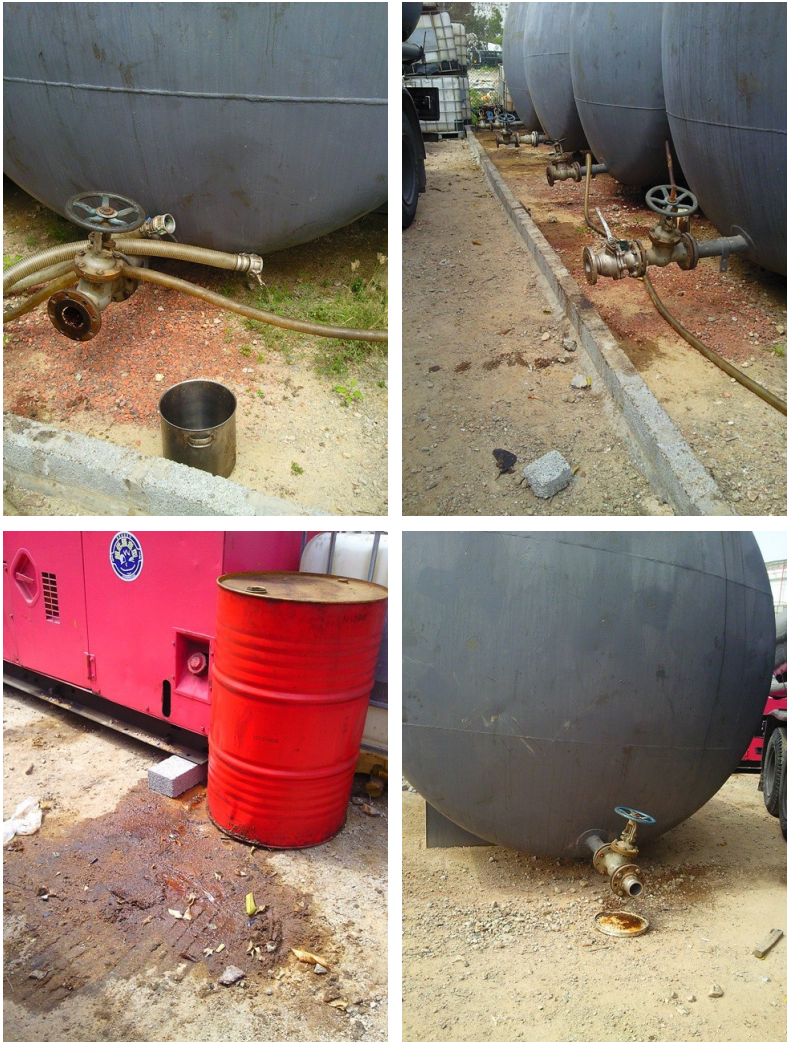
2	<p>At the reserved area for EcoPark's Wastewater Treatment Plant (WWTP), oil stain was found near the storage tanks. In addition, uncovered waste cooking oil bucket was observed on the bare ground. The tenant was reminded to remove the oil stain and dispose of the waste properly; and provide cover and drip tray / canvas underneath the buckets / storage tanks.</p>

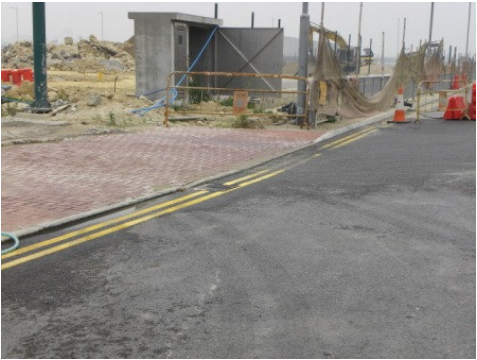
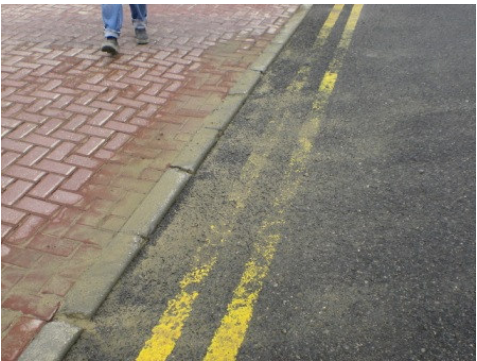
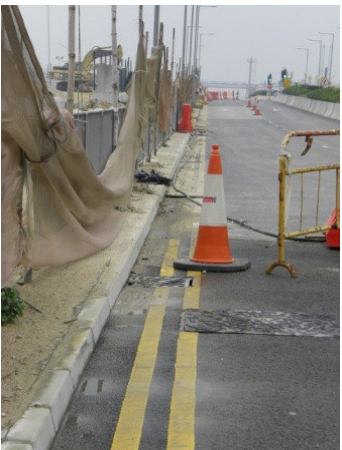
ET Findings / Recommendations (25 Jan 2010)	Operator / Tenant's Follow-up Actions
<p>1. Outside the tenant lot of Yan Oi Tong, muddy trial was found near the drains. SGJV was advised to liaise with the RE for clearing the muddy trial.</p>

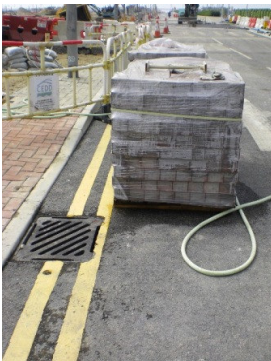
<p>During the site inspection on 23 Feb 2010, no muddy trial was found near the drains outside Yan Oi Tong's tenant lot. (Closed)</p>

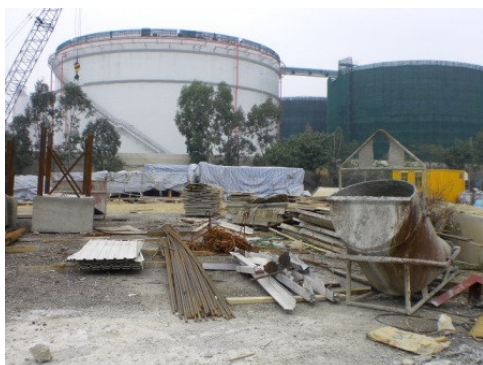
2. Piles of construction materials lied around in Shiu Wing's lot. The tenant was reminded to enhance housekeeping.

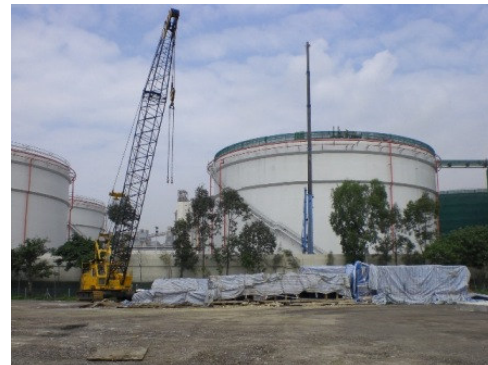
During the site inspection on 23 Feb 2010, the construction materials inside Shiu Wing's lot were removed. (Closed)

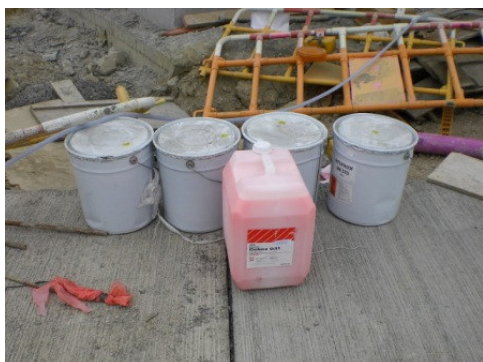
3. Chemicals were found without drip tray inside Li Tong's lot. The tenant was reminded to provide drip tray for all chemicals to prevent potential land contamination.

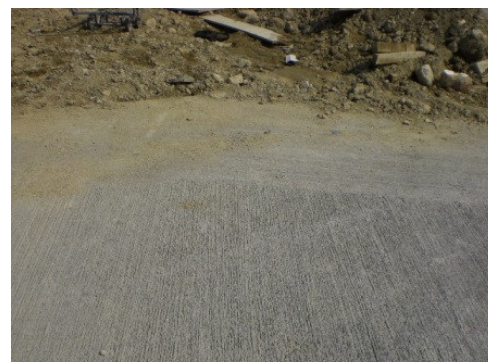
During the site inspection on 23 Feb 2010, chemicals inside Li Tong's lot were removed. (Closed)

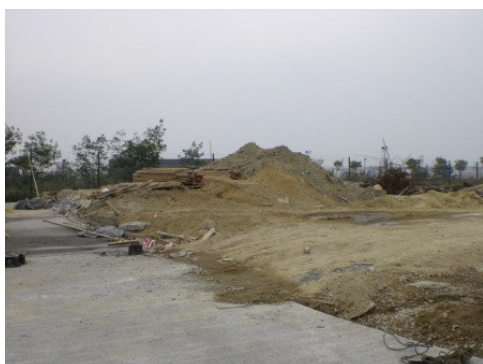
4. Large stockpile of soil were observed inside Li Tong's lot. The tenant was reminded to cover the stockpile with canvas so that the potential air quality impact could be minimised.

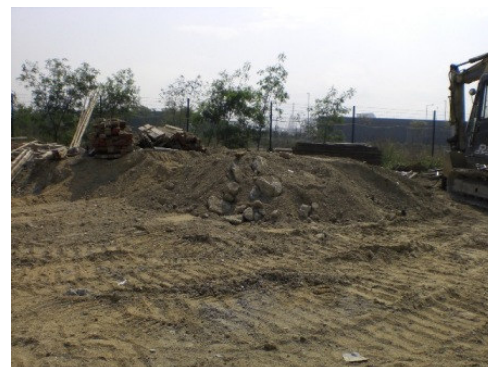
During the site inspection on 23 Feb 2010, large stockpile of soil were still observed inside Li Tong's lot. The tenant was again reminded to cover the stockpile with canvas so that the potential air quality impact could be minimised. (Outstanding)

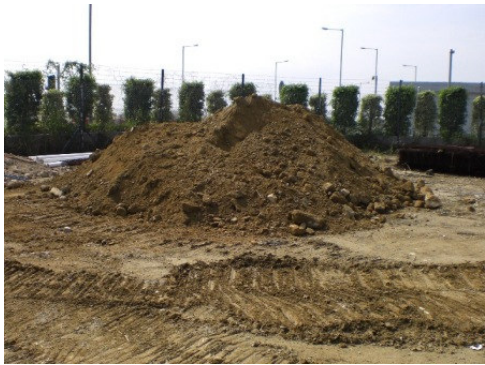
ET Findings / Recommendations (23 Feb 2010)	Operator / Tenant's Follow-up Actions
<p>1. Large stockpile of soil were observed inside Hung Wai's lot. The tenant was reminded to cover the stockpile with canvas so that the potential air quality impact could be minimised.</p>

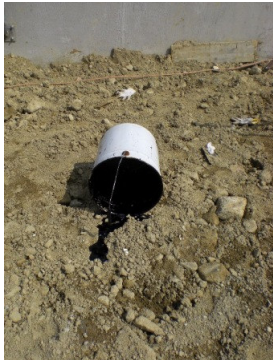
<p>To be found out in the next Monthly Site Audit.</p>
<p>2. Chemicals were spilled on the ground of Li Tong's lot. The tenant was reminded to clear the chemicals and provide proper treatment to the dirty soil. Drip tray should also be provided to all chemicals to prevent potential land contamination.</p>

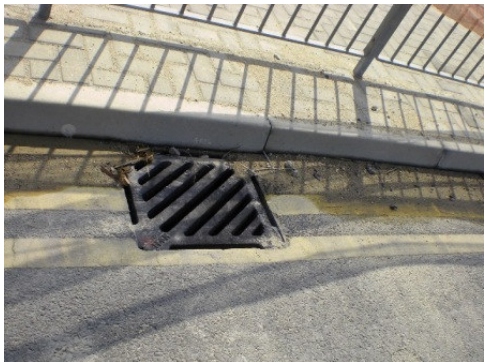
<p>To be found out in the next Monthly Site Audit.</p>
<p>3. Muddy trial was found near the drains outside the tenant lot "P9". SGJV was advised to liaise with the RE for clearing the muddy trial.</p>

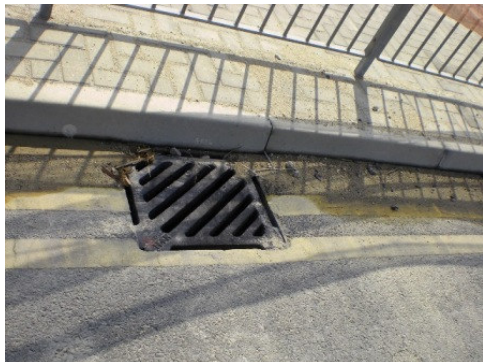
5. Muddy trial was found near the drains outside the tenant lot "P9". SGJV was advised to liaise with the RE for clearing the muddy trial.

During the site inspection on 22 Mar 2010, no muddy trial was found outside the tenant lot "P9". (Closed)

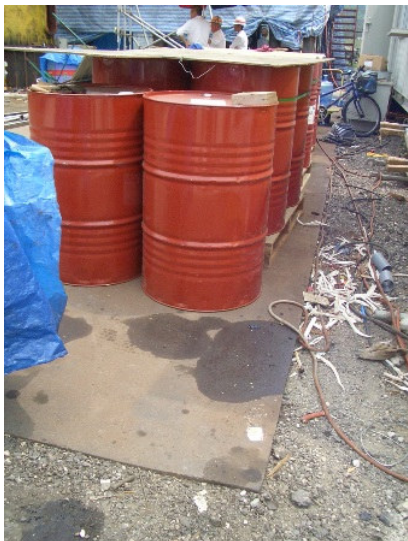
ET Findings / Recommendations (28 Apr 2010)	Operator / Tenant's Follow-up Actions
<p>1. Oil stain was found inside Shiu Wing's lot. The tenant was reminded to clear the stain and disposed of the contaminated materials properly. Drip tray should also be provided to all chemicals to prevent potential land contamination.</p>

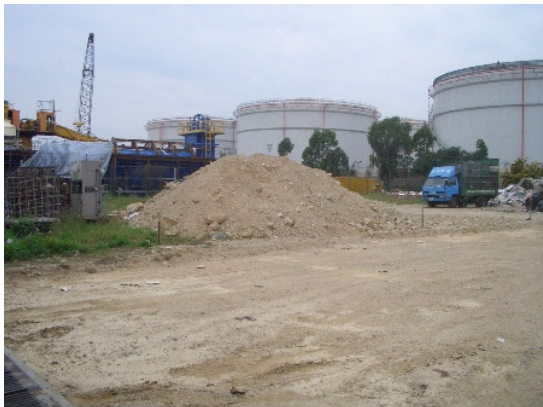
<p>To be found out in the next Monthly Site Audit.</p>
<p>2. Large stockpile of soil were observed inside Telford's lot. The tenant was reminded to cover the stockpile with canvas so that the potential air quality impact could be minimised.</p>

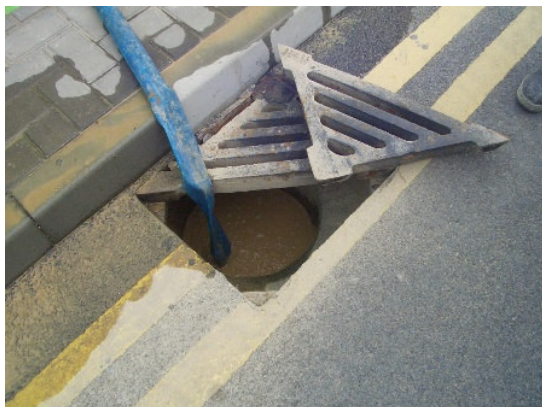
3. Muddy water was discharged directly into the drains outside the tenant lot of "P9". SGJV was advised to liaise with the RE for providing proper treatment to the muddy water (i.e. treated in the sedimentation tank) before discharge.
