Contract No. : EP/SP/52/06
Development of EcoPark in Tuen Mun Area 38

ENVIRONMENTAL MONITORING AND AUDIT

MONTHLY EM&A REPORT for

June 2010

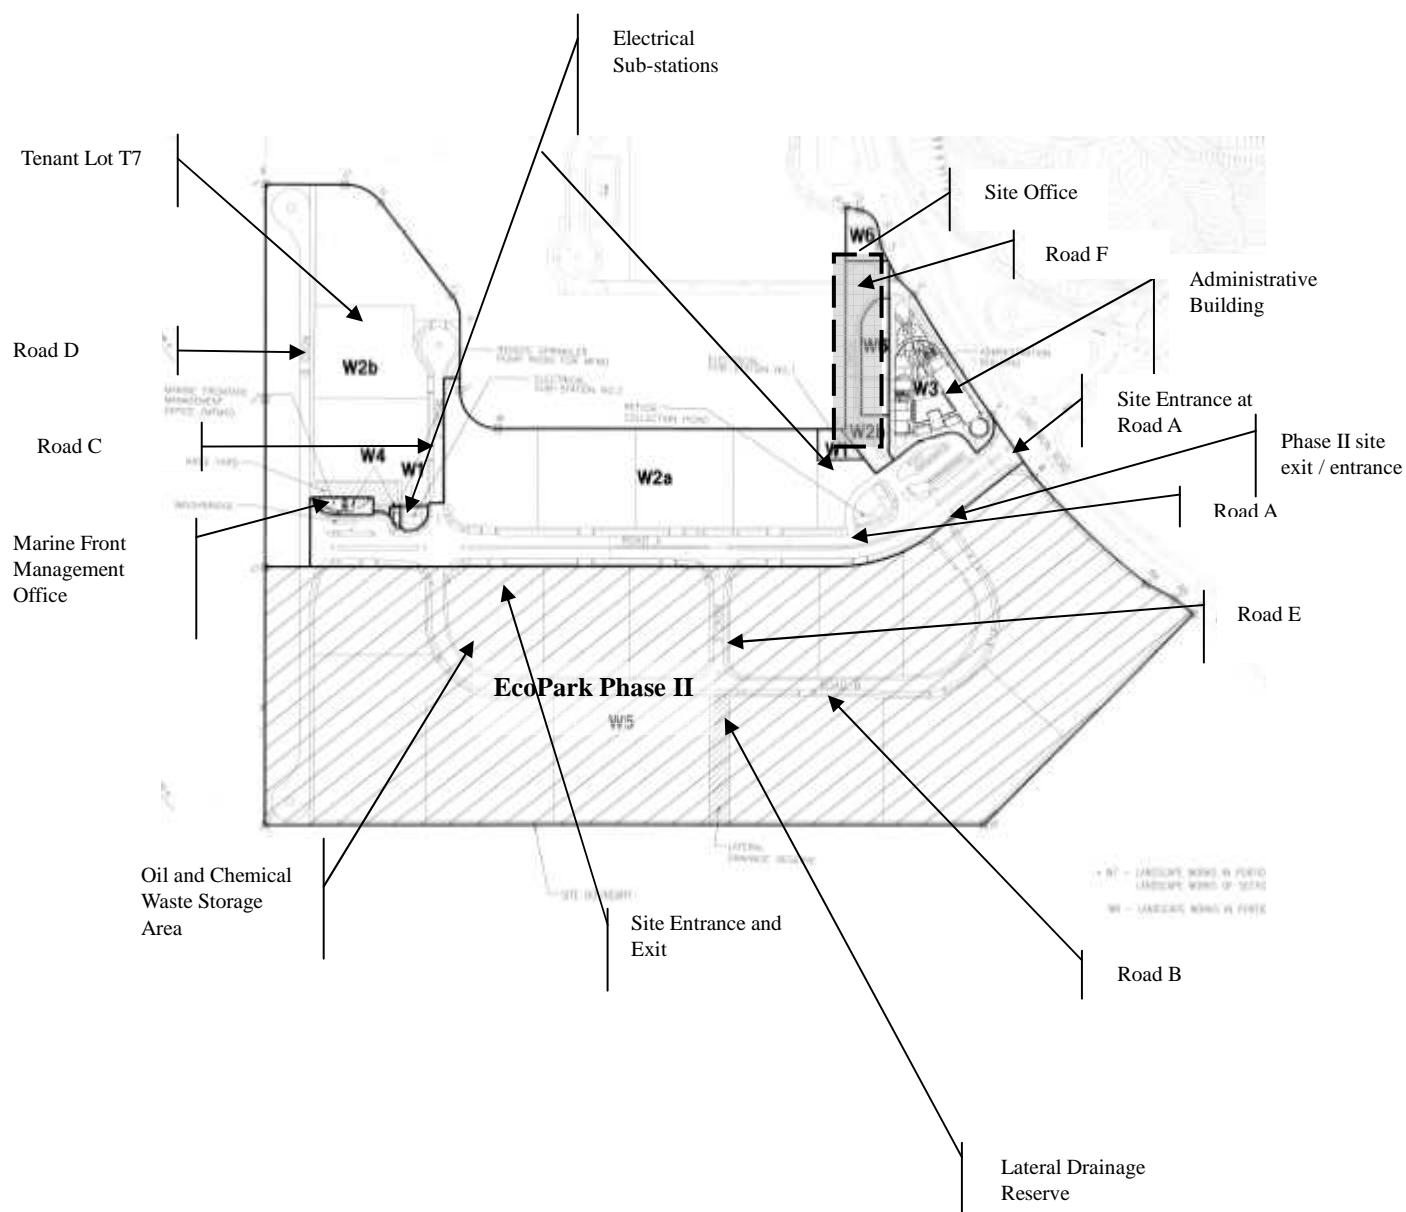
APPENDIX 1 - SITE LAYOUT PLAN

This is the forty-eighth monthly Environmental Monitoring and Audit (EM&A) Report for the Environmental Protection Department Contract No. EP/SP/52/06 entitled “Development of EcoPark in Tuen Mun Area 38”. The site layout plan is shown in Appendix 1. The report was prepared by the Environmental Team, Environmental Pioneers & Solutions Limited, of the Works Contractor, Kaden Construction Limited. The report is to be submitted to the Works Contractor, the Engineer and the Environmental Protection Department for the project.

- As informed by the Contractor, most equipment is mobile at site subject to work progress.
- Refer to Appendix 1 – Site layout plan for location of construction activities.
