**Agreement No. CE
20/2004(EP) North
East New
Territories (NENT)
Landfill Extension**

Monthly Environmental
Monitoring and Audit Report
(No. 10) – September 2023

Re: Contract No. EP/SP/77/15
North-East New Territories Landfill Extension (NENTX)
Monthly Environmental Monitoring and Audit Report (No.10) –
September 2023

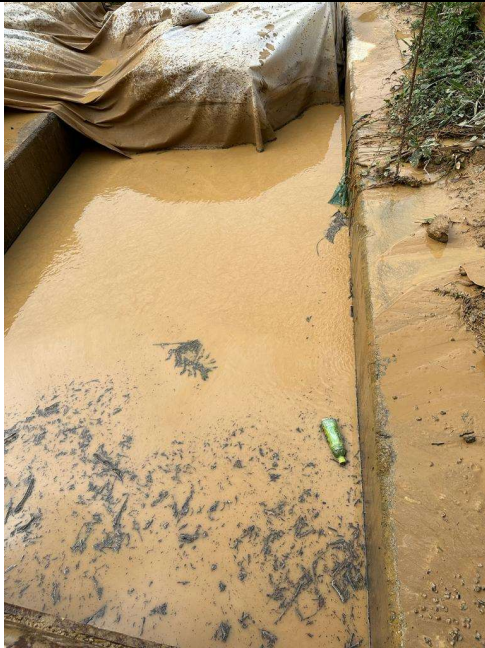
The untreated wastewater was leaked into the channel at Portion E3. The channel should be kept away from untreated wastewater and general waste.

The silt along and inside the existing channel has been removed and the Contractor has placed sandbag barriers to seal the leakage points. The Contractor has been recommended to construct paved earth bund along the existing channel to prevent the leakage from happening again.

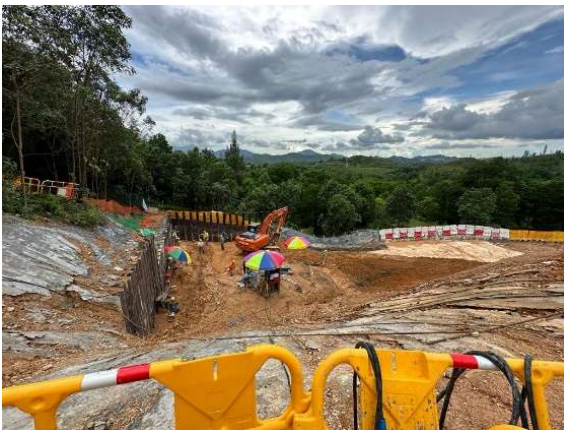
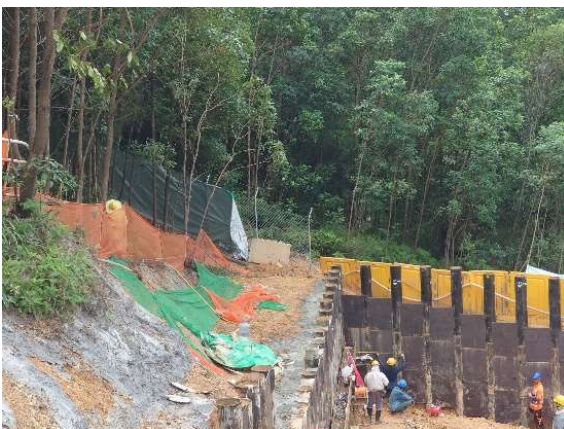
21 August 2023 Observation 1:

The edge of site boundary should be properly sealed to prevent leakage of surface runoff flowing out of the site.

The sandbag barriers and the trench were established by contractor.

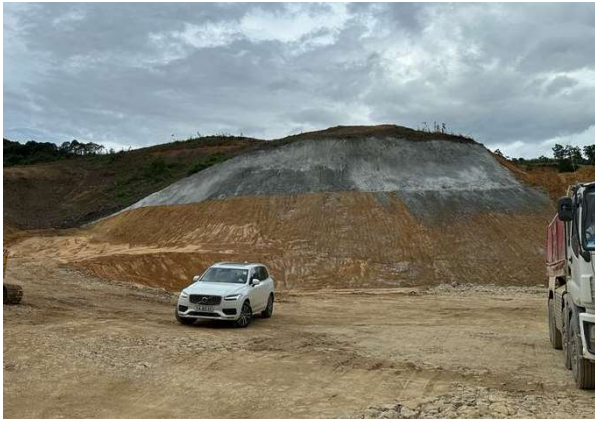
21 August 2023 Observation 4:

Implementation of slope protection should be enhanced at Portion E4.

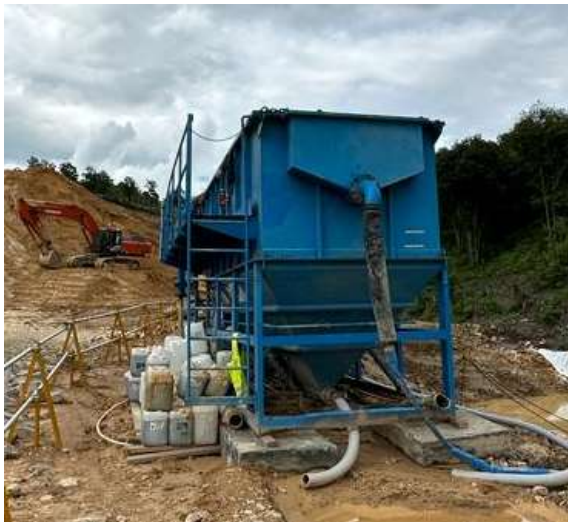
21 August 2023 Observation 5:

Chemical containers should be placed within the drip trays in Portion E4.

Waiting for Contractor's Input

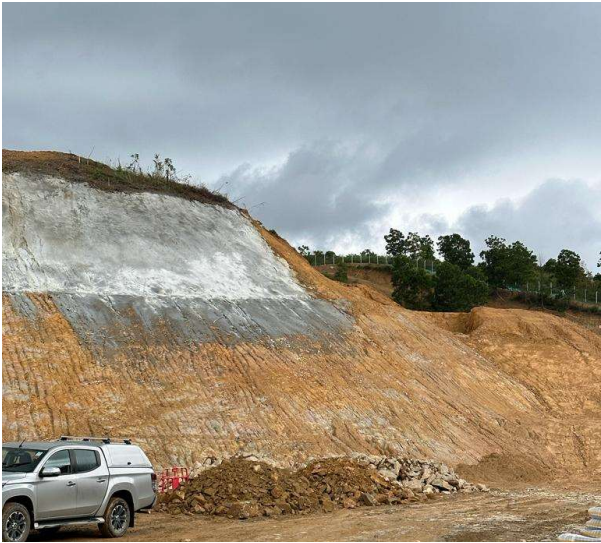
Observation and Recommendation	Follow-up status
<p><u>Portion E4</u></p>

<p>The slope protection measures should be enhanced in Portion A, B2 and E4 prior the rainfall and the tropical cyclone. The Contractor should cover the exposed slope with the impervious sheet as temporary measure or pave slope surface for long term.</p>	
<p><u>28 August 2023 Observation 2:</u></p>

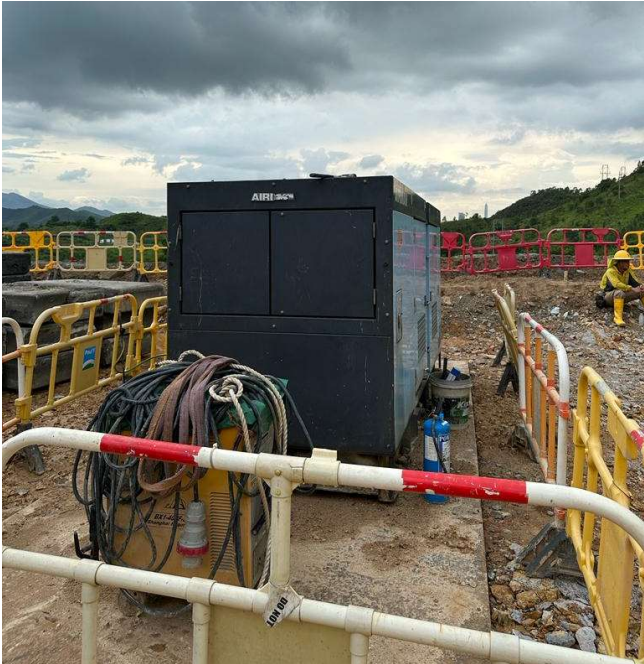
<p>NRMM label should be fixated on the generator in Portion A.</p>	<p>Waiting for contractor input</p>

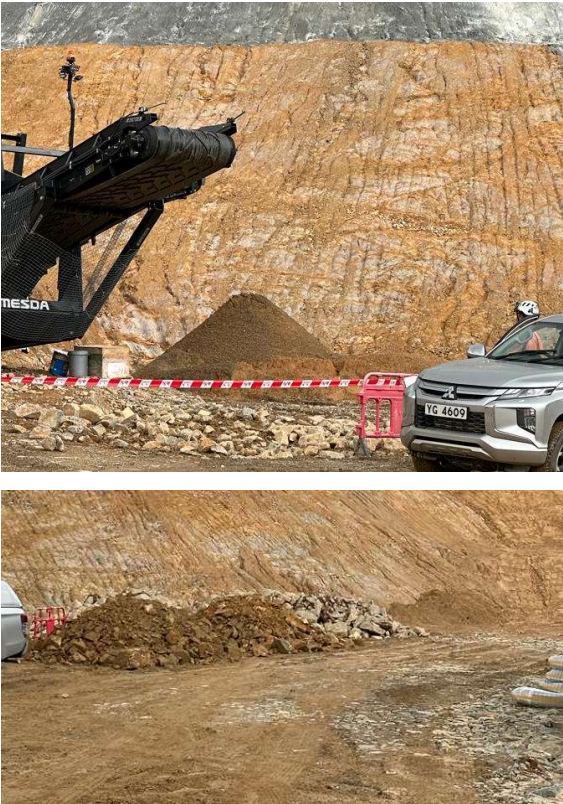
Observation and Recommendation	Follow-up status
<p><u>28 August 2023 Observation 5:</u></p>

<p>Dusty stickpiles should be covered with impervious sheet prior rainfall and tropical cyclone.</p>	<p>Waiting for contractor input</p>

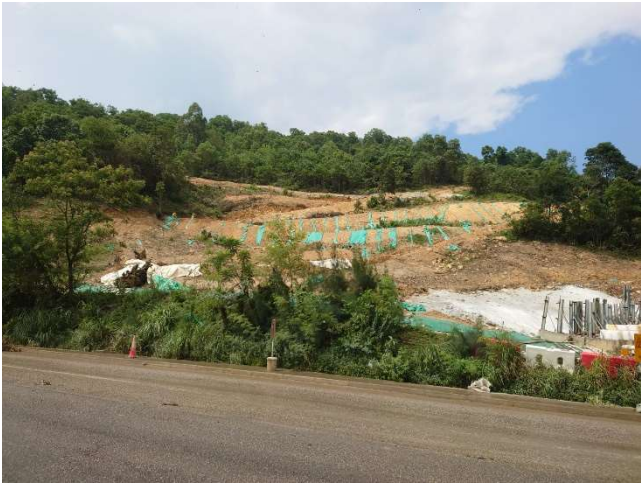
Observation and Recommendation	Follow-up status
<p data-bbox="132 248 451 275">4 September 2023 Observation 3</p>

<p data-bbox="132 786 783 840">The exposed slope surfaces at Portion B2 are not covered by impervious sheets.</p>	<p data-bbox="1002 530 1260 557">Waiting for contractor input</p>

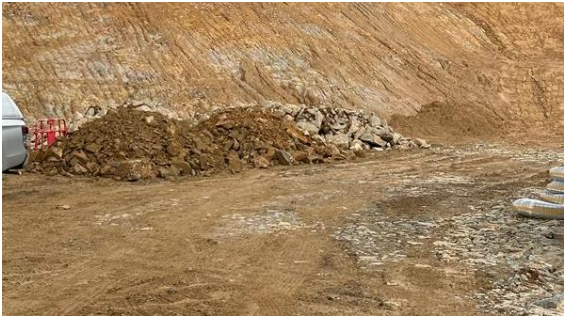
<p>Dusty stickpiles should be covered with impervious sheet prior rainfall and tropical cyclone.</p>	<p>Waiting for contractor input</p>

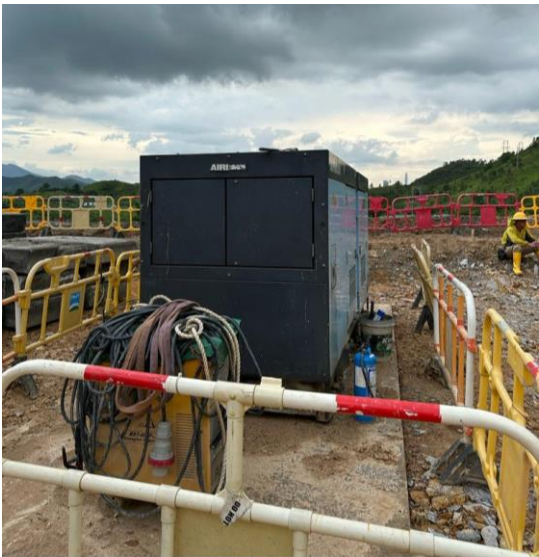
Observation and Recommendation	Follow-up status
<p><u>28 August 2023 Observation 2</u></p>

<p>NRMM label should be fixated on the generator in Portion A.</p>	<p>Waiting for contractor input</p>
<p><u>28 August 2023 Observation 5</u></p>

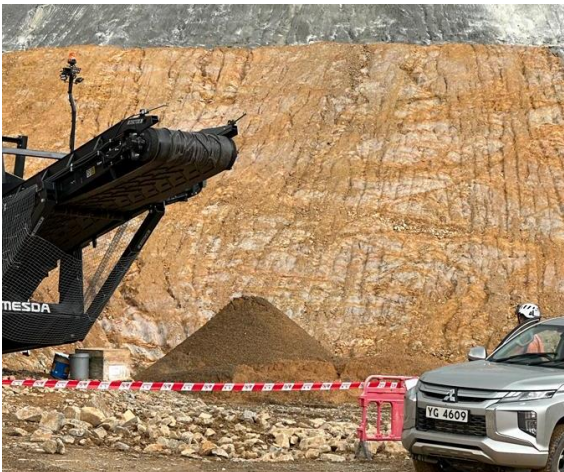
<p>Dusty stickpiles should be covered with impervious sheet prior rainfall and tropical cyclone.</p>	<p>Waiting for contractor input</p>

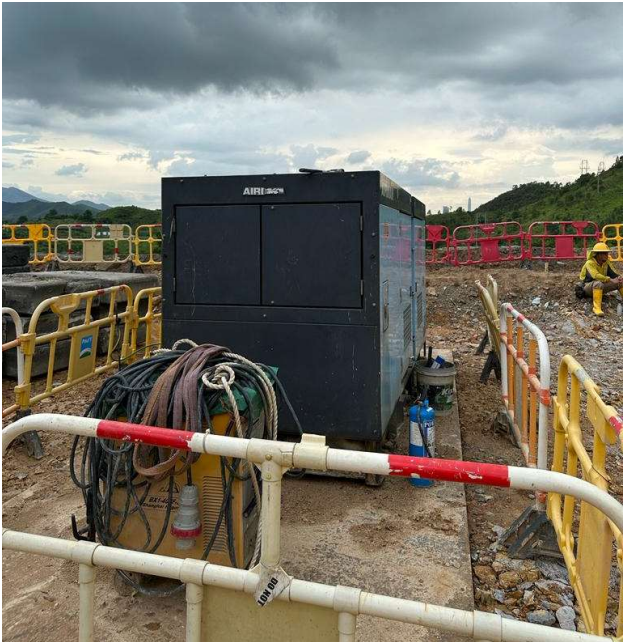
Observation and Recommendation	Follow-up status
<p><u>28 August 2023 Observation 2</u></p>

<p>NRMM label should be fixated on the generator in Portion A.</p>

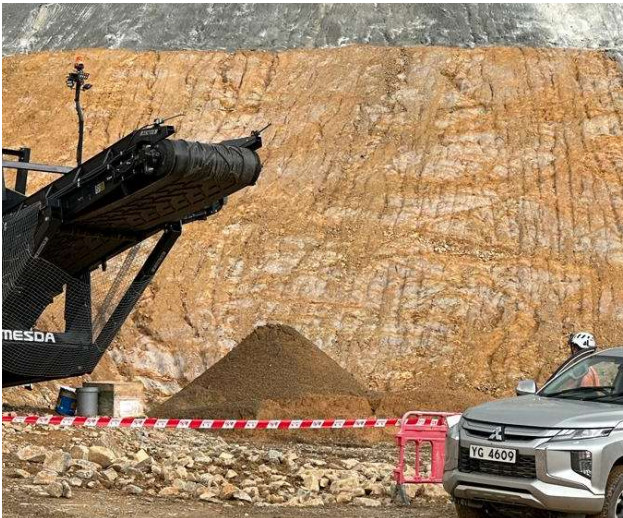
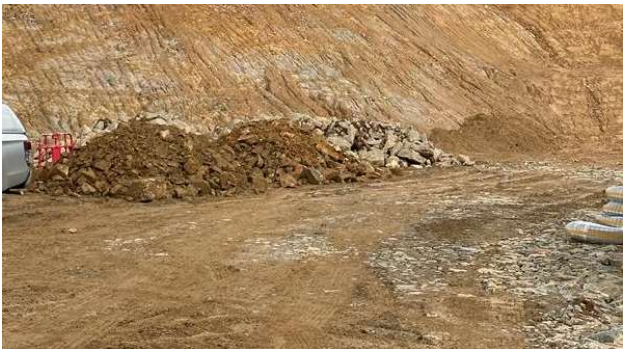
<p>Dusty stickpiles should be covered with impervious sheet prior rainfall and tropical cyclone.</p>

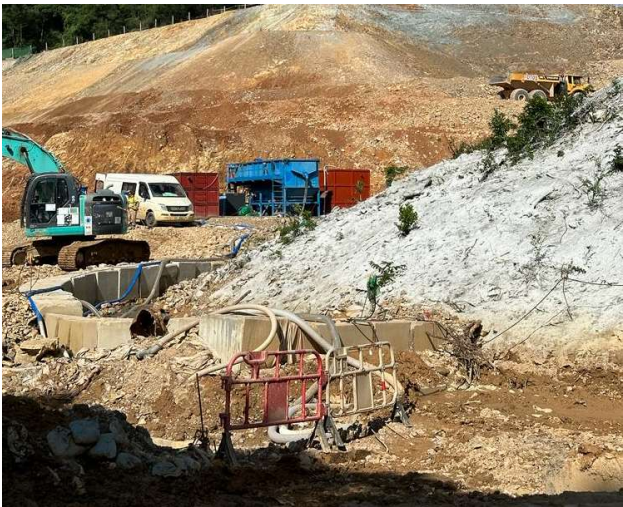
Observation and Recommendation	Follow-up status
<p>18 September 2023 Observation 6</p>

<p>Sediment/ silt traps shall be incorporated in the temporary drainage system to enhance retention time for silt/s and traps of the silt removal facilities be 5 minutes under maximum flow conditions.</p>	<p>Waiting for contractor input</p>

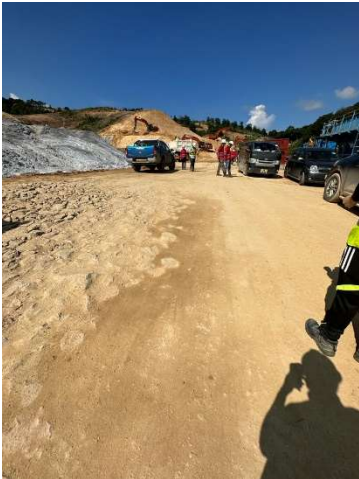
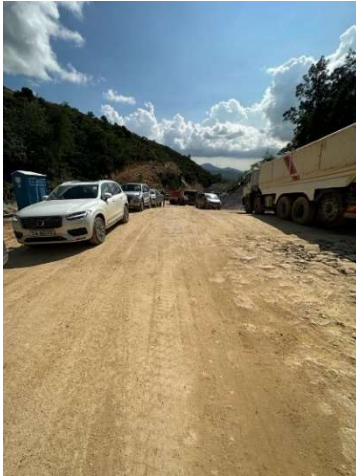
18 September 2023 Observation 7

The main haul road in Portion E4 was dry and dusty.

The Contractor arranged watering in Portion E3 and E4 to minimize dust dispersion.

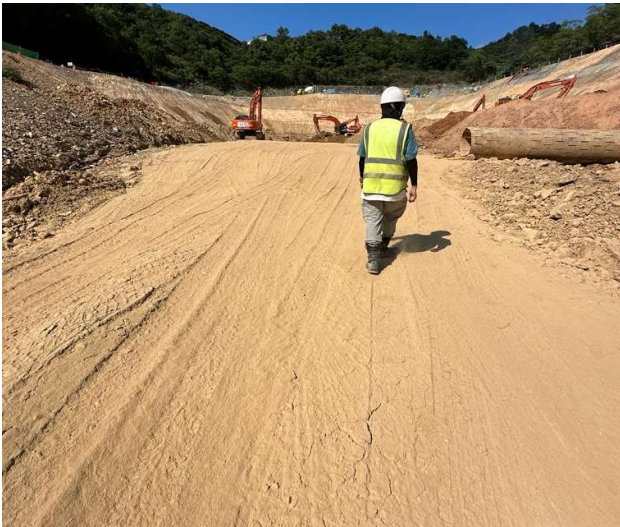
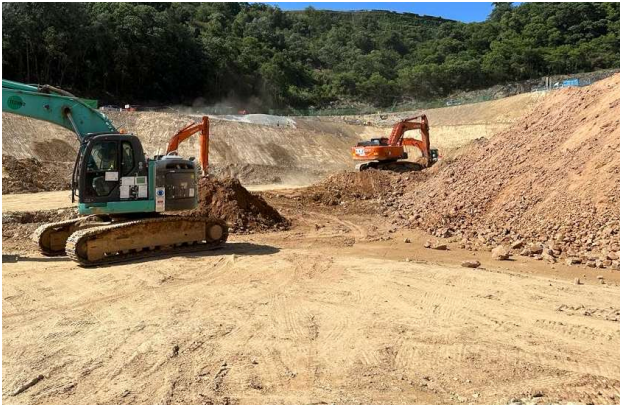
Observation 1.

The main haul road and work site should be wetted regularly to minimize the dust dispersion.

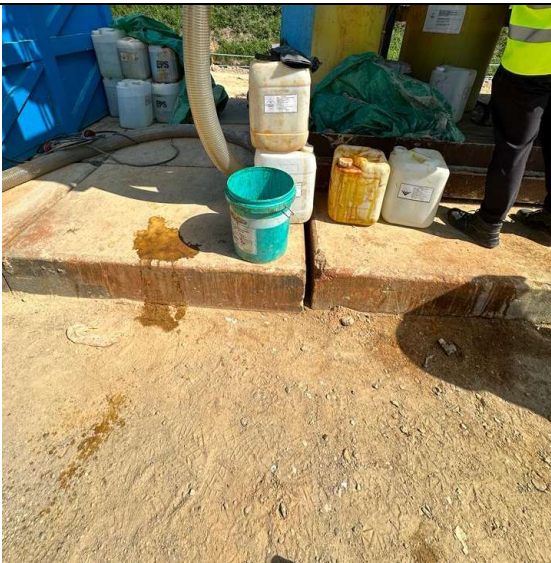
Observation 2.

Chemical spillage is observed at Portion E4 and chemical containers should be placed on the drip tray.

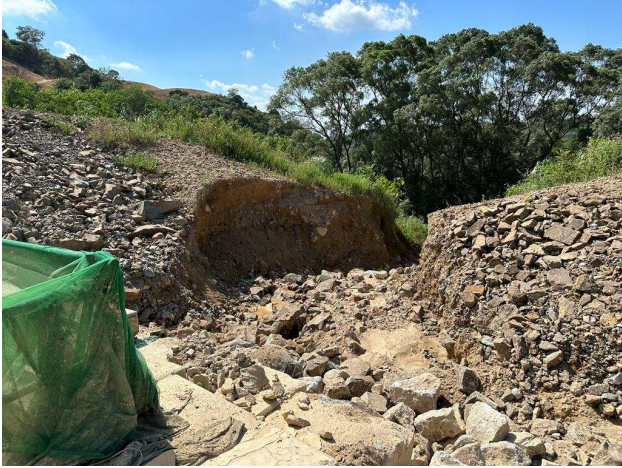
Observation 3

The exposed slope surface along the channel should be paved to reduce SS level in the wastewater.

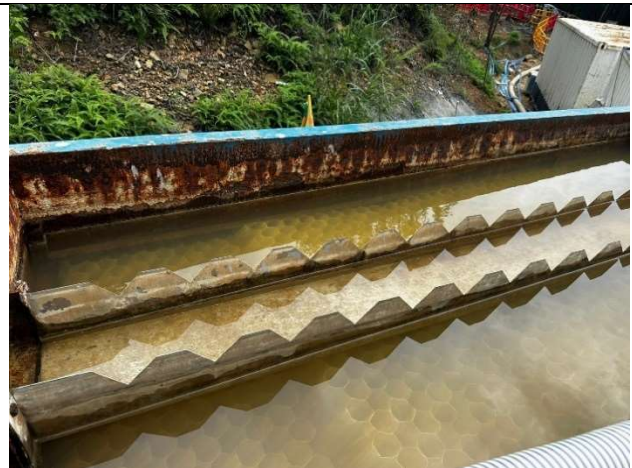
Observation 4

The accumulated sand or silt in the outlet of the silt removal facility at Portion A should be removed.

The accumulated sand and silt in the outlet of the silt removal facility at Portion A was removed by the contractor.

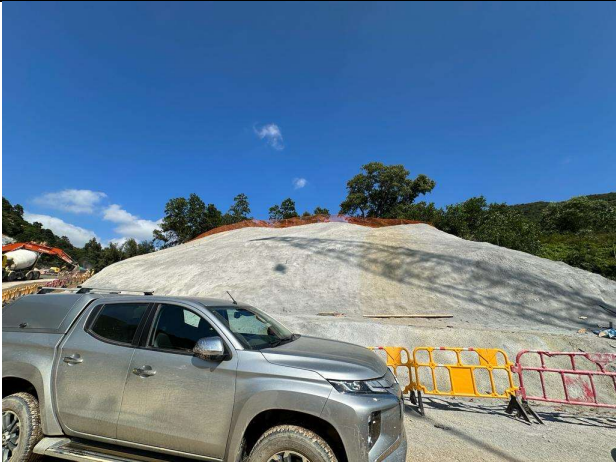
<p>Slope Protection in Portion A</p>

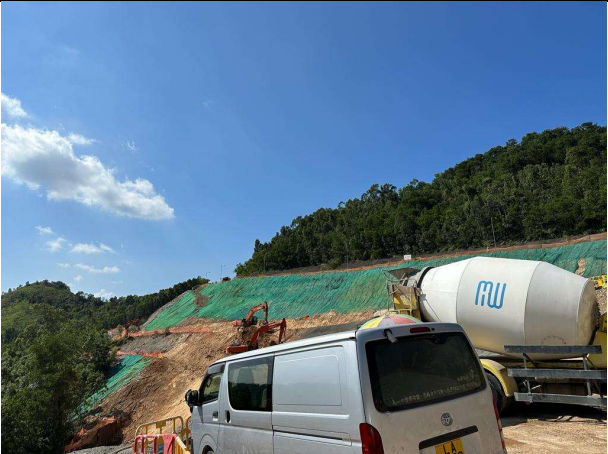
<p>Slope Protection in Portion A</p>

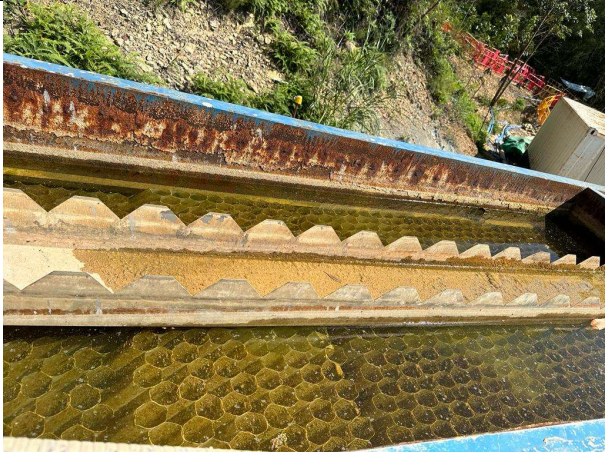
<p>Silt Removal Facility in Portion A</p>

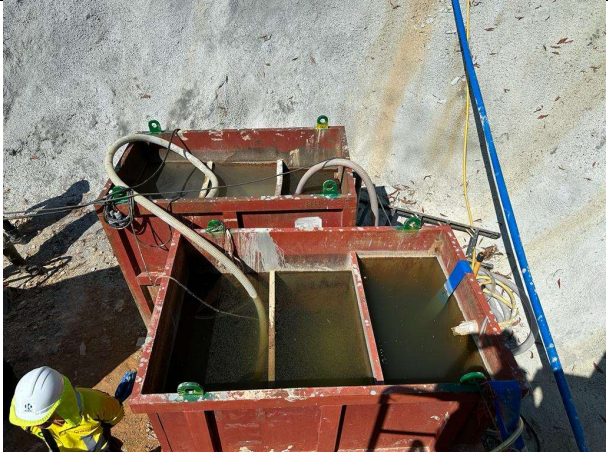
<p>Sedimentation Tanks in Portion A</p>

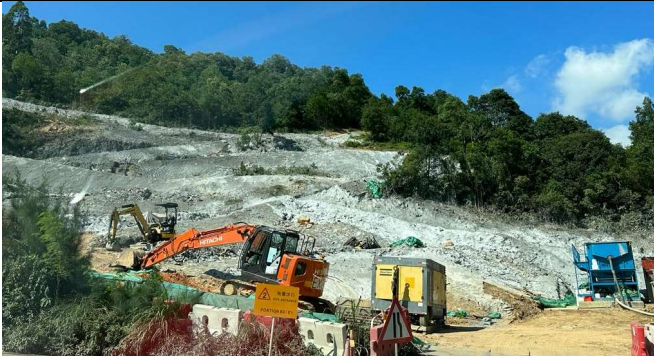
<p>Slope Protection and silt removal facility in Portion B2</p>

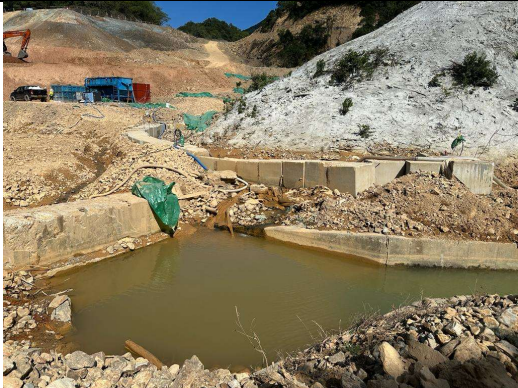
<p>Sedimentation basin in Portion E3</p>

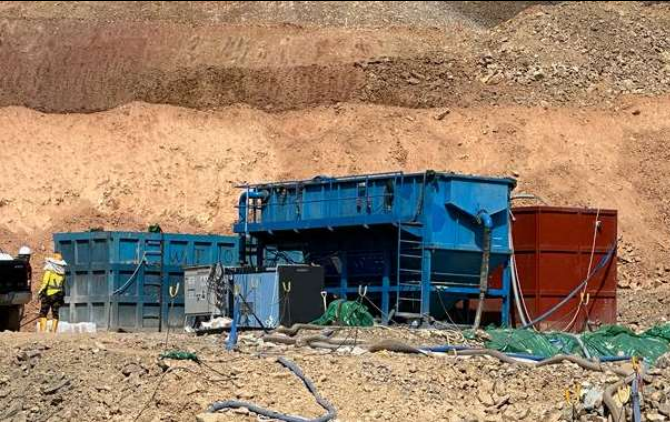
A photograph showing a large blue and red industrial structure, likely a silt removal facility or sedimentation tank, situated at the base of a steep, exposed earth slope. A worker in a yellow safety vest is visible near the structure. The ground in the foreground is muddy and uneven.

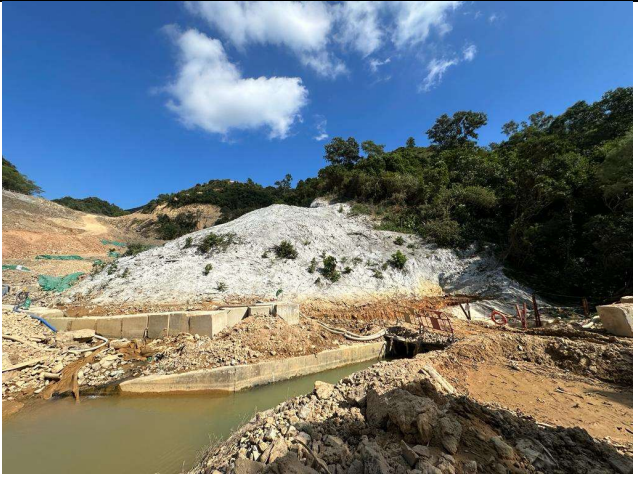
A photograph showing a steep, exposed earth slope with a concrete retaining wall at its base. The slope is covered with a layer of white material, possibly lime or cement, for stabilization. The sky is blue with scattered white clouds.

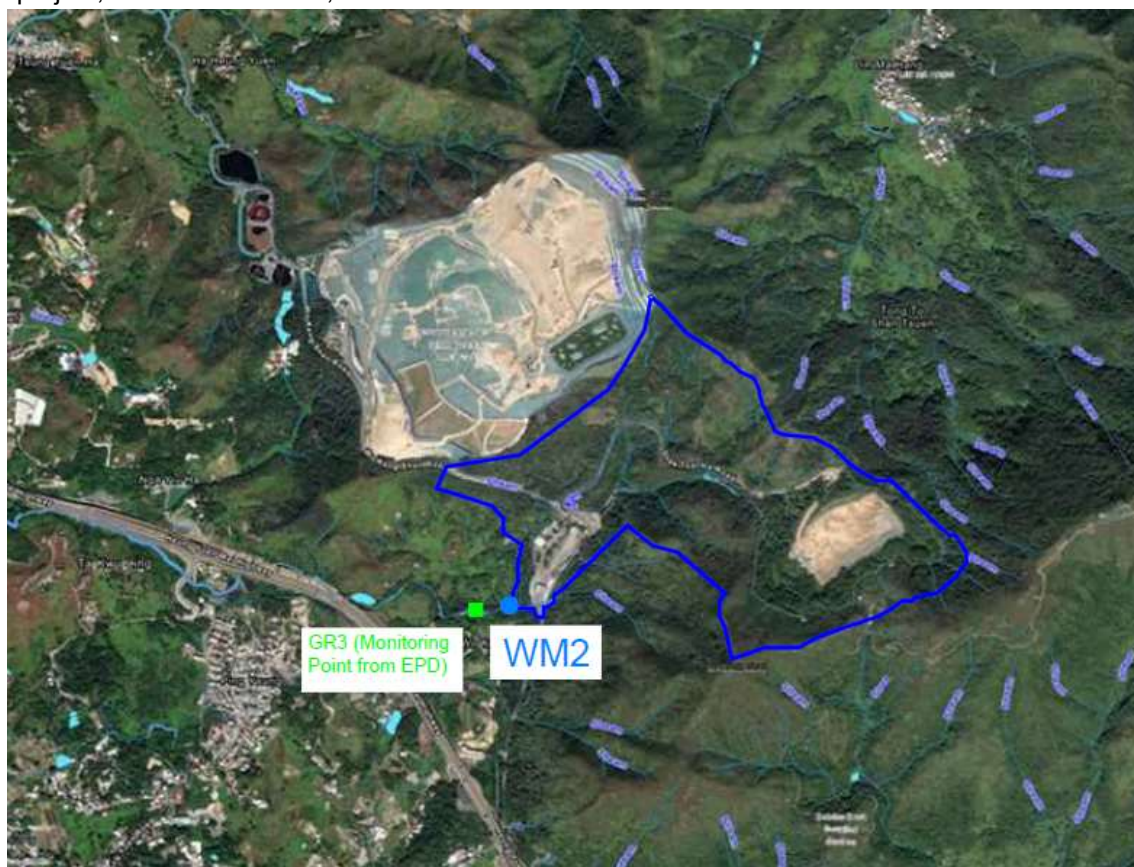
- 4.3 The GR3 is located downstream of the water quality monitoring station WM2 of the NENTX project. The WM2 is situated at the outfall of the box culvert, which collects the water from Portion A, Portion E3-1 of the project, the natural stream, and other areas.

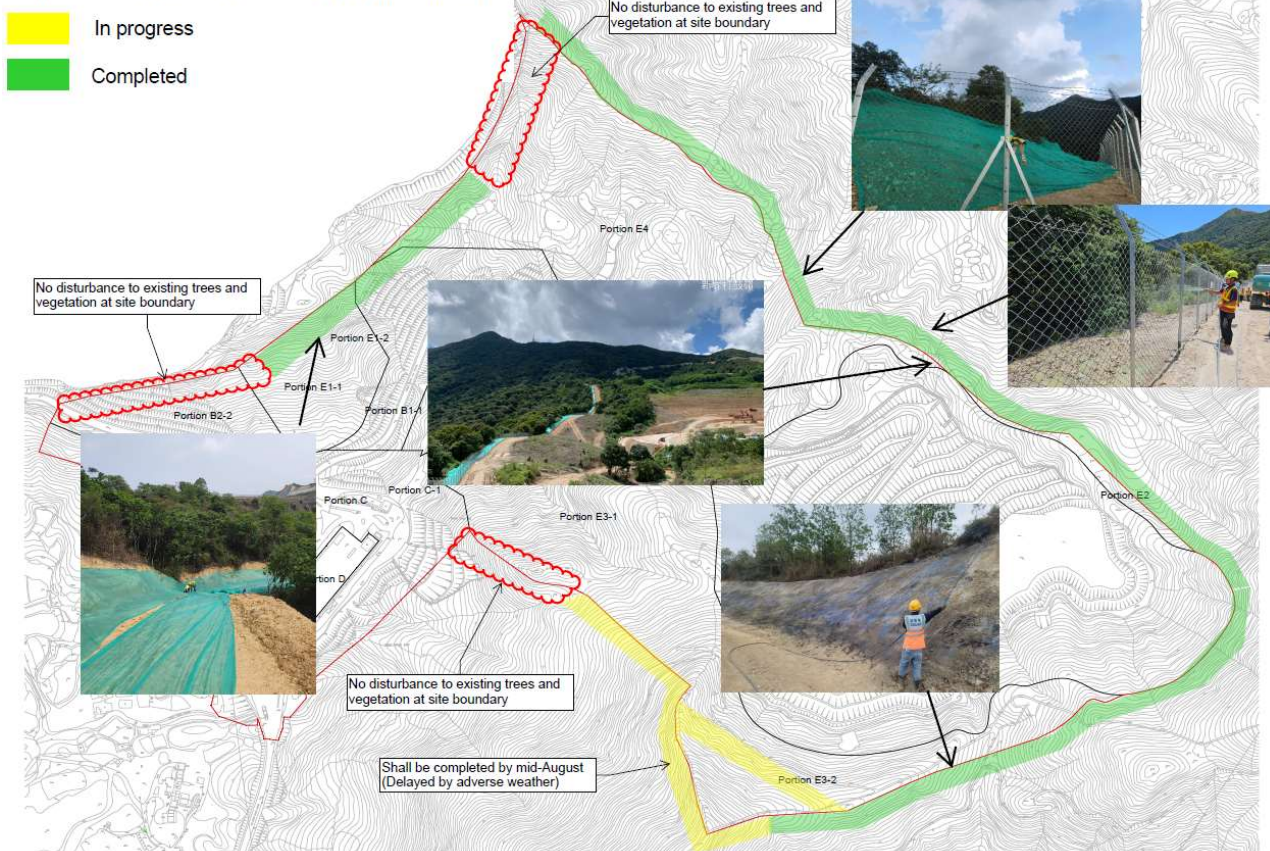
Slope protection layout (hydroseeding at site boundary)

5.2.1 Hydroseeding is conducted by the Contractor along the Project site boundary for the purpose of minimizing exposed slopes and is in progress. The below figure indicates the location and estimate time for hydroseeding.

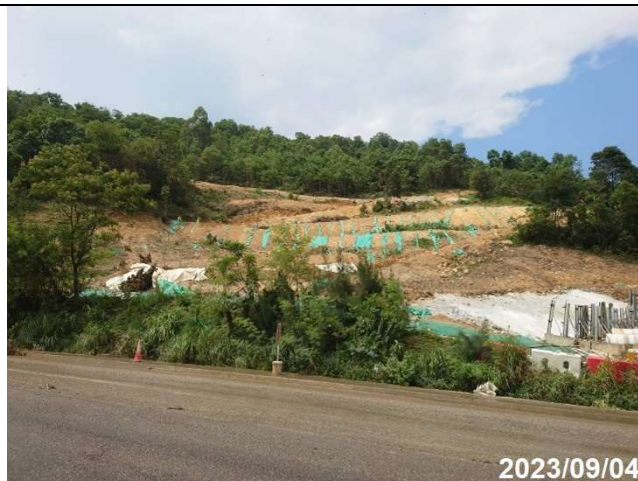
Photo 6-1 Observation 1

1. The exposed slope surfaces at Portion B2 were not covered by impervious sheets (See Photo 6-1).

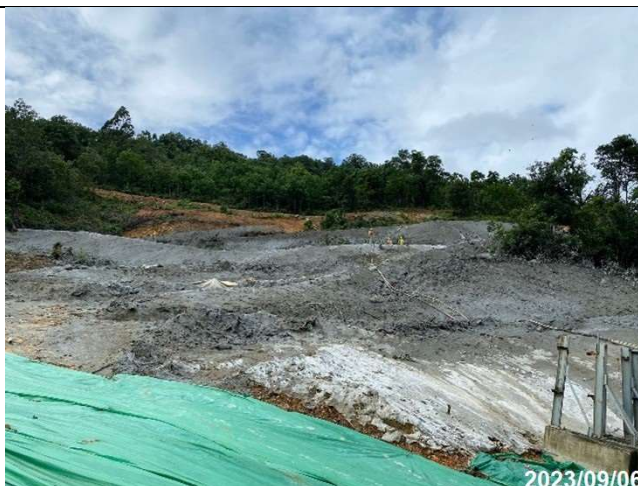
Photo 7-1 Slope Surface Protection at Portion B2

1. The slope surface protection was conducted by contractor at Portion B2 (See Photo 7-1).

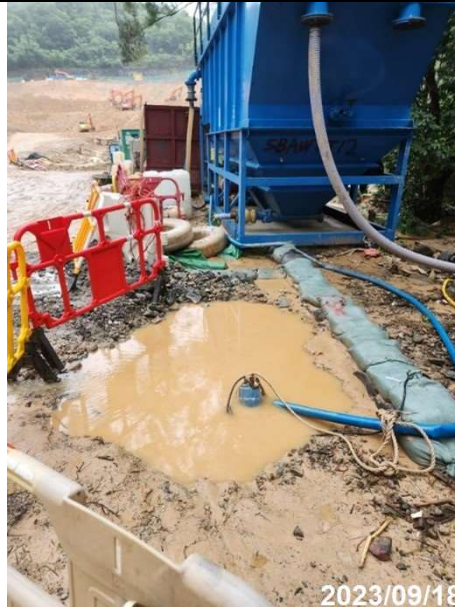
Photo 9-1 Rectified action for Observation 1

<p>9.1 The further actions taken by contractor are listed below:</p> <ol style="list-style-type: none"> 1. The Contractor used sandbag barriers to intercept surface runoff entering to the channel, constructed small sump pit to gather surface runoff and pumped out for wastewater treatment (See Photo 9-1).

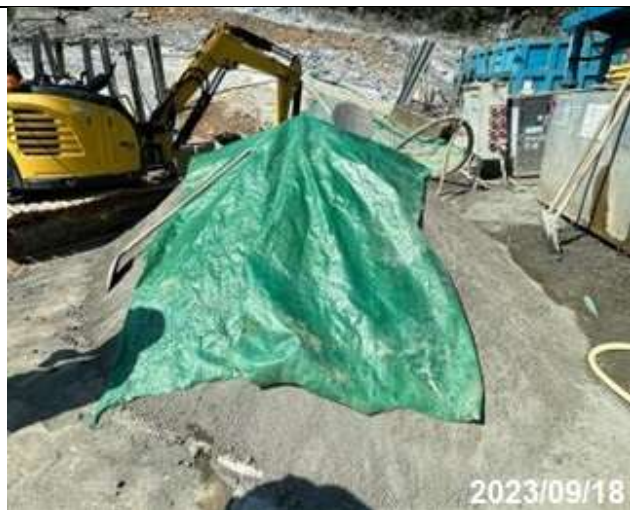
Photo 10-1 Observation 1

1. The dry PFA in Portion B2 should be covered entirely with impervious sheets.³ (See Photo 10-1).
2. The metal plate at the vehicle entrance in Portion B2 should cover unpaved road surface. (See Photo 10-2).
3. Sediment/ silt traps shall be incorporated in the temporary drainage system to enhance retention time for silt/s and traps of the silt removal facilities be 5 minutes under maximum flow conditions. (See Photo 10-3).
4. The main haul road in Portion E4 is dry and dusty (See Photo 10-4 to 10-5).

Photo 10-3 Observation 3	Photo 10-4 Observation 4
  <p>Taken by ET</p>	  <p>Taken by ET</p>
Photo 10-5 Observation 4	
  <p>Taken by ET</p>	
<p>10.2 The recommendation of corrective actions for the weekly site inspection on 18 September 2023 are listed below:</p> <ol style="list-style-type: none"> 1. The Contractor has been reminded to cover dry PFA entirely with impervious sheets. 2. Vehicle entrance should be paved with concrete, bituminous materials, hardcore or metal plates, and kept clear of dusty materials. 3. The Contractor has been advised to reconstruct the demolished sedimentation basin to act as silt trap and to achieve 5 minutes of retention time under maximum flow condition. 4. The Contractor has been advised to schedule watering and recommended to install water sprinklers or mist spray in long term.

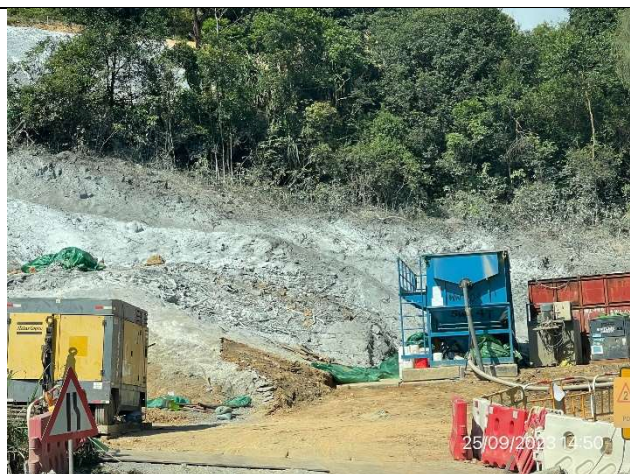
Photo 11-1 Rectified action for Observation 1

1. The dry PFA was removed by contractor (See Photo 11-1).
2. The dust control measure was conducted by contractor at Portion E3 & E4 (See Photo 11-2 to 11-3).

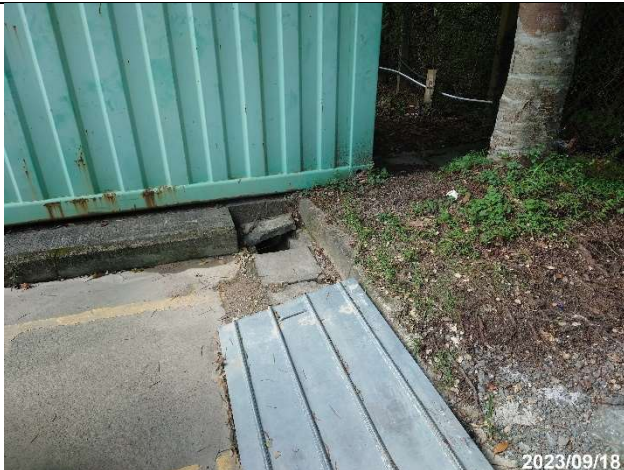
12.13 The branch of the existing channel was found near the gate of the assess road to WM2. The muddy water was not found at the branch of the existing channel near the car park (See Photo 12-16). To track the potential source of this branch, it can be found that there is one stormwater hole near the gate (runoff from the car park of NENT Landfill can flow directly to the branch of the existing channel (See Photo 12-16 & 12-17). The stormwater drain & water tank at the car park of NENT Landfill were found (See Photo 12-18 & 12-19). The potential sources of runoff at the branch included the runoff from the car park of NENT Landfill, the stormwater drain & water tank near the car park. Although the muddy water was not found under investigation, it cannot exclude the runoff flow to the existing channel under heavy rain (See Photo 12-20).

Photo 12-17 Stormwater hole near the gate (Runoff from Car park of NENT Landfill can be flowed directly to the existing channel)

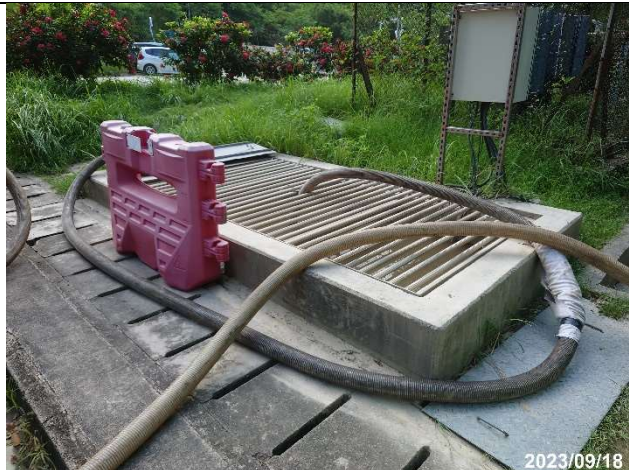
Photo 12-18 Stormwater drain at the Car park of NENT Landfill

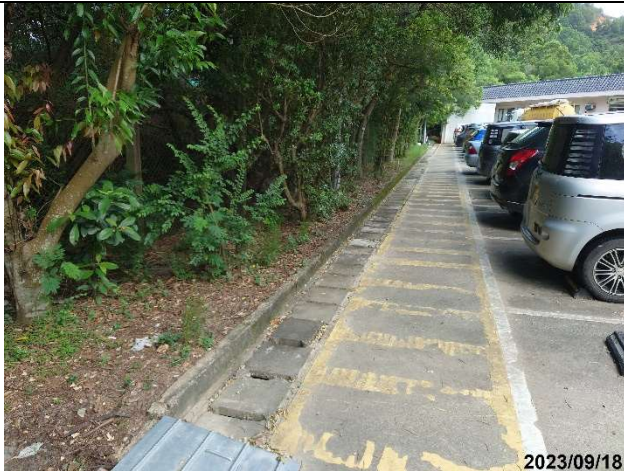
Photo 12-19 Another side of Car Park of NENT Landfill

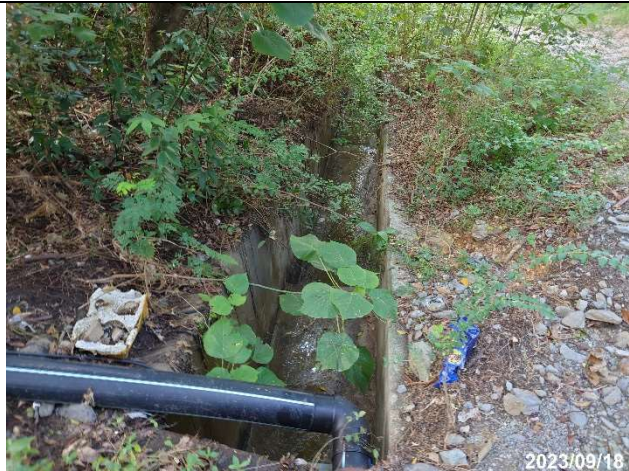
Photo 12-20 Existing Channel near the gate (Runoff from carpark flow to the channel.)

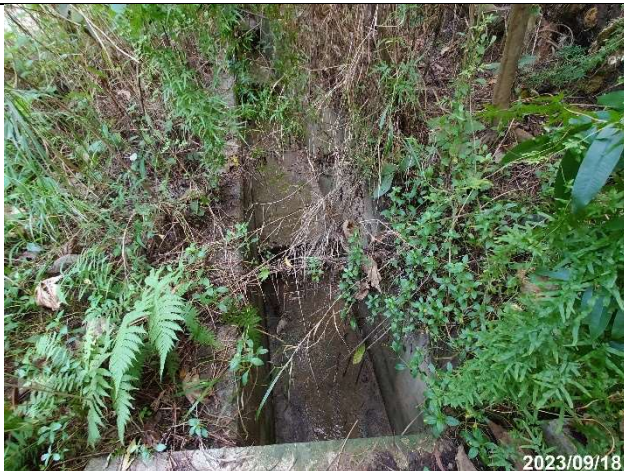
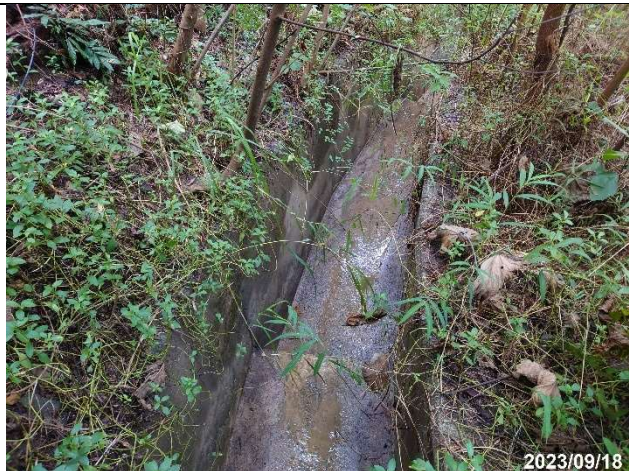
12.14 The colour of runoff at the existing channel near construction dust monitoring location AM3 is shown in Photo 12-21 to 12-22.

Photo 12-21 Existing channel (Runoff from carpark flow to the channel.)

Photo 12-22 Existing channel (Runoff from carpark flow to the channel.)

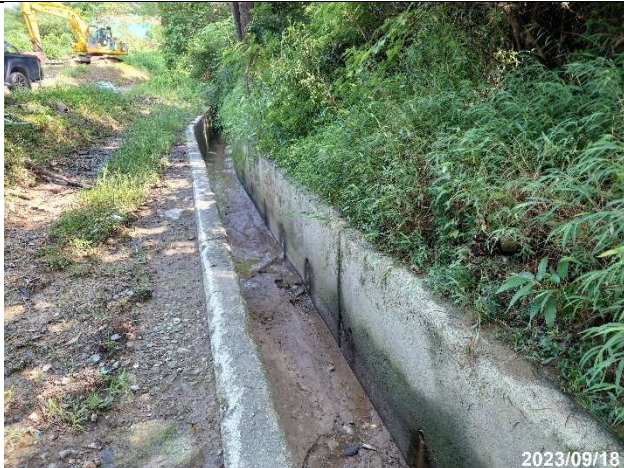
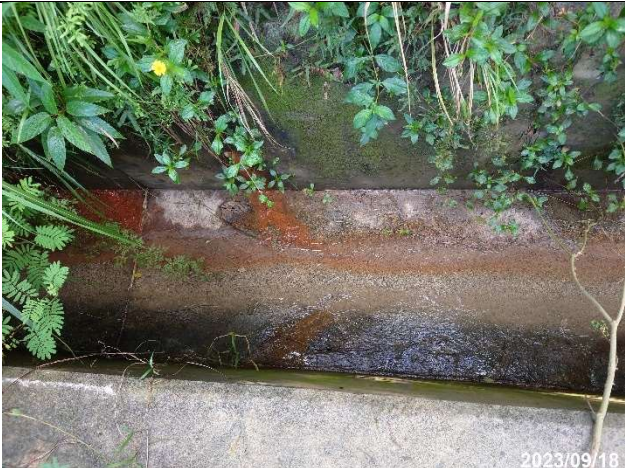
12.15 The photo record of existing channel (Runoff from Wo Keng Shan Road (Northing (m): 844511, Easting (m): 835655), Discharge water from the silt removal facilities at Portion A, other runoff from stormwater drain the car park flow to the channel, NENT Landfill Carpark, Water Tank & other stormwater drains) is shown in Photo 12-23 to 12-24.

<p>Photo 12-23 Existing channel (Runoff from carpark flow to the channel.)</p>	<p>Photo 12-24 Existing channel (Runoff from carpark flow to the channel.)</p>

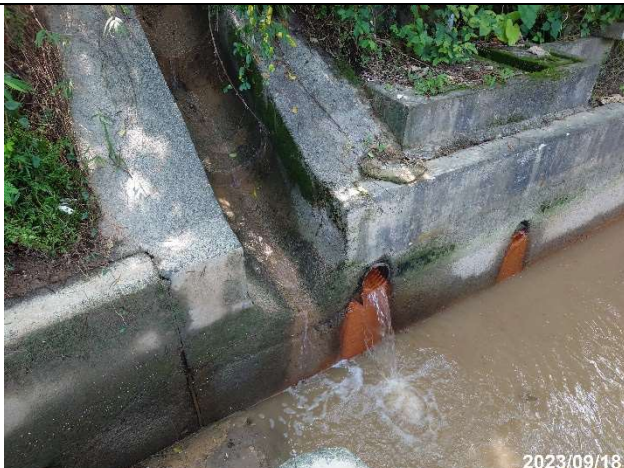
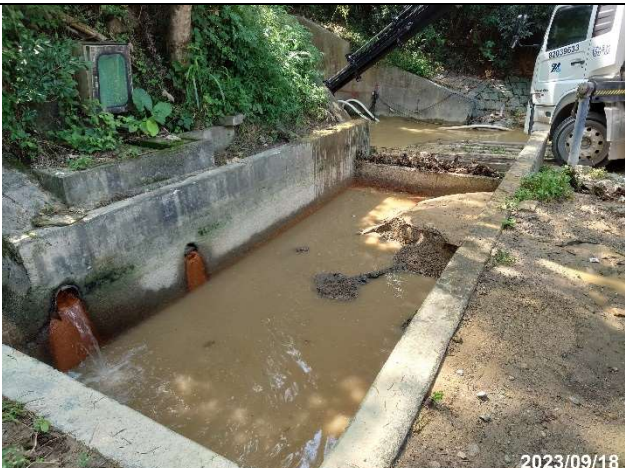
12.16 The outlet of the stormwater drain (runoff from Wo Keng Shan Road can flow directly to the existing channel) was found near the outlet of the branch of the existing channel from Portion A (See Photo 5-25 to 5-26. The water quality of runoff at the outlet of the branch of the existing channel from Portion A was clean.

<p>Taken by ET</p>
<p>Photo 12-25 Outlet of Stormwater Drain (Runoff from Wo Keng Shan Road can be flowed directly to the existing channel)</p>	<p>Photo 12-26 Exit of Existing Channel from Portion A (Runoff from Wo Keng Shan Road flow to the channel.)</p>

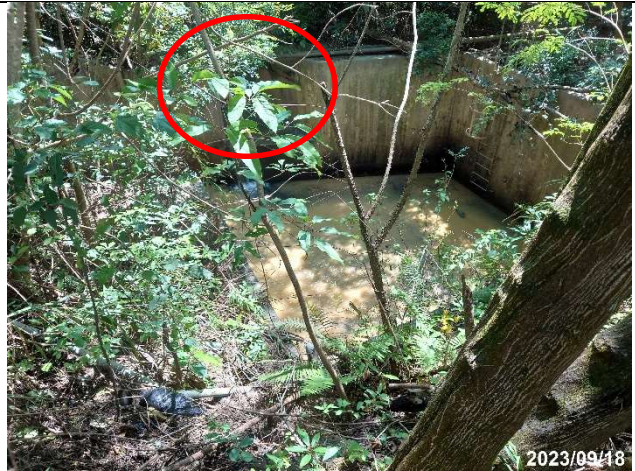
Photo 12-28 Existing Channel near Portion C

<p>Taken by ET</p>
<p>Existing Channel near Portion C, Outlet of Box Culvert under Portion C & Inlet of Box Culvert under Wo Keng Shan Road</p>	
<p>12.19 The photo record of the investigation for the Outlet of the Box Culvert under Portion C & the inlet of the Box Culvert under Wo Keng Shan Road is presented from Photo 12-27 to 12-32.</p> <p>12.20 According to the investigation, the muddy water was found at the existing channel near Portion C (Inlet of the Box Culvert under Wo Keng Shan Road & Outlet of the Box Culvert under Portion C) (See Photo 12-27, 12-28 & 12-30).</p> <p>12.21 It can be observed that a high amount of muddy water came from the outlet of the Box Culvert under Portion C (See Photo 12-31).</p> <p><u>Under Heavy Rain: Potential Source 4 – Branch of Natural Stream near Wo Keng Shan and;</u> <u>Under Heavy Rain: Potential Source 5 – Branch of stormwater drain near the boundary of NENT Landfill</u></p> <p>12.22 In addition, the branches of the natural stream from Wo Keng Shan (See Photo 12-29, Outlet see Photo 12-28) & branch of stormwater drain near the boundary of NENT Landfill (See Photo 12-32, Outlet see Photo 12-30) were found under investigation. But it can be viewed that the water quality of the branch of the natural stream from Wo Keng Shan was clear while there is not any runoff that came from the branch of the stormwater drain near the boundary of NENT Landfill. Although the muddy water was not found under investigation, it cannot be excluded that the muddy water may come from two branches under heavy rain.</p>

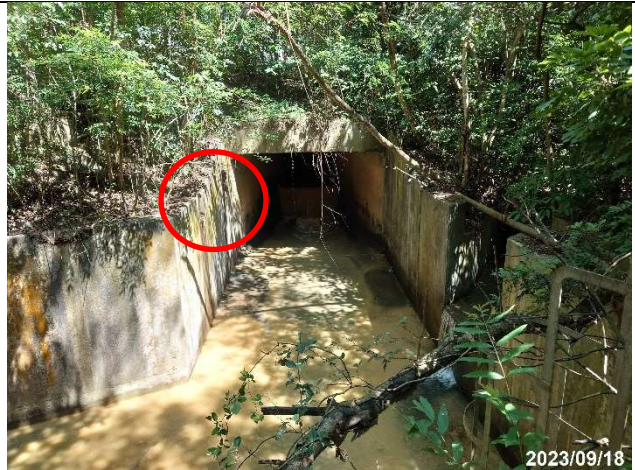
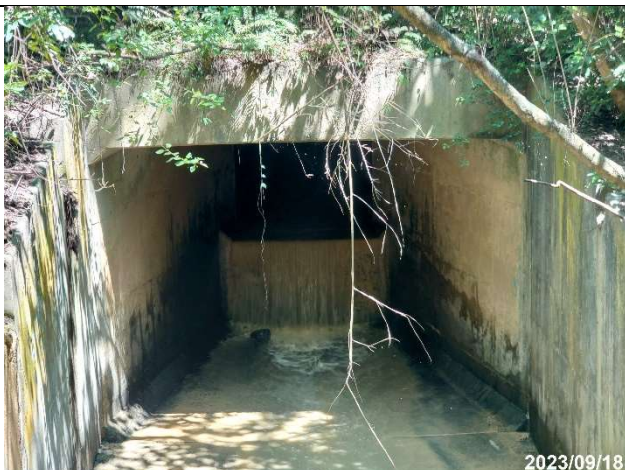
Photo 12-30 Outlet of Box Culvert under Portion C

Photo 12-31 Outlet of Box Culvert under Portion C

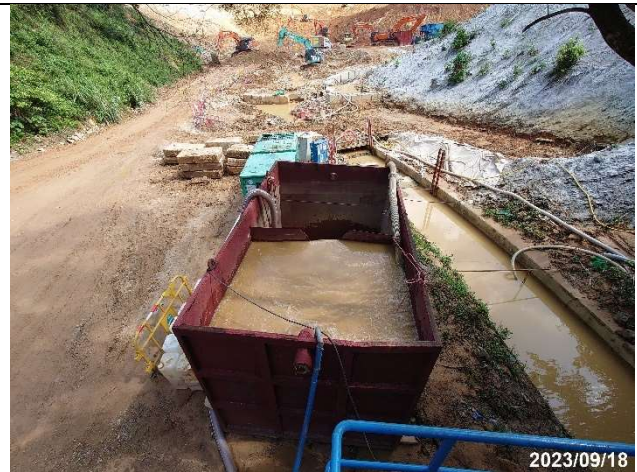
Photo 12-36 Sedimentation Tank at Portion E3-1

12.24 According to the investigation, the sedimentation basins with Geotextile & rock bunds were broken during extreme weather from 8 to 9 September 2023. The repair of sedimentation basins & rock bunds was conducted by the contractor (See Photo 12-33 to 12-35). It was viewed that the retention time for silts and sediment traps was not enough for silt and sediment deposition (See Photo 12-33 to 12-34).

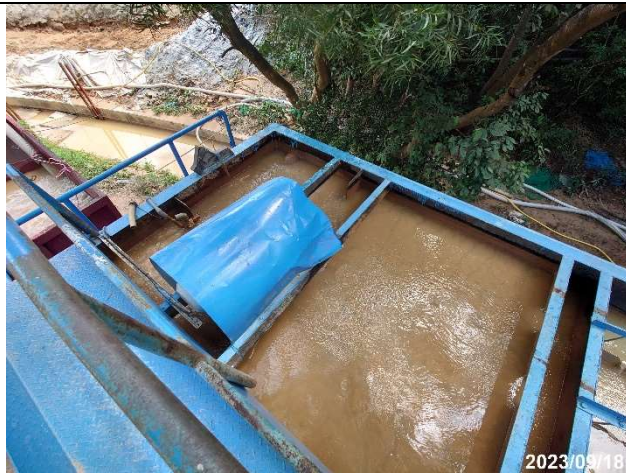
Photo 12-37 Silt Removal Facility at Portion E3-1

12.26 According to the observation of the silt removal facilities at Portion E3-1, one of the silt removal facilities was broken during the extreme weather from 8 to 9 September 2023. The silt removal facility was repaired by the contractor under investigation. The Contractor has been advised to repair the sedimentation basins, rock bunds & silt removal facilities at Portion E3-1 as soon as possible. Moreover, the Contractor has been recommended to review the design of silt removal facilities whether following the guidelines in Appendix A1 of ProPECC PN 1/94, which states that the retention time for silts and sediments traps should be 5 minutes under maximum flow conditions.

12.27 Another silt removal facility at Portion E3-1 was functional. After the check of another silt removal facility at Portion E3-1, it was observed that the muddy water was kept to discharge to the existing channel after being treated by the facility (See Photo 12-41). The condition of the silt removal facility at Portion E3-1 is shown in Photo 12-36 to 12-39). It reflected that the silt removal facilities at Portion E3-1 may involve non-compliance with the requirement of the WPCO Licenses. The Contractor has been recommended to review the capacity of silt removal facilities and sedimentation basins enough to handle the construction runoff under heavy rain to avoid the construction runoff discharge into the existing channel.

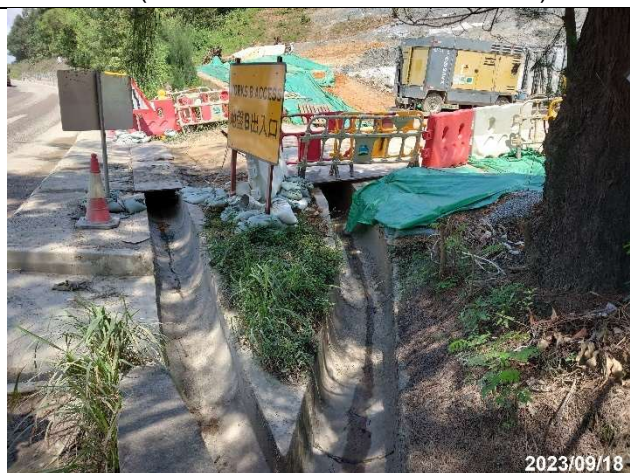
Photo 12-49 Branch of Existing Channel near Portion B2 (Face to Manhole near Portion B2)

12.37 According to the investigation, It can observed there are two branches of Existing Channel near Portion B2 (Face to the Entrance of Portion B2) which one collected the runoff from Wo Keng Shan Road and another one collected from upstream point near Northing (m): 844586, Easting (m): 835427 (See Photo 12-49 to 12-50). Although the muddy water was not found under investigation, it cannot exclude the muddy water may be came from two branches under heavy rain.

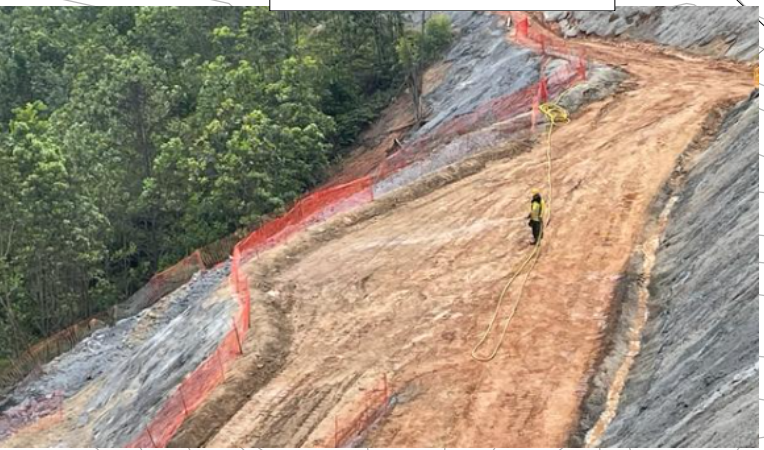
Installed sprinkler along main entrance haul road
