# **North East New Territories (NENT) Landfill Extension**

Monthly Environmental  
Monitoring and Audit Report  
(No. 30) – May 2025

2025-06-13

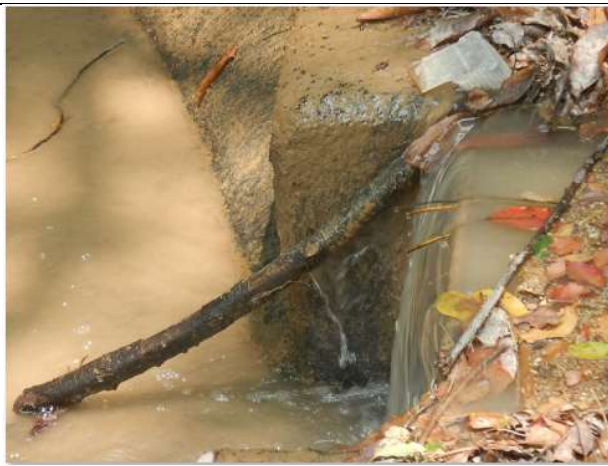
Photo 1-2 EPD Monitoring Location GR3

- 1.3 The location of **Photo 1-1** & **Photo 1-2** are at the Ping Yuen River near the roundabout on Heung Yuen Wai Highway (Ping Yuen Tsuen). **Photo 1-3** presents the water sample on 7 April 2025 at EPD Monitoring Location GR3. The detailed layout, including the complaint location, Surface Water Monitoring Location WM2 and related natural stream is presented in **Figure 1**.

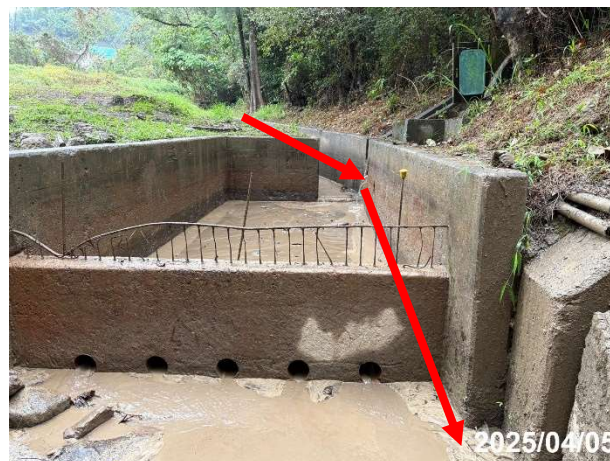
**Photo 3-2 Branch of Existing Channel near Portion A**

3.4 **Photo 3-2** showed that the colour of surface runoff at the Branch of the Existing Channel near Portion A appeared brown colour on that day. **Photo 3-3** showed that the colour of surface runoff at the river confluence position between the Box Culvert under Wo Keng Shan

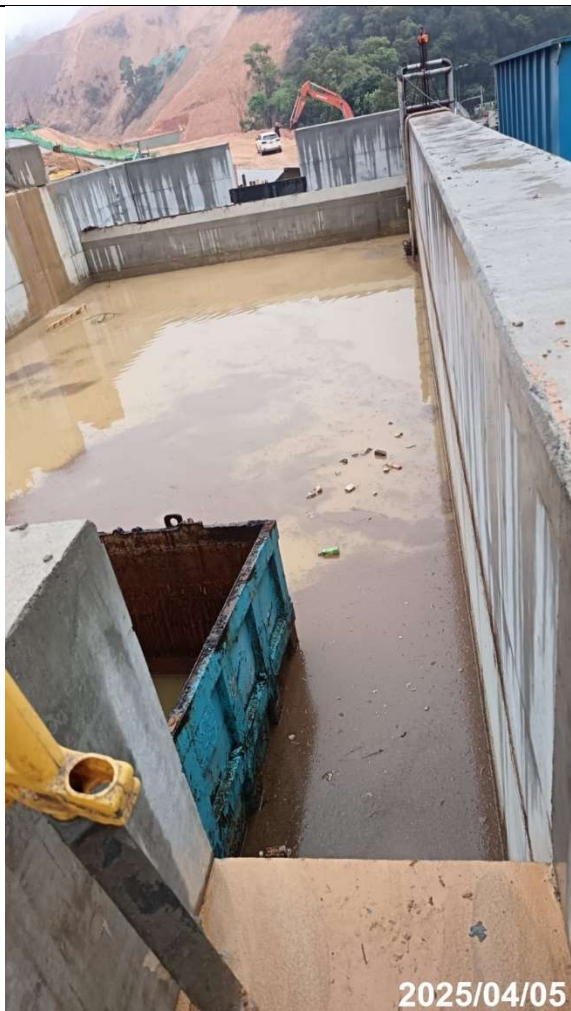
**Photo 3-4 Sedimentation Basin at Portion B2/E1**

3.6 The removal of deposited silt and grit from the existing catchpit and the maintenance of sedimentation basin and silt removal facilities were conducted by the contractor when before the rainstorm. **Photos 3-4 to 3-13** showed no overflow of the sedimentation basins, tanks and clear discharged water discharged into the designated point from 5 to 7 April 2025.

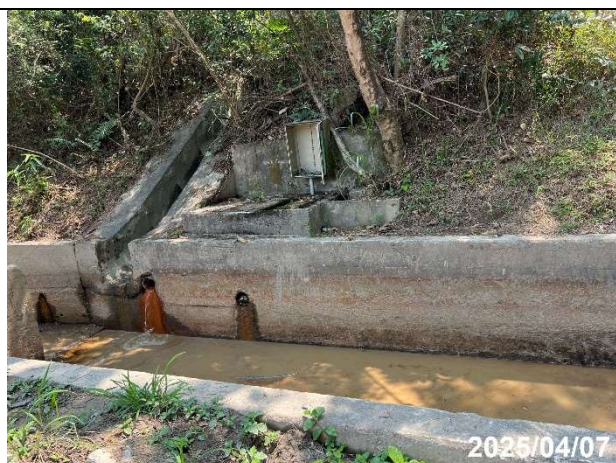
**Photo 3-15 Branch of Existing Channel near Portion A**

3.8 **Photos 3-15 to 3-16** showed that the colour of surface runoff at the Branch of the Existing Channel near Portion A & the river confluence position between the Box Culvert under Wo Keng Shan Road and the Branch of the Existing Channel near Portion A appeared brown colour on 7 April 2025.

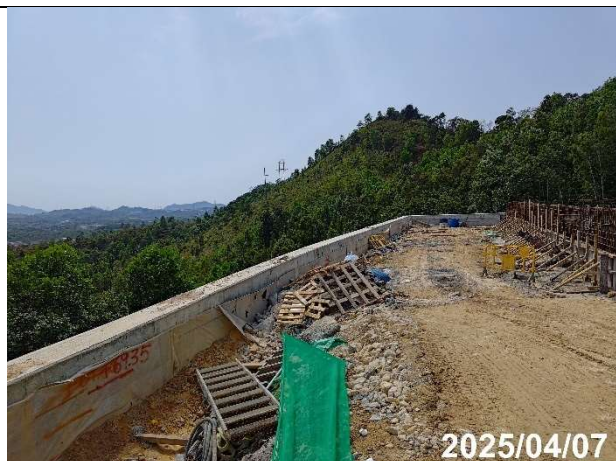
**Photo 6-1 Site boundary of Portion A**

835332 and the entrance of Shek Tsai Ha Road. In conclusion, no deficiency regarding the control of construction runoff was observed during the weekly site inspection.

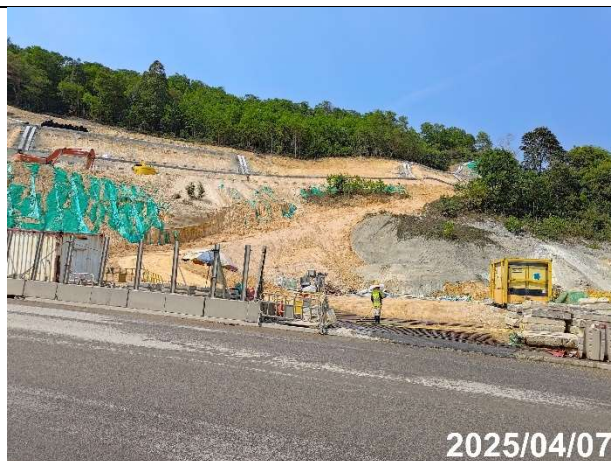
**Photo 6-2 Wo Keng Shan Road between Northing (m): 844604, Easting (m): 835332 and the entrance of Shek Tsai Ha Road**

- 6.1 A joint weekly site inspection was carried out with ER, IC, Contractor and ET on 7 April 2025. No construction runoff flowed into Ping Yuen River directly were found during the weekly site inspection. The detailed photo records are presented in **Photos 6-1 to 6-3**. **Photo 6-1** showed the low elevation of site boundary of Portion A are fully surrounded by the retaining wall. The retaining wall can avoid the untreated construction runoff did not flow outside site boundary. **Photos 6-2 and 6-3** viewed that there was no construction runoff from the NENTX project flowed into the Wo Keng Shan Road between Northing (m): 844604, Easting (m):

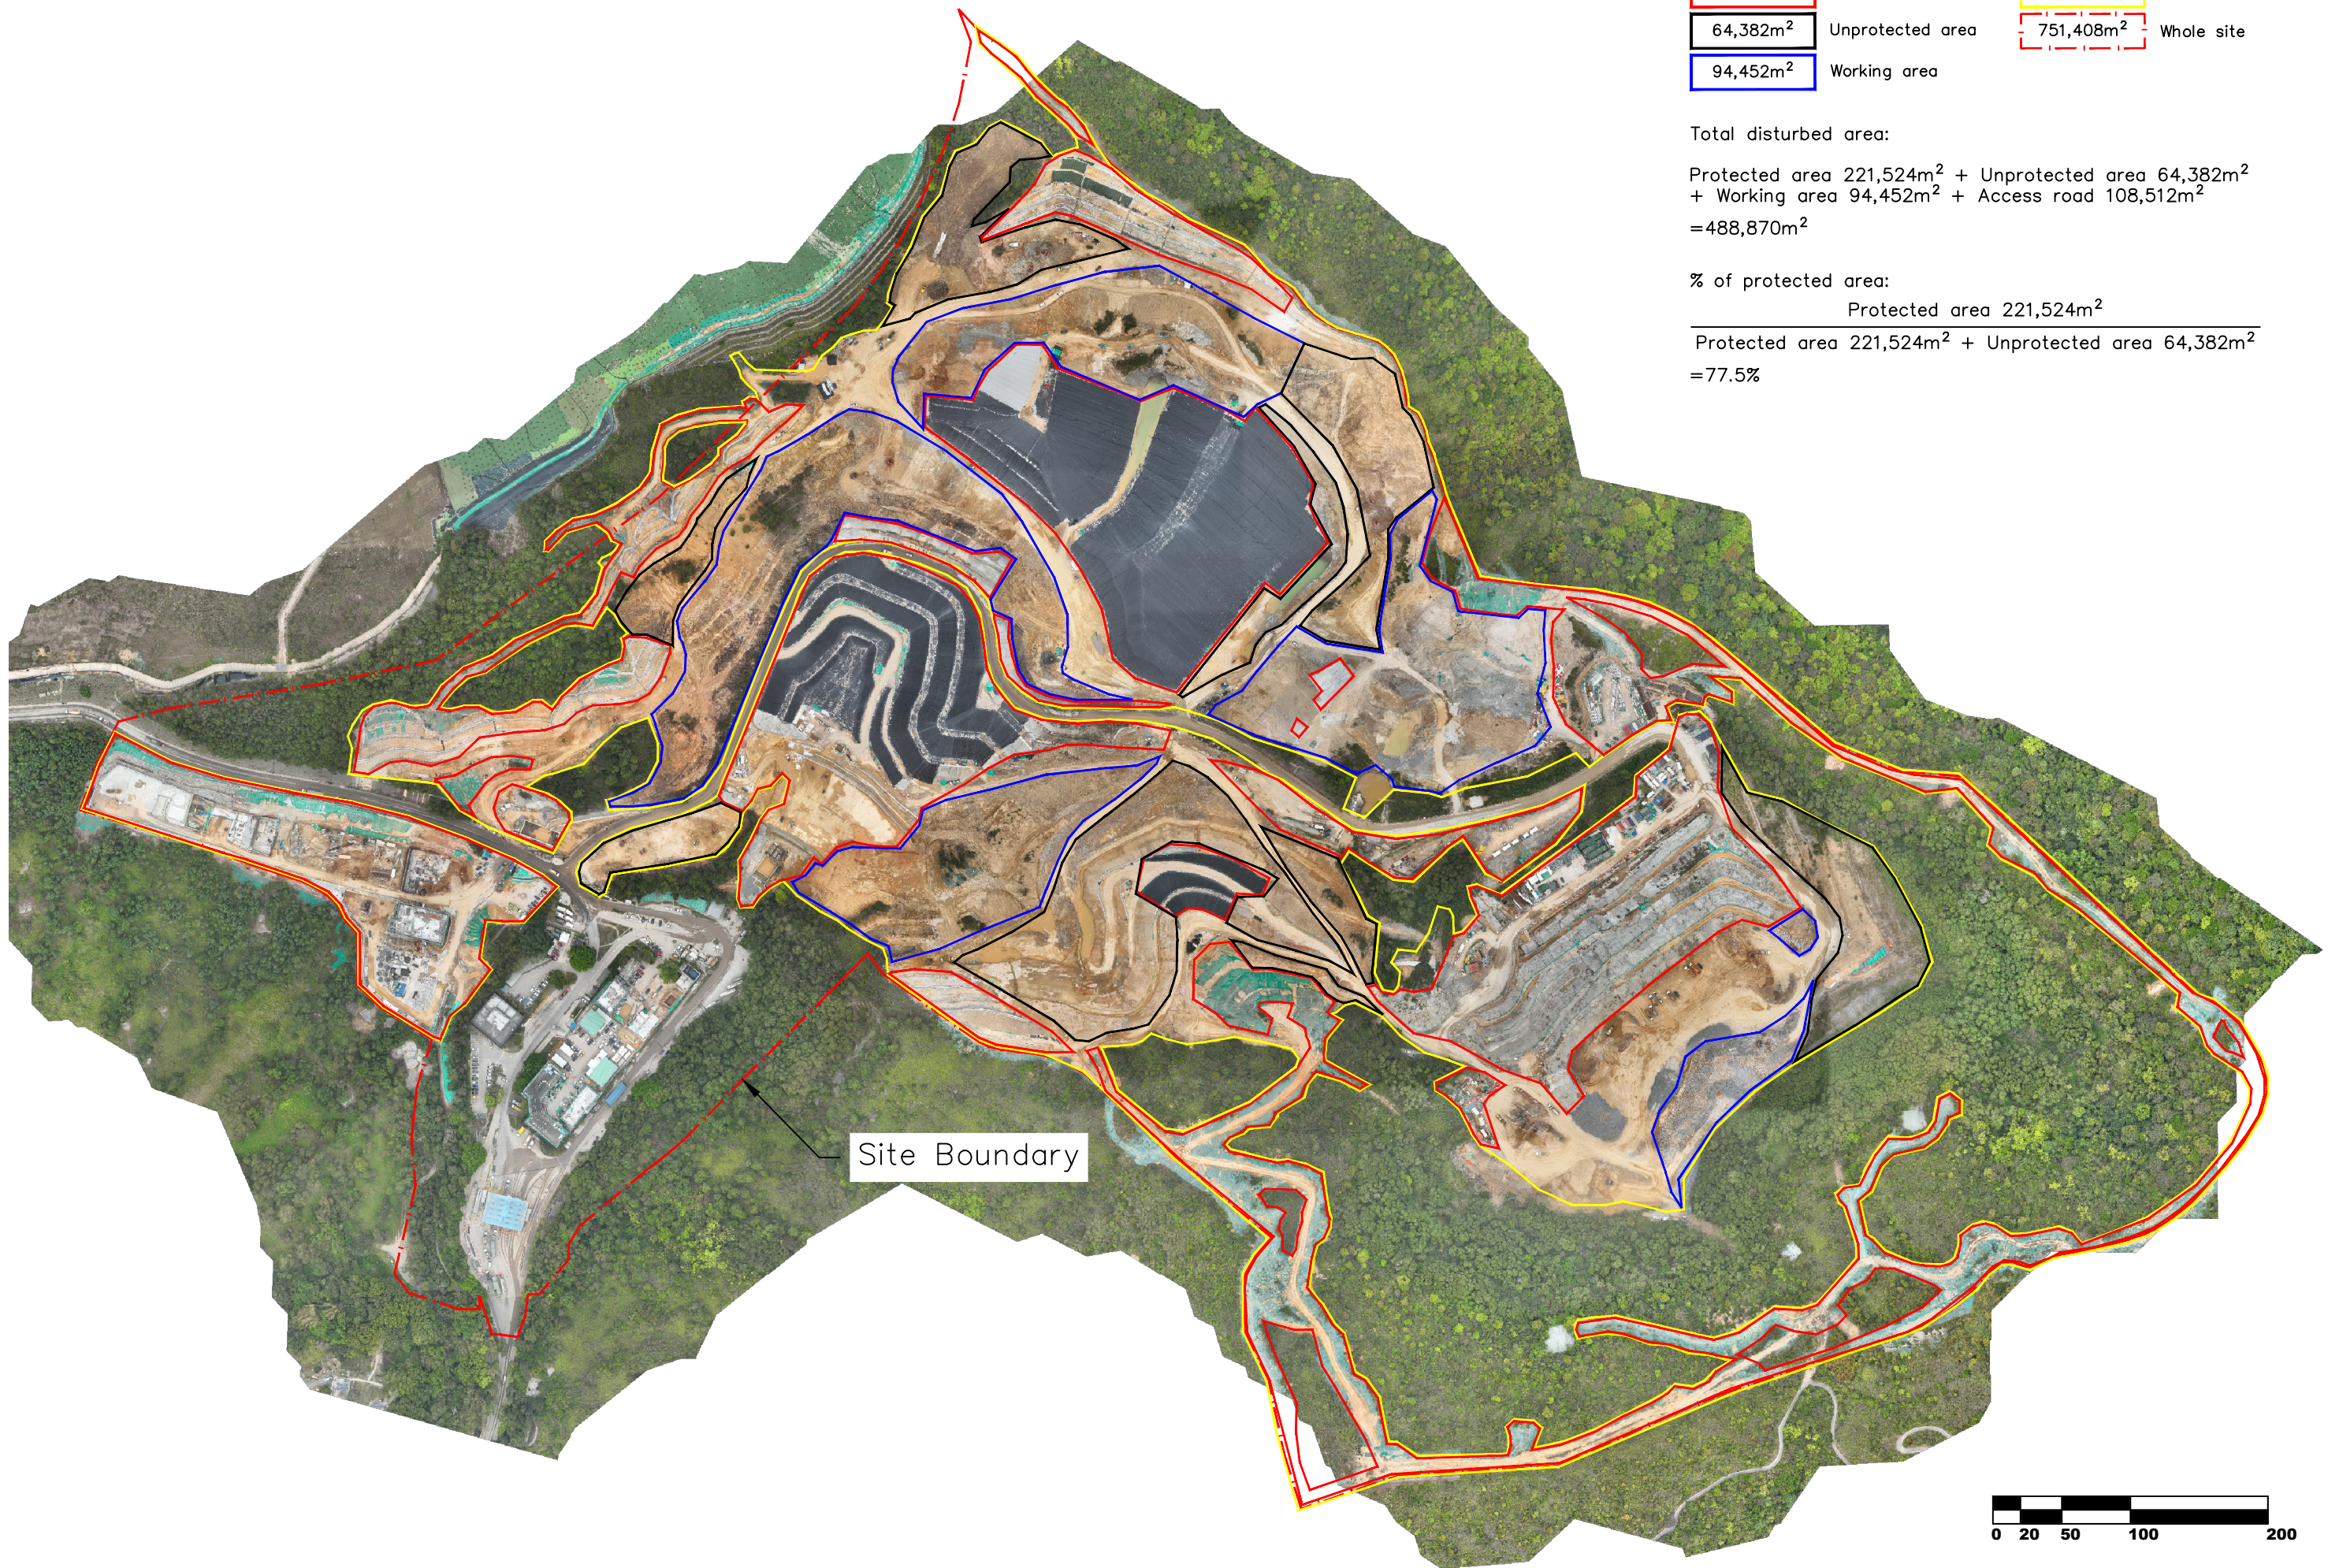
### **Layout of Protected Area**

| 221,524m <sup>2</sup> | Protected area | 108,512m <sup>2</sup> | Access Road |
| 64,382m <sup>2</sup> | Unprotected area | 751,408m <sup>2</sup> | Whole site |

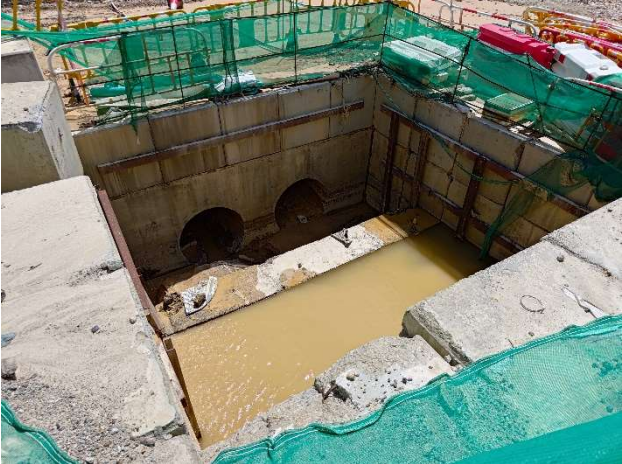
| Sedimentation Basin at Portion E3-1 | Retaining Wall at Portion E3-1 |

1. Accumulated silt was found at the sedimentation basin of Portion E3-1. The Contractor was recommended to clean up the accumulated silt at the sedimentation basin regularly.
2. Waste and standing water were found at the U-channel of Portion A. The Contractor was advised to remove the waste and direct the standing water into silt removal facilities for treatment.
