# Ocean Park Master Redevelopment Project

## Monthly Environmental Monitoring & Audit Report – July 2007

**EP-249/2006/A – Condition 3.4**

**Monthly EM&A Report – July 2007**

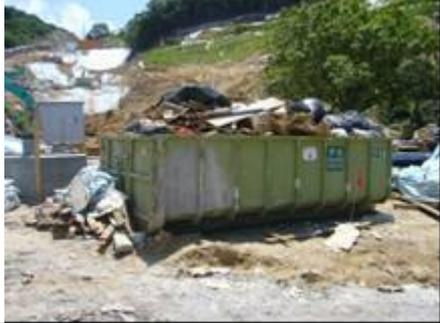
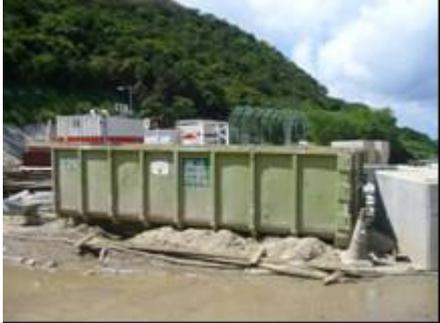
<p><b>P1030112: Waste skip was full and construction waste was accumulated around the skip. Waste shall be removed from the site more frequently.</b></p>	<p><b>Closed – P1030398: Construction waste accumulating around the waste skip was no longer observed.</b></p>

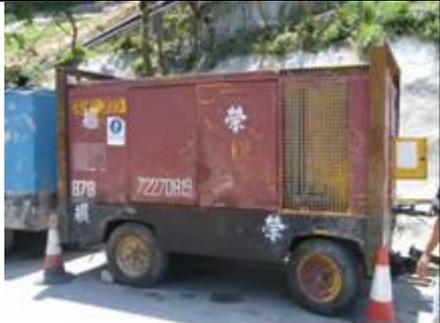
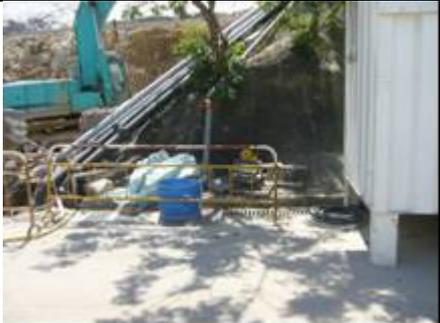
<p><b>P1030111 &amp; P1030114: Noise emission labels were not attached to two air compressors which were in operation.</b></p>	<p><b>Closed – P1030396: The two air compressors were not observed in operation during the site inspection.</b></p>

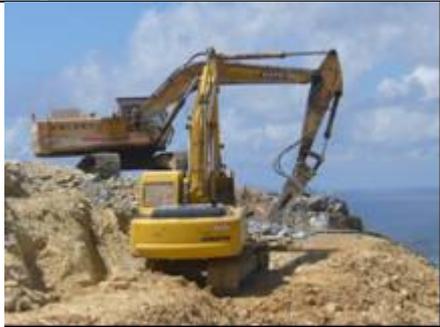
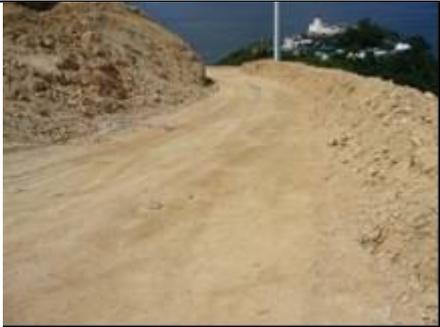
<p style="color: red;">P1030392: Dust was observed generated from rock breaking activity. Water spray shall be provided during rock breaking activities to suppress dust.</p>	<p style="color: red;">P1030391: Haul roads were dry and dusty. Water spray shall be provided to suppress dust.</p>

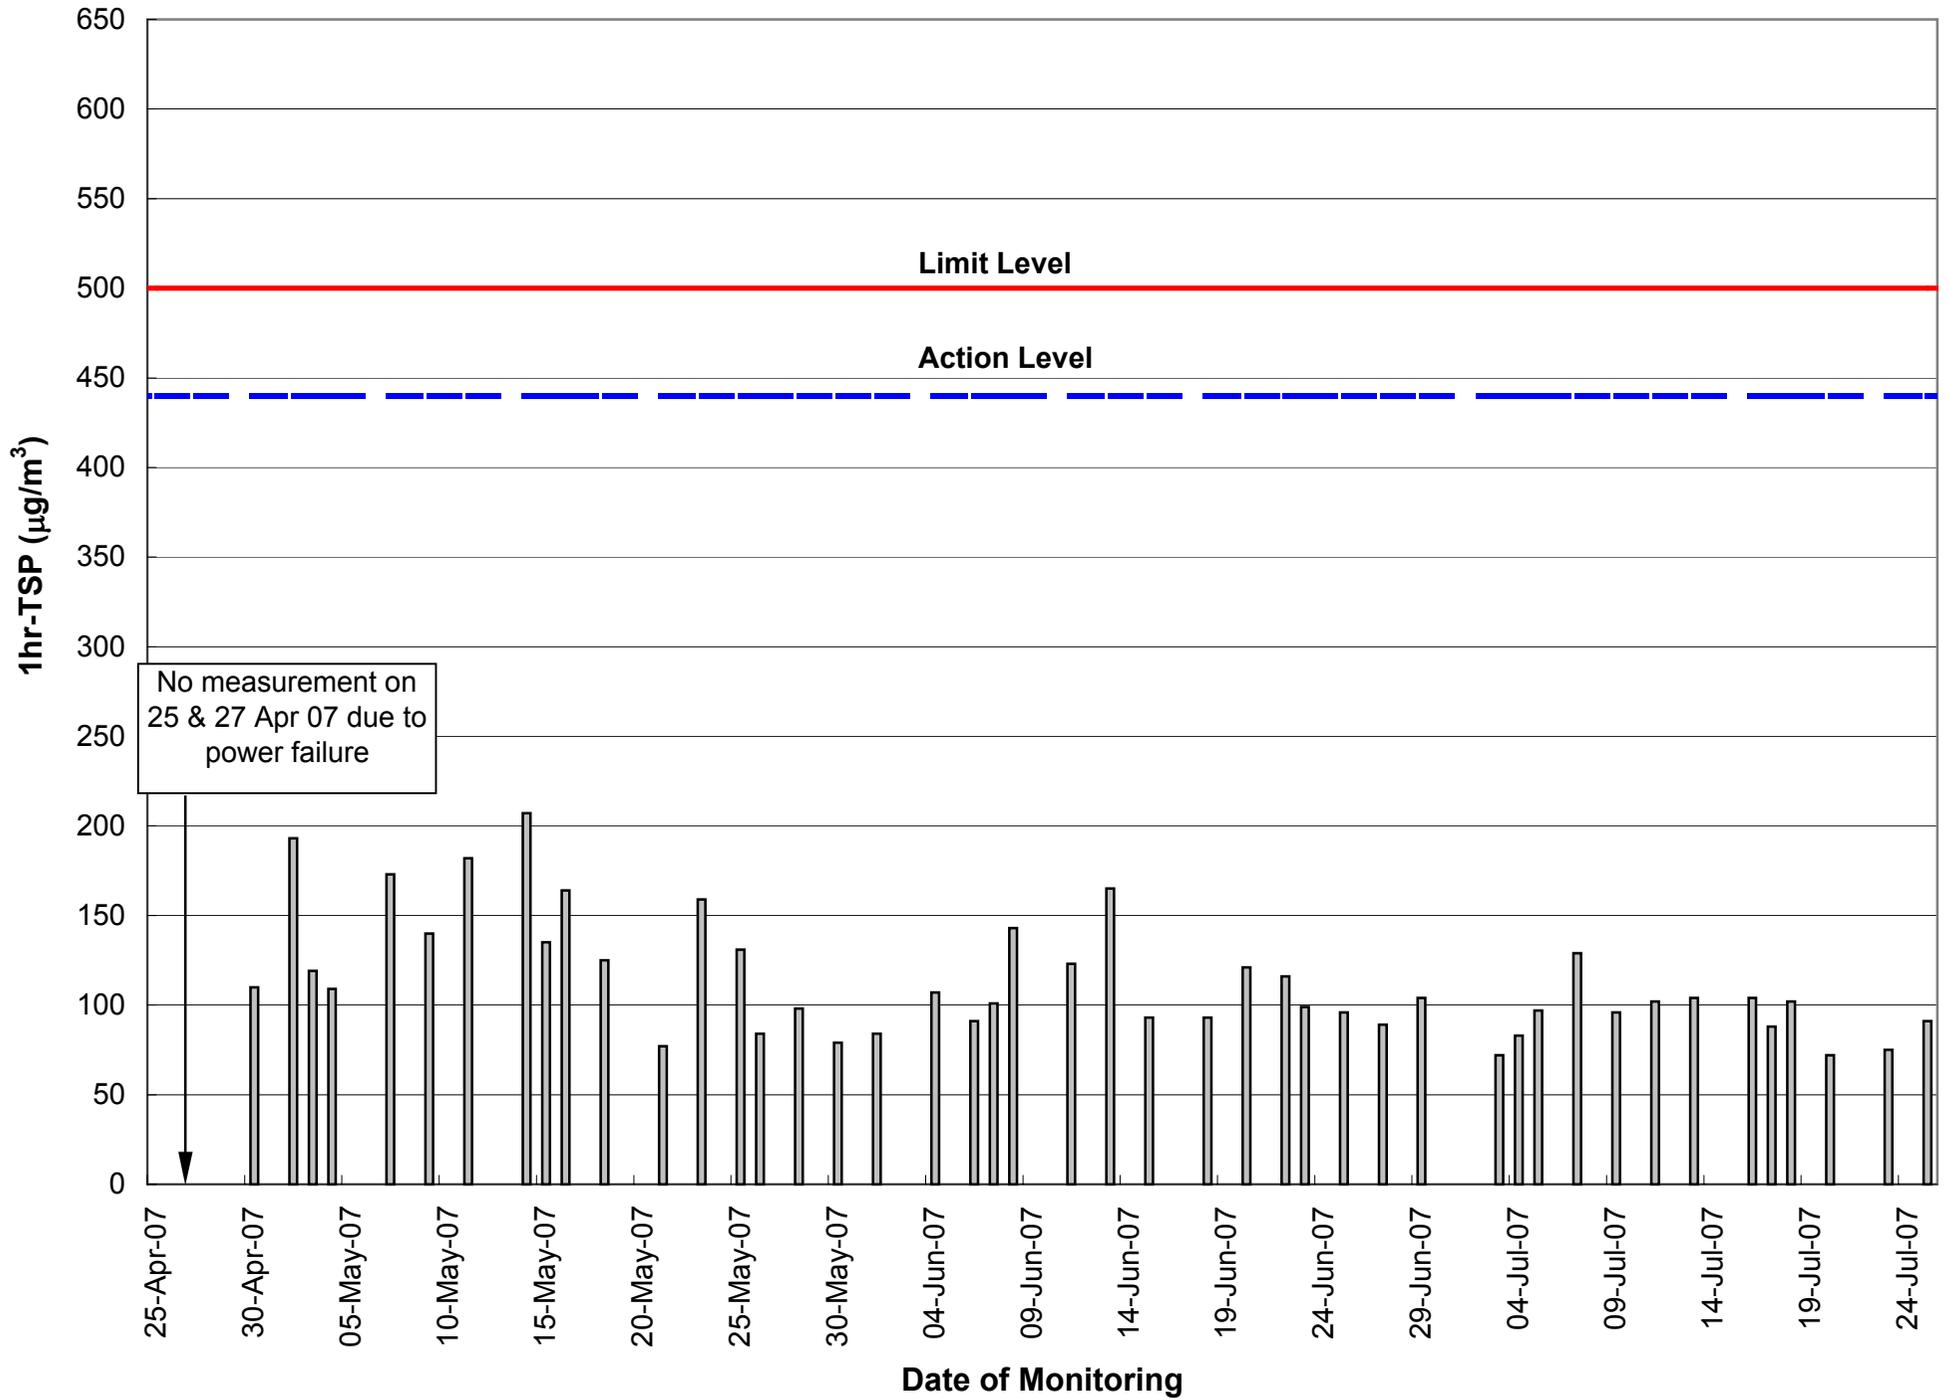
Figure C.1 1-hr TSP monitoring results of Monitoring Station AM1

- 2.7 The air quality monitoring results of 1-hr TSP and 24-hr TSP of the reporting month are summarized in Tables 2.4 and 2.5. All monitoring data and graphical presentation of the monitoring results are provided in Appendix C. No 1-hr TSP measurements have been conducted on 22 & 23 June 2007 and no 24-hr TSP measurement taken on 23 June 2007 at AM3 due to power supply failure.
- 2.8 All measured 1-hour & 24-hour TSP concentrations were below the Action and Limit (AL) Levels in the reporting month.

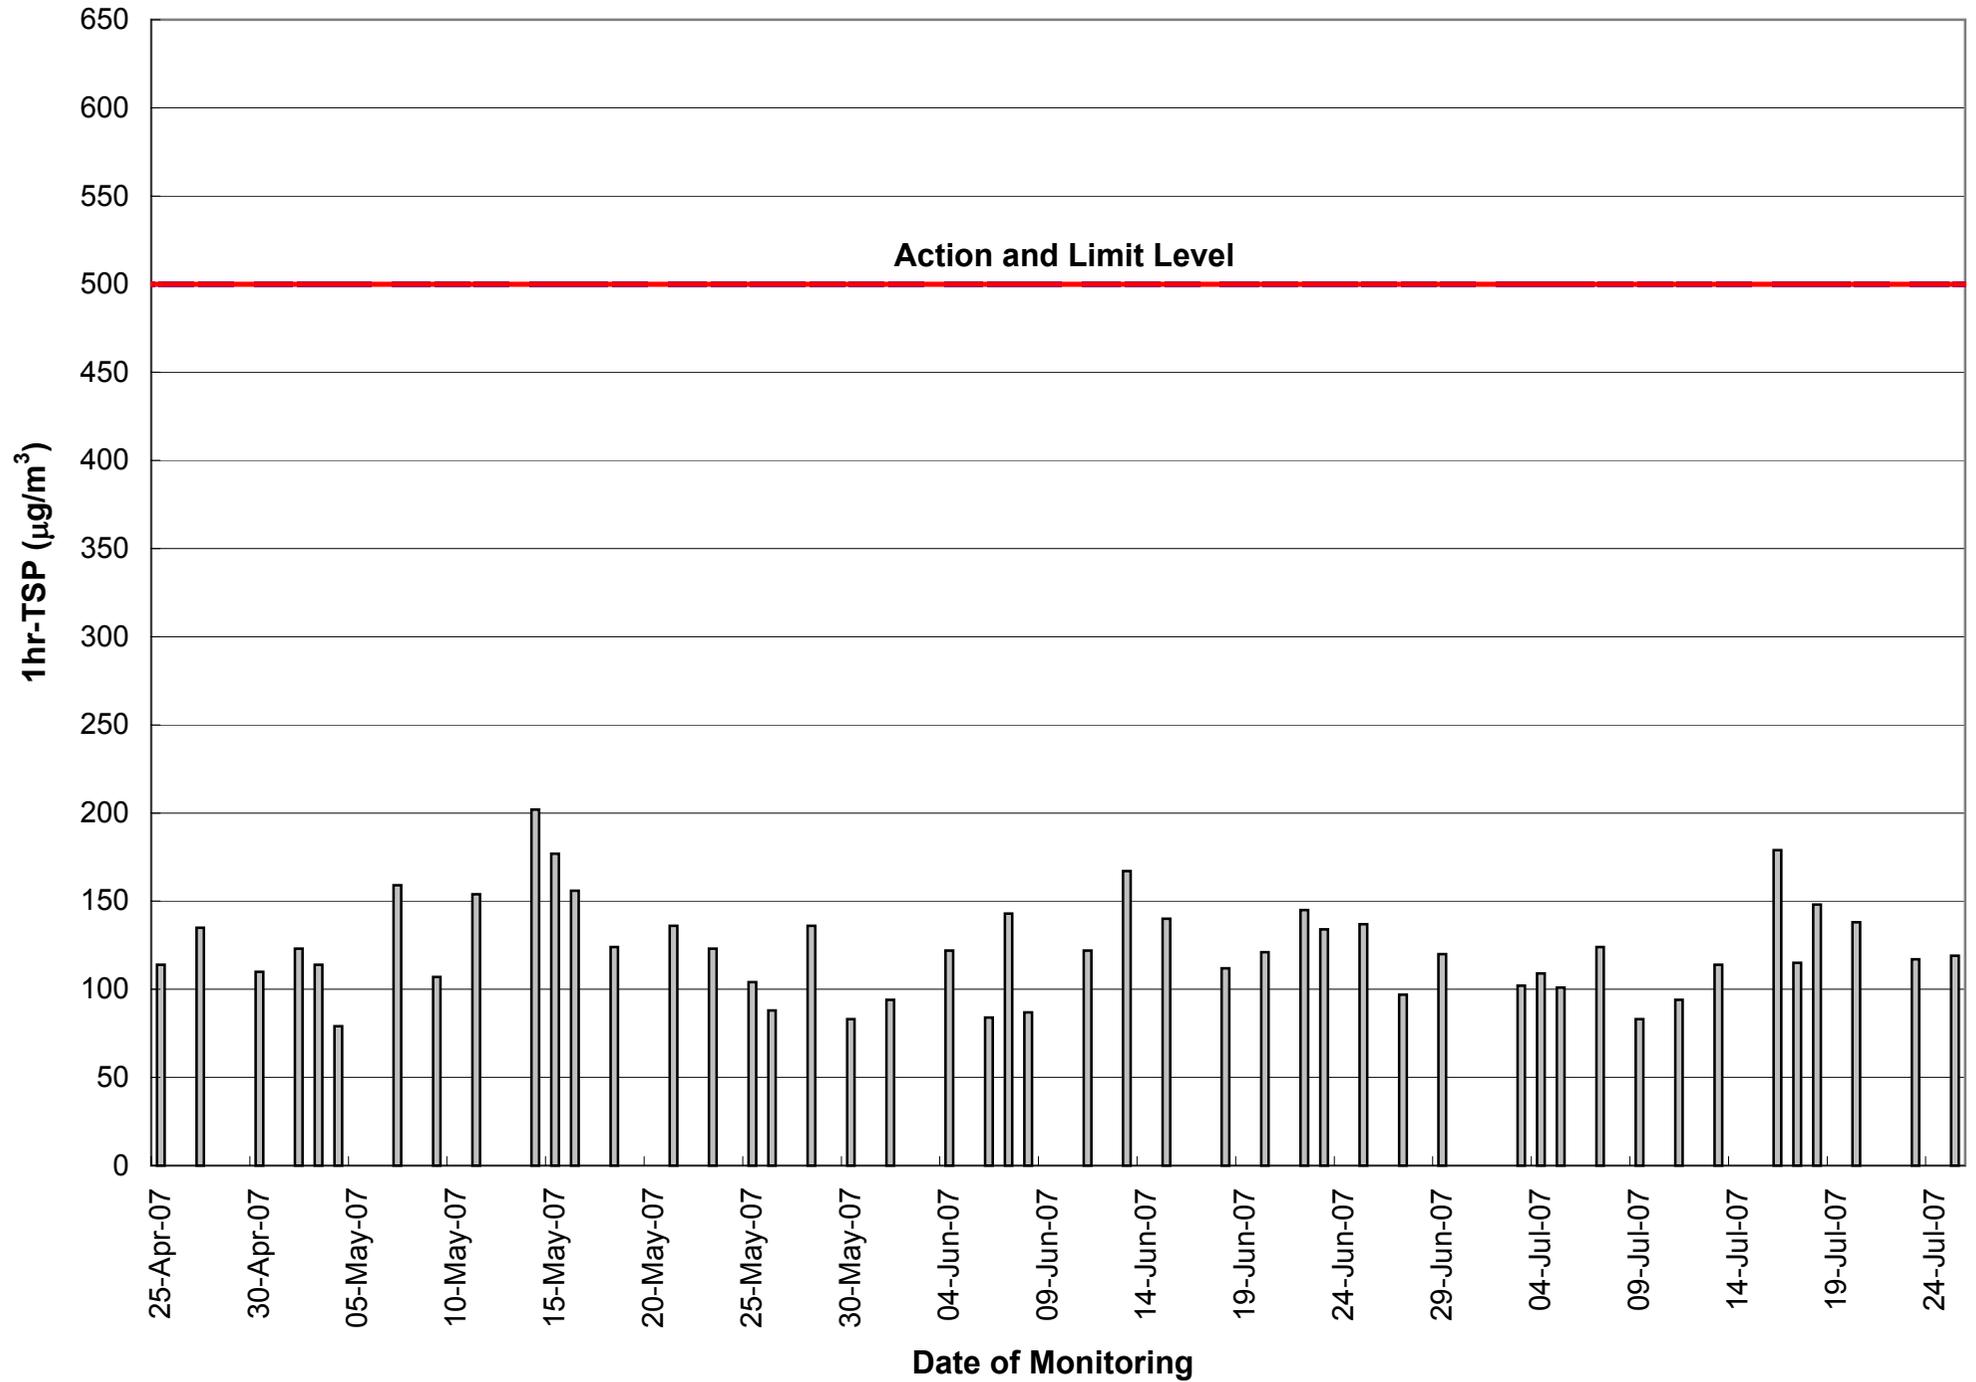
Figure C.2 1-hr TSP monitoring results of Monitoring Station AM2

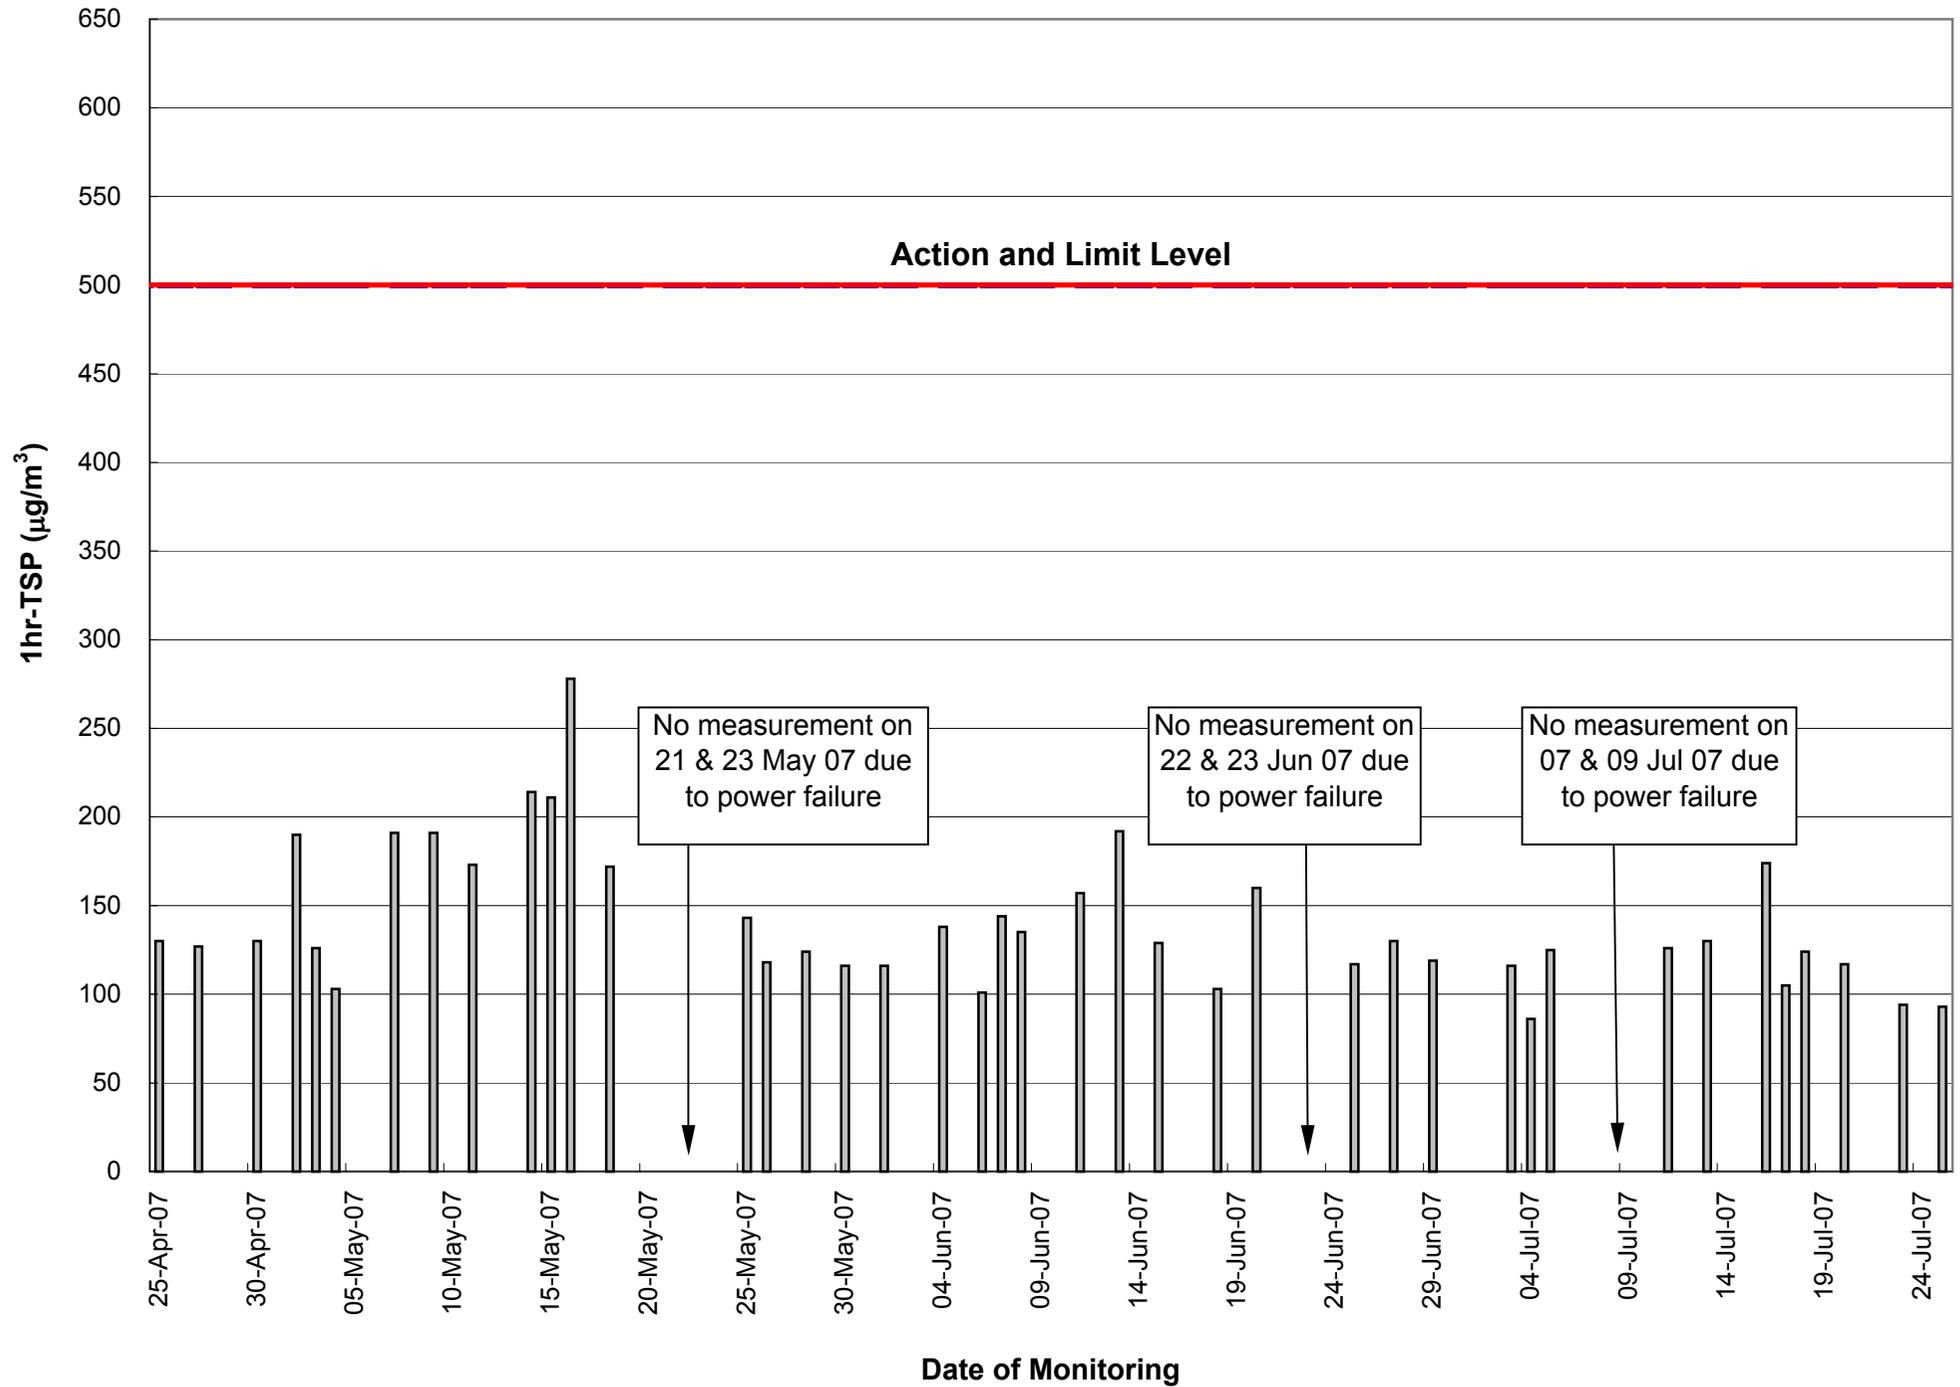
Figure C.3 1-hr TSP monitoring results of Monitoring Station AM3

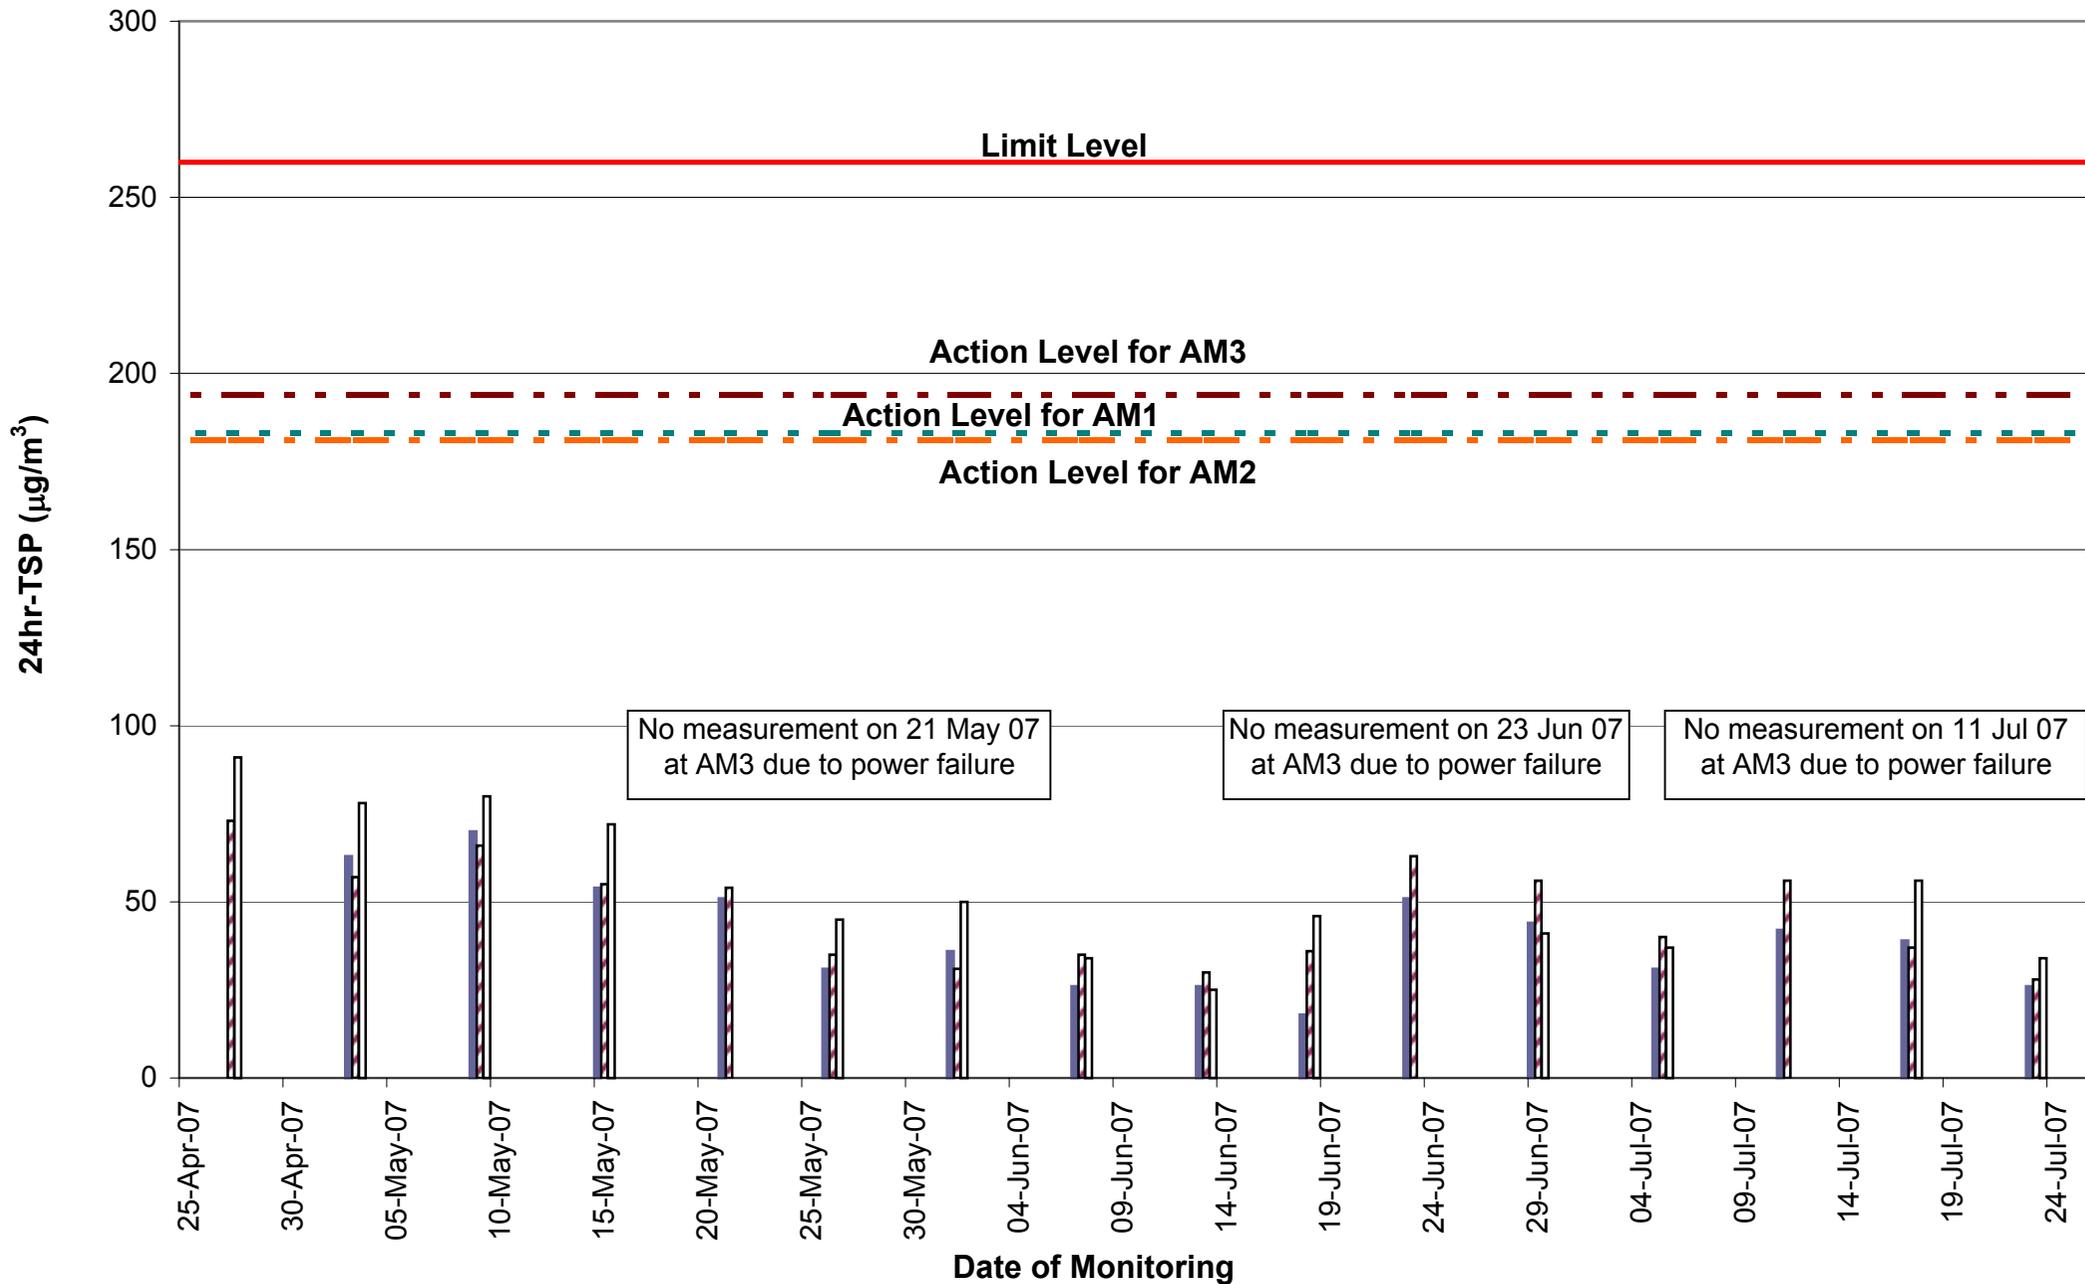
Figure C.4 24-hr TSP monitoring results of Monitoring Station AM1, AM2 & AM3

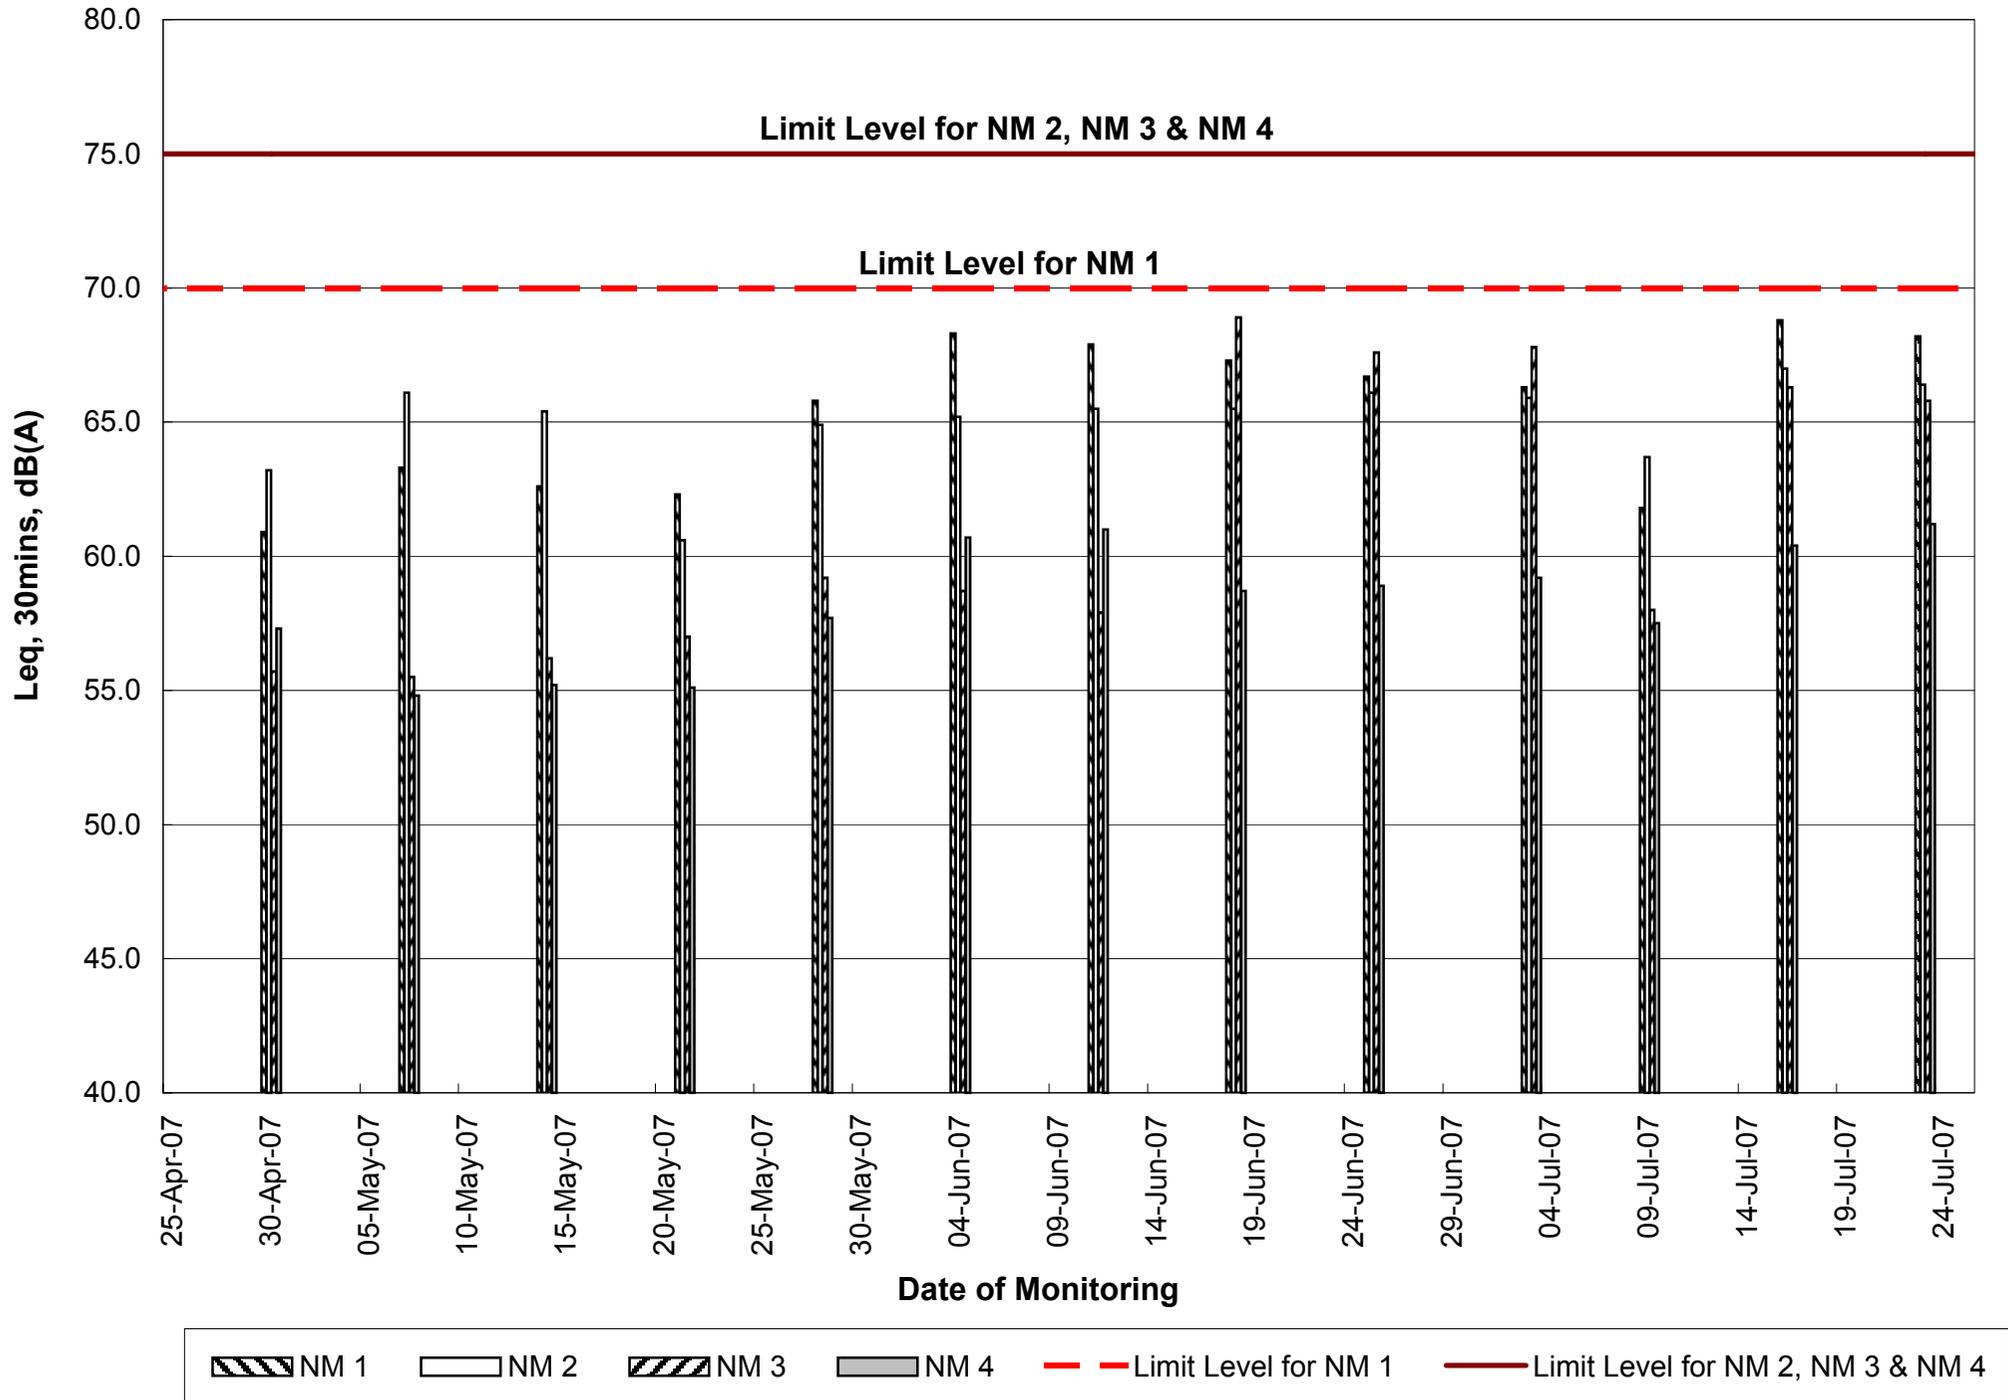
**Fig D.1 - Daytime Noise Monitoring Results of Monitoring Stations NM1, NM2, NM3 & NM4**

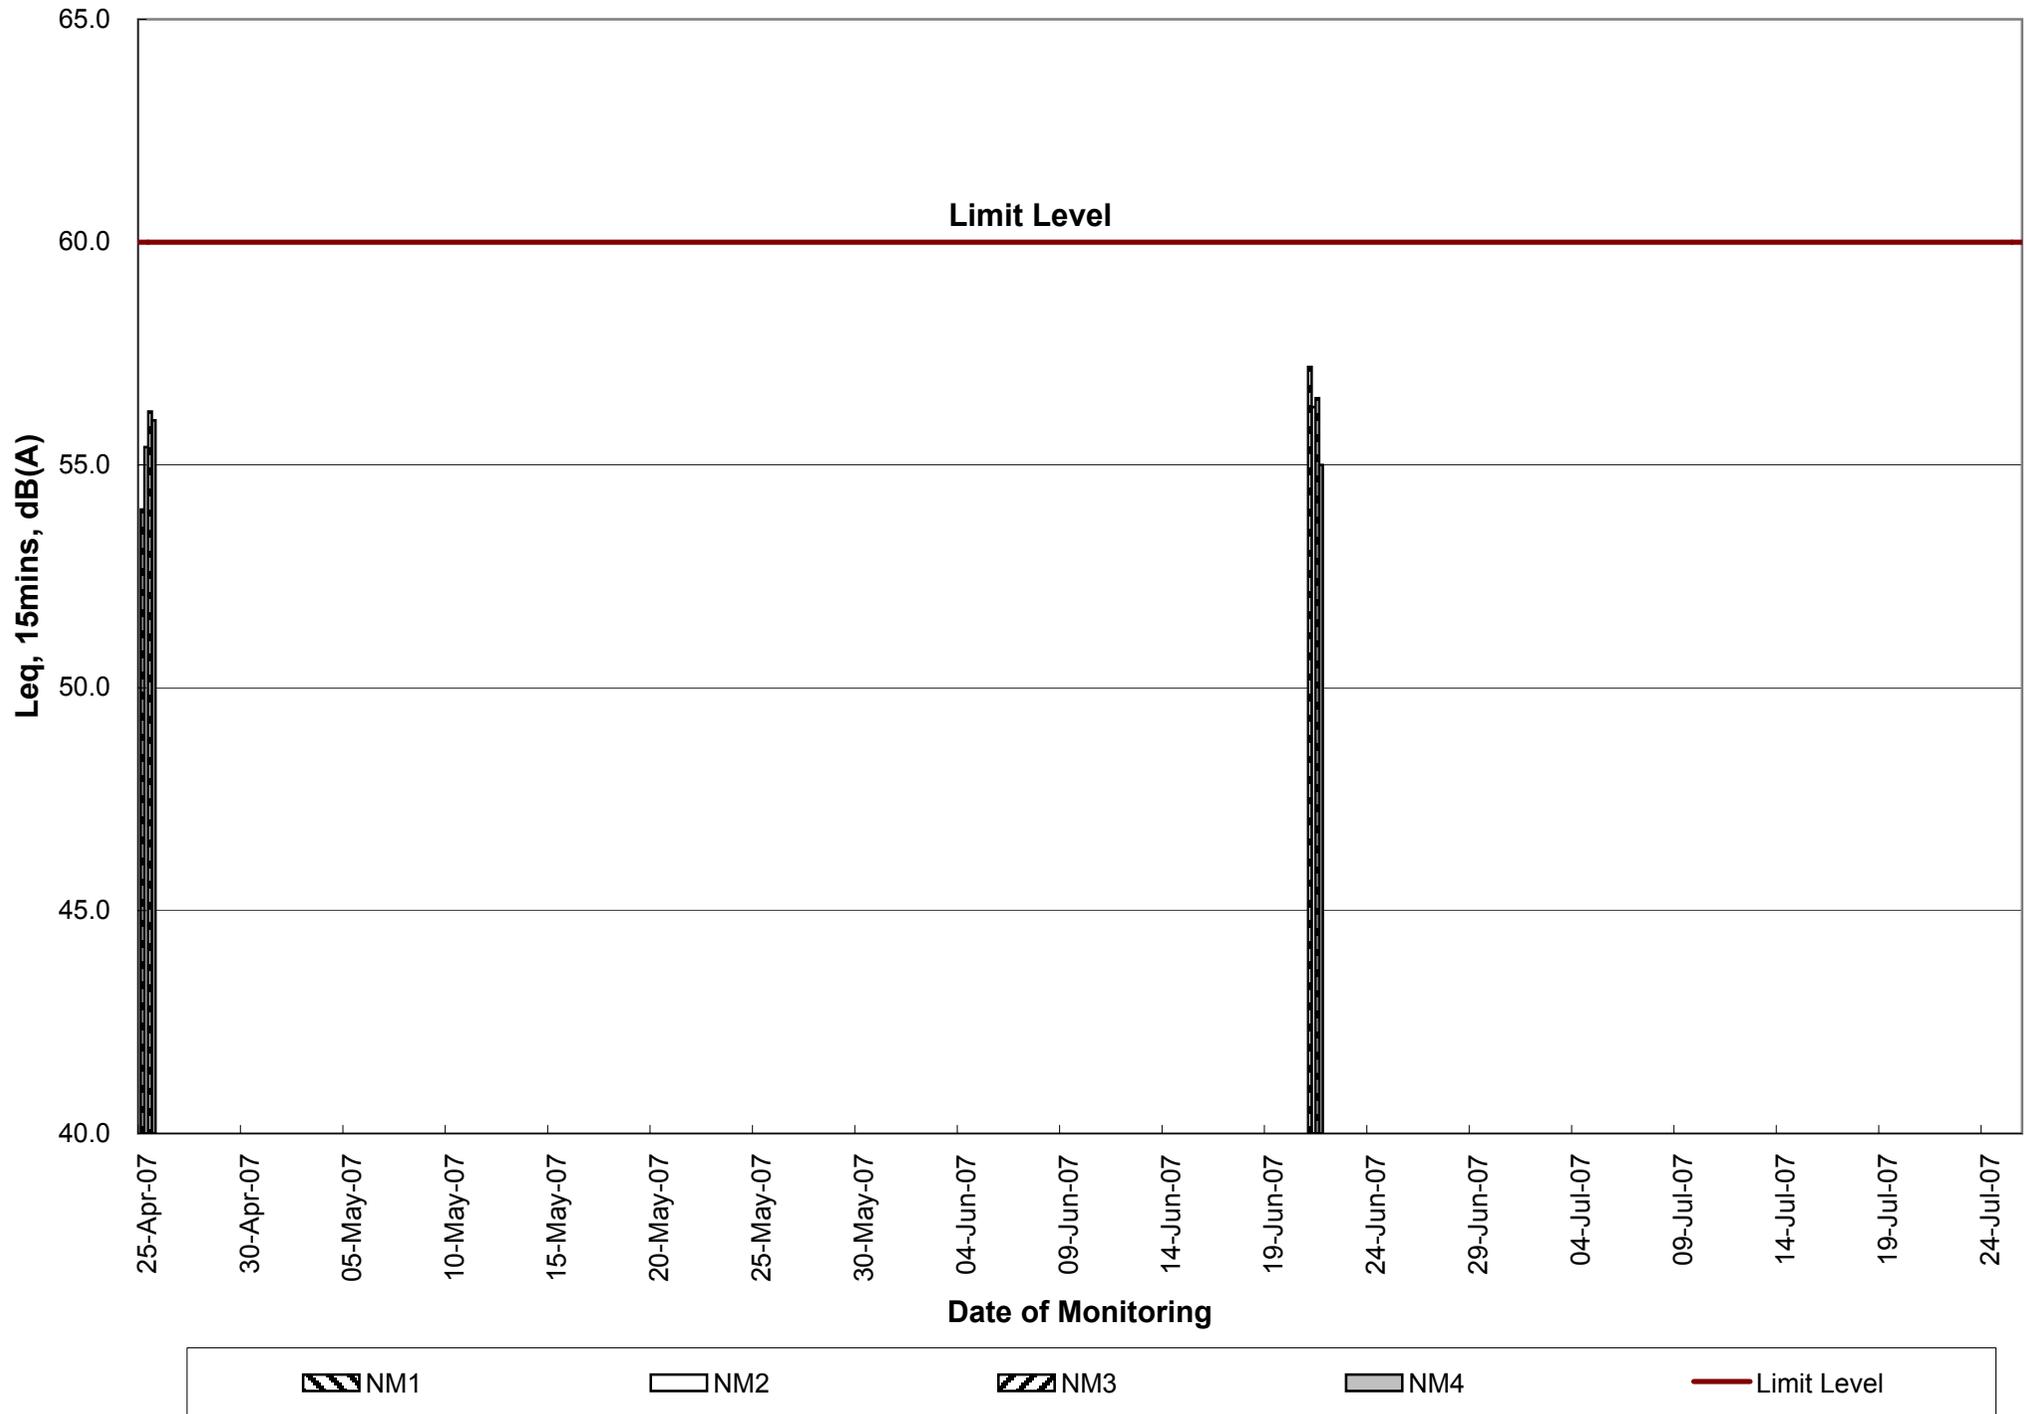
Fig D.2 - Evening Noise Monitoring Results of Monitoring Stations NM1, NM2, NM3 & NM4

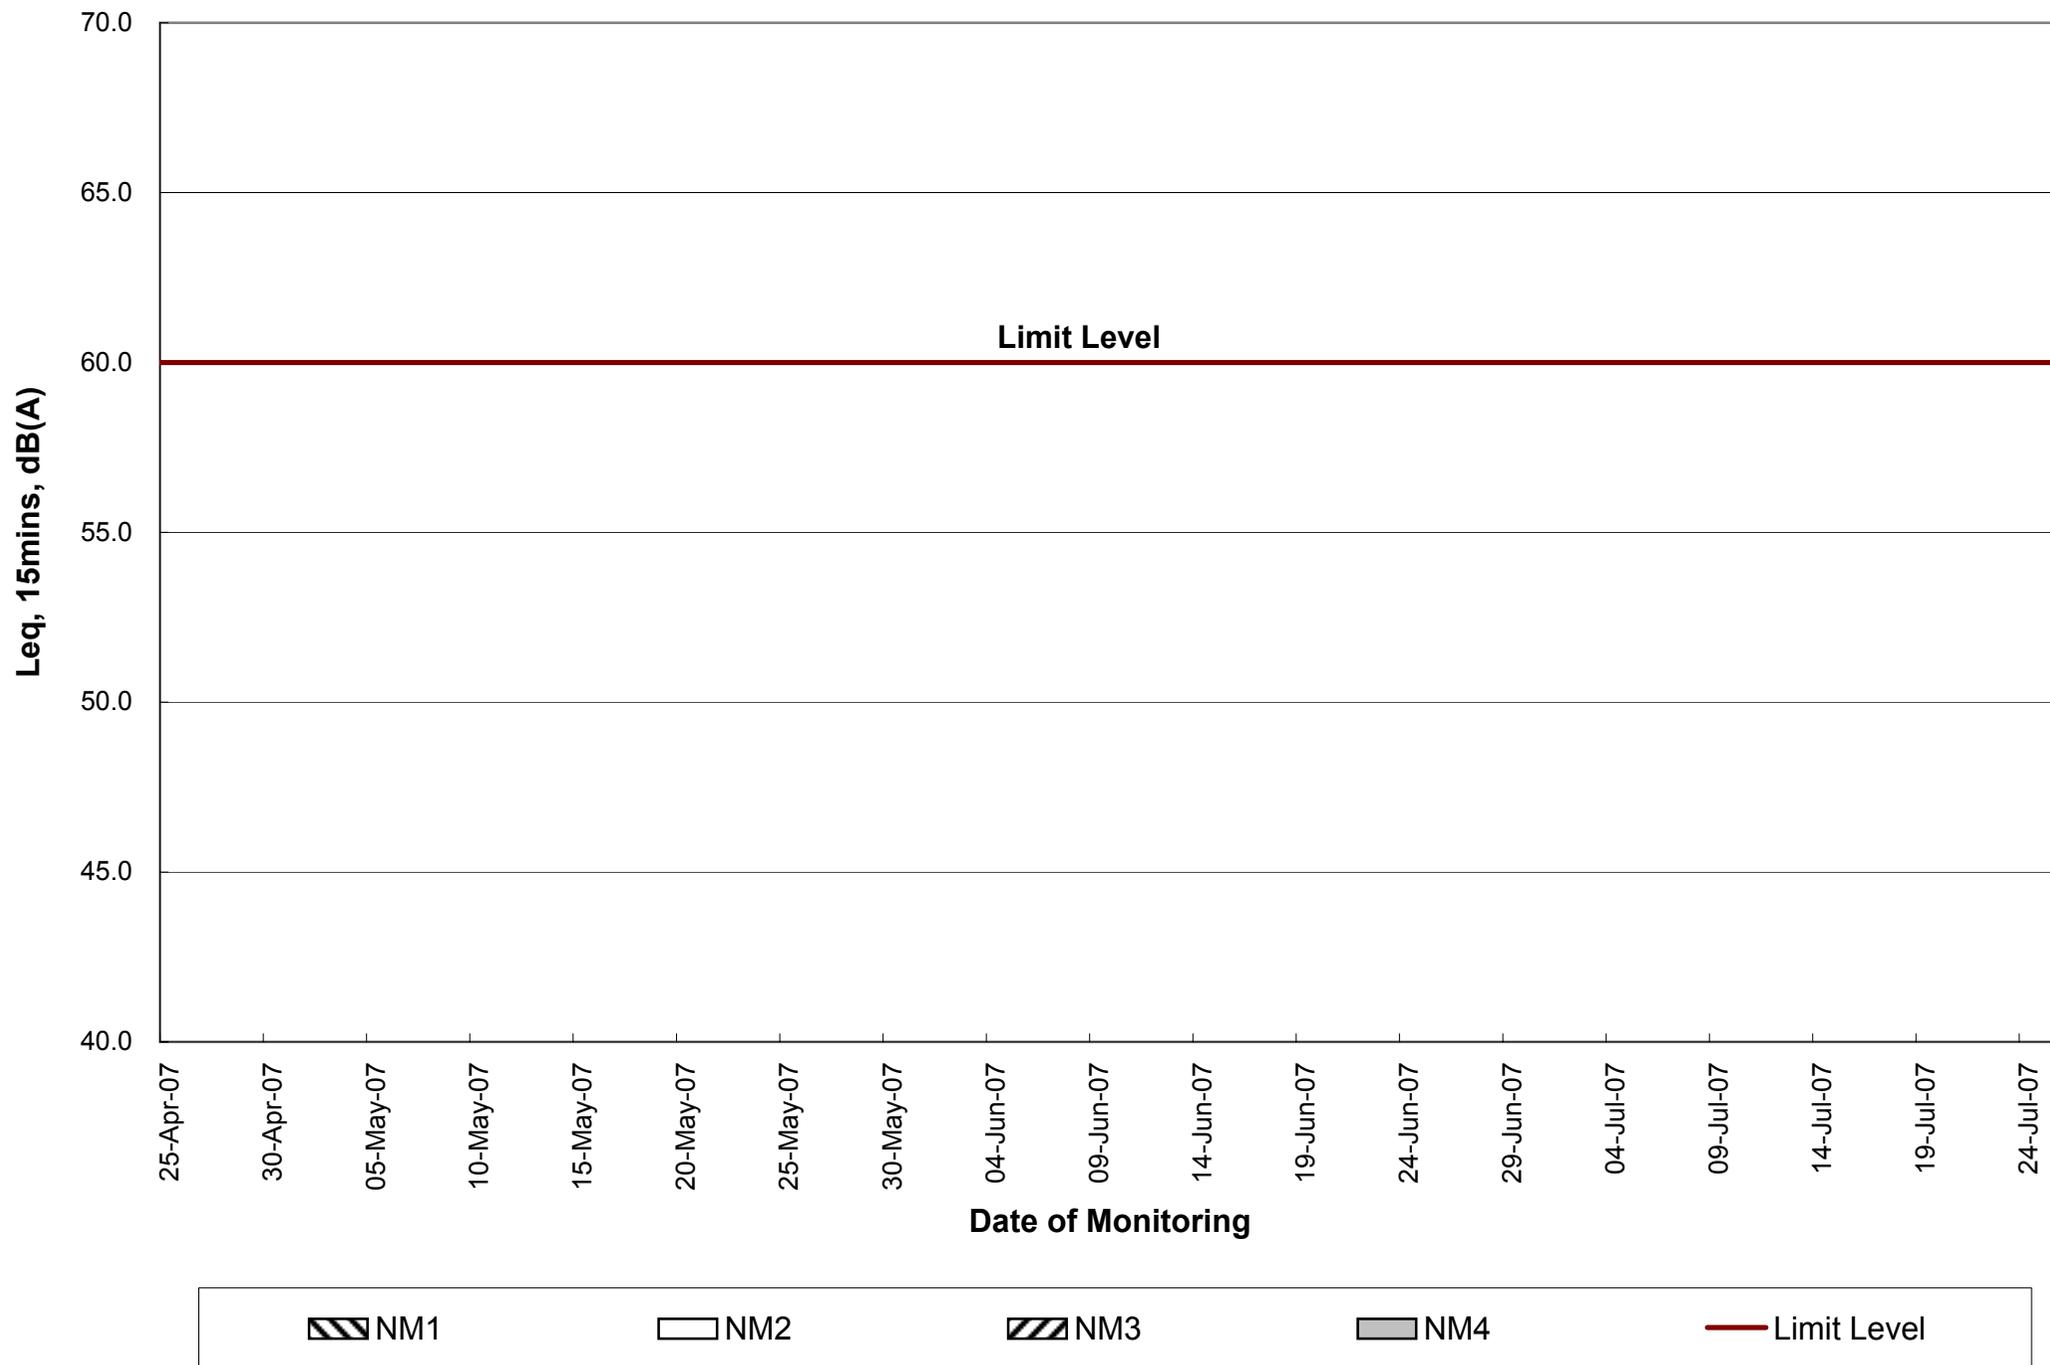
Figure D.3 - Holiday Noise Monitoring Results of Monitoring Stations NM1, NM2, NM3 & NM4

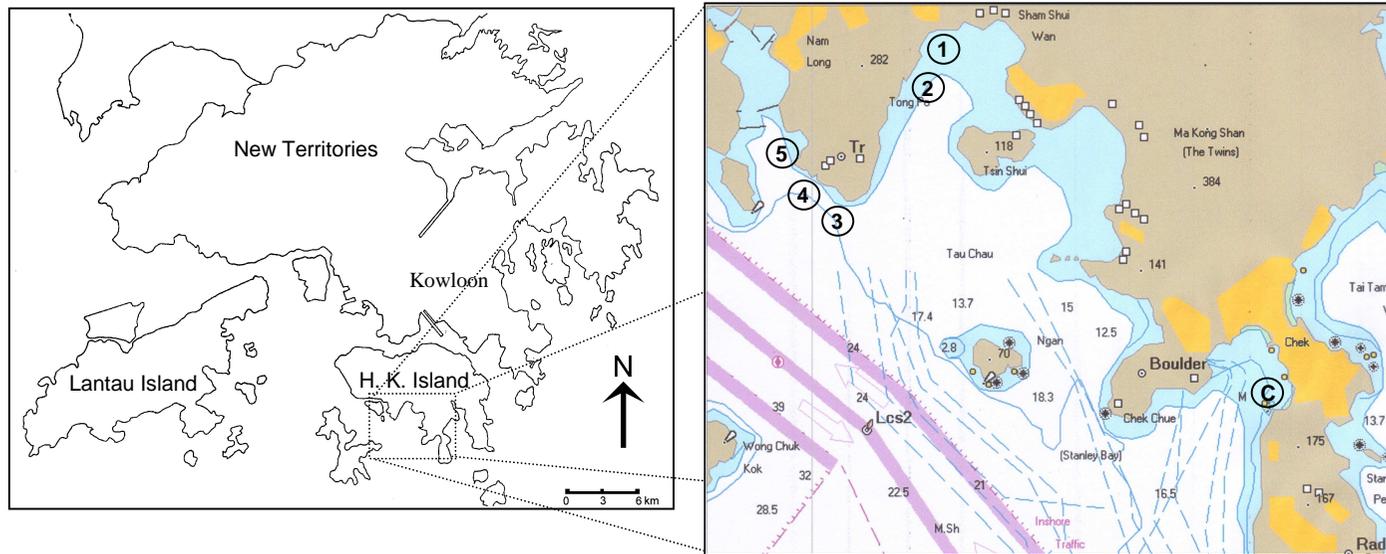
**Fig. 2.1 Map Showing the Locations of the 5 Impact Monitoring Sites (1 to 5) and the Control Site (C).**

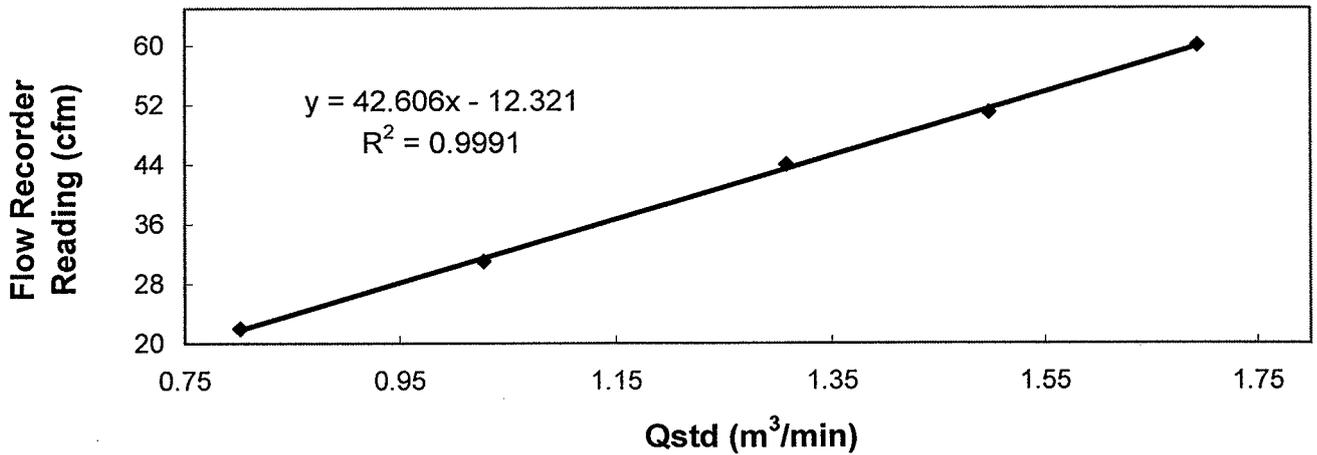
Flow recorder reading (cfm)	60	51	44	31	22
Qstd (Actual flow rate, m <sup>3</sup> /min)	1.69	1.50	1.31	1.03	0.80
Pressure :	756.06 mm Hg		Temp. :	306 K

**Sampler 1174 Calibration Curve  
Site: Ocean Park (AM-1)  
Date of Calibration: 03 July 2007**

The high volume sampler complies \* / ~~does not comply~~ \* with the specified requirements and is deemed acceptable \* / unacceptable \* for use.

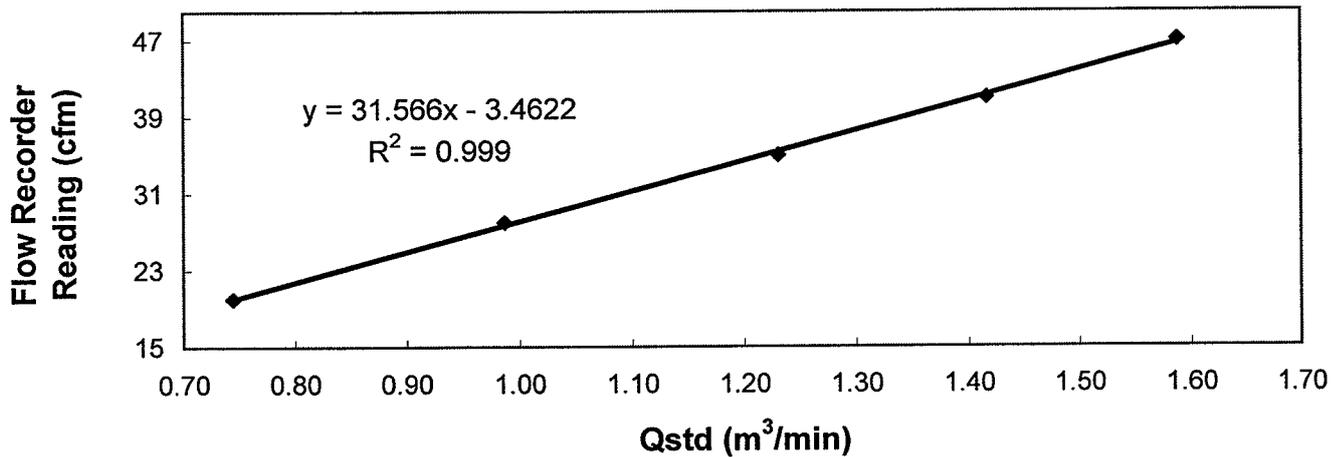
Flow recorder reading (cfm)	47	41	35	28	20
Qstd (Actual flow rate, m <sup>3</sup> /min)	1.59	1.42	1.23	0.99	0.74
Pressure :	755.31 mm Hg			Temp. :	301 K

**Sampler 1177 Calibration Curve**  
**Site: Ocean Park (AM-2)**  
**Date of Calibration: 08 June 2007**

The high volume sampler complies \* / ~~does not comply~~ \* with the specified requirements and is deemed acceptable \* / unacceptable \* for use.
