# Ocean Park Master Redevelopment Project

## Monthly Environmental Monitoring & Audit Report – July 2007

**EP-249/2006/A – Condition 3.4**

**Monthly EM&A Report – July 2007**

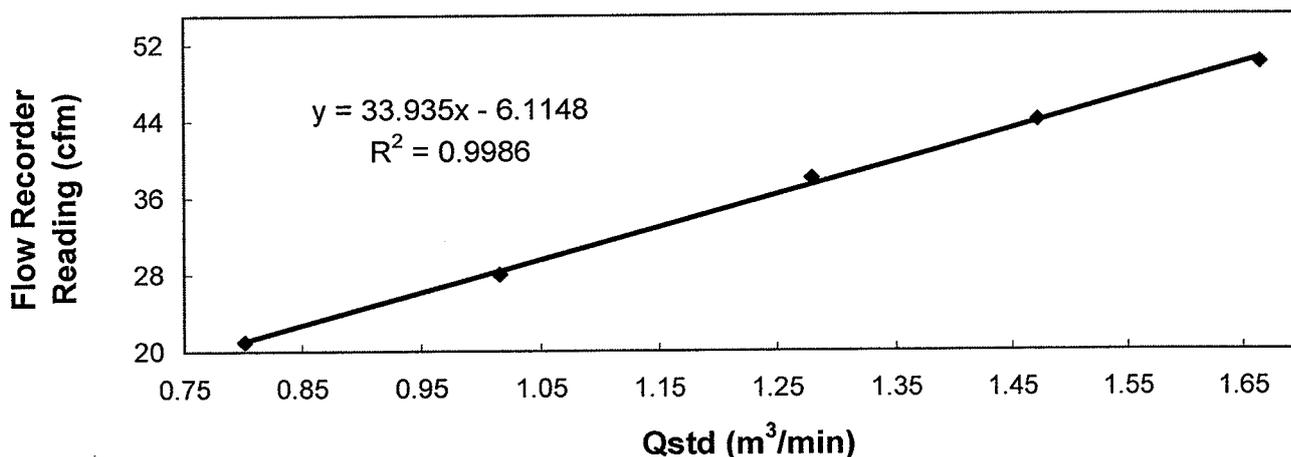
Results	Flow recorder reading (cfm)	50	44	38	28	21
	Qstd (Actual flow rate, m <sup>3</sup> /min)	1.67	1.47	1.28	1.02	0.80
	Pressure :	756.06 mm Hg			Temp. :	306 K

**Sampler 9998 Calibration Curve  
Site: Ocean Park (AM-3)  
Date of Calibration: 03 July 2007**

The high volume sampler complies \* / does not comply \* with the specified requirements and is deemed acceptable \* / unacceptable \* for use.

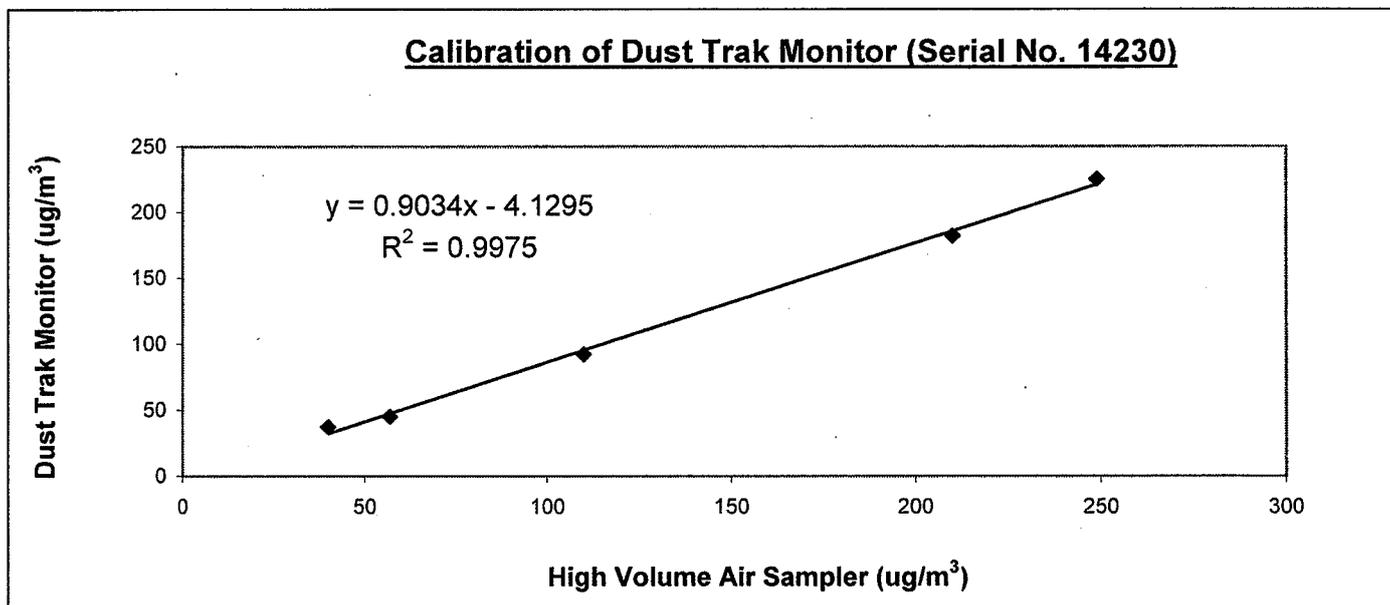
Dust Trak Monitor ( $\mu\text{g}/\text{m}^3$ )	40	57	110	210	249
High Volume Air Sampler ( $\mu\text{g}/\text{m}^3$ )	37	45	92	182	225
High Volume Air Sampler Serial No.: 1178			Calibration Date: 12 / 03 / 2007

The Dust Trak Monitor complies \* / ~~does not comply~~ \* with the internal calibration procedures and is deemed acceptable \* / unacceptable \* for use.
