Ocean Park Master Redevelopment Project

Monthly Environmental Monitoring & Audit Report – August 2007

Environmental Permit No. EP-249/2006/A - Condition 3.4

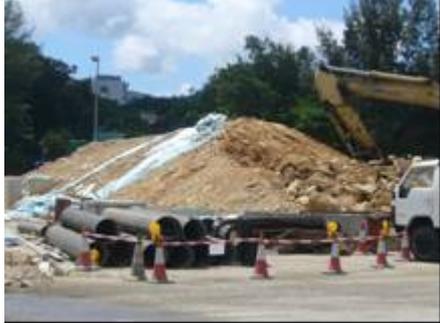
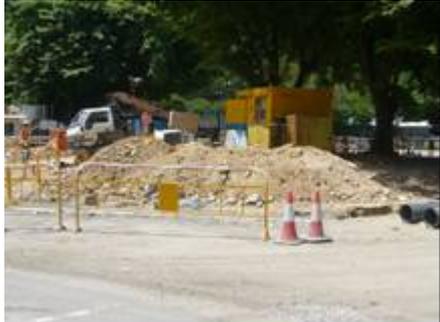
<p>P1030406 & P1030405: A stockpile was being operated by an excavator while another stockpile was idled and uncovered. Tarpaulin sheets shall be provided to cover the idle stockpile entirely.</p>	<p>Closed - P1030769: Stockpile was not observed.</p>
Next to Panda House/Near Wing Hing Road

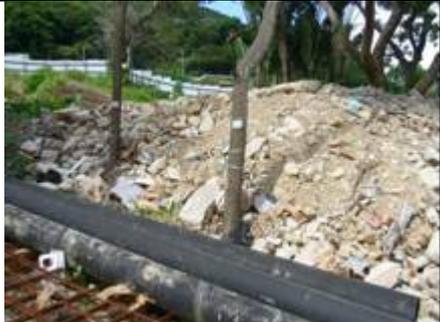
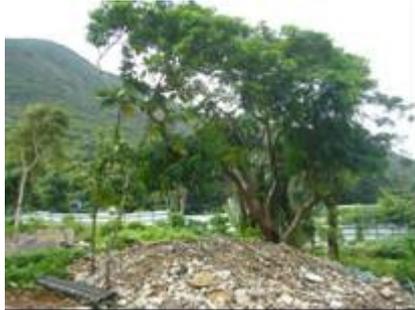
<p>P1030388: Debris was banked around a couple of trees. The Contractor shall move the debris away from the trees and remove and dispose the debris as soon as possible.</p>	<p>P1030796: C&D material was still banked around a couple of trees. The Contractor should stockpile these materials away from the trees and remove and dispose the C&D material as soon as possible.</p>
Top of Summit

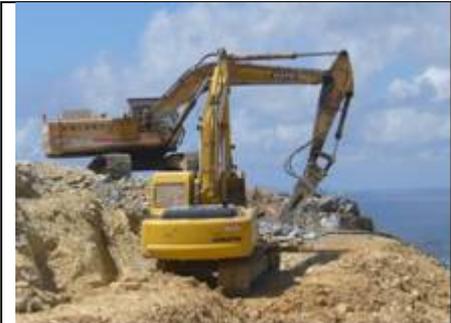
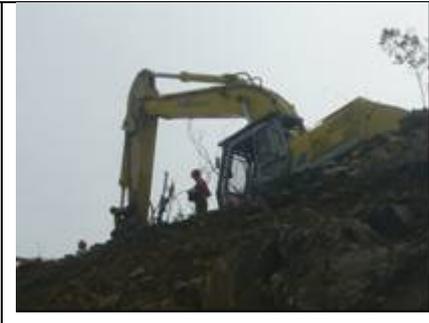
<p>P1030392: Dust was observed generated from rock breaking activity. Water spray shall be provided during rock breaking activities to suppress dust.</p>		<p>Closed - P1030778: Rock breaking activity was not in operation.</p>

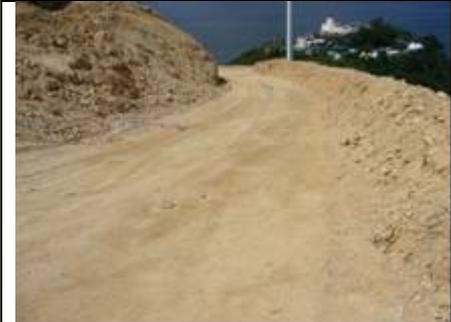
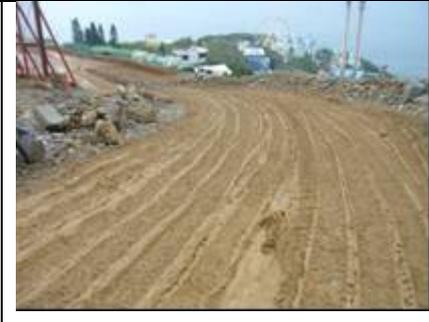
<p>P1030391: Haul roads were dry and dusty. Water spray should be provided to suppress dust.</p>		<p>Closed: P1030771: Haul roads were wetted.</p>	
Observations in August 2007			
Top of Summit		Adit Portal

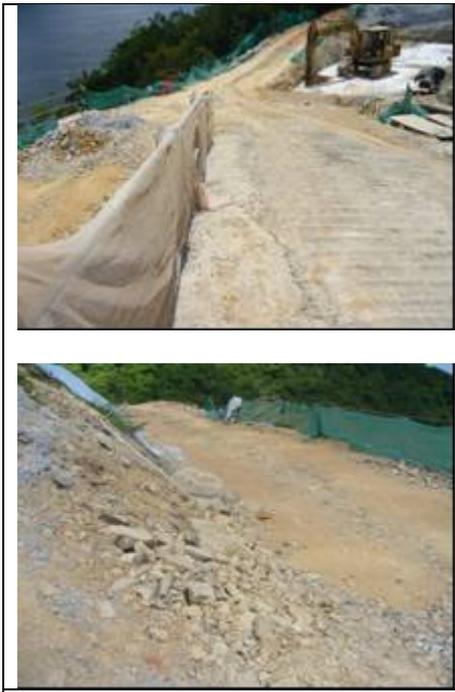
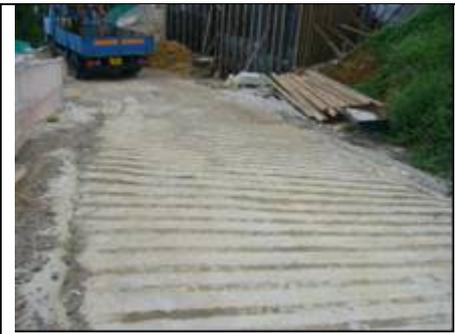
<p>P1030416 & P1030418: Haul roads were dry and dusty. Water spray shall be provided more frequently.</p>	<p>Closed - P1030805: Haul roads were paved and not observed to be dusty.</p>

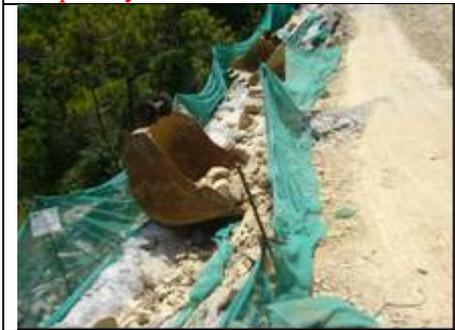
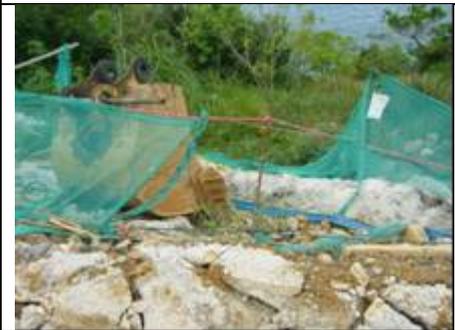
<p>P1030419: Debris and rocks were accumulated along the temporary drainage channel. Any blockage of the drainage channel shall be cleared as soon as possible.</p>	<p>P1030809: Debris and rocks were still accumulated along the temporary drainage channel. Any blockage of the drainage channel should be cleared as soon as possible.</p>
Observations in August 2007

- (i) Item No. 1 and Item 2 from last month were closed.
- (ii) Item No. 3 from last month was outstanding. The drainage channel was still blocked by debris and rocks. The Contractor shall remove all blockages as soon as possible.
- (iii) Stagnant water was observed in a few drip trays and on site. The Contractor shall remove them as soon as possible.
- (iv) A sedimentation tank was full of water. The Contractor shall pump the water to the sedimentation tank next to the discharge point for treatment prior to discharge.
- (v) A chemical container was placed on bareground. The Contractor was reminded to place it on paved area and/or provide it with drip tray.

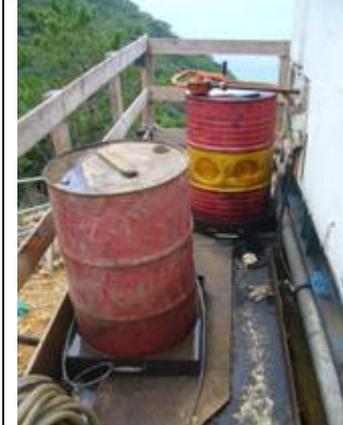
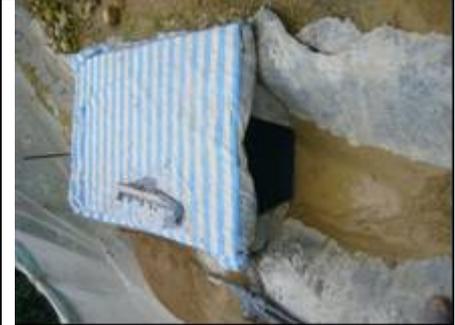
<p>P1030817: Stagnant water was observed in a few drip trays with oil drums in them. The</p>	<p>P1030813: A sedimentation tank was full of water. The Contractor should pump the water to</p>

- ① Item No. 3 from last month was outstanding. The drainage channel was still blocked by debris and rocks. The Contractor shall remove all blockages as soon as possible.
- ② Stagnant water was observed in a few drip trays and on site. The Contractor shall remove them as soon as possible.
- ③ A sedimentation tank was full of water. The Contractor shall pump the water to the sedimentation tank next to the discharge point for treatment prior to discharge.
- ④ A chemical container was placed on bareground. The Contractor was reminded to place it on paved area and/or provide it with drip tray.

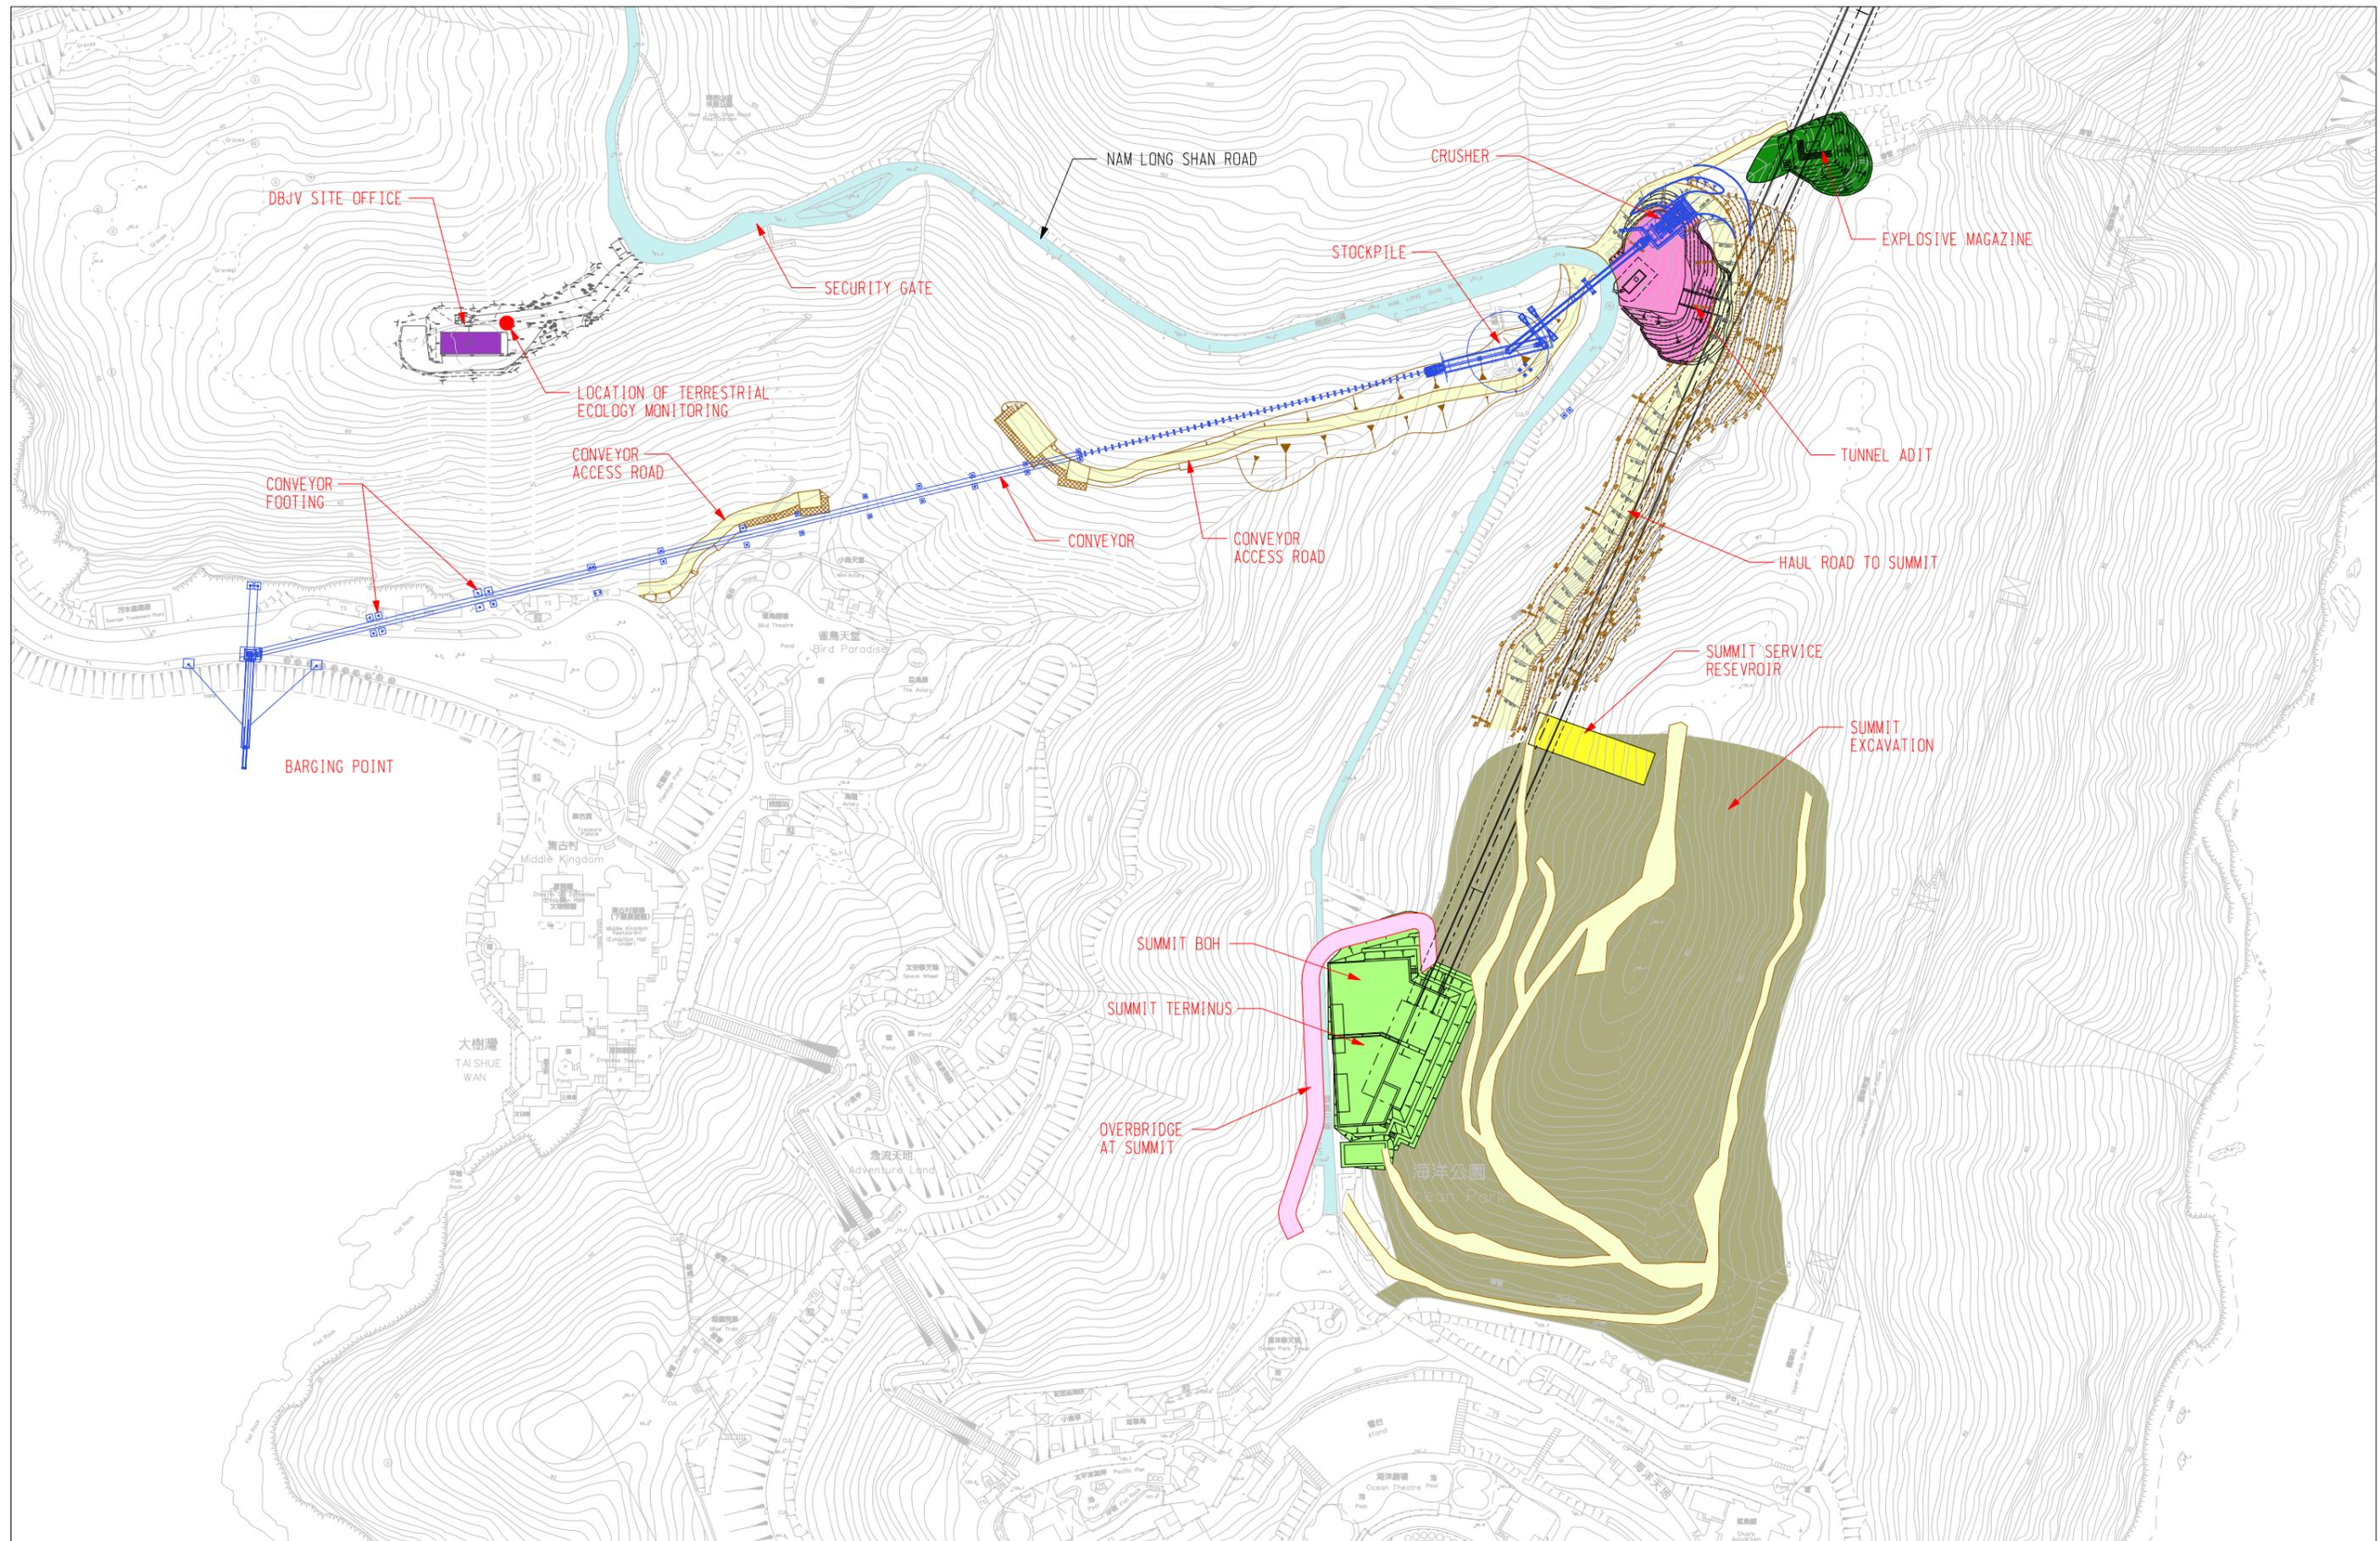
FIGURE 1.3
LAYOUT OF WORK SITE (SUMMIT)
AND LOCATION OF
TERRESTRIAL ECOLOGY MONITORING

Monitoring of the health and condition of the transplanted plant species of conservation interest should be monitored at least once a month during the first 12 month after transplantation. Proposed monitoring location would be next to the Contract CI-05 site office shown in figure 1.3 of Part 2 of the report.

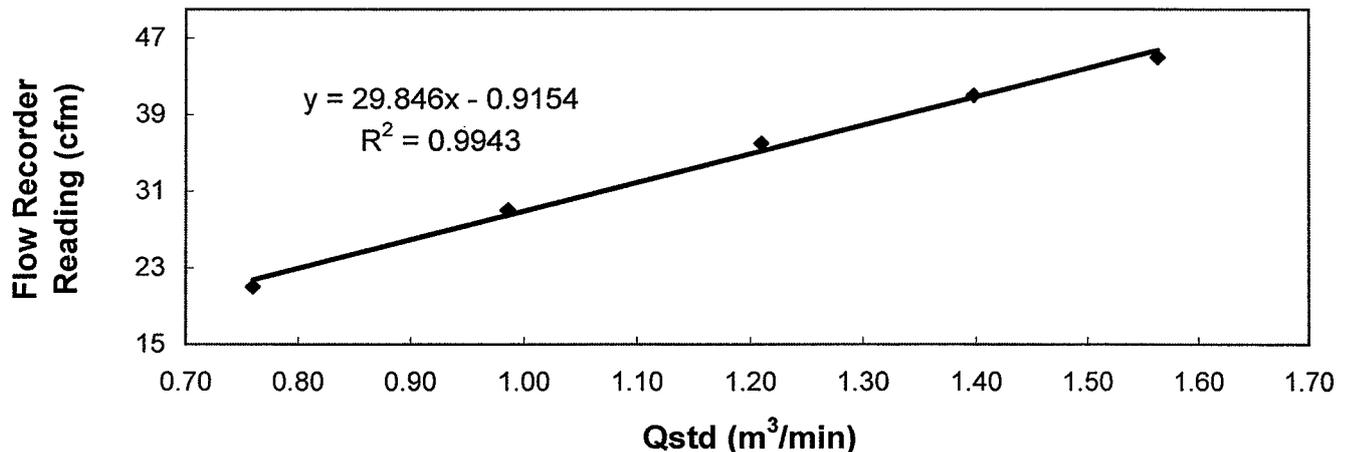
Sampler 1177 Calibration Curve
Site: Ocean Park (AM-2)
Date of Calibration: 08 August 2007

Flow recorder reading (cfm)	45	41	36	29	21
Qstd (Actual flow rate, m ³ /min)	1.56	1.40	1.21	0.99	0.76
Pressure :	751.56 mm Hg			Temp. :	300 K

Acceptance Criteria : Correlation coefficient (r) of the calibration curve greater than 0.990 after a 5-point calibration

The high volume sampler complies * / ~~does not comply~~ * with the specified requirements and is deemed acceptable * / unacceptable * for use.

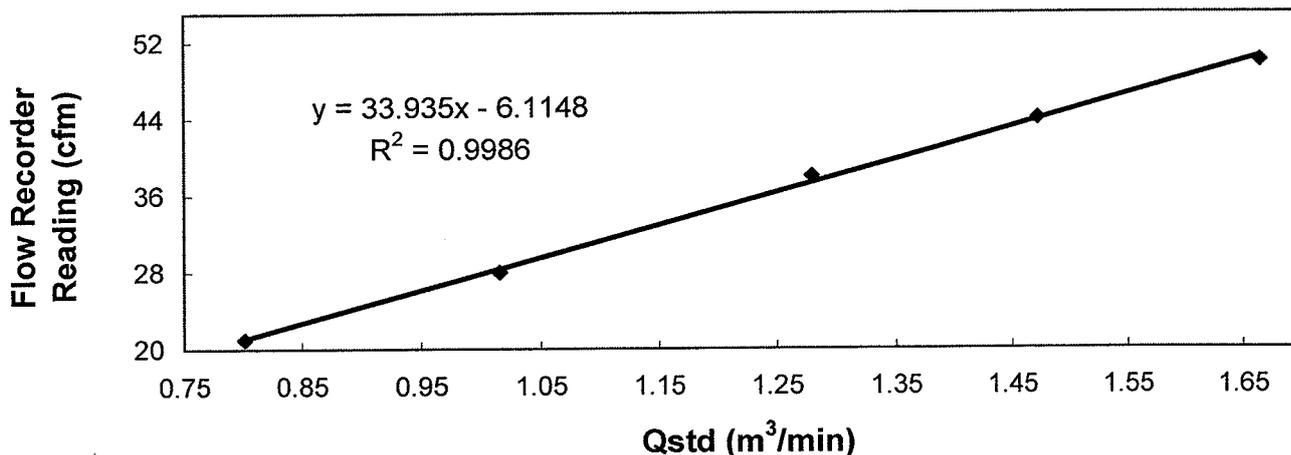
Sampler 9998 Calibration Curve
Site: Ocean Park (AM-3)
Date of Calibration: 03 July 2007

Results	Flow recorder reading (cfm)	50	44	38	28	21
	Qstd (Actual flow rate, m ³ /min)	1.67	1.47	1.28	1.02	0.80
	Pressure : 756.06 mm Hg	Temp. : 306 K

Acceptance Criteria : Correlation coefficient (r) of the calibration curve greater than 0.990 after a 5-point calibration

The high volume sampler complies * / does not comply * with the specified requirements and is deemed acceptable * / unacceptable * for use.
