Ocean Park Master Redevelopment Project

Monthly Environmental Monitoring & Audit Report – October 2007

Environmental Permit No. EP-249/2006/A - Condition 3.4

Monthly EM&A Report – October 2007

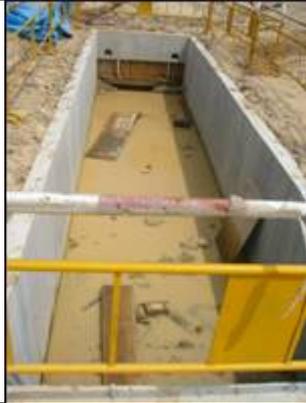
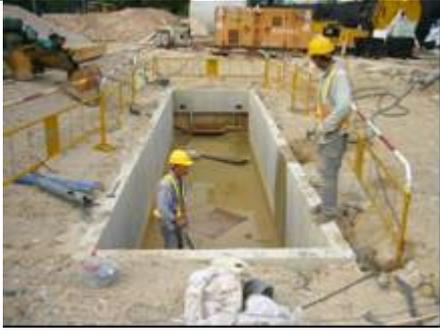
P1030032: Oil was accumulated in a drip tray. The Contractor should remove the oil accumulated in the drip tray as soon as possible.	Closed - P1040260: Oil accumulated in the drip tray was removed.
Citybus Depot

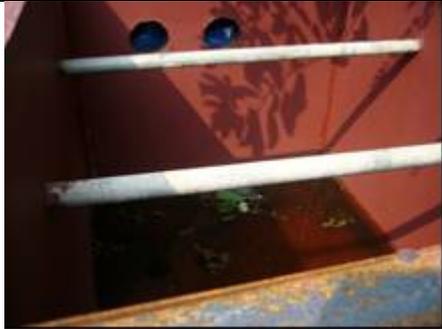
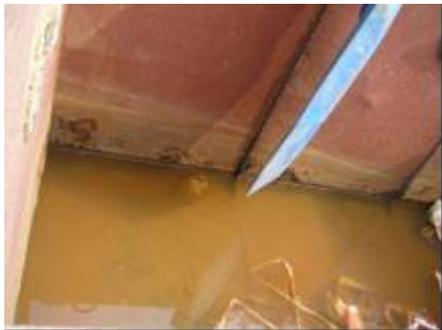
<p>P1040242: Sedimentation tank was accumulated with mud and sand. The Contractor should maintain it more frequently.</p>	<p>P1040291: A hydraulic oil tank was placed on bare ground. The Contractor should provide it with a drip tray to avoid oil spillage.</p>
Top of Summit

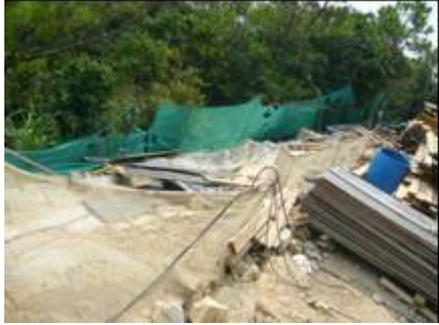
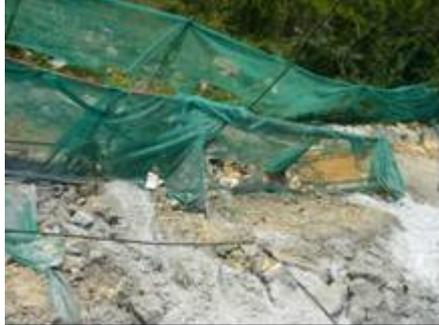
<p>P1040250 & P1040259: Stagnant water was observed in two sedimentation tanks which were not in use. The Contractor should apply larvicide to avoid mosquito breeding.</p>

- (iii) Stagnant water was observed in two sedimentation tanks which were not in use. The Contractor was reminded to spray with larvicide.

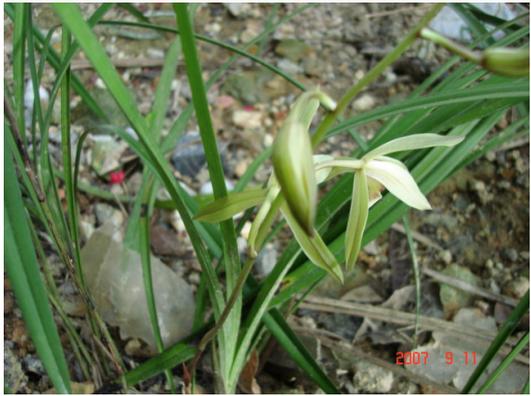
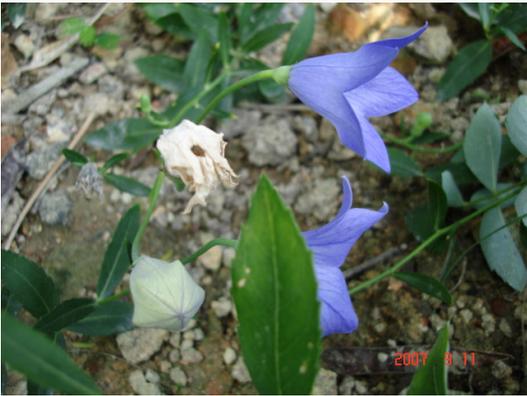
Photo 1 - Sword-leaved Orchid	Photo 2 - Balloon Flower

- 3.3 The transplanted plants and the plant receptor (Photo 7) is generally in good condition. Some of the transplanted Sword-leaved Orchids are bearing with flowers and fruits (Photos 1, 3 & 5). Most of the transplanted Balloon Flowers at the receptor site are bearing with flowers and fruits (Photos 2 & 6). These two transplanted plants have relatively higher survival rates of over 95%.
- 3.4 Regular maintenance including watering, weeding, apply fertilizer and pest checking should be applied continuously at the receptor site in order to achieve higher survival rate. Since the dry season was coming, twice a week watering is recommended.

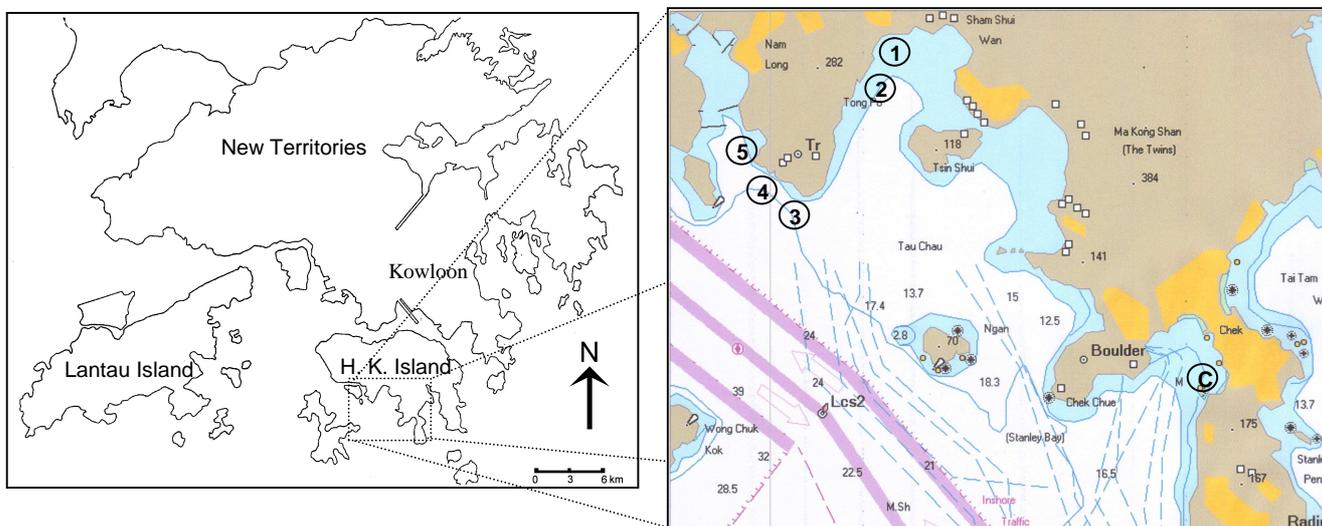
Fig. 2.1 Map Showing the Locations of the 5 Impact Monitoring Sites (1 to 5) and the Control Site (C).

2.1.1 Five locations close to the potential impact areas were identified and designated as Impact Monitoring Sites (Sites 1 to 5; Fig. 2.1). In order to identify background environmental perturbations that are not associated with the construction, St. Stephen Beach, which is away from the impact areas, was designated as the Control Site (Control Site C; Fig. 2.1). Locations (GPS coordinates) of the Impact Monitoring Site 5 and the Control Site C, and conditions during the surveys on 14 October 2007 are summarized in Tables 3.1.

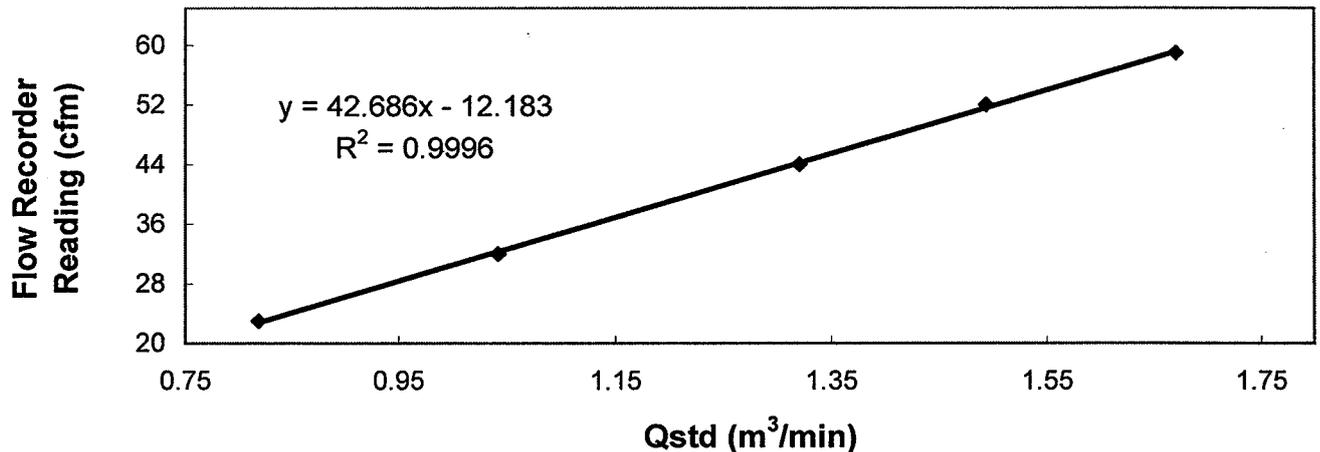
Sampler 1174 Calibration Curve
Site: Ocean Park (AM-1)
Date of Calibration: 03 September 2007

Acceptance Criteria : Correlation coefficient (r) of the calibration curve greater than 0.990 after a 5-point calibration

The high volume sampler complies * / does not comply * with the specified requirements and is deemed acceptable * / unacceptable * for use.

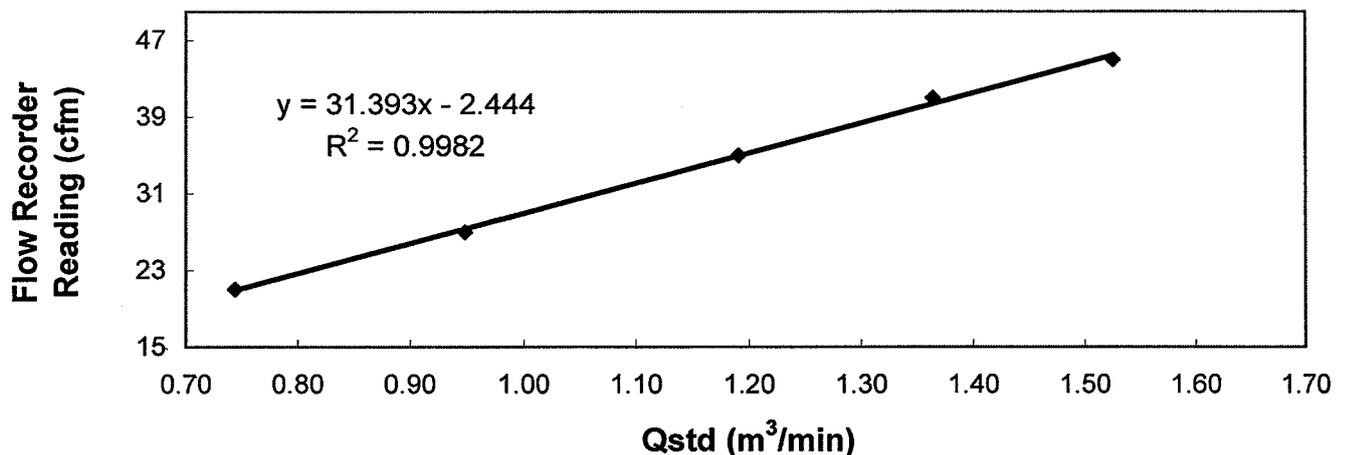
Sampler 1177 Calibration Curve
Site: Ocean Park (AM-2)
Date of Calibration: 03 September 2007

Acceptance Criteria : Correlation coefficient (r) of the calibration curve greater than 0.990 after a 5-point calibration

The high volume sampler complies * / ~~does not comply~~ * with the specified requirements and is deemed acceptable * / unacceptable * for use.

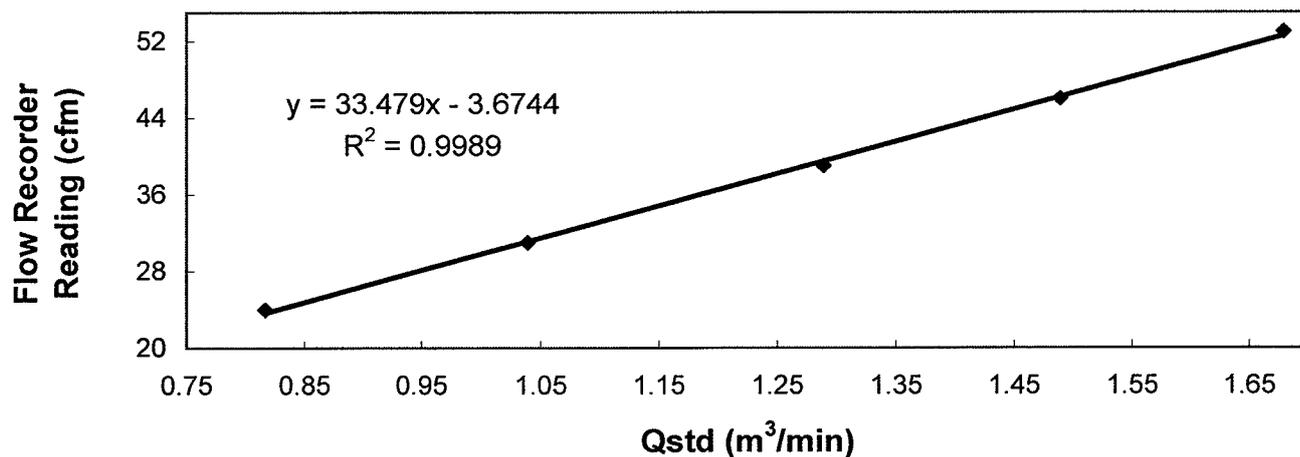
Sampler 9998 Calibration Curve
Site: Ocean Park (AM-3)
Date of Calibration: 14 September 2007

Acceptance Criteria : Correlation coefficient (r) of the calibration curve greater than 0.990 after a 5-point calibration

The high volume sampler complies * / does not comply * with the specified requirements and is deemed acceptable * / unacceptable * for use.
