# Ocean Park Master Redevelopment Project

Monthly Environmental Monitoring & Audit Report – November 2007

**Environmental Permit No. EP-249/2006/A - Condition 3.4**

**Monthly EM&A Report – November 2007**

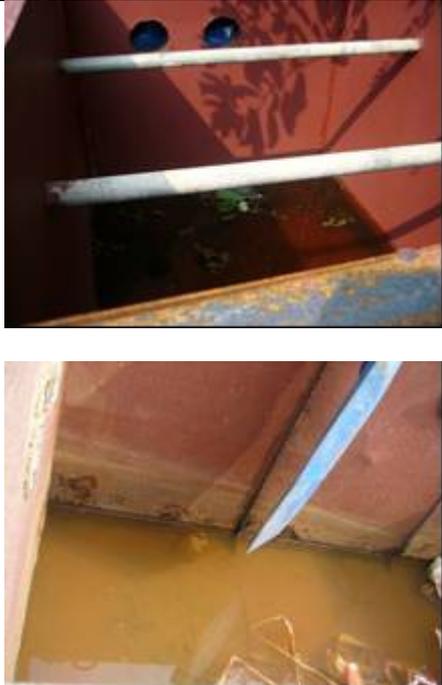
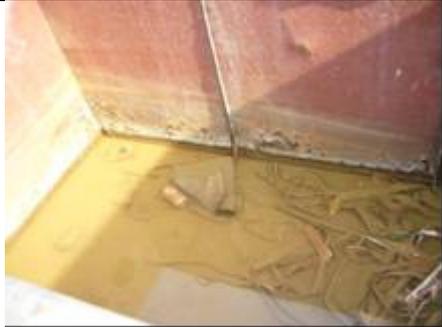
<b>Top of Summit</b>

<p>P1040250 &amp; P1040259: Stagnant water was observed in two sedimentation tanks which were not in use. The Contractor should apply larvicide to avoid mosquito breeding.</p>	<p>P1050189: Stagnant water was still observed in a sedimentation tank which was not in use. The Contractor shall remove the stagnant water to avoid mosquito breeding.</p>
<b>Observations in November 2007</b>	
<b>Top of Summit &amp; Crusher Conveyor Transfer Point</b>

- (ii) Stagnant water was observed in two sedimentation tanks which were not in use. The Contractor was reminded to remove it as soon as possible.

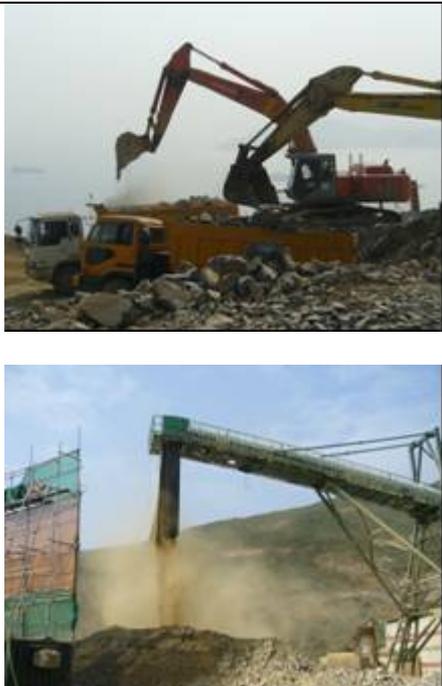
<p>P1050175 &amp; 1050184: Dust was observed generated during transfer of excavated material at Top of Summit and the Crusher Conveyor Transfer Point was generally dusty.</p>

- (iv) Dust was observed generated during transfer of excavated material at Top of Summit and the crusher conveyor transfer point was general dusty. More improvement work should be provided at the area.

- To prohibit any open burning on site.
- To recommend that the Contractors should regularly maintain the machinery and vehicles on site.
- To follow up any exceedance caused by the construction works.
- To monitor the implementation dust suppression measures on dry surfaces, at the crusher and conveyor belt area by the Contractors.
- To increase the water spraying at the truck loading area of the crusher and along haul road.

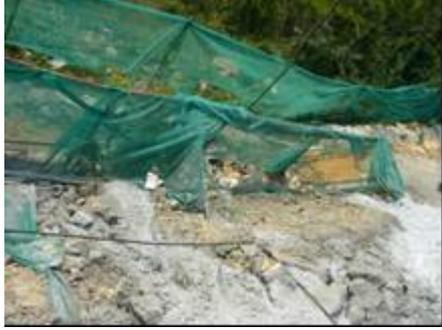
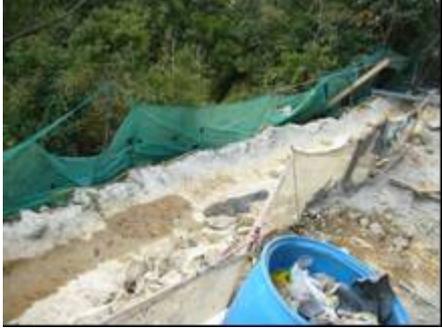
<p>P1040236: Debris was still observed accumulated in the temporary drainage channel. The Contractor should clear all blockages of the temporary drainage channel as soon as possible.</p>	<p>Closed – P1050160: Debris accumulated in the temporary drainage channel was removed.</p>

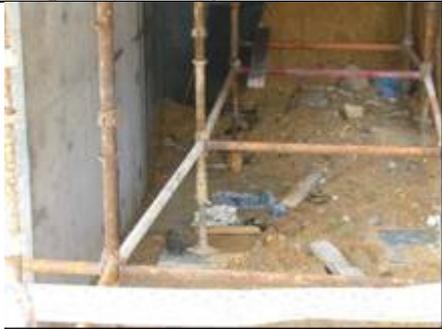
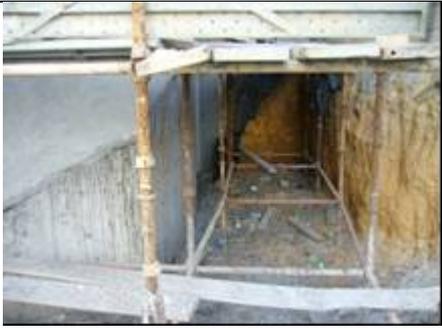
<p>P1040234: Stagnant water was still observed behind the Plant Room Block. The Contractor should remove them as soon as possible.</p>	<p>Closed - P1050159: Stagnant water behind the Plant Room Block was removed.</p>

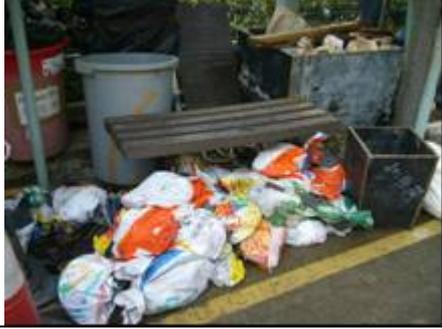
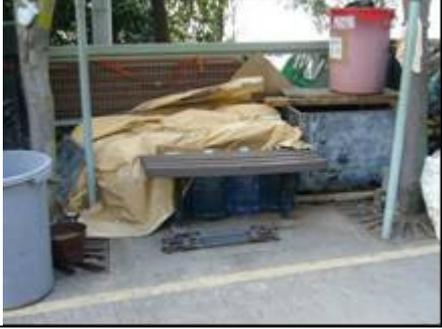
<p>P1040233: Housekeeping should be further improved.</p>	<p>Closed – P1050164: Housekeeping was improved.</p>

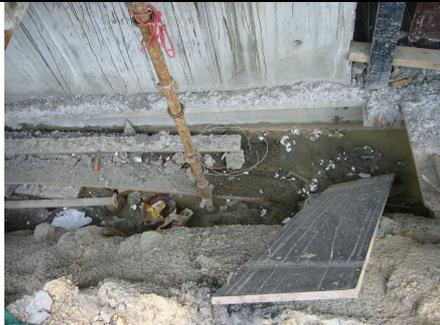
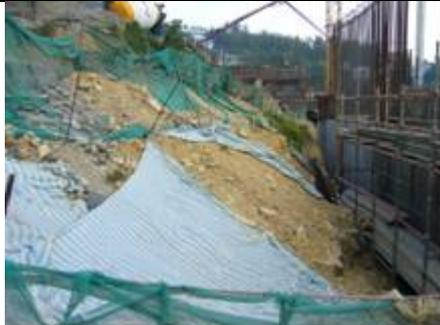
Observations in November 2007

P1050162: Stagnant water and general refuse were observed along the boundary of Plant Block. The Contractor shall remove them as soon as possible.	P1050163: Slope adjacent to Pool Block was not covered entirely with tarpaulin. The Contractor shall cover the exposed slope entirely.
Contract CW02 Astounding Asia	
Follow up observations in October 2007	
Observation in last site inspection	Observation in this site inspection

- All observations from last month were closed.
- Stagnant water and general refuse were observed along the boundary of Plant Blocks. The Contractor shall remove them as soon as possible.
- Slope adjacent to Pool Block was not covered entirely with tarpaulin. The Contractor should cover the exposed slope entirely.

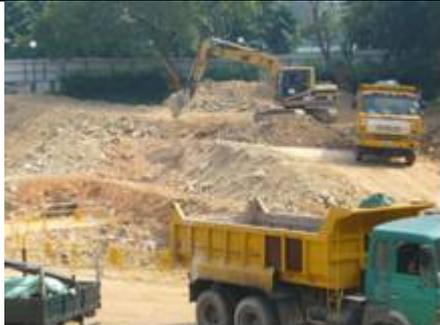
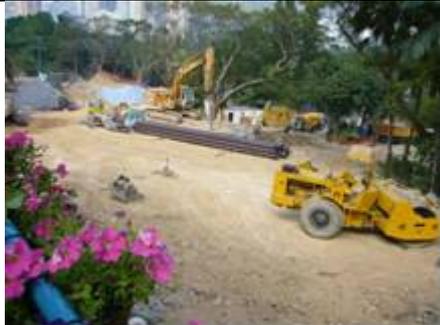
P1040220: Exposed slope and soil surfaces were dry and dusty. The Contractor should provide water spray to suppress dust more frequently during dry season.	Closed - P1050165: Water spray was provided more frequently to exposed slope and soil surfaces during dry season.

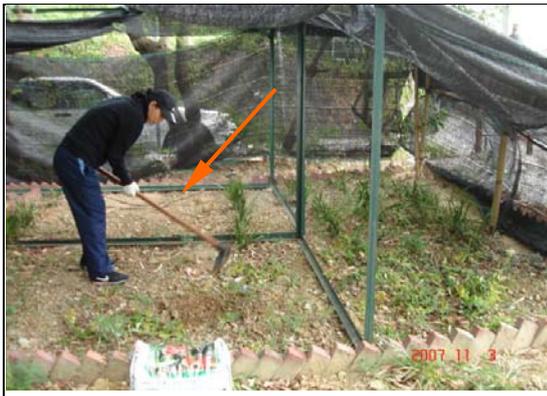
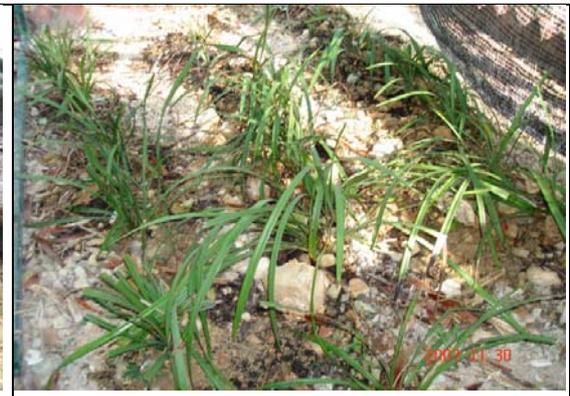
<p>Photo 1 - Plant nursery and the transplanted Chinese Lily (arrow).</p>	<p>Photo 2 - Transplanted Sword-leaved Orchid at the plant nursery site.</p>

- 3.3 The transplanted plants and the plant receptor (Photo 1) is generally in good condition. Most of the transplanted Sword-leaved Orchids were healthy (Photo 2). All the transplanted Balloon Flowers at the receptor site were bearing with flower or fruits (Photo 3), while some of the plants were experience seasonal shrunken (Photo 4).
- 3.4 Regular maintenance including watering, weeding, apply fertilizer and pest checking to be applied continuously at the receptor site in order to achieve higher survival rate. Twice a week watering was recommended during the current dry season.

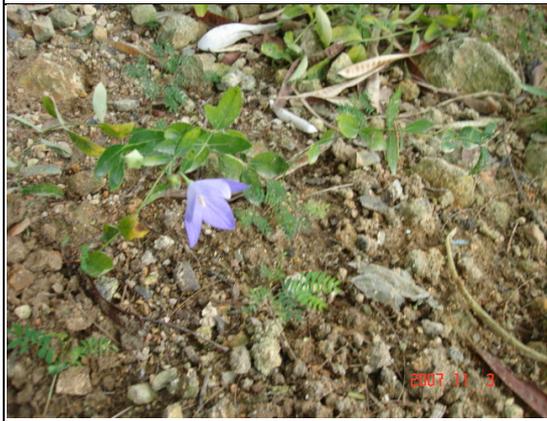
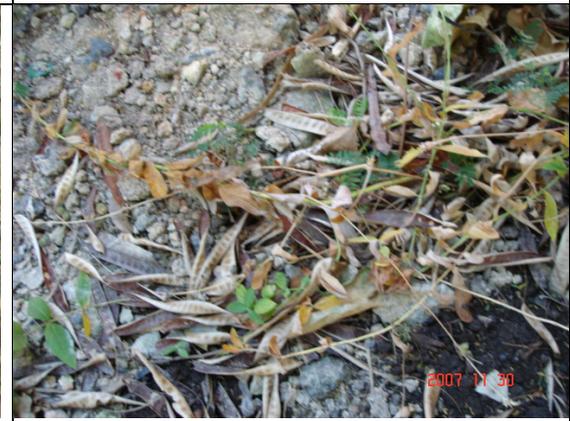
<p>Photo 3 - Balloon Flower bearing flower and fruits.</p>	<p>Photo 4 - Balloon Flower ~ seasonal shrunken.</p>

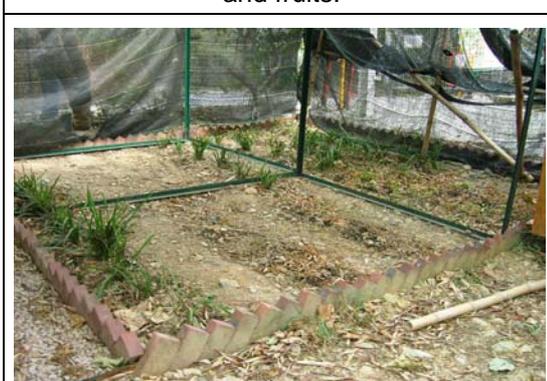
<p>Photo 5 - Transplanted Chinese Lily at the plant nursery site.</p>
