Ocean Park Master Redevelopment Project

Monthly Environmental Monitoring & Audit Report – February 2008

Environmental Permit No. EP-249/2006/A - Condition 3.4

Monthly EM&A Report – February 2008

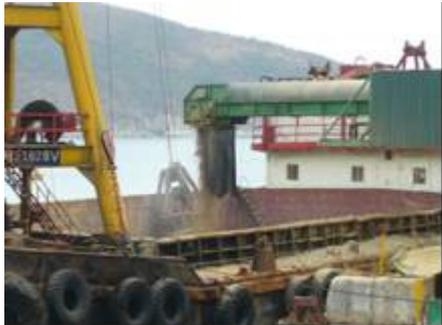
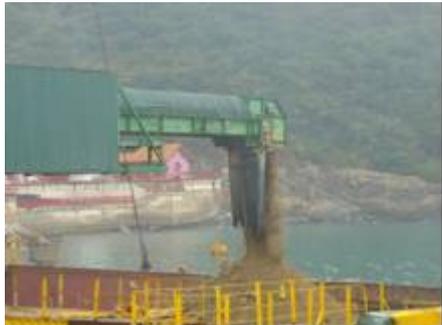
<p>P1050440:& P1050452: The Crusher Area and the Conveyor Crusher Area were generally dusty. The Contractor shall ensure the automatic water sprays were working properly to suppress dust.</p>	<p>Closed – P1050633 & P1050624: The Crusher Area and the Conveyor Crusher Area were less dusty due to heavy rain.</p>
Barging Point

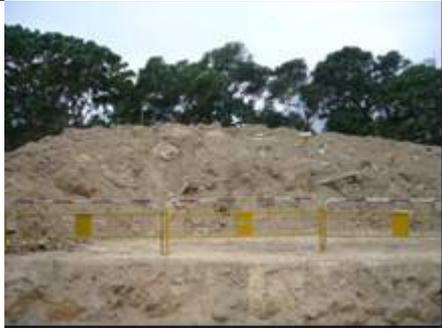
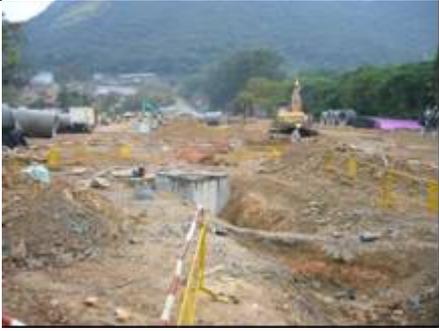
<p>P1050438 & P1050466: A few gully pits and catchpit outlets within the site were not provided with sandbags. The Contractor shall ensure discharge of muddy surface runoff into public drains were avoided.</p>		<p>P10505620 & P1050646: The catchpit outlets within the site were blocked while a few gully pits were not provided with sandbags to divert the site runoff. The Contractor shall ensure discharge of muddy surface runoff into public drains be prohibited.</p>	
<p>Citybus Depot</p>

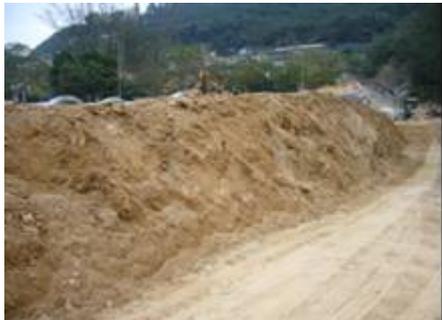
<p>P1050459 & P1050461: Stockpiles of dusty materials were idled and uncovered. The Contractor shall ensure they are compacted and covered by tarpaulin sheets or other means to suppress dust.</p>		<p>Closed - P1050645: Stockpiles of dusty materials were either compacted or no longer observed.</p>

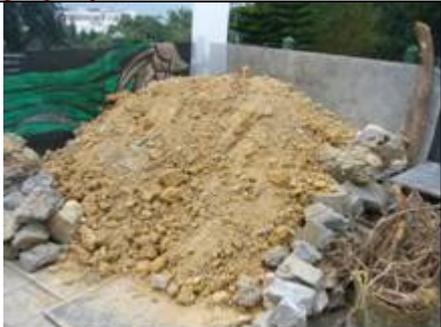
<p>P1050390 & P1050398: Scrap materials and general refuse were accumulated near the Bird Exercise Aviary and the Transformer Room. The Contractor shall remove and dispose them properly.</p>	<p>Closed: P1050556 & P1050567: Scrap materials and general refuse accumulated near the Bird Exercise Aviary and the Transformer Room were removed.</p>

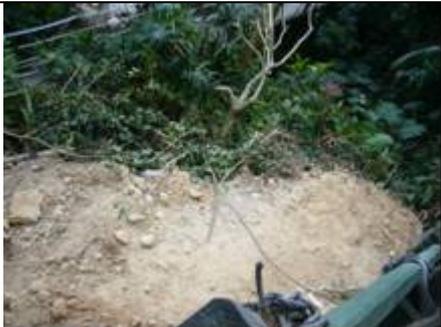
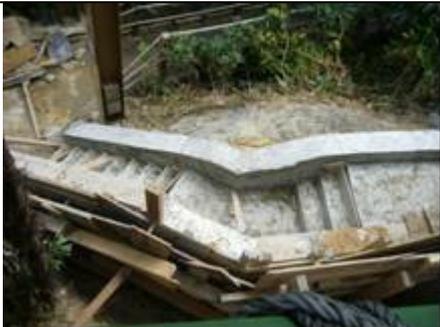
N/A
<p>P1050393: Stockpile of backfill material at the New Panda House was idle and uncovered. The Contractor shall cover it with tarpaulin or other means.</p>	<p>Closed: Stockpile of backfill material was no longer observed at the New Panda House.</p>

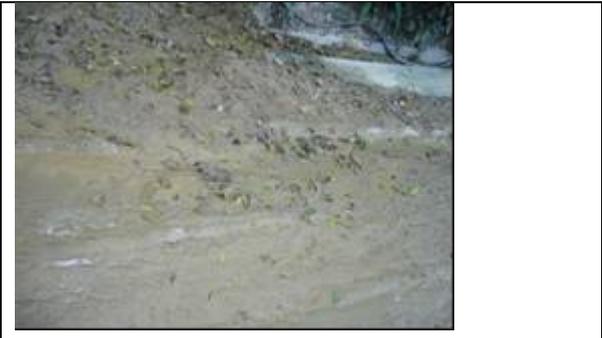
<p>P1050567 & P1050570: Stockpiles of excavated materials located next to the Generator Room and between Main Aviary and AA Restaurant were not covered with tarpaulin sheets or other means. The Contractor shall cover them with tarpaulin sheets or other means properly.</p>		<p>P1050569: Mud was accumulated on the access road and drainage channel between the Main Aviary and AA Restaurant. The Contractor shall remove the mud on the access road and any blockage of the drainage channel as soon as possible.</p>

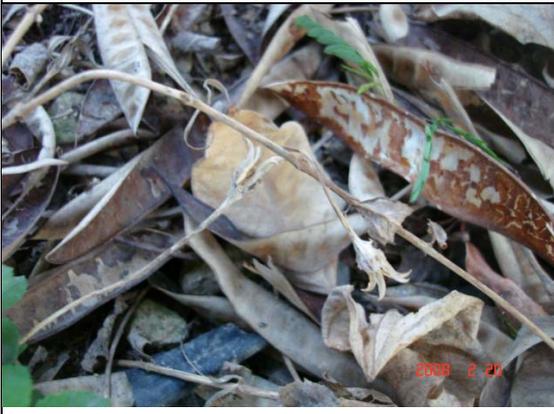
<p>Photo 3 - Balloon Flower: seasonal shrunken.</p>	<p>Photo 4 - Balloon Flower: new seedling.</p>

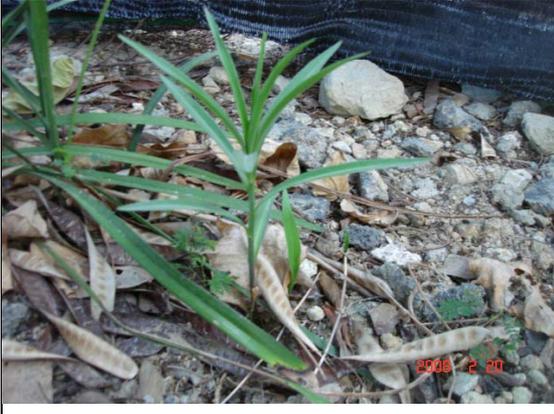
<p>Photo 5 - Chinese Lily: new seedling.</p>

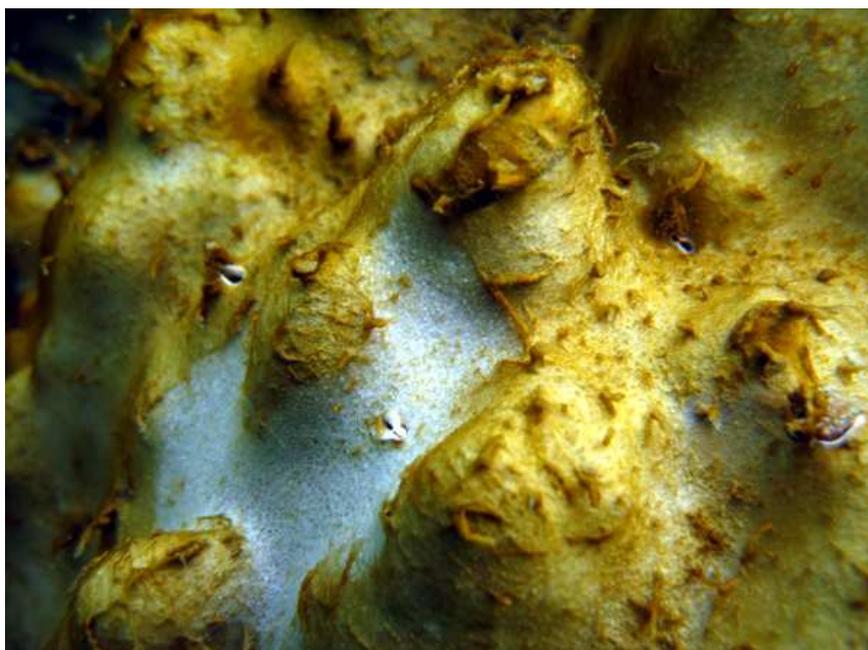
Four of the tagged *Porites* colonies (each in Sites 3, 4 and 5 and Control Site C) showed abnormal status with symptoms of paleness polyps, production of a mucus layer on colony surface and overgrowth of microalgae on the mucus layer. These symptoms were only observed in *Porites* sp.. Similar phenomenon was also recorded in the eastern and southern waters in the same period. The phenomenon has never been reported in Hong Kong before. The symptom is believed not to be caused by construction work, as no apparent increment of sediment is recognized, and the observation is not limited to the impact sites.

Fig. 4.1 Symptoms showing by *Porites* colonies. Paleness polyps, production of a mucus layer on colony surface and algal overgrowth on the mucus layer.

- 4.1.4 The prolong (~3 weeks), extremely low water temperature (13-15°C) has been recorded from late January to late February 2008 and is going to extend to a couple of weeks in Hong Kong waters (Hong Kong Observatory). As mean winter water temperature in Hong Kong is usually ~17°C, the below-average water temperature in this winter is believed to have adverse effect on the survival of tropical marine communities, in particular the hard coral species including the *Porites* colonies.

- 4.1.5 Further observation is necessary in order to evaluate the bleaching and mortality status of the tagged *Porites* colonies (C03, D05, E04 and F04). If the symptoms persist, or mortality increase due to factors other than the construction sources (as indicated by concomitant occurrence in both impact and control sites), the colonies will be considered not suitable for monitoring purpose and new colonies of other species will be tagged to accomplish the objective.

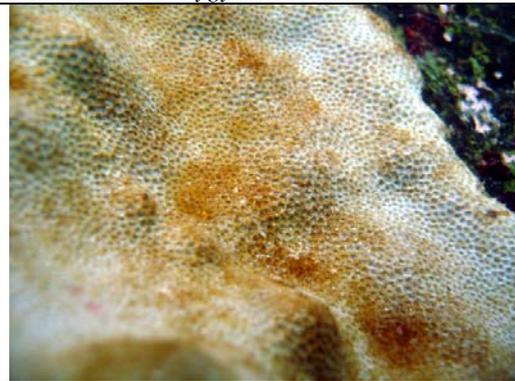
C03

Porites sp.

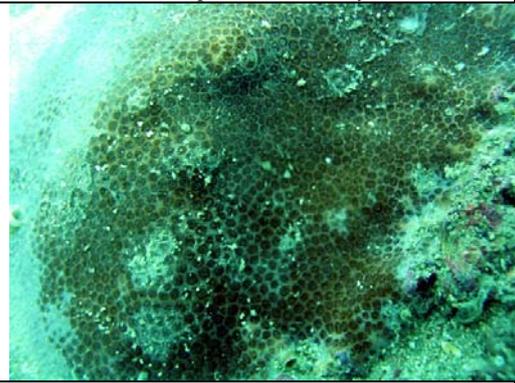
E04

Porites sp.

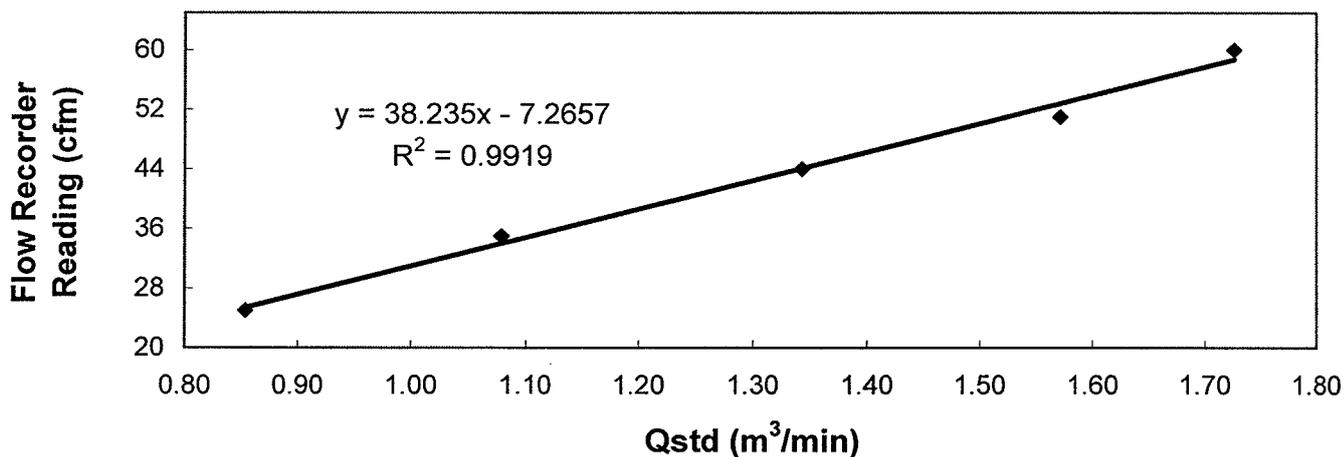
**Sampler 1174 Calibration Curve
Site: Ocean Park (AM-1)
Date of Calibration: 02 January 2008**

Flow recorder reading (cfm)	60	51	44	35	25
Qstd (Actual flow rate, m ³ /min)	1.73	1.57	1.34	1.08	0.85
Pressure :	769.56 mm Hg		Temp. :	295 K

Acceptance Criteria : Correlation coefficient (r) of the calibration curve greater than 0.990 after a 5-point calibration

The high volume sampler complies * / does not comply * with the specified requirements and is deemed acceptable * / unacceptable * for use.

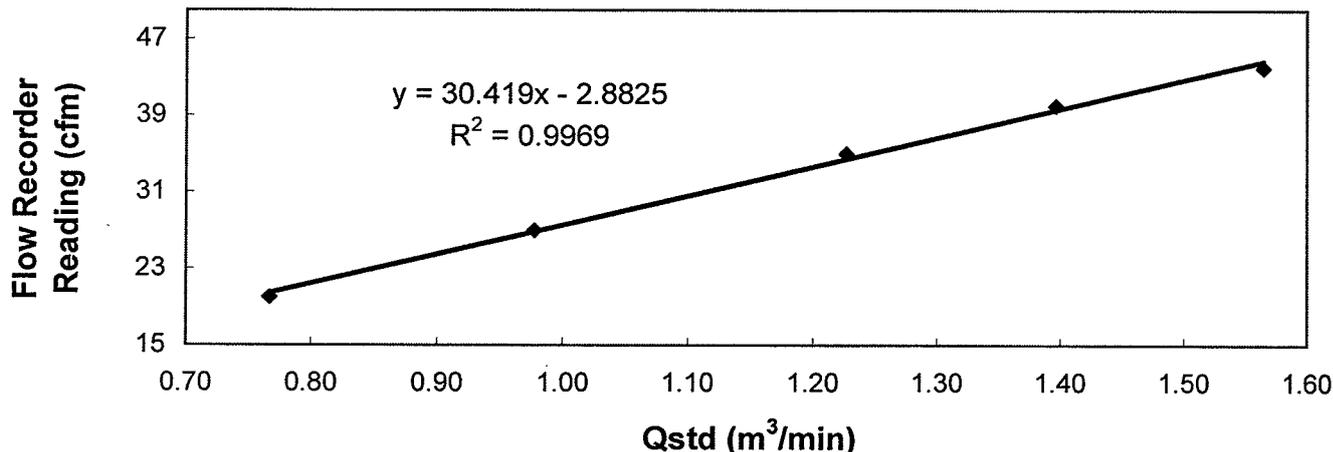
Sampler 1177 Calibration Curve
Site: Ocean Park (AM-2)
Date of Calibration: 02 January 2008

Acceptance Criteria : Correlation coefficient (r) of the calibration curve greater than 0.990 after a 5-point calibration

The high volume sampler complies * / ~~does not comply~~ * with the specified requirements and is deemed acceptable * / unacceptable * for use.

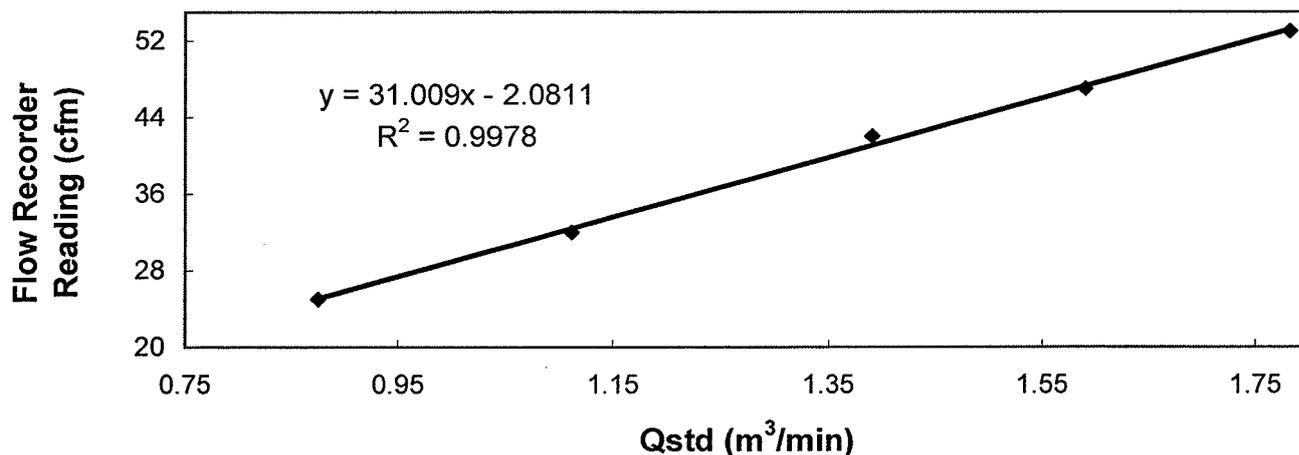
Sampler 9998 Calibration Curve
Site: Ocean Park (AM-3)
Date of Calibration: 02 January 2008

Acceptance Criteria : Correlation coefficient (r) of the calibration curve greater than 0.990 after a 5-point calibration

The high volume sampler complies * / ~~does not comply~~ * with the specified requirements and is deemed acceptable * / ~~unacceptable~~ * for use.
