# Ocean Park Master Redevelopment Project

Quarterly Environmental Monitoring & Audit  
Report – from July 2009 to September 2009

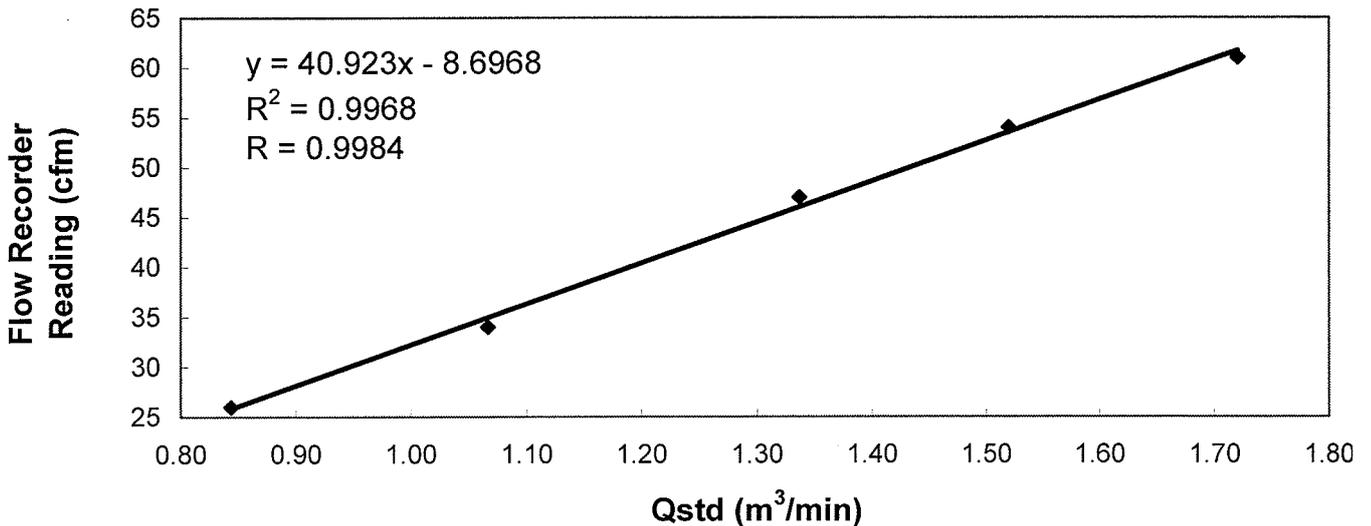
**Sampler 1174 Calibration Curve**  
**Site: Ocean Park (AM-1)**

Flow recorder reading (cfm)	61	54	47	34	26
Qstd (Actual flow rate, m <sup>3</sup> /min)	1.72	1.52	1.34	1.07	0.84
Pressure :	759 mm Hg			Temp. :	298 K

Acceptance Criteria : Correlation coefficient (r) of the calibration curve greater than 0.990 after a 5-point calibration.

The high volume sampler complies\* / does-not-comply\* with the specified requirements and is deemed acceptable\* / unacceptable\* for use.

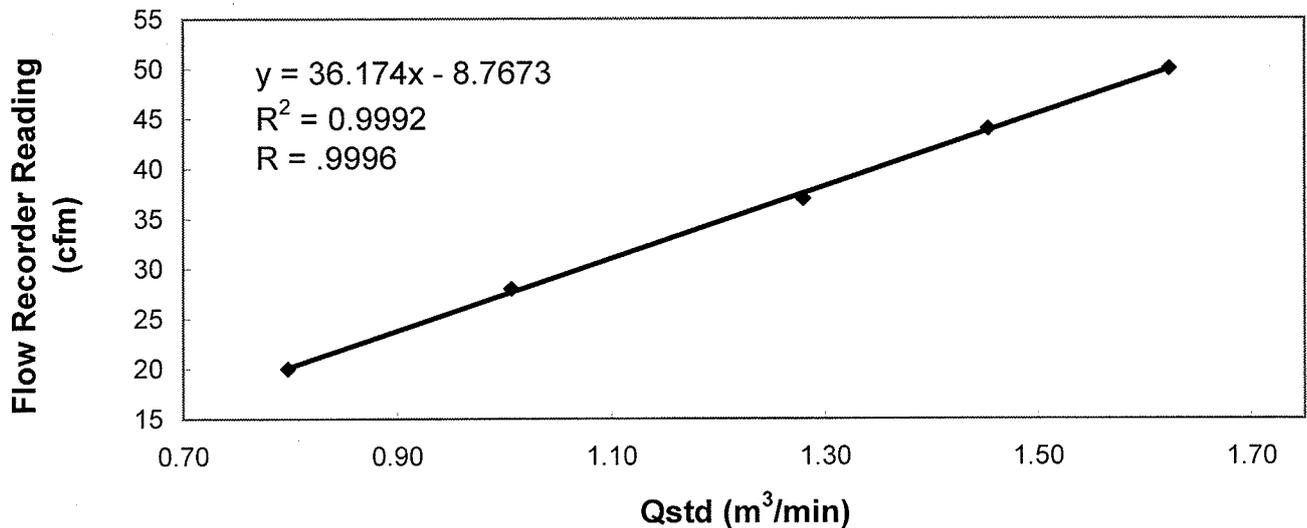
**Sampler 1177 Calibration Curve  
Site: Ocean Park (AM-2)**

Flow recorder reading (cfm)	50	44	37	28	20
Qstd (Actual flow rate, m <sup>3</sup> /min)	1.62	1.45	1.28	1.01	0.80
Pressure :	760 mm Hg		Temp. :	298 K

Acceptance Criteria : Correlation coefficient (r) of the calibration curve greater than 0.990 after a 5-point calibration.

The high volume sampler complies\* / ~~does not comply\*~~ with the specified requirements and is deemed acceptable\* / unacceptable\* for use.

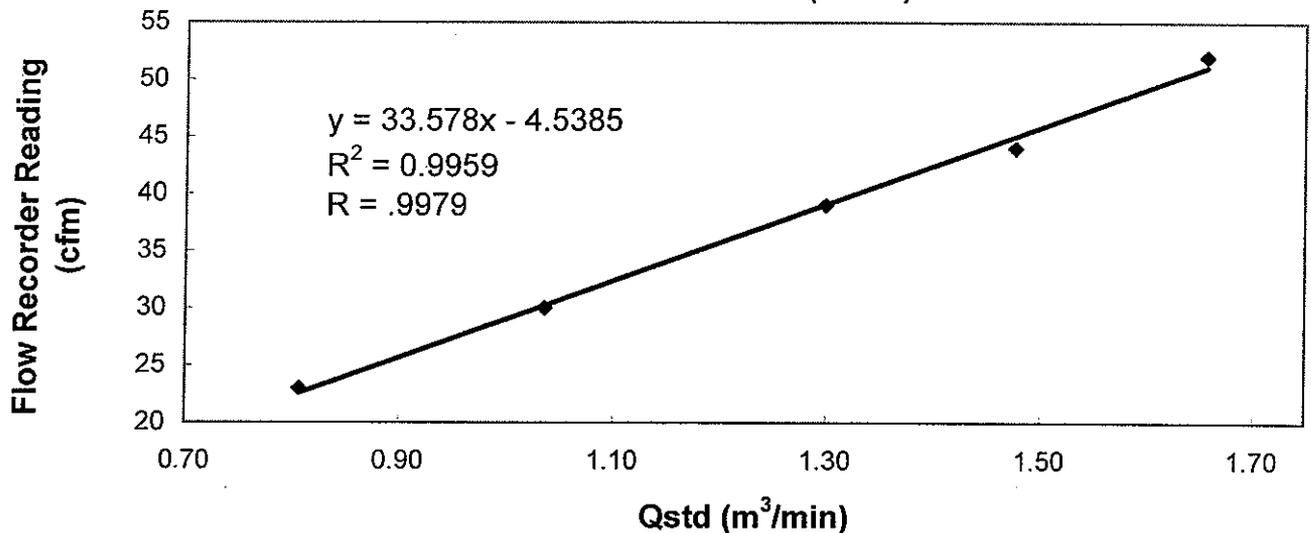
**Sampler 1177 Calibration Curve**  
Site: Ocean Park (AM-2)

Flow recorder reading (cfm)	52	44	39	30	23
Qstd (Actual flow rate, m <sup>3</sup> /min)	1.66	1.48	1.30	1.04	0.81
Pressure :	761 mm Hg		Temp. :	303 K

Acceptance Criteria : Correlation coefficient (r) of the calibration curve greater than 0.990 after a 5-point calibration.

The high volume sampler complies\* / does not comply\* with the specified requirements and is deemed acceptable\* / unacceptable\* for use.

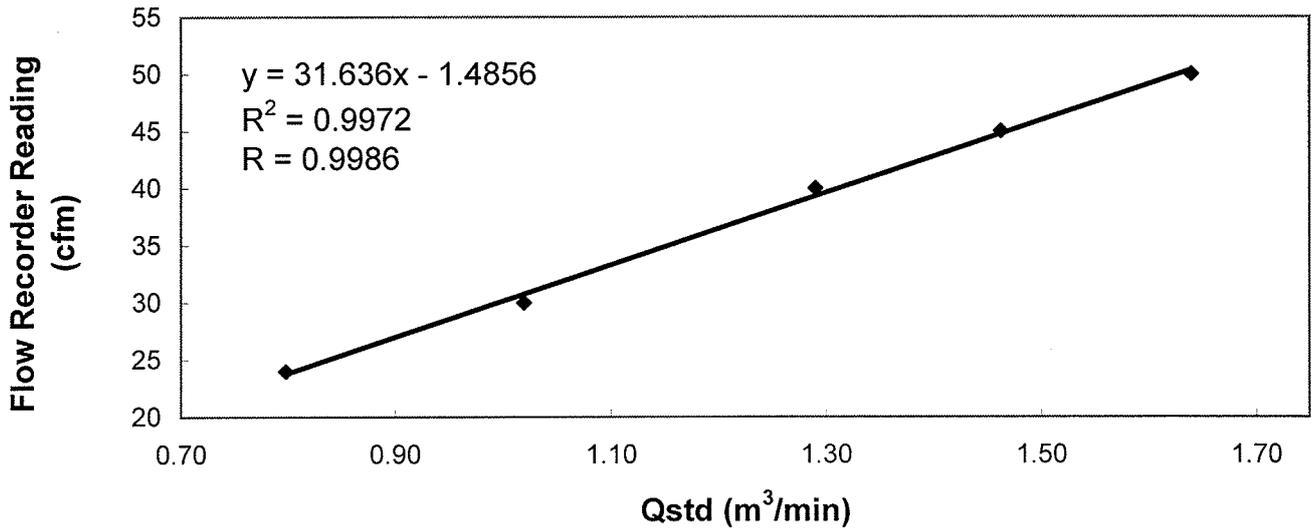
**Sampler 9998 Calibration Curve**  
**Site: Ocean Park (AM-3)**

Flow recorder reading (cfm)	50	45	40	30	24
Qstd (Actual flow rate, m <sup>3</sup> /min)	1.64	1.46	1.29	1.02	0.80
Pressure :	760 mm Hg			Temp. :	298 K

Acceptance Criteria : Correlation coefficient (r) of the calibration curve greater than 0.990 after a 5-point calibration.

The high volume sampler complies\* / ~~does not comply\*~~ with the specified requirements and is deemed acceptable\* / unacceptable\* for use.

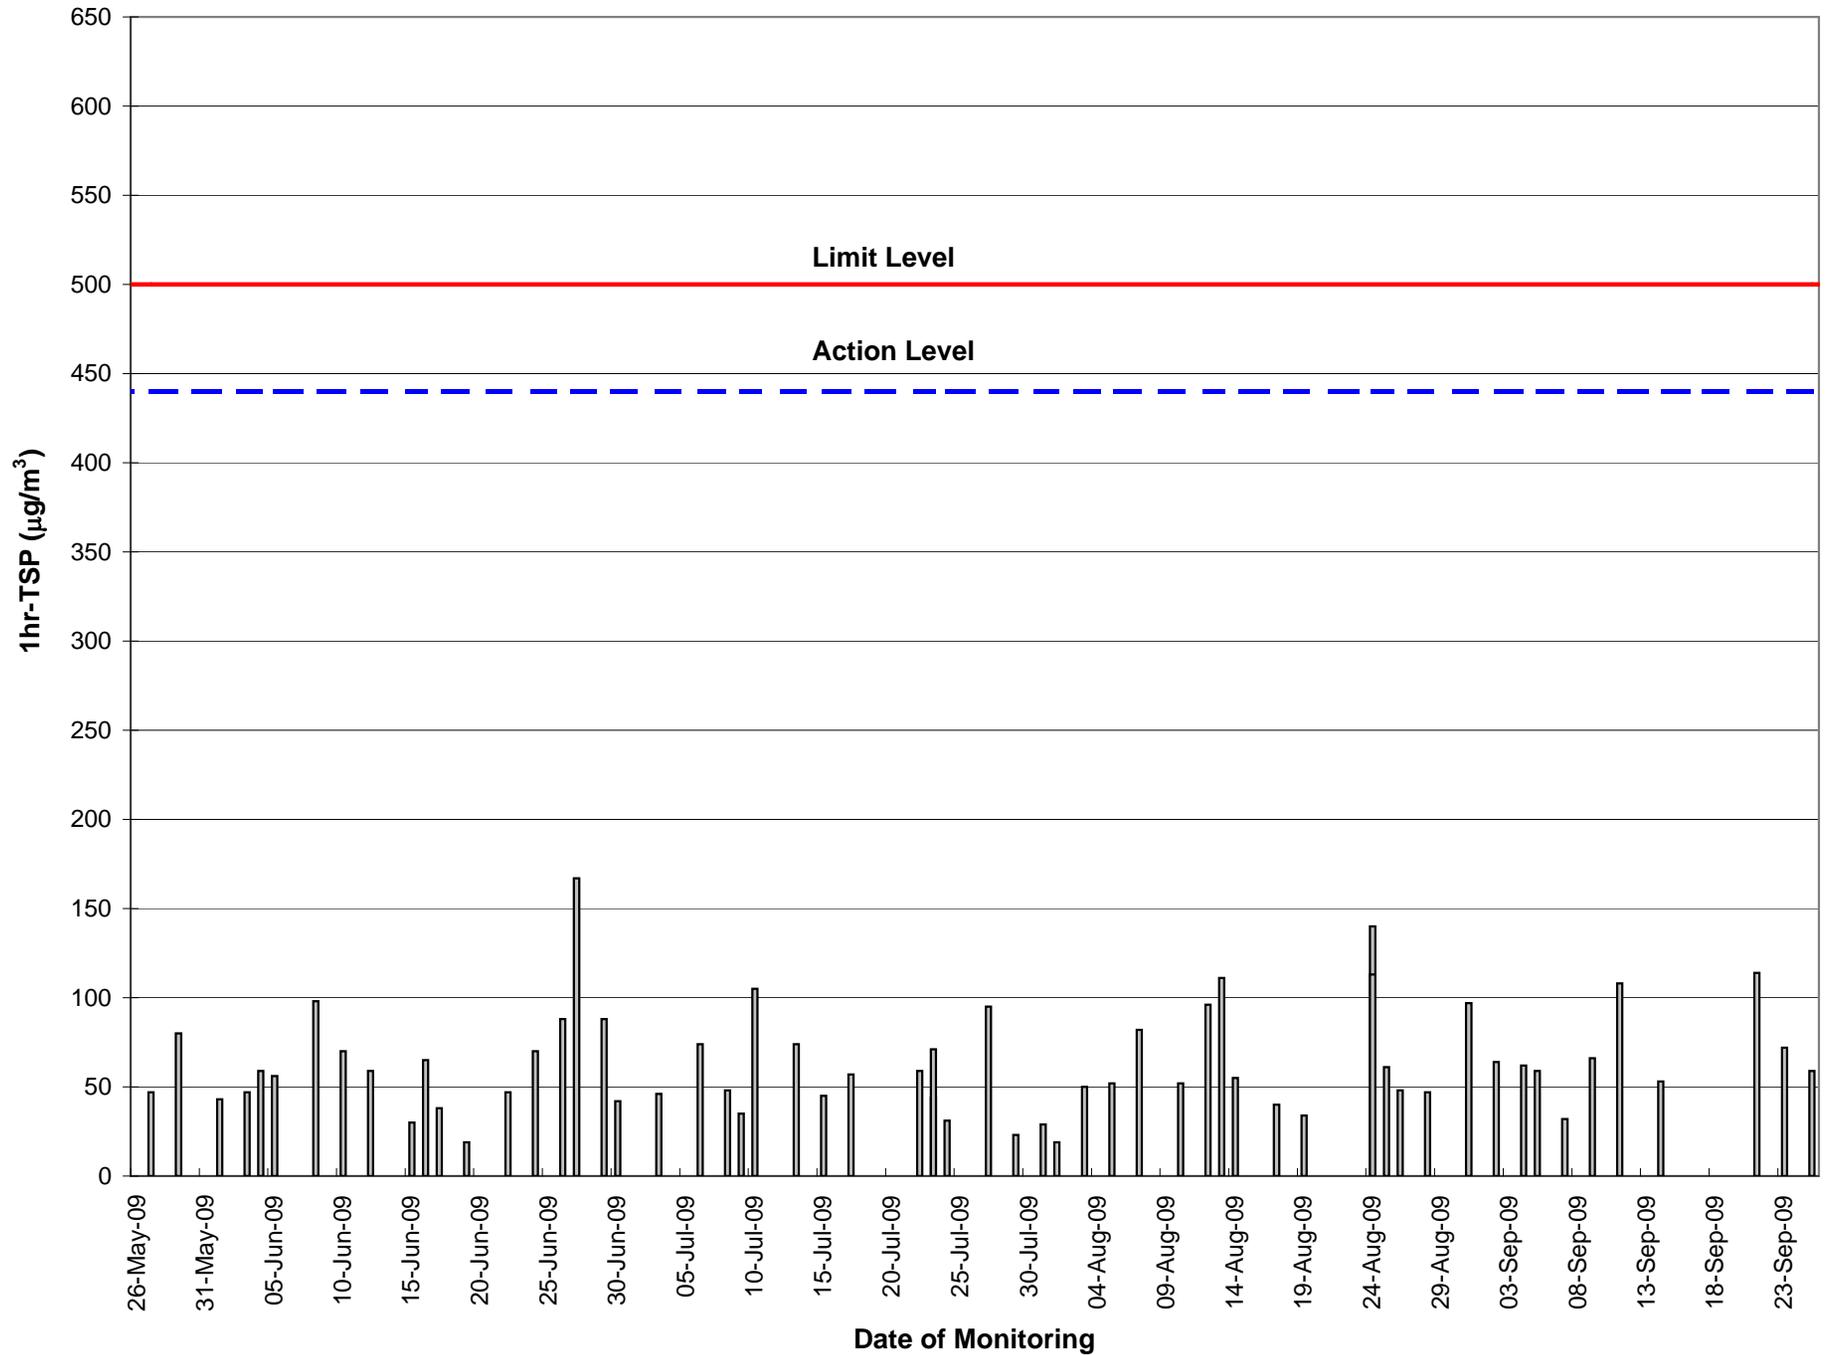
Figure C.1 1-hr TSP monitoring results of Monitoring Station AM1

- 3.1 No exceedance of Action and Limit Level for 1-hour TSP and 24-hour TSP was recorded in the reporting quarter. Graphical presentations of the air quality monitoring results are provided in **Appendix E**.

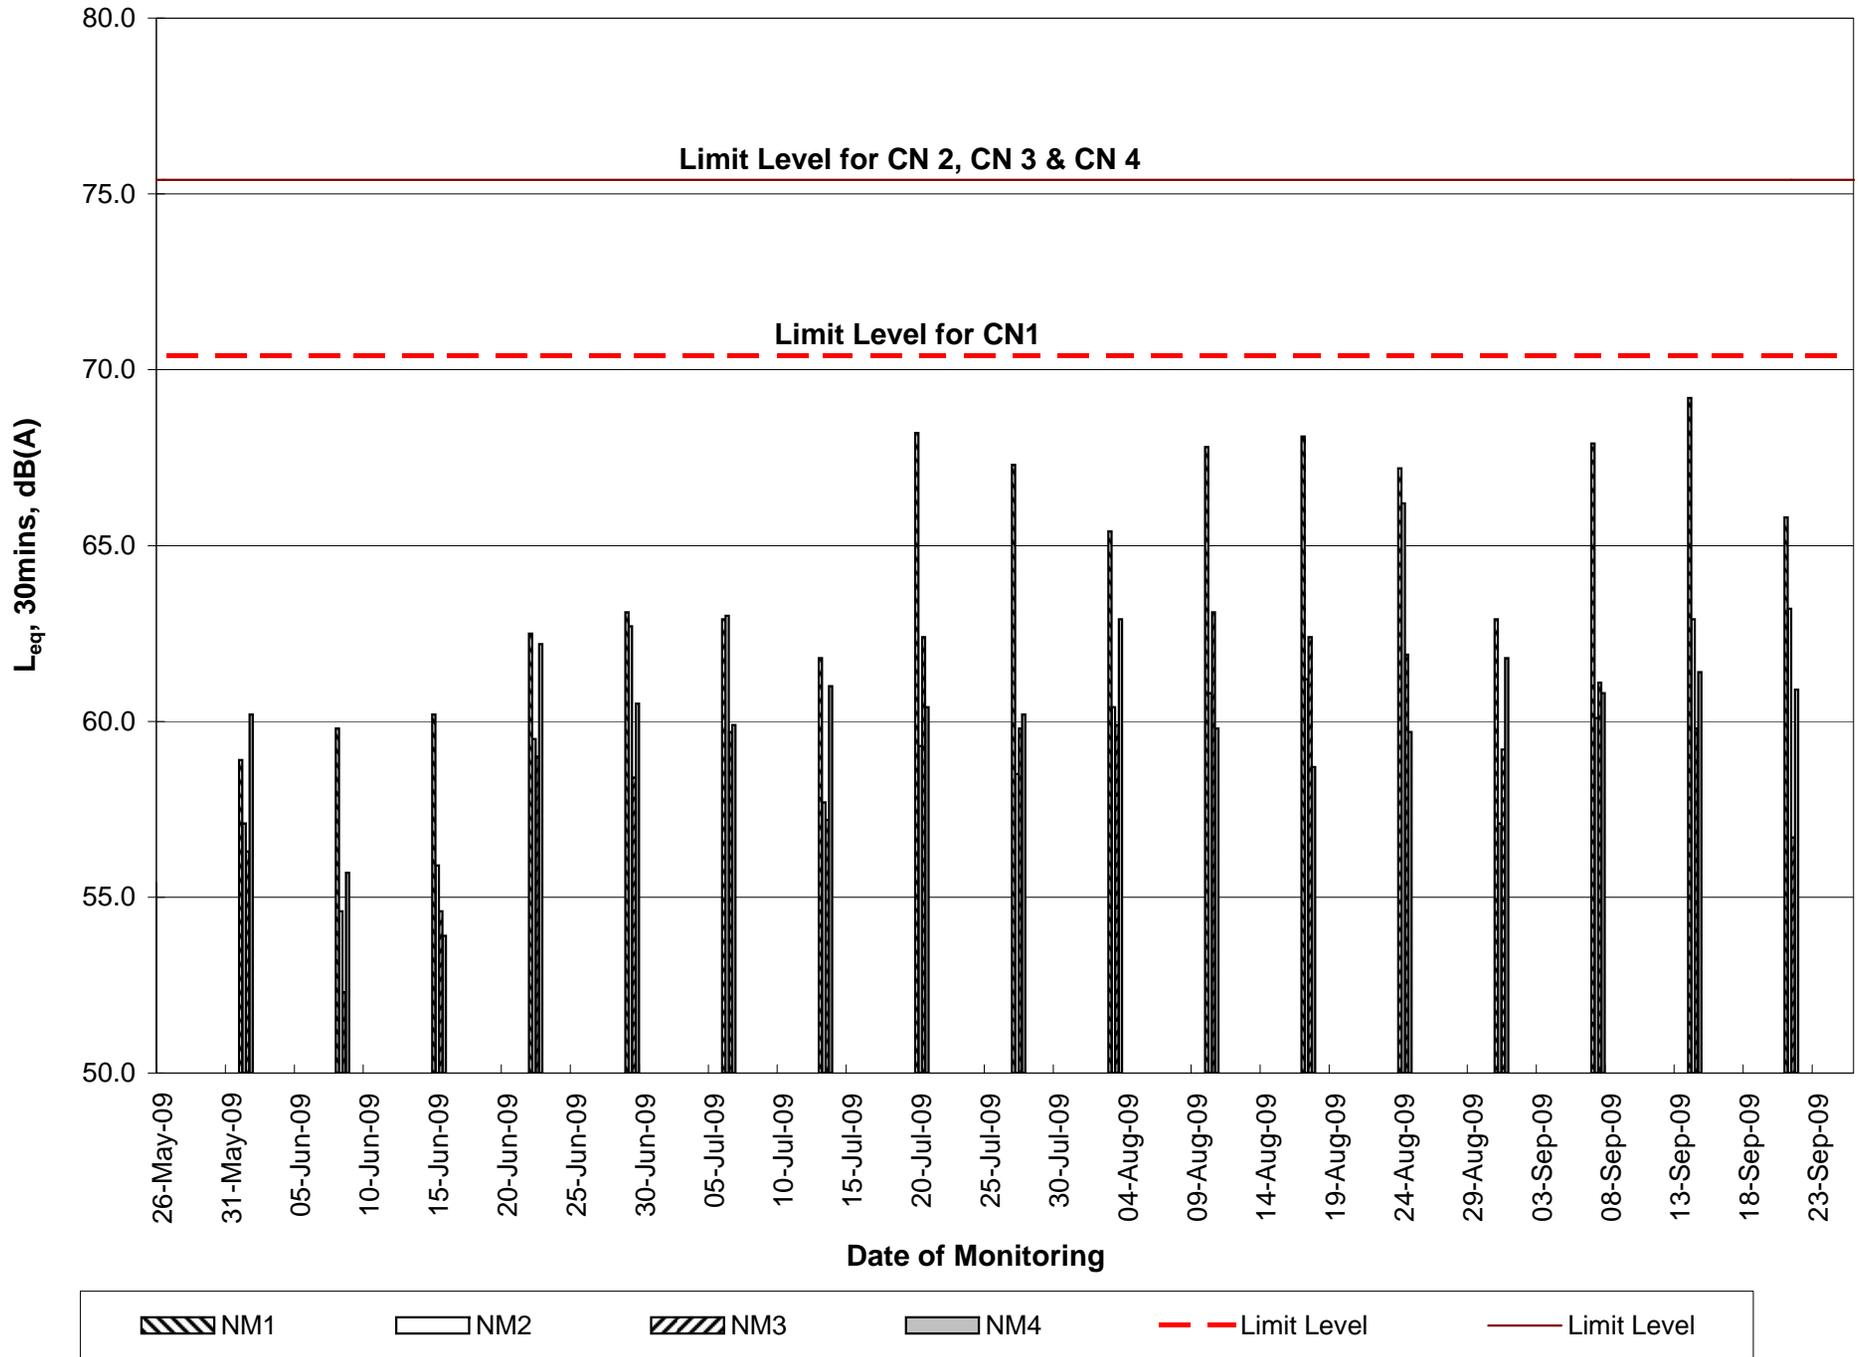
Fig D.1 - Daytime Noise Monitoring Results of Monitoring Stations CN1, CN2, CN3 & CN4

- 3.2 Noise monitoring was carried out for daytime (0700-1900) and evening time (1900 -2300) at four stations in the reporting quarter. No Holiday-time noise monitoring was scheduled in the reporting quarter. Graphical presentations of the noise monitoring results are provided in **Appendix F**.

All measured noise levels during daytime and evening time were below the AL levels.

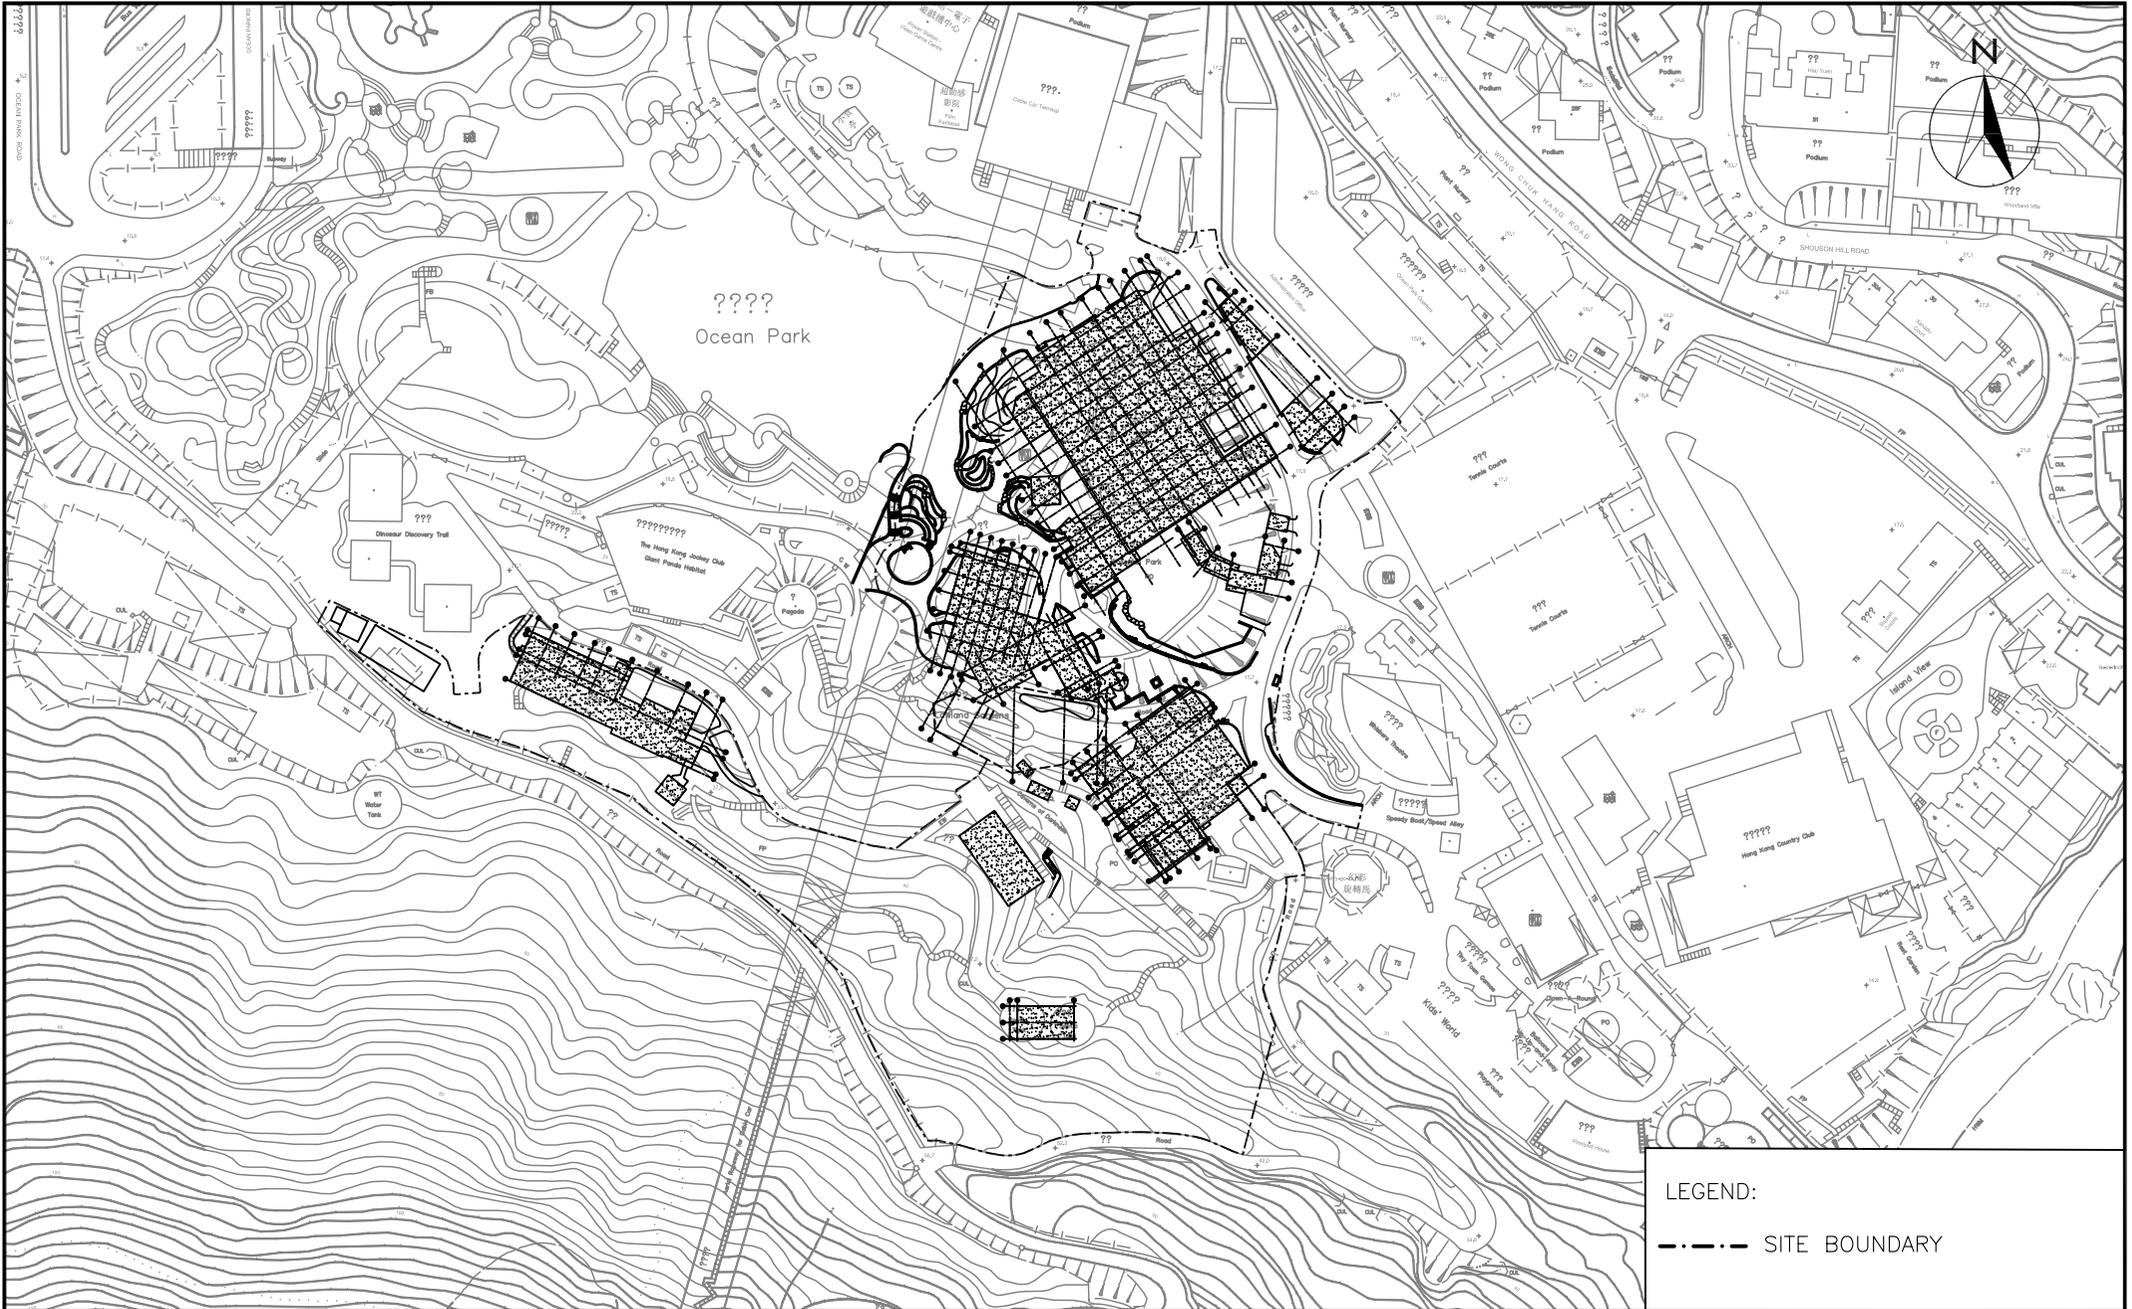
**Figure 1.2**

1.6 A layout plan of the Project is provided in **Figure 1.2 to Figure 1.3 and Figure 1.4** Figure 1.2 shows the layout plan of CW-02 Astounding Asia. Figure 1.3 shows the layout plan of CI-07 Entry Plaza, Aqua City and Grand Aquarium. Figure 1.4 shows the layout plan of CS-02 Rainforest.

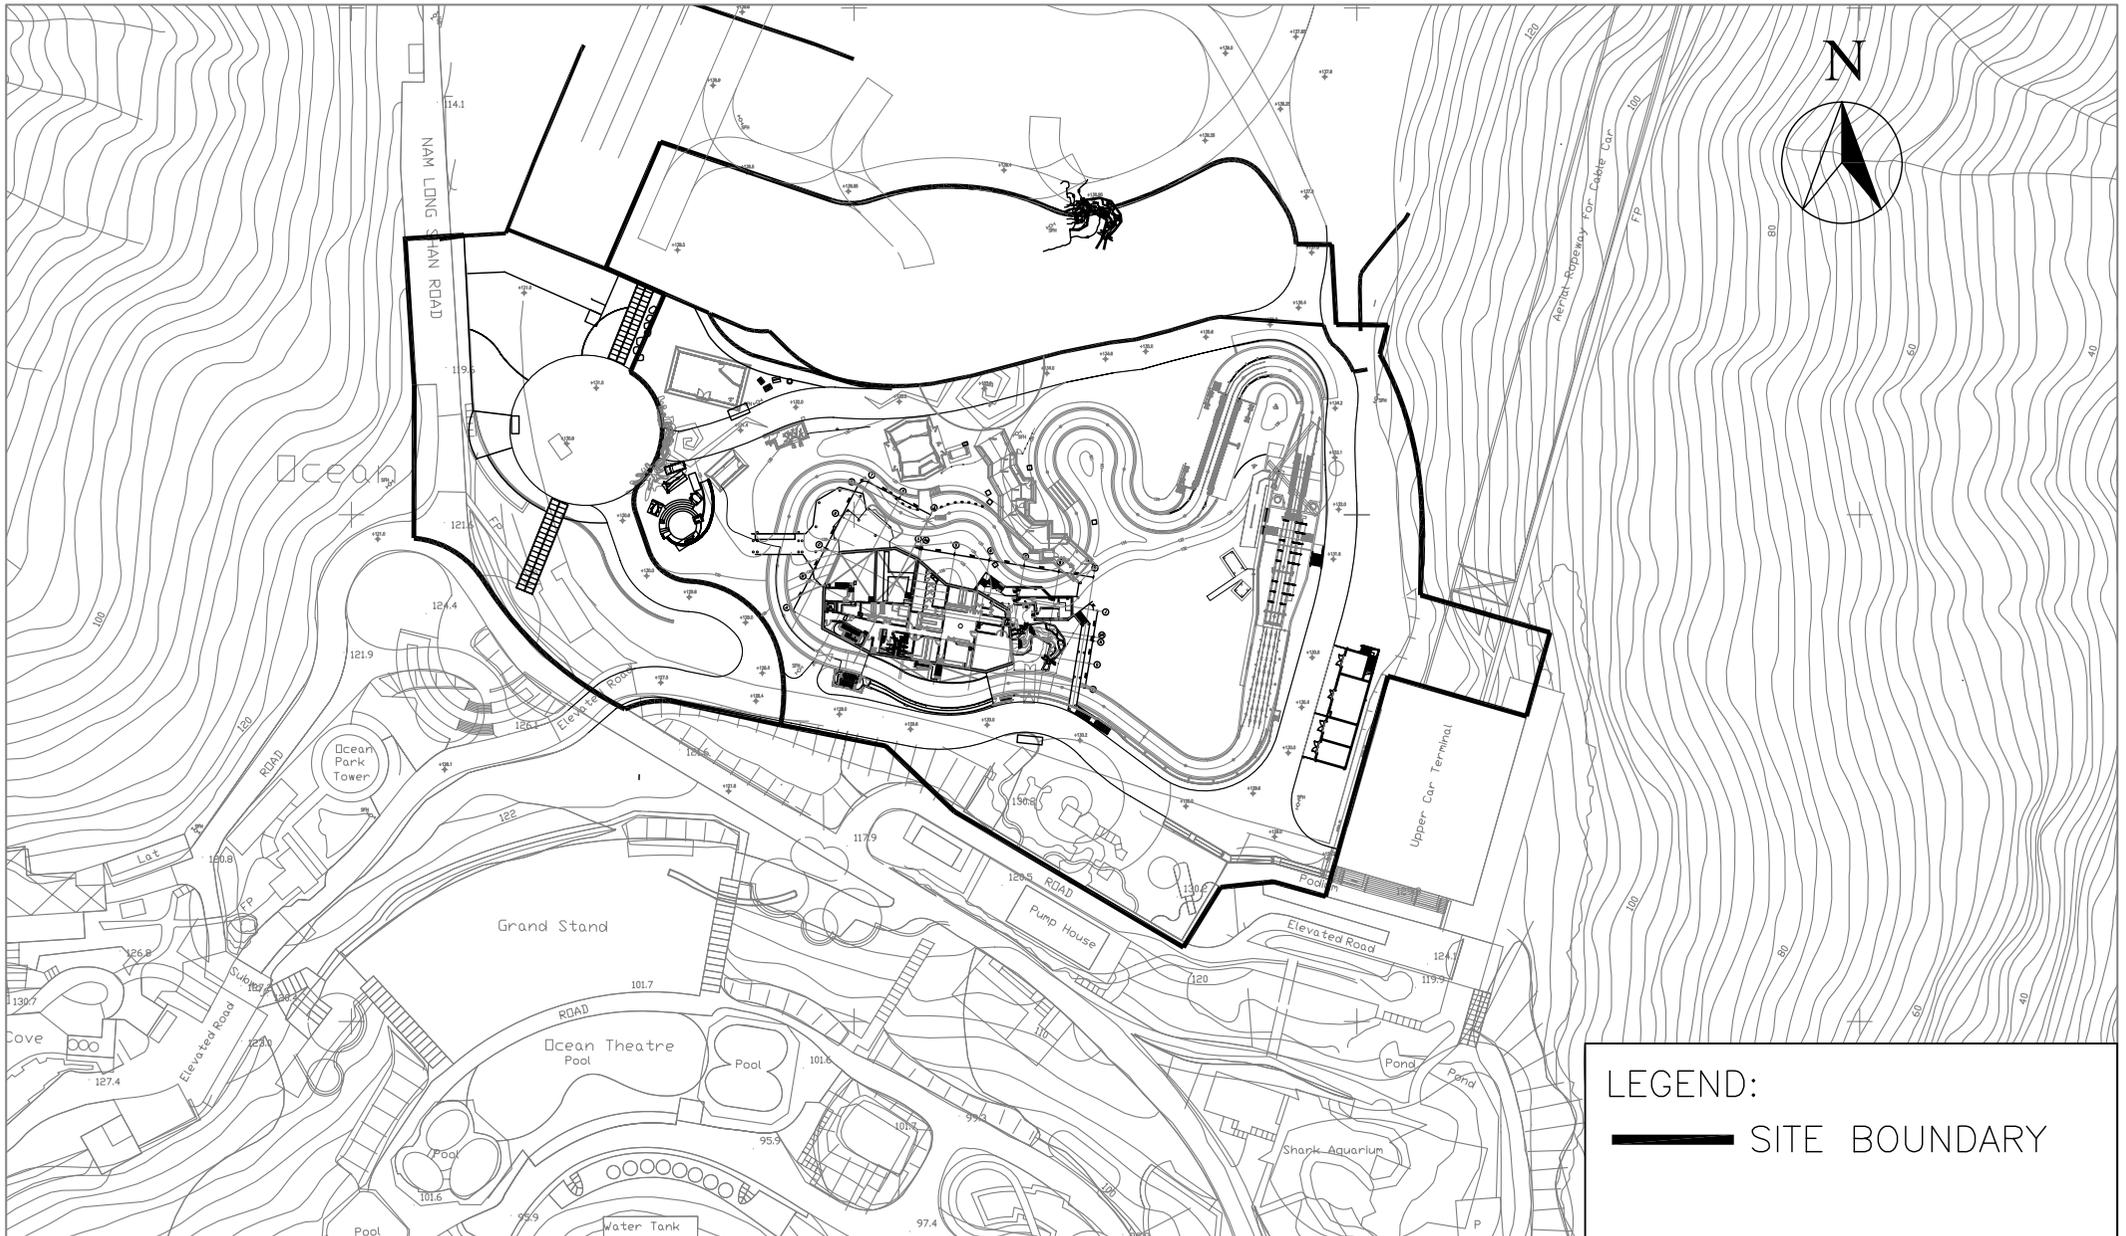
**Figure 1.4**

<b>永興聯合建築有限公司</b> <b>W. HING CONSTRUCTION CO. LTD.</b>	CONTRACT NO. CS02 OCEAN PARK REDEVELOPMENT PROJECT – RAINFOREST <b>SITE LAYOUT PLAN</b>	SCALE	A4 1:1500	DATE	JULY 2009	
		CHECK	Kan Kwok	DRAWN	HC LAU	
		JOB NO.	CS02	DRAWING No.	CS02/SL/01	REV

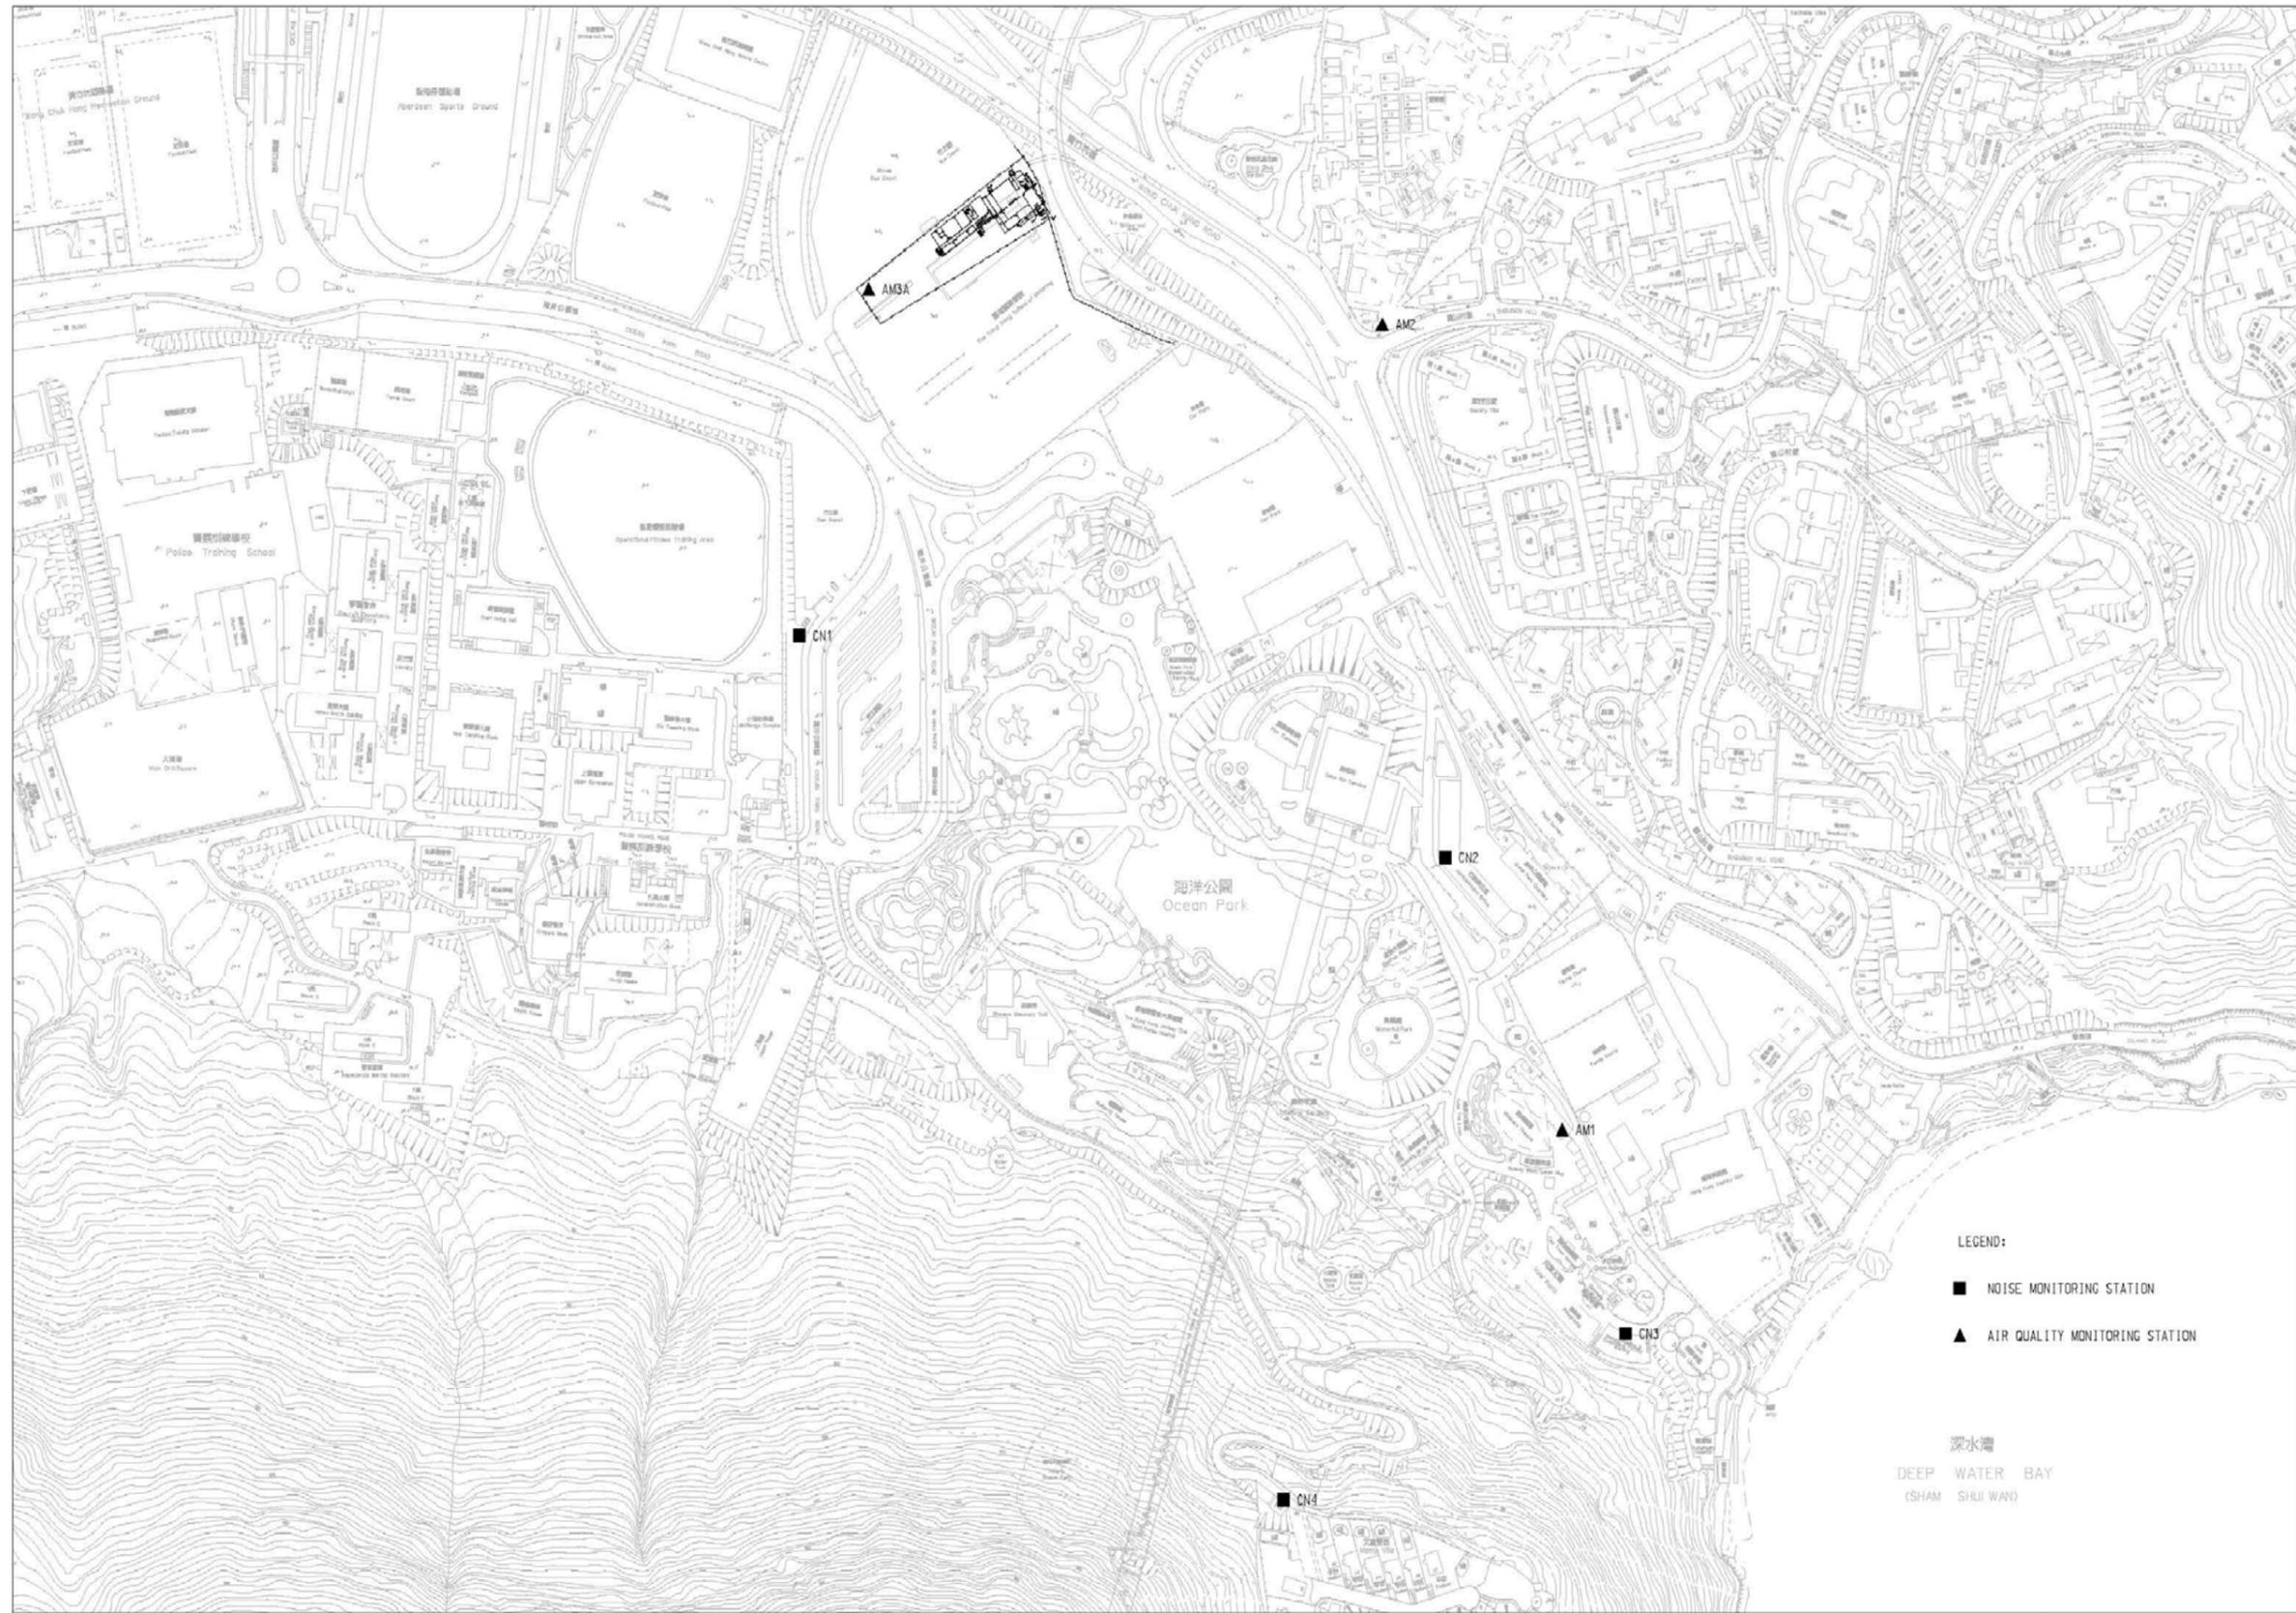
- 2.1 The EM&A Manual designates locations for the CET to monitor environmental impacts in terms of air quality, noise and ecology from the Project. The locations of air quality, noise and ecology monitoring and their control station(s) if applicable; are depicted in **Figure 1.5** and **Figure 1.6**. **Appendix B** gives the details of the monitoring programme.
