Ocean Park Master Redevelopment Project

Monthly Environmental Monitoring & Audit
Report – November 2009

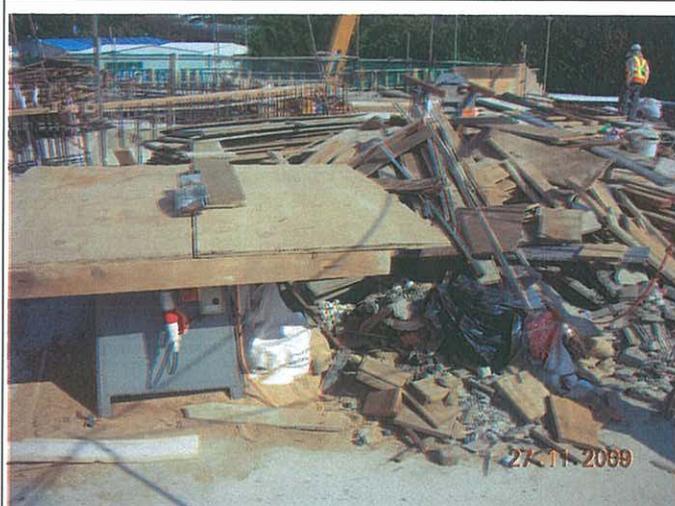
1. General refuge and saw dust were accumulated next to table saw.

1. The contractor was reminded to clean up the refuge and provide adequate bags to store saw dust.

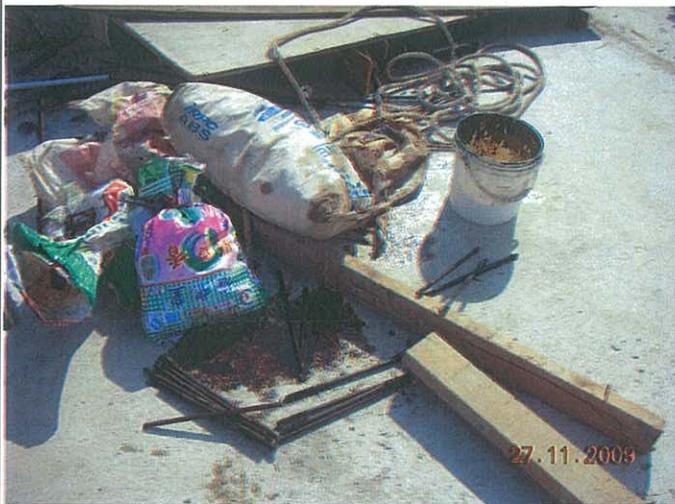
1. Oil spill was observed on the podium deck.

1. The contractor was reminded to clean up and provide drip tray underneath all chemical and oil containers in future.
