# Ocean Park Master Redevelopment Project

Quarterly Environmental Monitoring & Audit  
Report – from January 2010 to March 2010

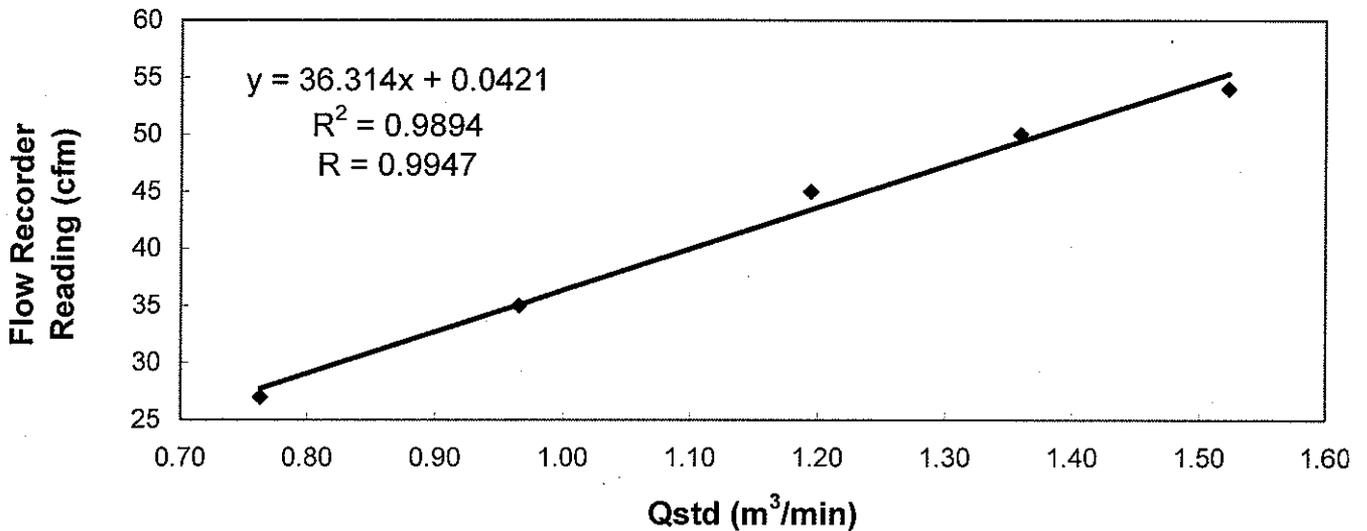
**Sampler 1174 Calibration Curve**  
Site: Ocean Park (AM-1)

Flow recorder reading (cfm)	54	50	45	35	27
Qstd (Actual flow rate, m <sup>3</sup> /min)	1.52	1.36	1.19	0.96	0.76
Pressure :	764 mm Hg			Temp. :	302 K

Acceptance Criteria : Correlation coefficient (r) of the calibration curve greater than 0.990 after a 5-point calibration.
