Ocean Park Master Redevelopment Project

Monthly EM&A Report – May 2010

Environmental Permit No. EP-249/2006/A - Condition 3.4

Monthly Environmental Monitoring & Audit
Report – May 2010

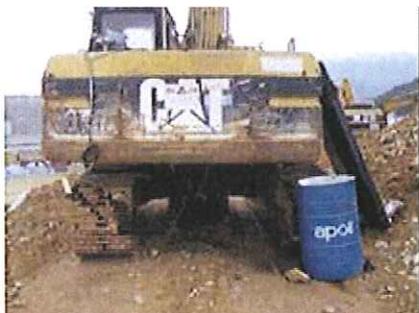
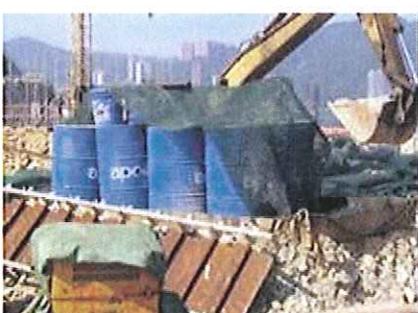
<p>P1080986 & P1080994: A few oil drums were not provided with drip tray and oil spillage due to machinery maintenance or repair was observed. The Contractor should ensure all oil drums on site are provided with drip tray and oil spillage should be avoided.</p>	<p>Closed - P1090377 & P1090378: Oil drums were provided with drip trays while contaminated soil from oil spillage had been disposed as chemical waste.</p>

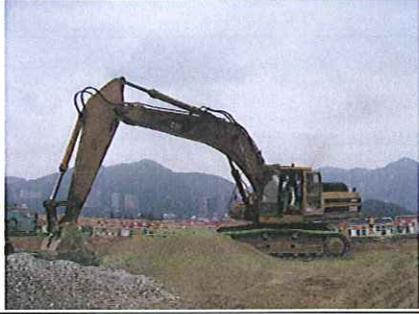
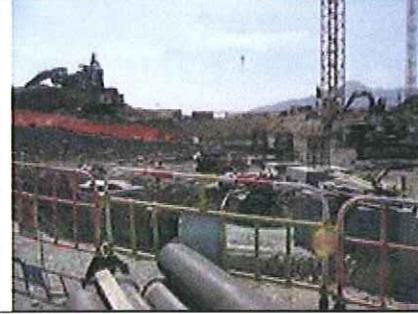
<p>P1080992: Stockpiles of dusty material was not covered with tarpaulin sheets or other means. The Contractor should cover all idle stockpiles of dusty materials on-site to suppress dust.</p>	<p>P1090384: Stockpiles of dusty material was not covered with tarpaulin sheets or other means. The Contractor should cover all idle stockpiles of dusty materials on-site to suppress dust.</p>

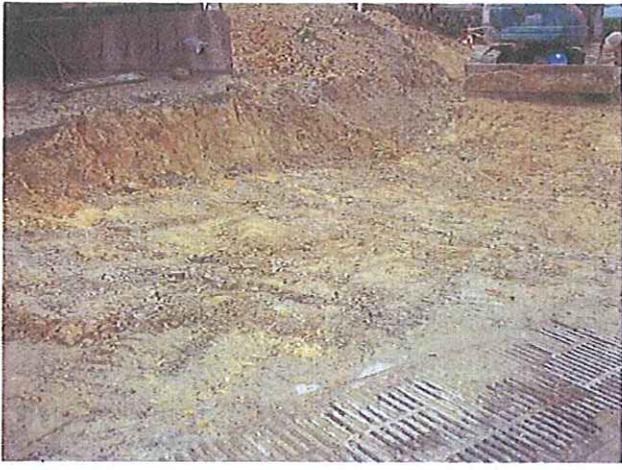
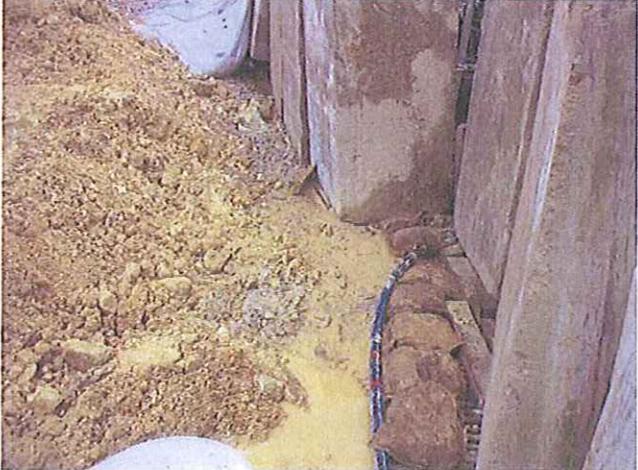
<p>1. No protection was made to prevent soil from the slope behind GA entering the surface channel.</p>	<p>1. The contractor was reminded to provide sandbag to prevent soil entering the surface channel.</p>

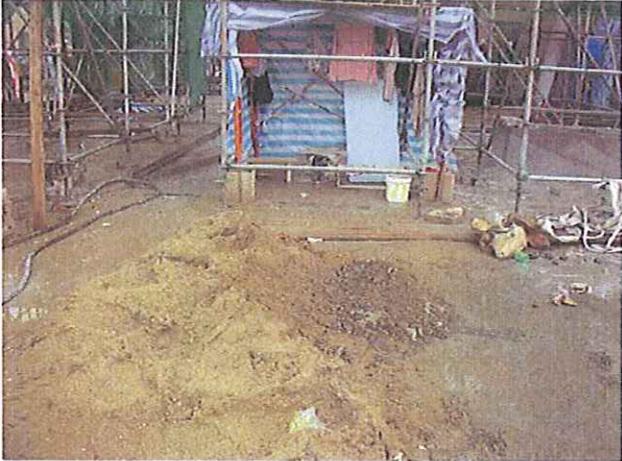
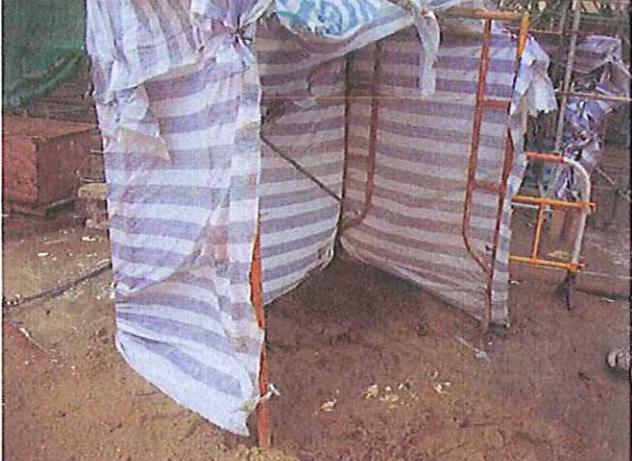
<p>2. Mixing cement and sand was conducted at open exposed area on the Entry Plaza Podium.</p>	<p>2. The contractor was reminded to provide temporary facilities for mixing cement and sand and ensure the workers would utilize the facilities appropriately.</p>

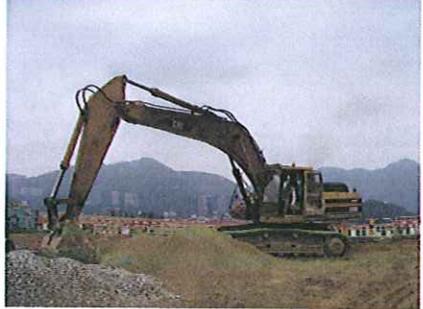
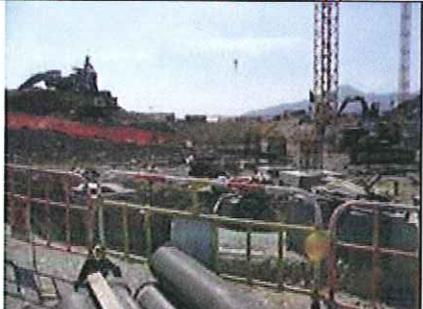
<p>P1080992: Stockpiles of dusty material was not covered with tarpaulin sheets or other means. The Contractor should cover all idle stockpiles of dusty materials on-site to suppress dust.</p>	<p>P1090384: Stockpiles of dusty material was not covered with tarpaulin sheets or other means. The Contractor should cover all idle stockpiles of dusty materials on-site to suppress dust.</p>
