Ocean Park Master Redevelopment Project

Quarterly Environmental Monitoring & Audit Report – from April to June 2010

Quarterly EM&A Report for April to June 2010

Submitted by Ocean Park Corporation on 14-07-2010

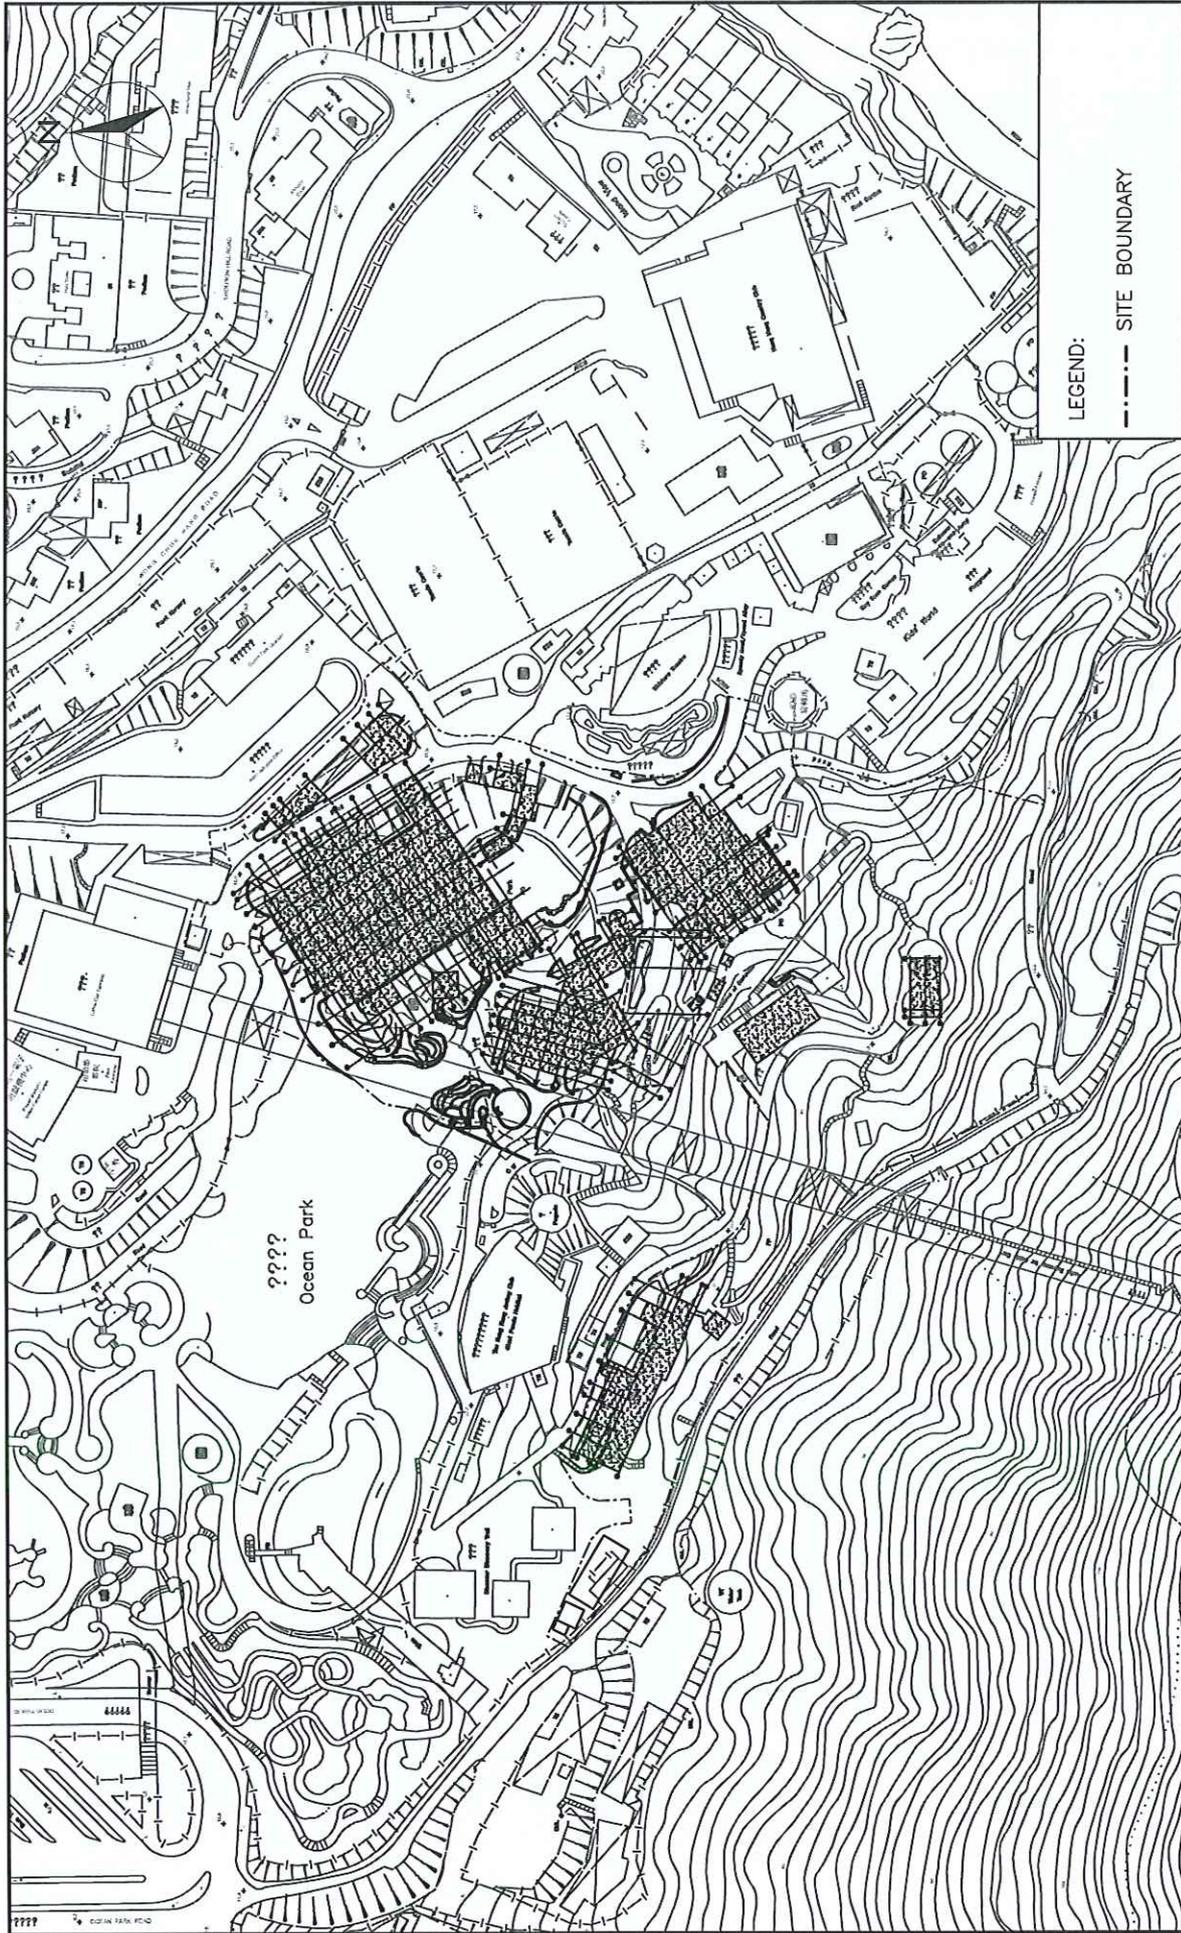
Figure 1.2

<p>CINOTECH Cinotech Consultants Limited</p>		<p>CONTRACT NO. CW02 OCEAN PARK REDEVELOPMENT PROJECT – ASTOUNDING ASIA SITE LAYOUT PLAN</p>		<p>SCALE A4 1:2000</p>	<p>DATE AUG 2007</p>
<p>CHECK JOB No.</p>	<p>MA7025</p>	<p>CHECK JOB No.</p>	<p>EW</p>	<p>DRAWN DRAWING No.</p>	<p>TL REV</p>
			<p>1.1</p>	<p>—</p>

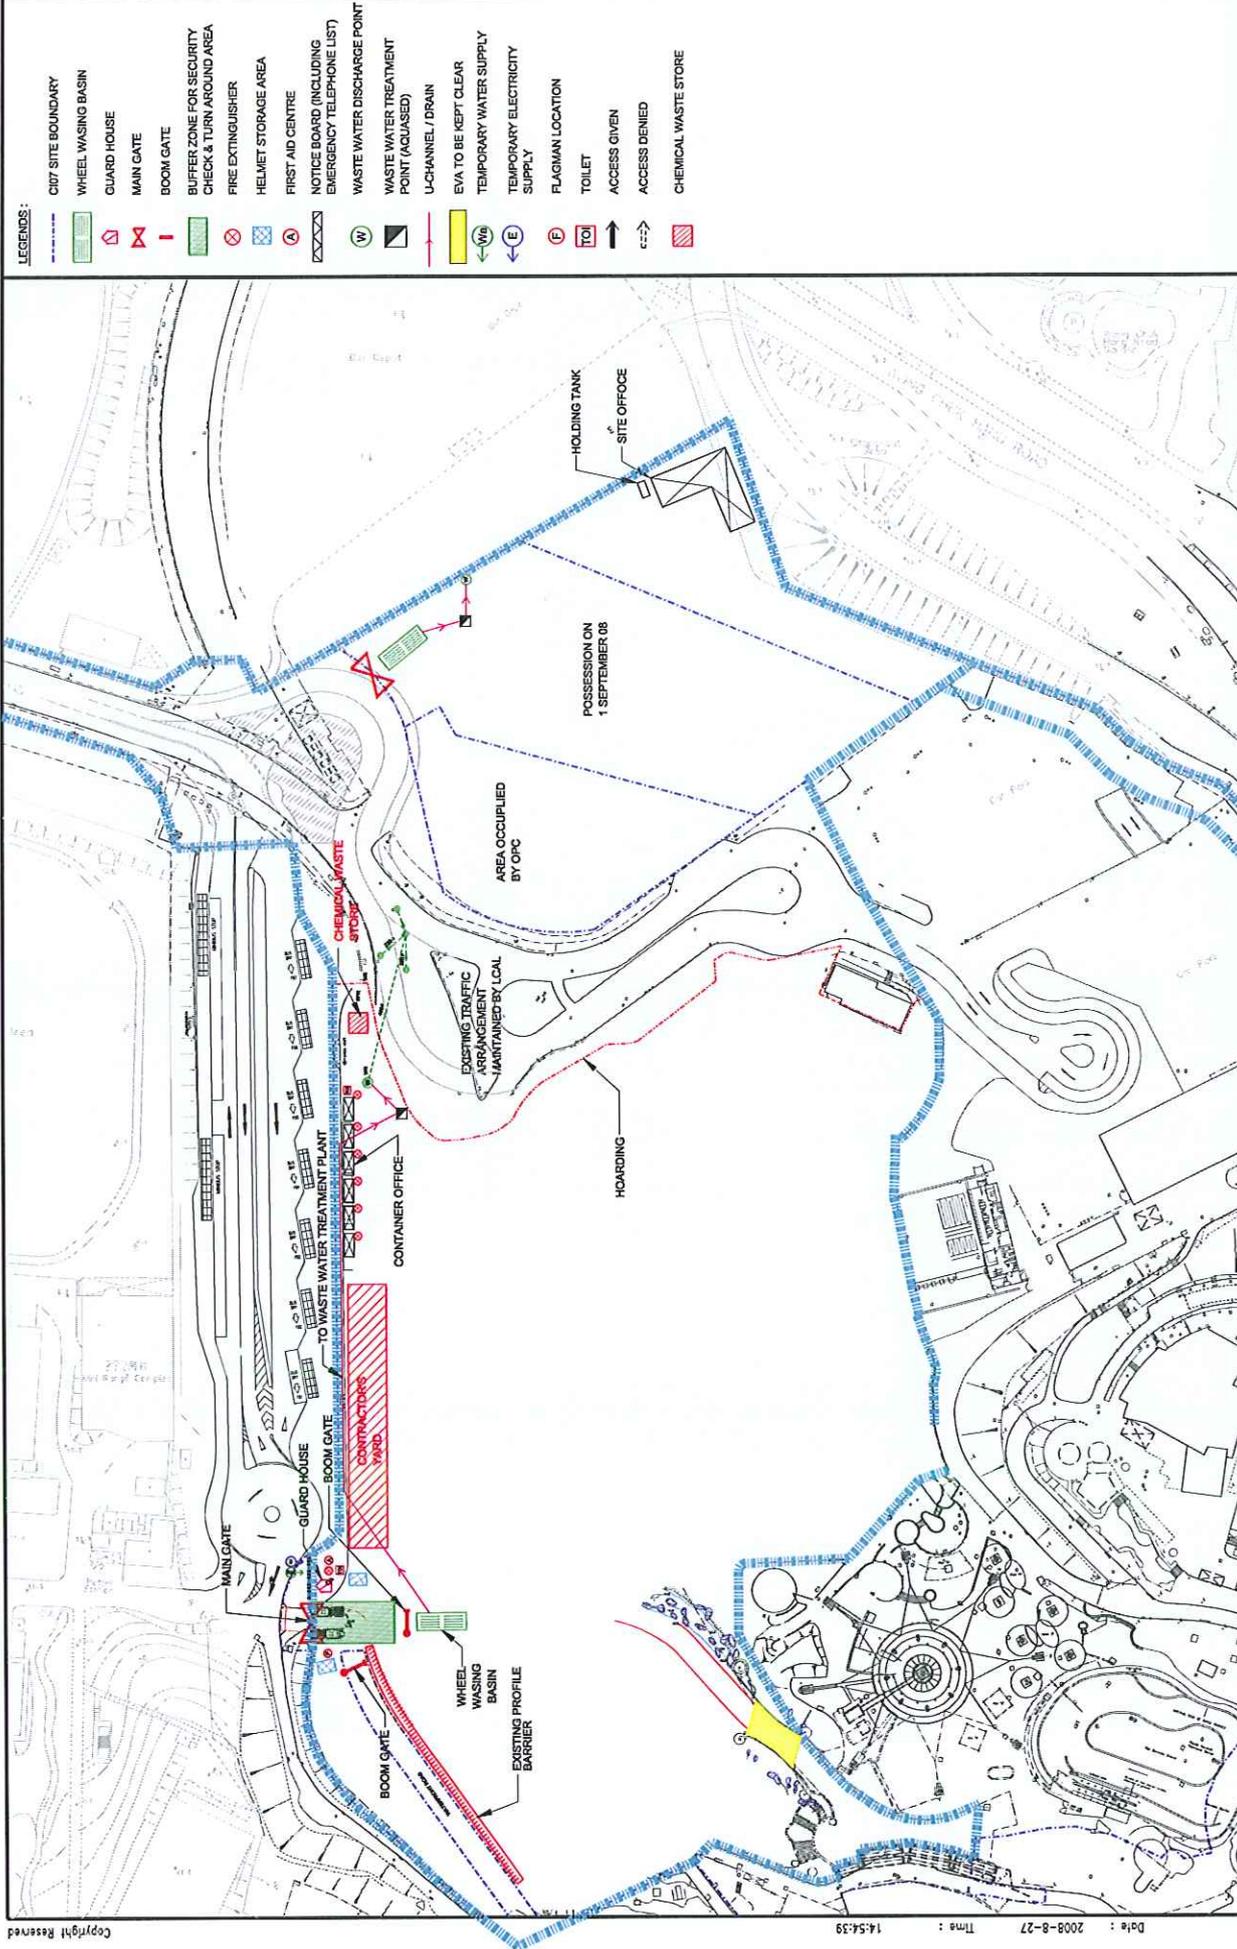
Figure 1.3

DESIGNED BY	LEIGHTON		
DRAWN BY	H2458/E/4003		
CHECKED BY	12-8-2008		
SCALE	1:1250		
DATE	12-8-2008		
REV.	A		
PROJECT TITLE	OCEAN PARK REDEVELOPMENT		
CONTRACT NO.	CONTRACT NO. C107		
DRAWING TITLE	ENTRY PLAZA, AQUA CITY & GRAND AQUARIUM		
DESCRIPTION	CONTRACTOR'S YARD & CHEMICAL WASTE STORE ADDED		
DATE	27-08-08		
REVISION	A		
CS			
Ho			
Print By:			
Filename:	G:\DRAWINGS\JOB\12458E Ocean Park C107\4003\4003A.dgn

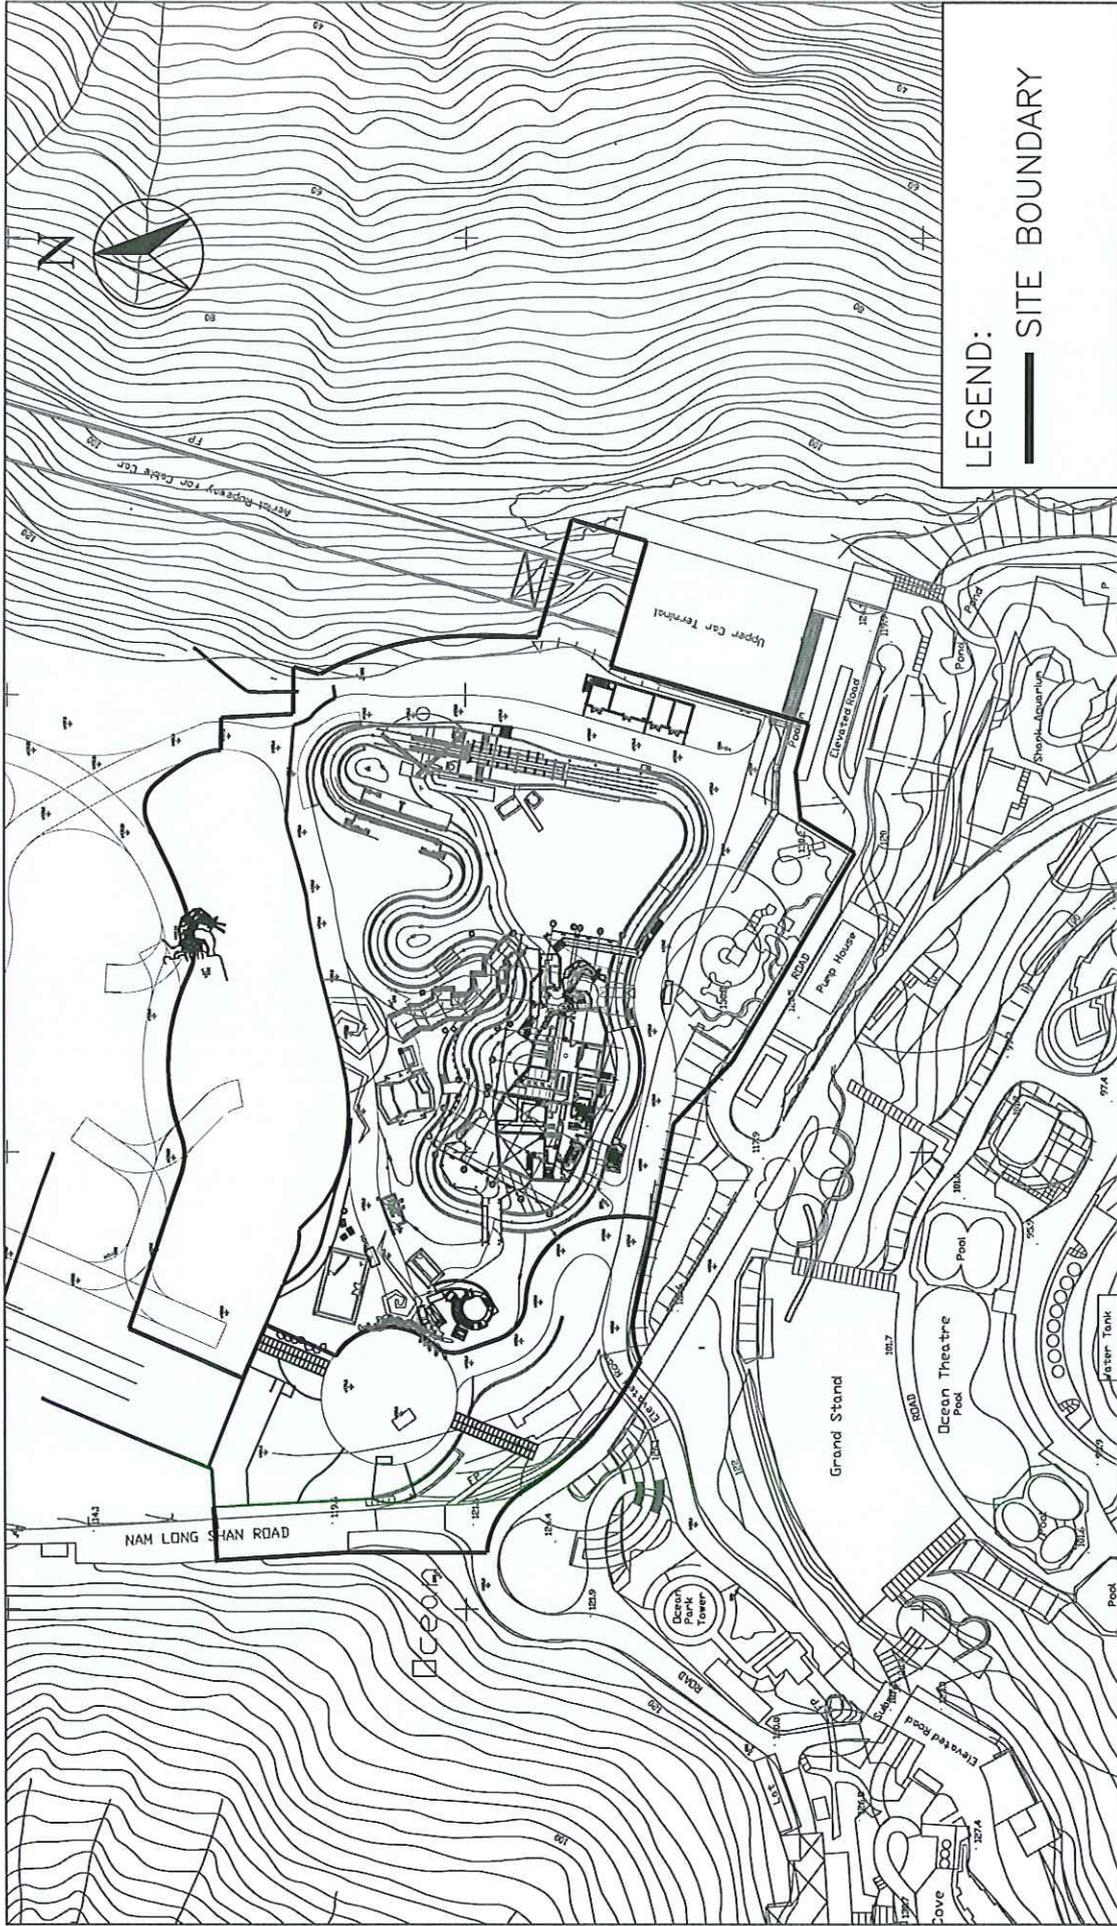
Figure 1.4

永興聯合建築有限公司 W. HING CONSTRUCTION CO. LTD.		CONTRACT NO. CS02 OCEAN PARK REDEVELOPMENT PROJECT – RAINFOREST SITE LAYOUT PLAN		SCALE A4 1:1500	DATE JULY 2009
		CHECK Kan Kwok	DRAWN HC LAU		
		JOB NO. CS02	DRAWING NO. CS02/SL/01	REV —

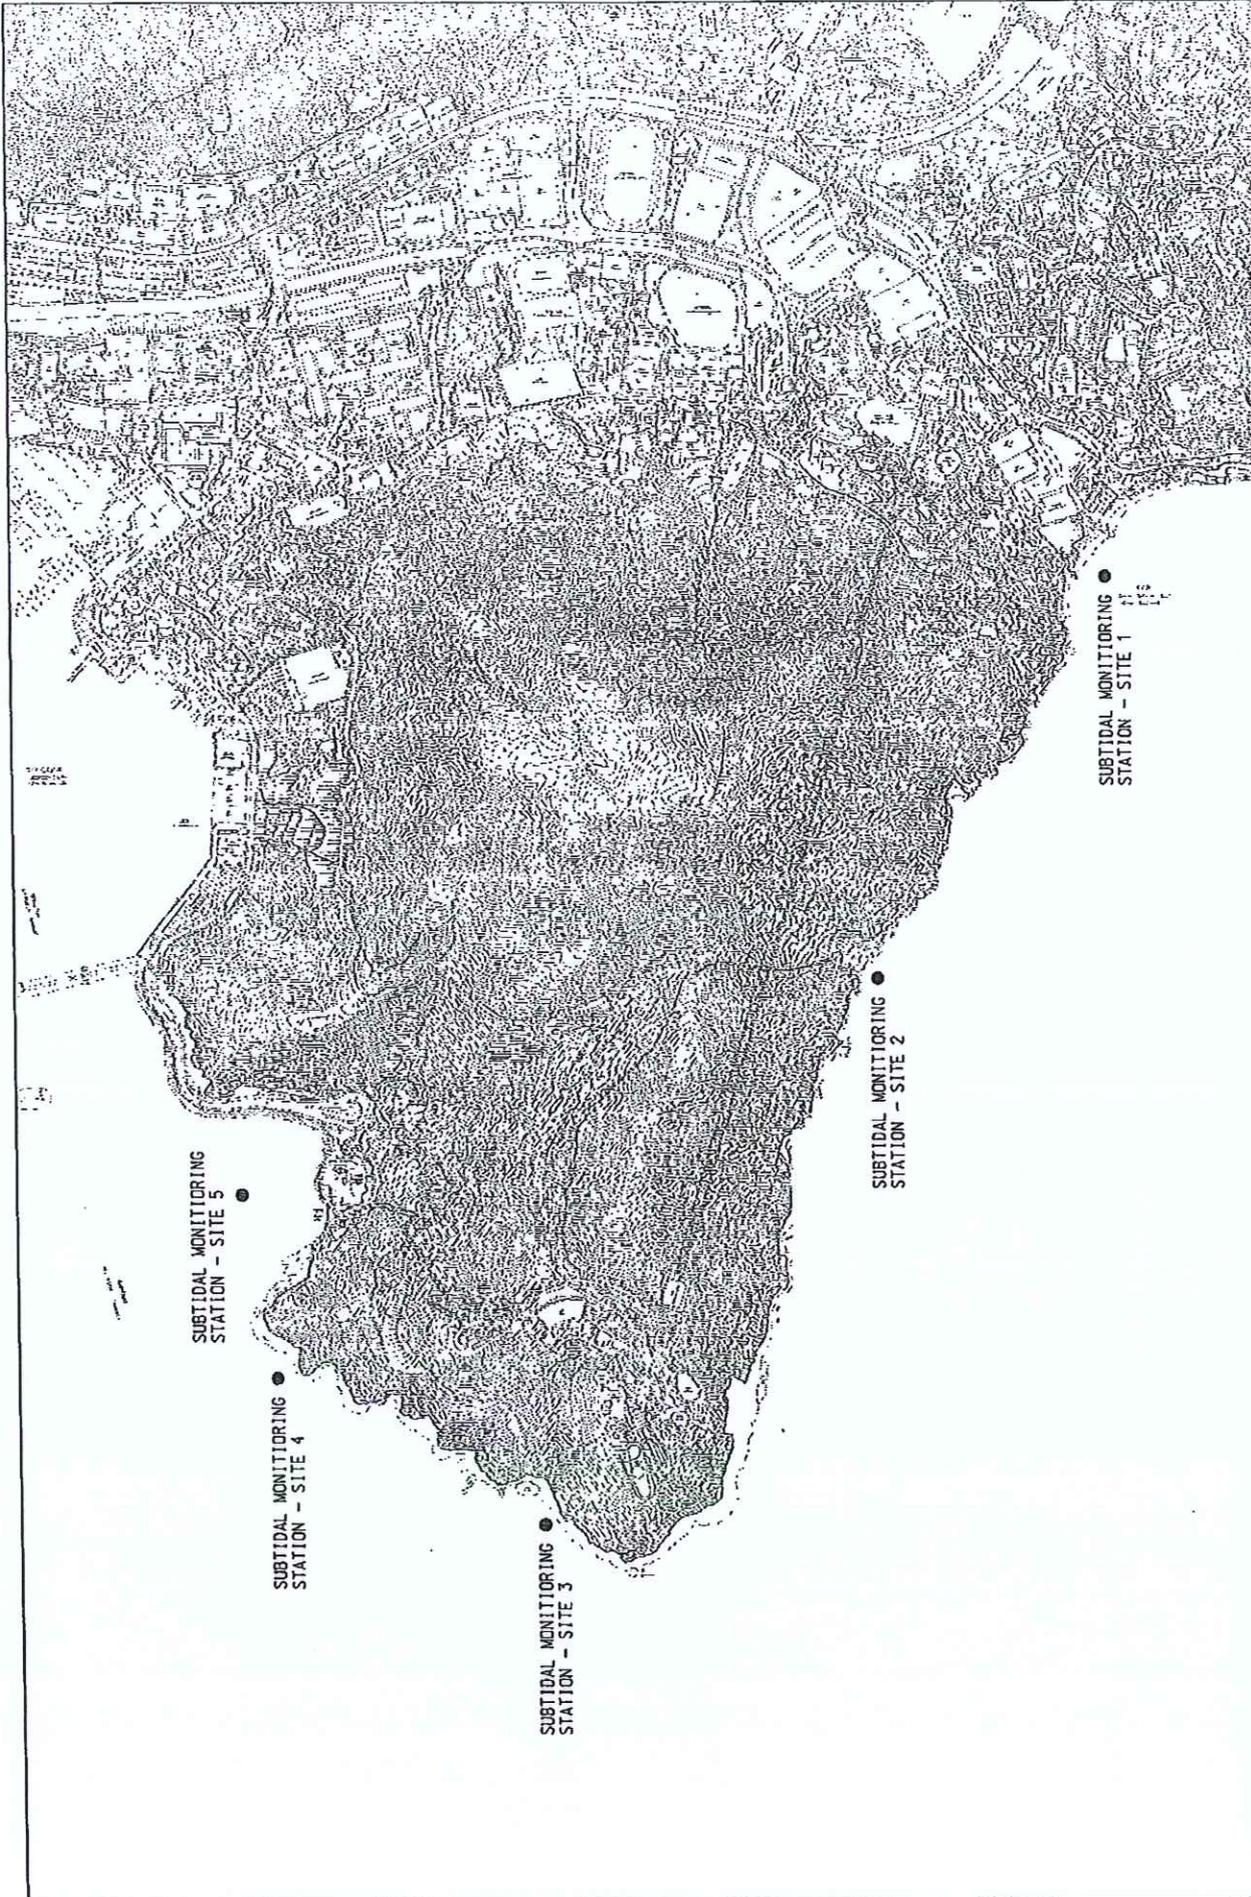
Figure 1.7

SHEET NO. 1 OF 1 DATE: 08/11/05		DRAWING NO. 1 OF 1 DATE: 08/11/05		PROJECT TITLE OCEAN PARK REDEVELOPMENT Contract No. C005 Site Formation, Funicular Turned and Miscellaneous Works		QUANTITY TITLE FIGURE 5-1 LOCATIONS OF SUBTIDAL MONITORING STATION		DRAWING NO. DATE SCALE PROJECT NO.	
SHEET NO. 1 OF 1 DATE: 08/11/05		DRAWING NO. 1 OF 1 DATE: 08/11/05		PROJECT TITLE OCEAN PARK REDEVELOPMENT Contract No. C005 Site Formation, Funicular Turned and Miscellaneous Works		QUANTITY TITLE FIGURE 5-1 LOCATIONS OF SUBTIDAL MONITORING STATION		DRAWING NO. DATE SCALE PROJECT NO.	
SHEET NO. 1 OF 1 DATE: 08/11/05		DRAWING NO. 1 OF 1 DATE: 08/11/05		PROJECT TITLE OCEAN PARK REDEVELOPMENT Contract No. C005 Site Formation, Funicular Turned and Miscellaneous Works		QUANTITY TITLE FIGURE 5-1 LOCATIONS OF SUBTIDAL MONITORING STATION		DRAWING NO. DATE SCALE PROJECT NO.

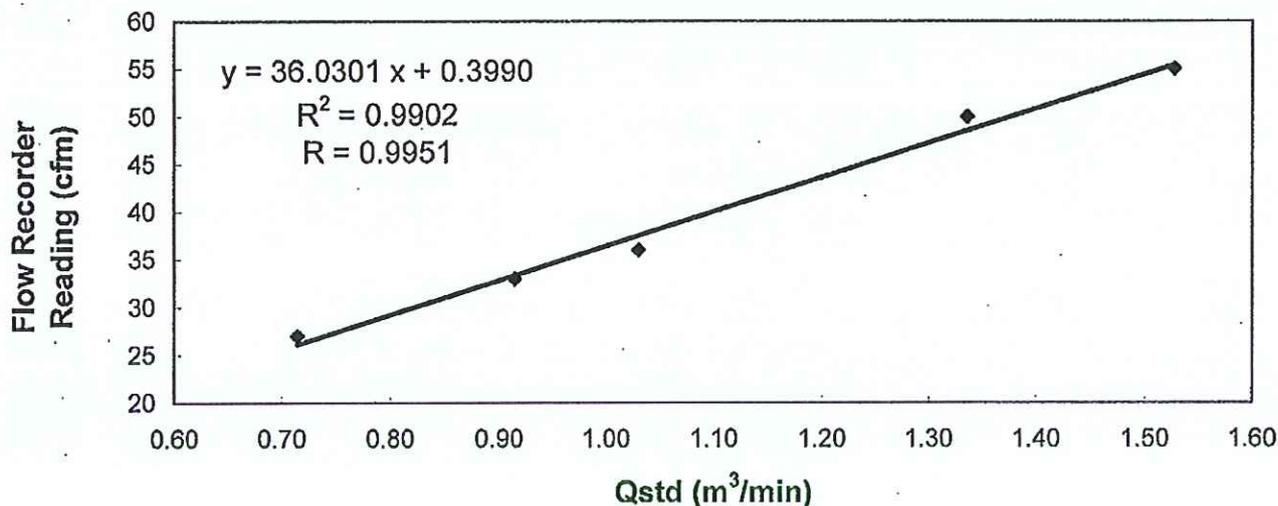
**Sampler 1174 Calibration Curve
Site: Ocean Park (AM-1)**

Flow recorder reading (cfm)	55	50	36	33	27
Qstd (Actual flow rate, m ³ /min)	1.53	1.34	1.03	0.91	0.71
Pressure :	758.31 mm Hg		Temp. :	298 K

Acceptance Criteria : Correlation coefficient (r) of the calibration curve greater than 0.990 after a 5-point calibration.

The high volume sampler complies* / ~~does not comply*~~ with the specified requirements and is deemed acceptable* / unacceptable* for use.

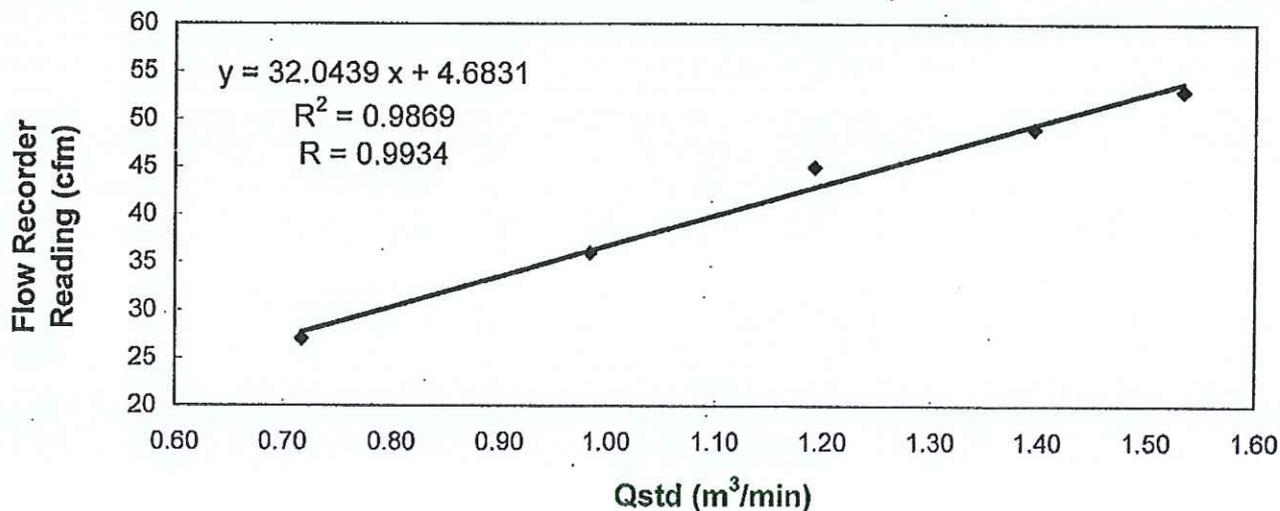
Sampler 1174 Calibration Curve
Site: Ocean Park (AM-1)

Flow recorder reading (cfm)	53	49	45	36	27
Qstd (Actual flow rate, m ³ /min)	1.53	1.40	1.19	0.98	0.72
Pressure : 761.31 mm Hg	Temp. : 297 K

Acceptance Criteria : Correlation coefficient (r) of the calibration curve greater than 0.990 after a 5-point calibration.

The high volume sampler complies* / does not comply* with the specified requirements and is deemed acceptable* / unacceptable* for use.

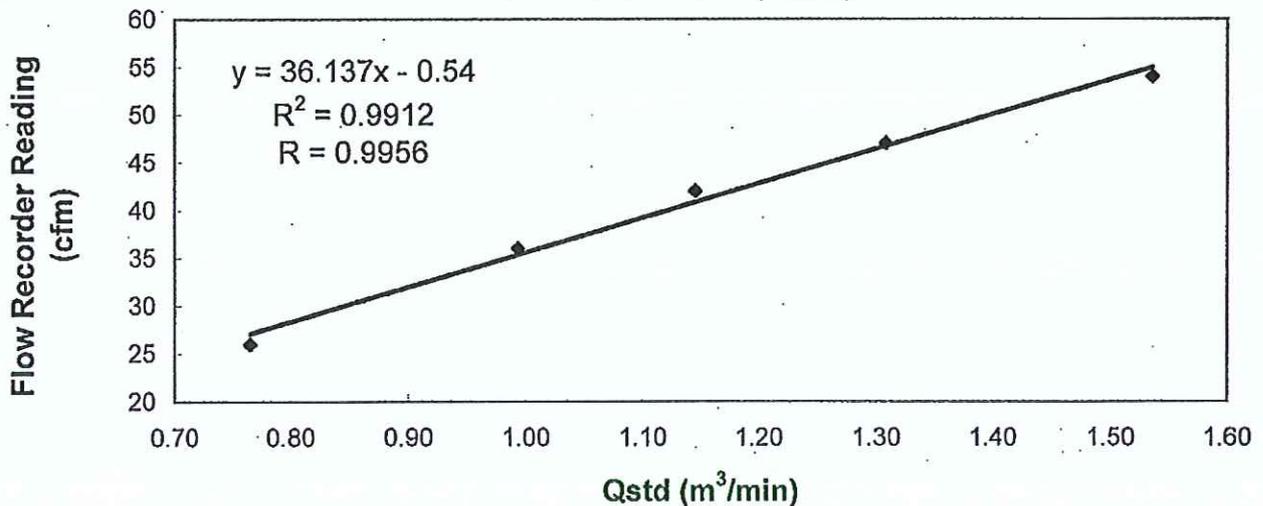
Sampler 1177 Calibration Curve
Site: Ocean Park (AM-2)

Flow recorder reading (cfm)	54	47	42	36	26
Qstd (Actual flow rate, m ³ /min)	1.54	1.31	1.15	0.99	0.77
Pressure :	758.31 mm Hg			Temp. :	298 K

Acceptance Criteria : Correlation coefficient (r) of the calibration curve greater than 0.990 after a 5-point calibration.

The high volume sampler complies* / does not comply* with the specified requirements and is deemed acceptable* / unacceptable* for use.

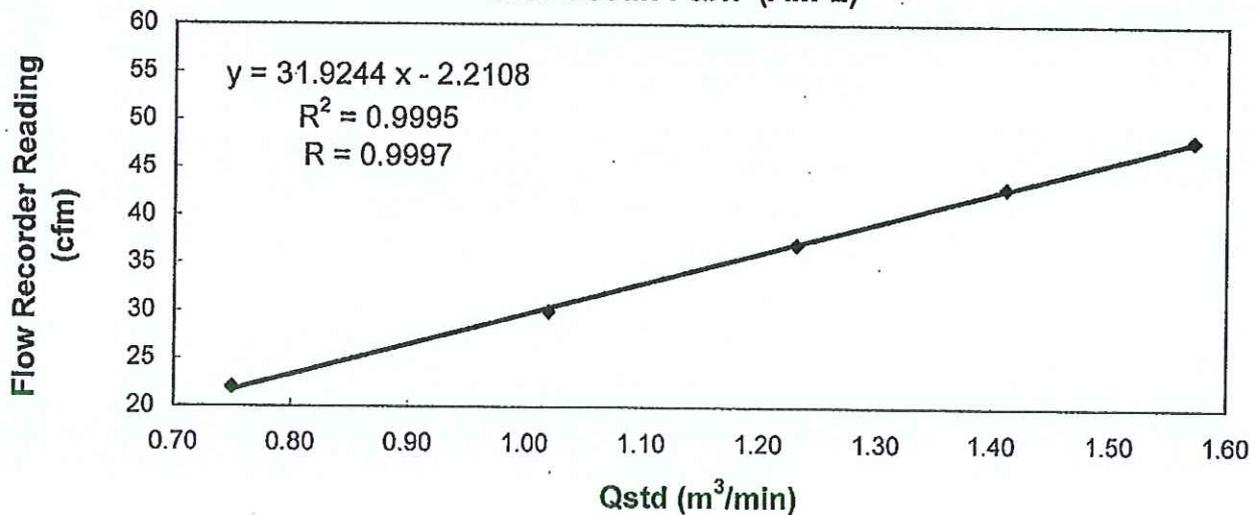
Sampler 1177 Calibration Curve
Site: Ocean Park (AM-2)

Flow recorder reading (cfm)	48	43	37	30	22
Qstd (Actual flow rate, m ³ /min)	1.57	1.41	1.23	1.02	0.75
Pressure :	761.31 mm Hg		Temp. :	298 K

Acceptance Criteria : Correlation coefficient (r) of the calibration curve greater than 0.990 after a 5-point calibration.

The high volume sampler complies* / does not comply* with the specified requirements and is deemed acceptable* / unacceptable* for use.

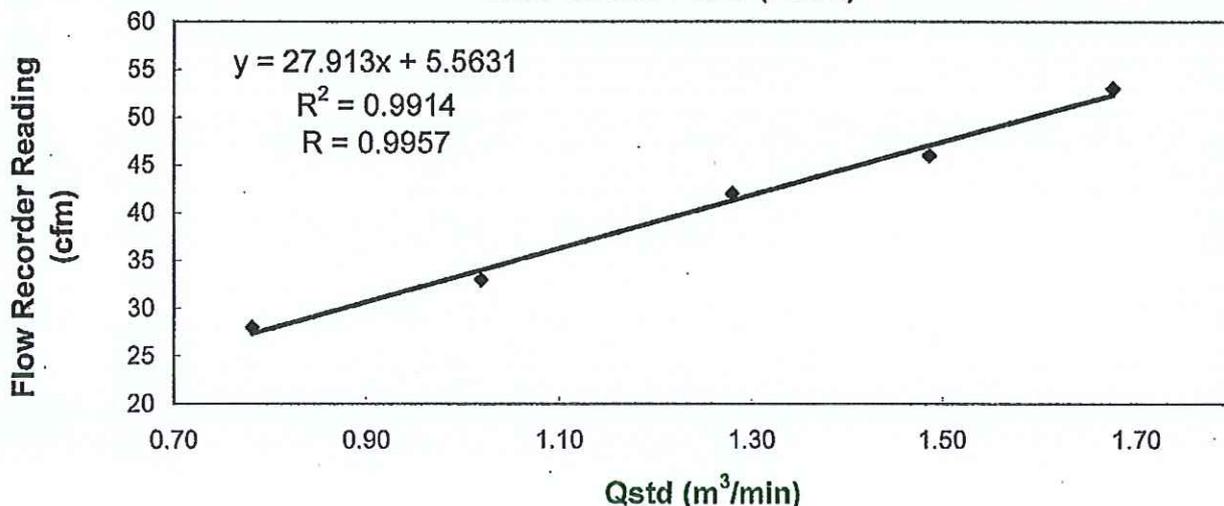
Sampler 9998 Calibration Curve
Site: Ocean Park (AM-3)

Flow recorder reading (cfm)	53	46	42	33	28
Qstd (Actual flow rate, m ³ /min)	1.68	1.49	1.28	1.02	0.78
Pressure :	758.31 mm Hg		Temp. :	298 K

Acceptance Criteria : Correlation coefficient (r) of the calibration curve greater than 0.990 after a 5-point calibration.

The high volume sampler complies* / does not comply* with the specified requirements and is deemed acceptable* / unacceptable* for use.

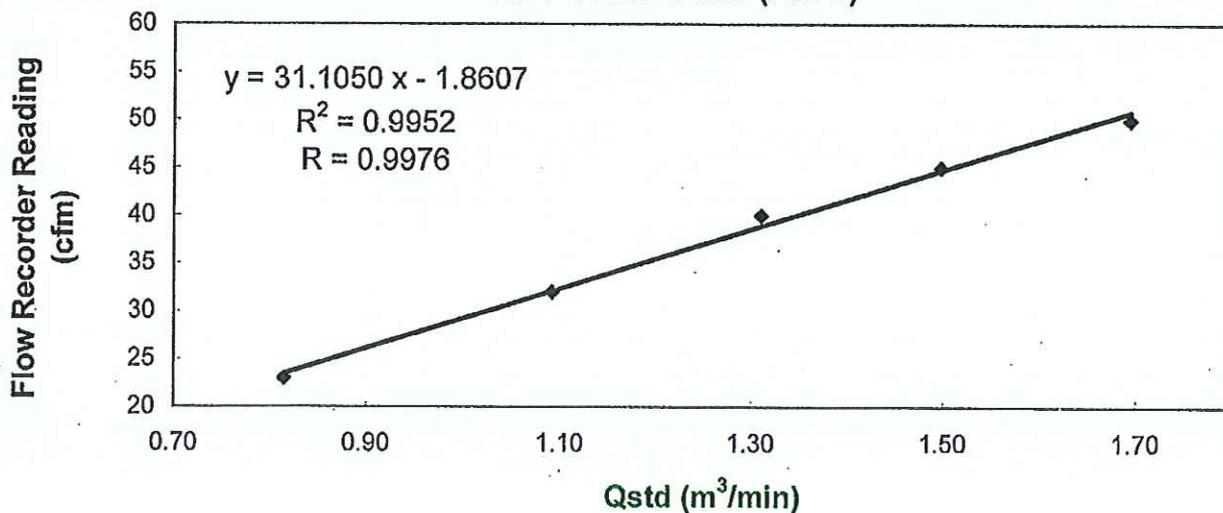
Sampler 9998 Calibration Curve
Site: Ocean Park (AM-3)

Flow recorder reading (cfm)	50	45	40	32	23
Qstd (Actual flow rate, m ³ /min)	1.69	1.50	1.31	1.09	0.81
Pressure :	761.31 mm Hg			Temp. :	298 K

Acceptance Criteria : Correlation coefficient (r) of the calibration curve greater than 0.990 after a 5-point calibration.

The high volume sampler complies* / does not comply* with the specified requirements and is deemed acceptable* / unacceptable* for use.

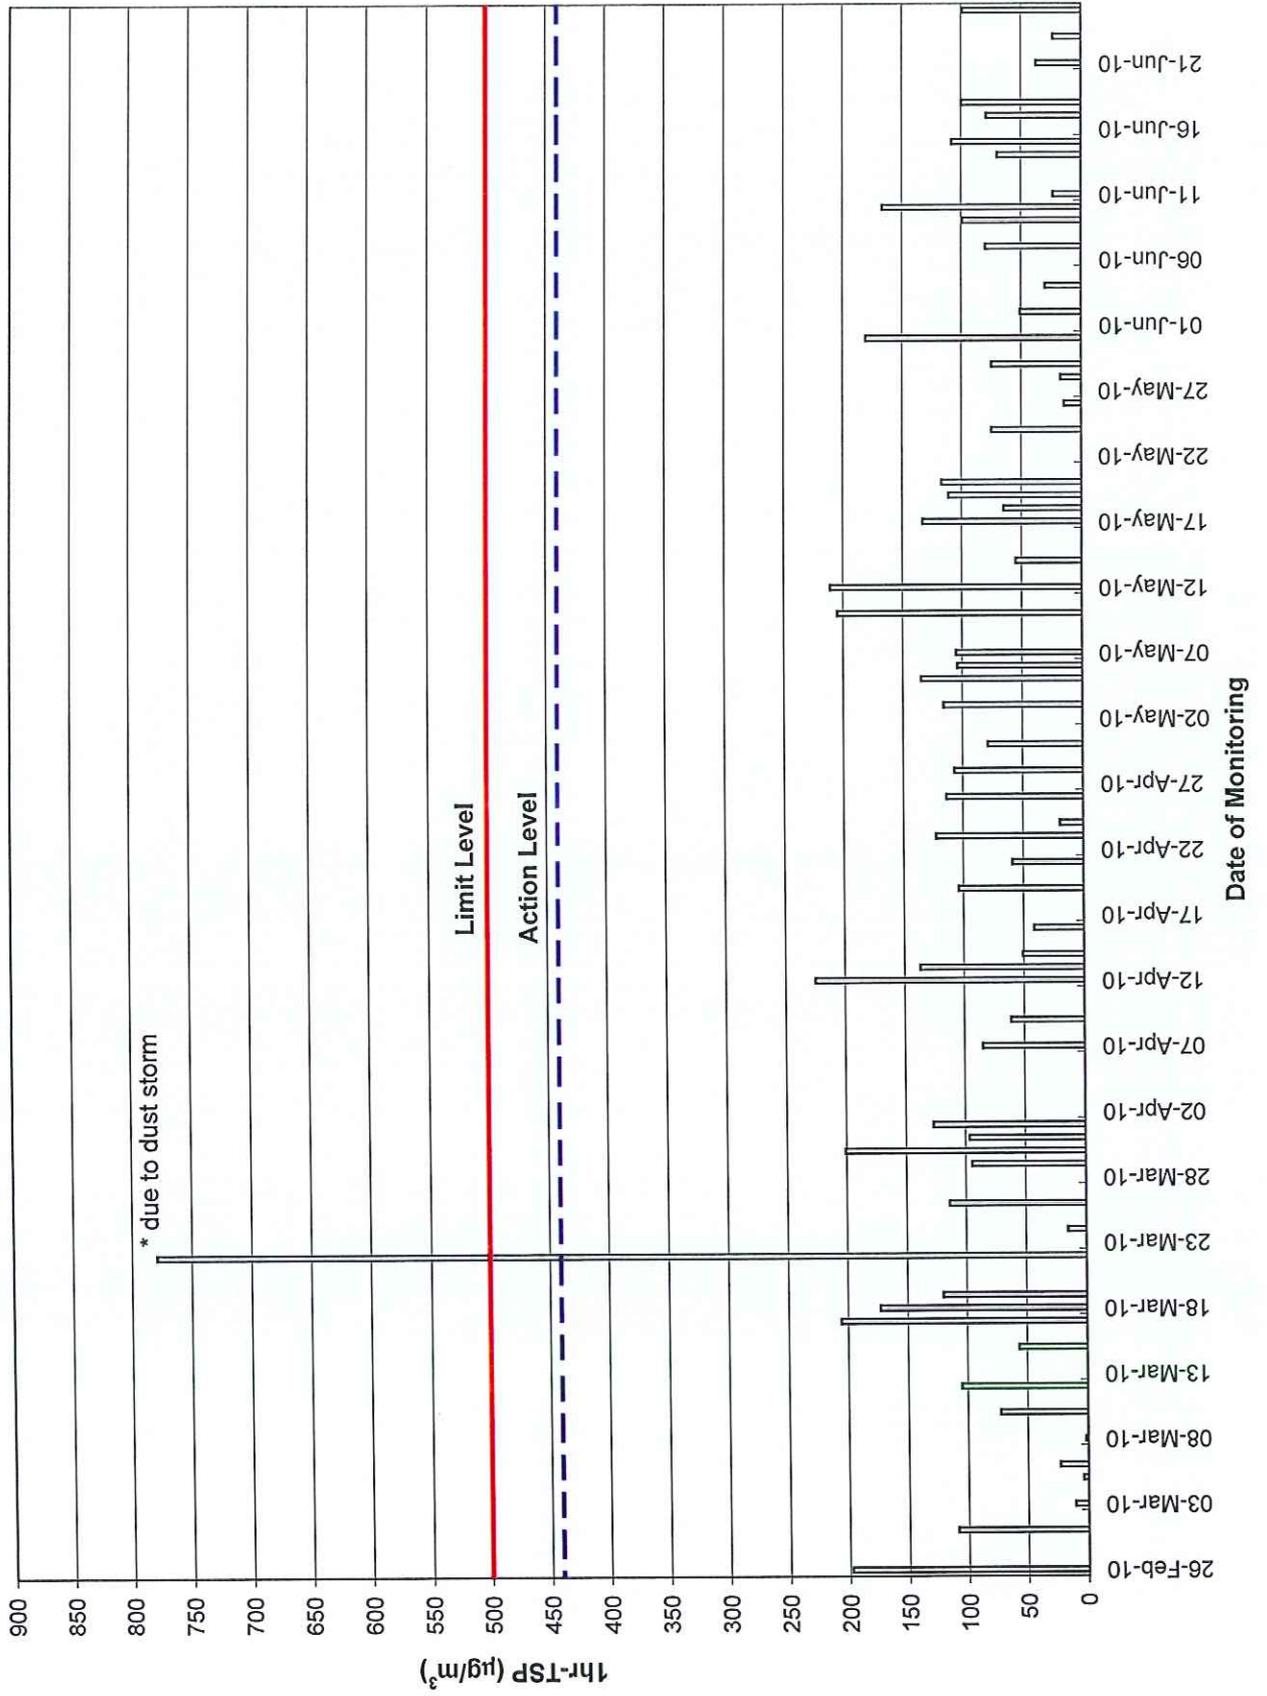
Figure C.1 1-hr TSP monitoring results of Monitoring Station AM1

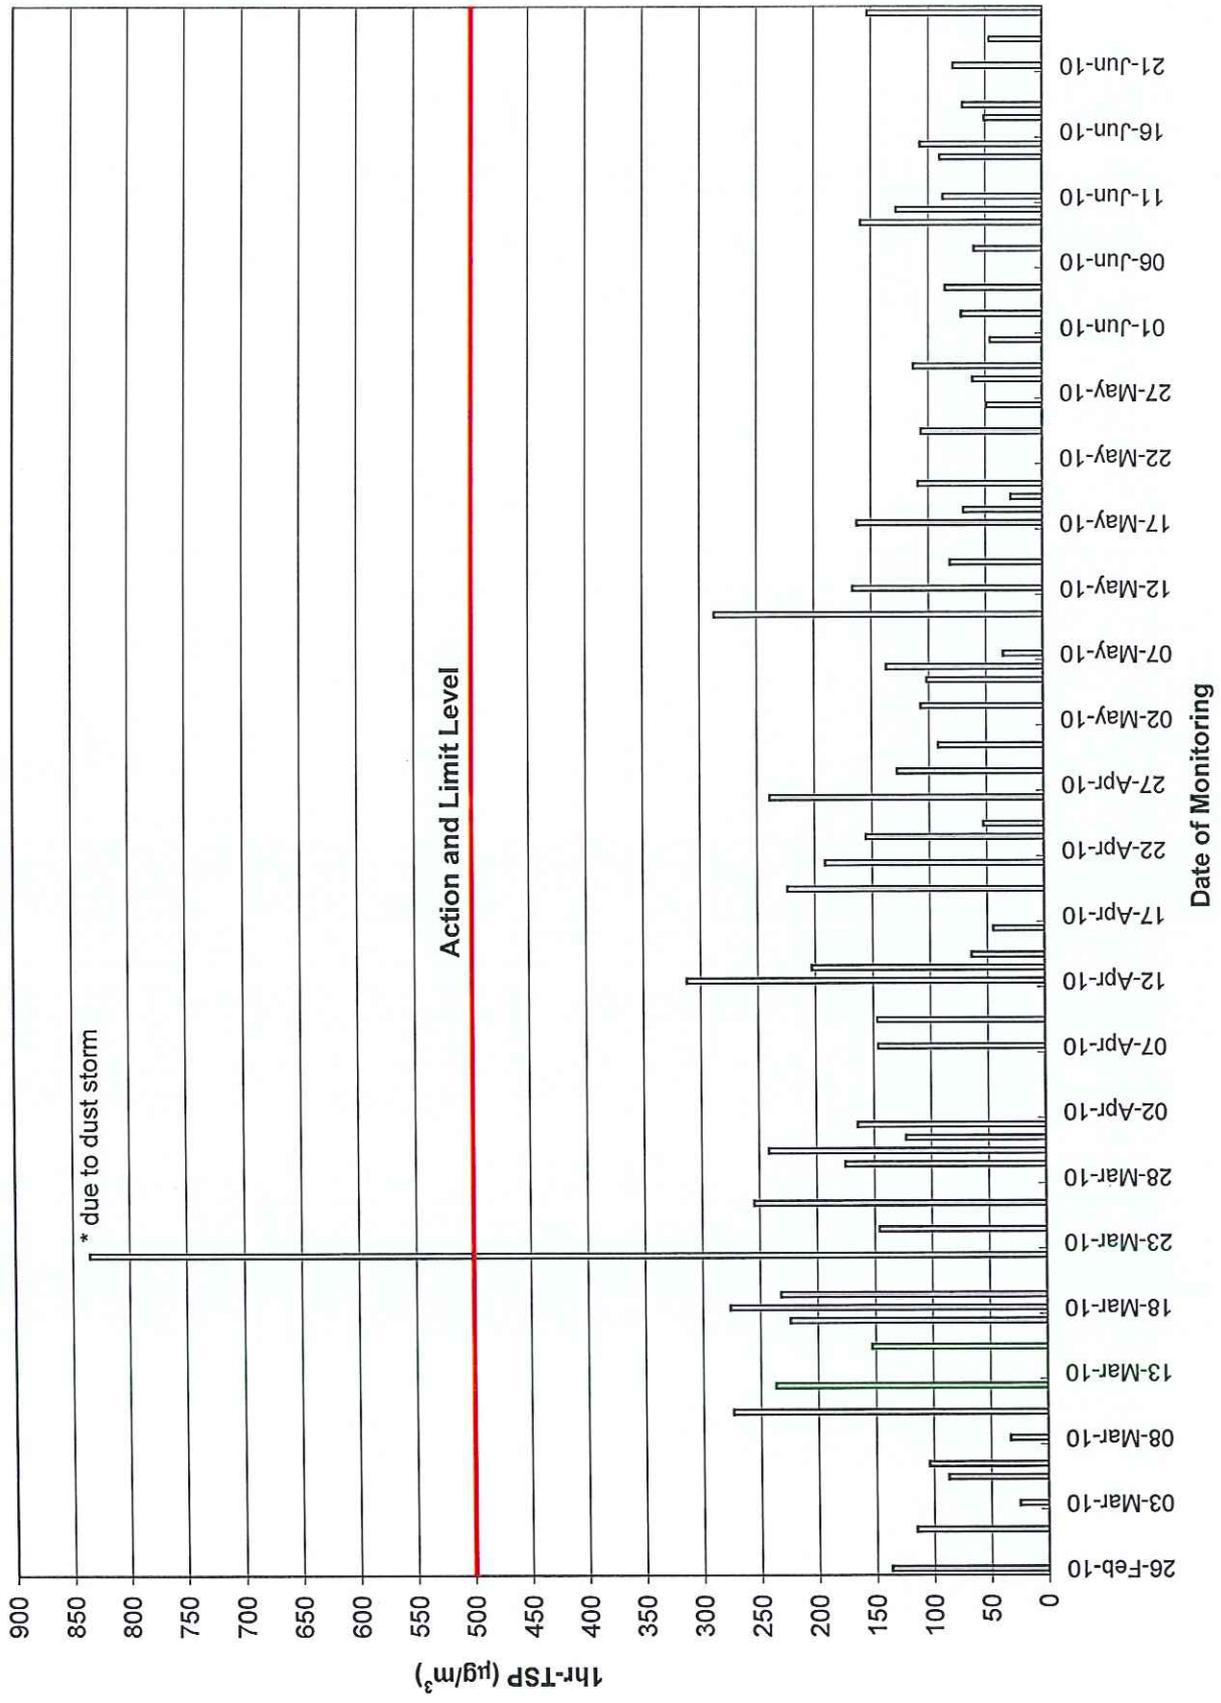
Figure C.2 1-hr TSP monitoring results of Monitoring Station AM2

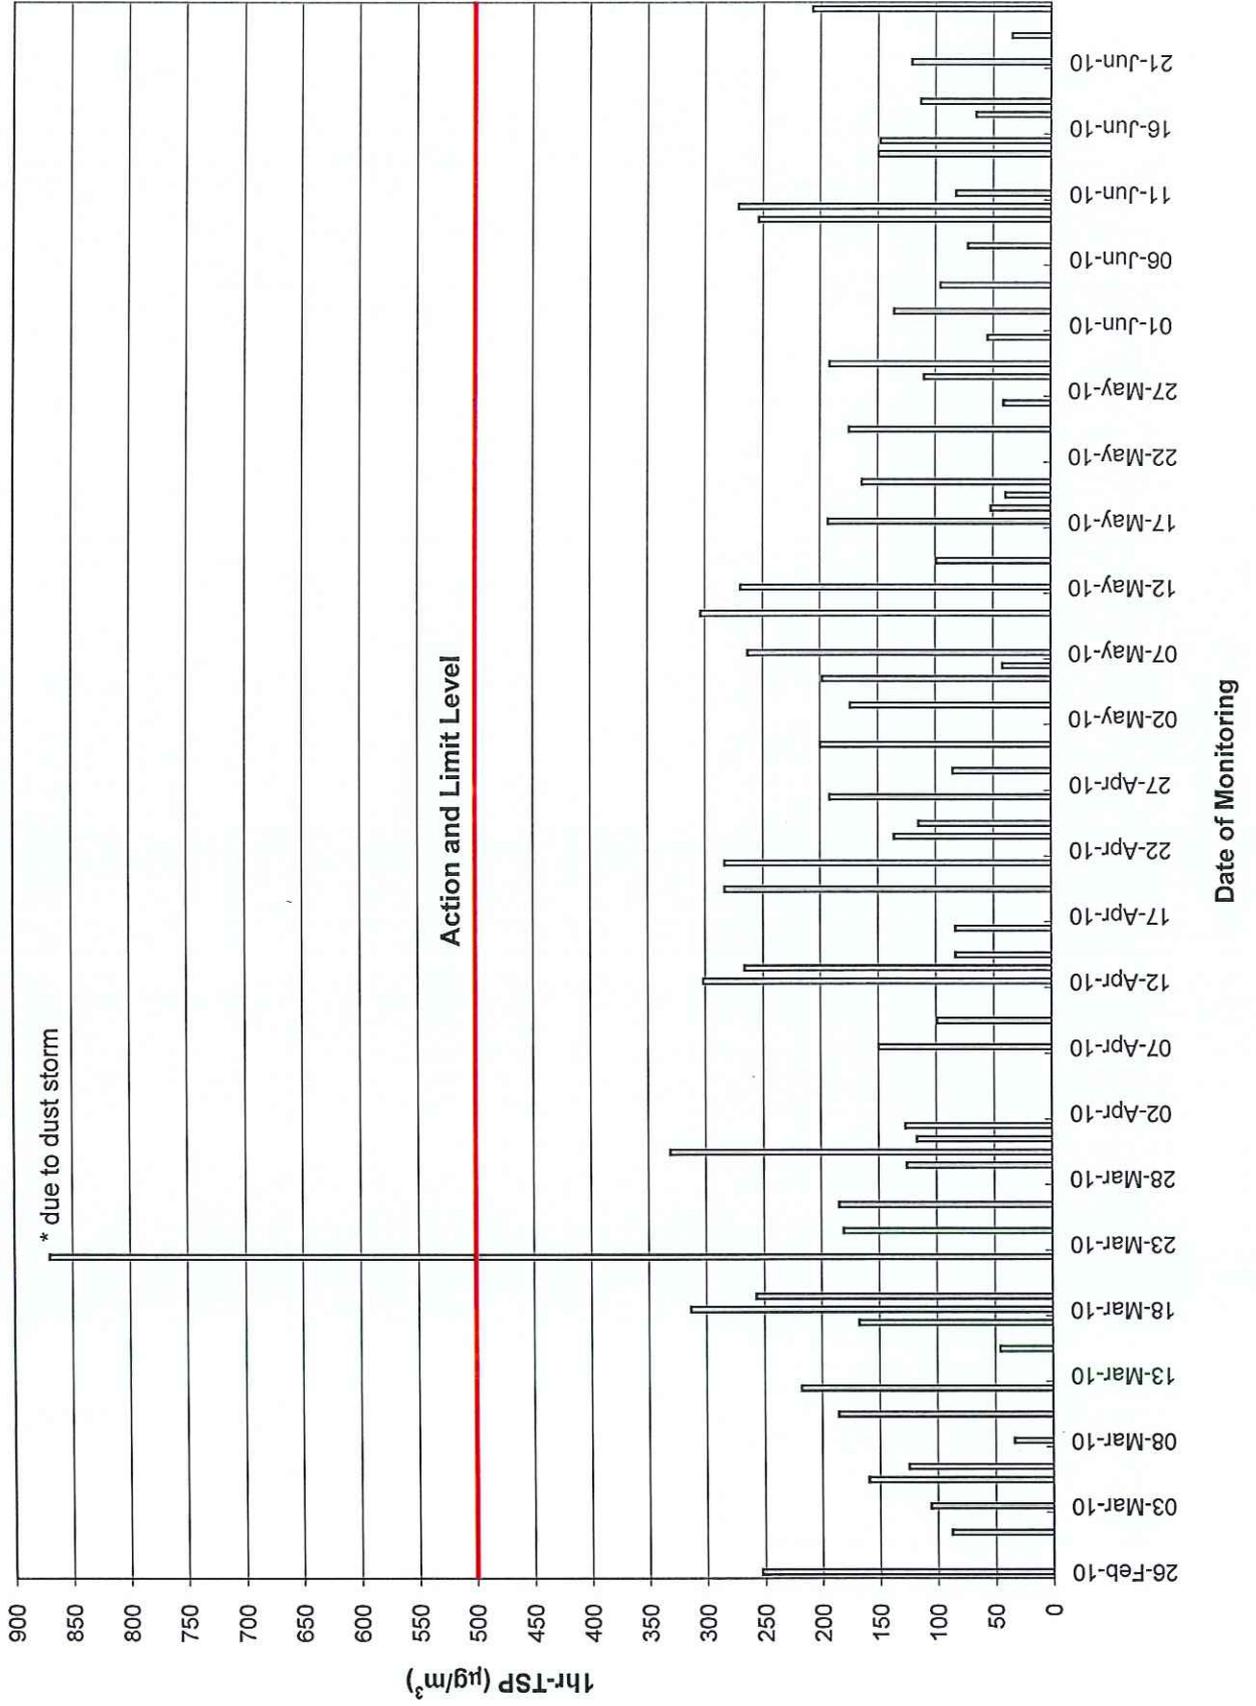
Figure C.3 1-hr TSP monitoring results of Monitoring Station AM3A

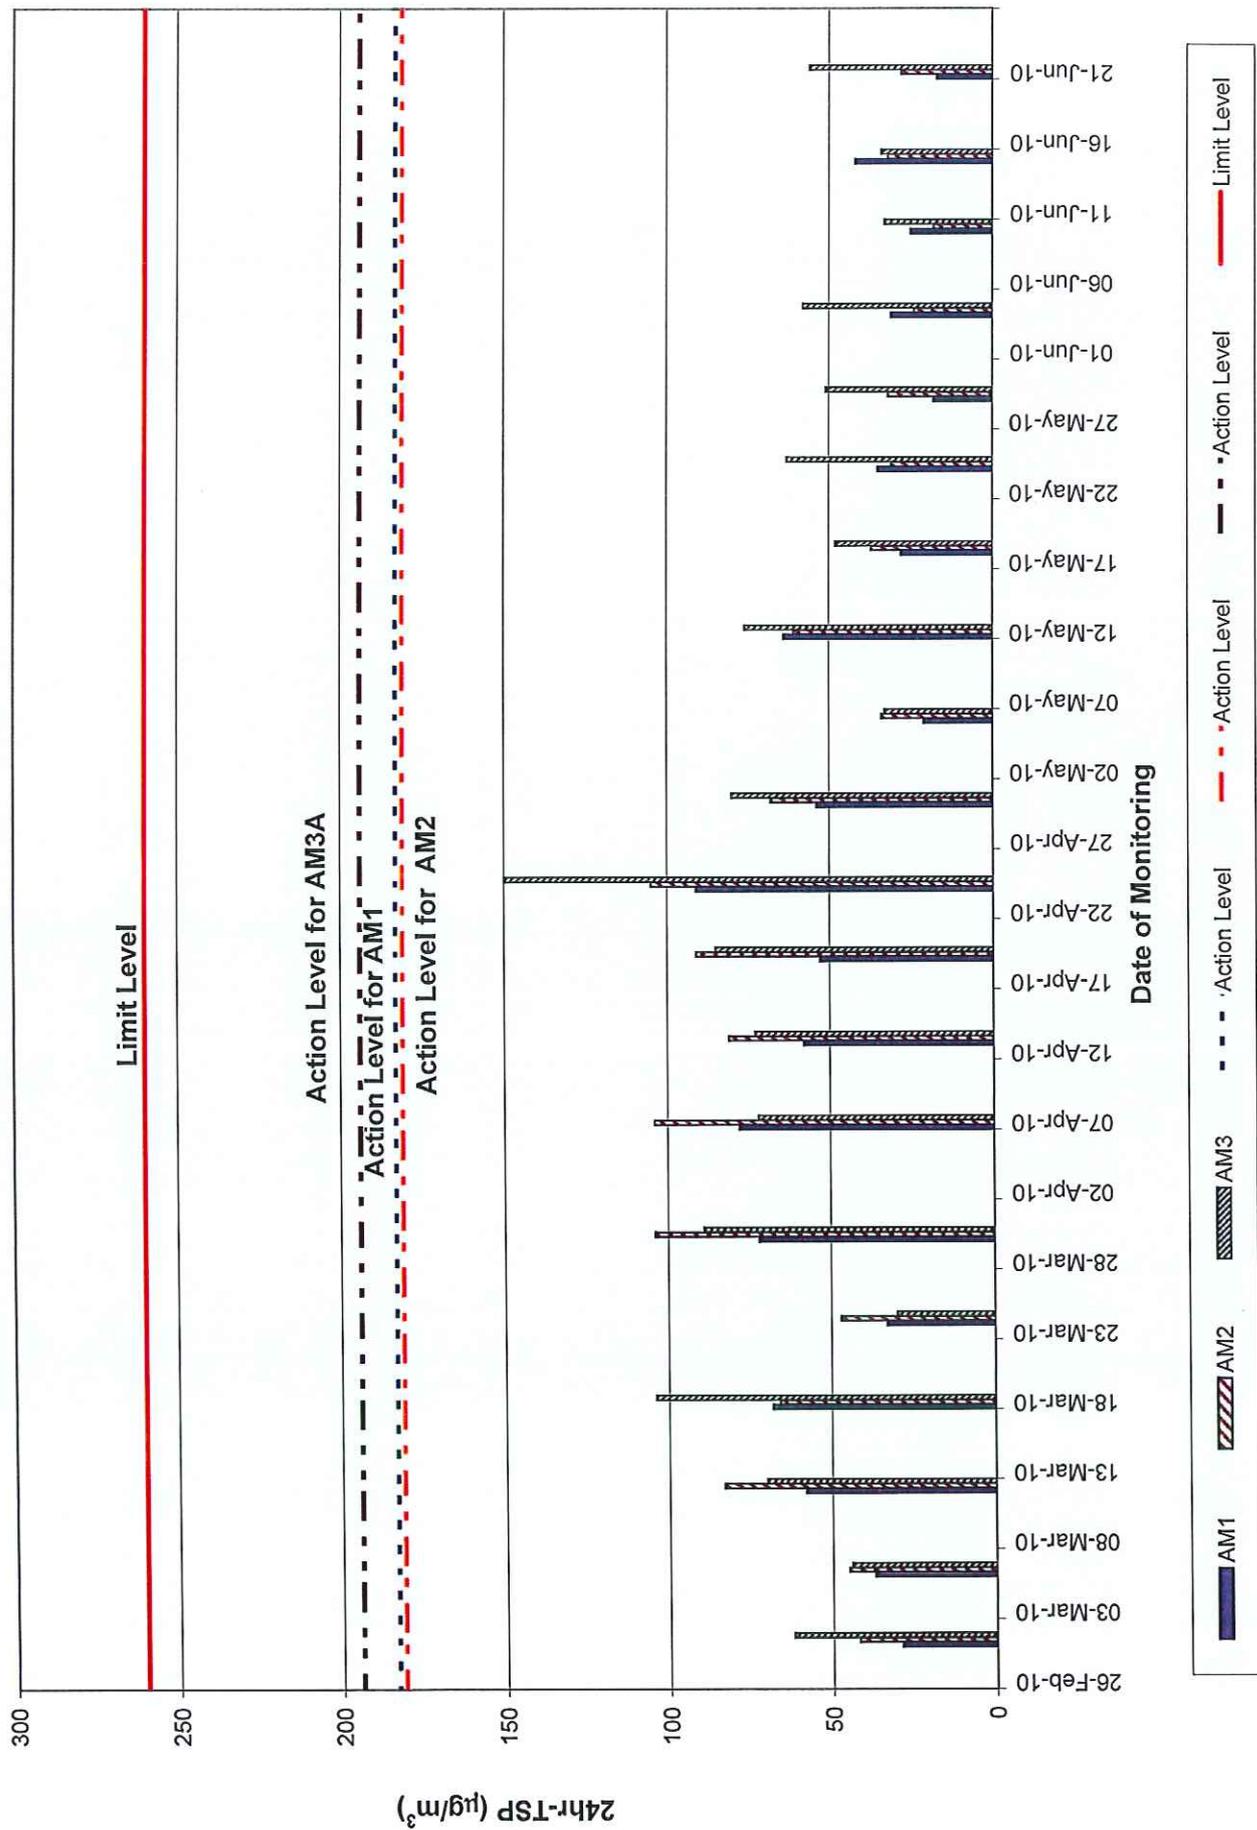
The measured 24-hour TSP concentrations in the reporting quarter were below the Action and Limit Levels in the reporting quarter.

Figure C.4 24-hr TSP monitoring results of Monitoring Station AM1, AM2 & AM3A
