Ocean Park Master Redevelopment Project

Quarterly Environmental Monitoring & Audit Report – from April to June 2010

Quarterly EM&A Report for April to June 2010

Submitted by Ocean Park Corporation on 14-07-2010

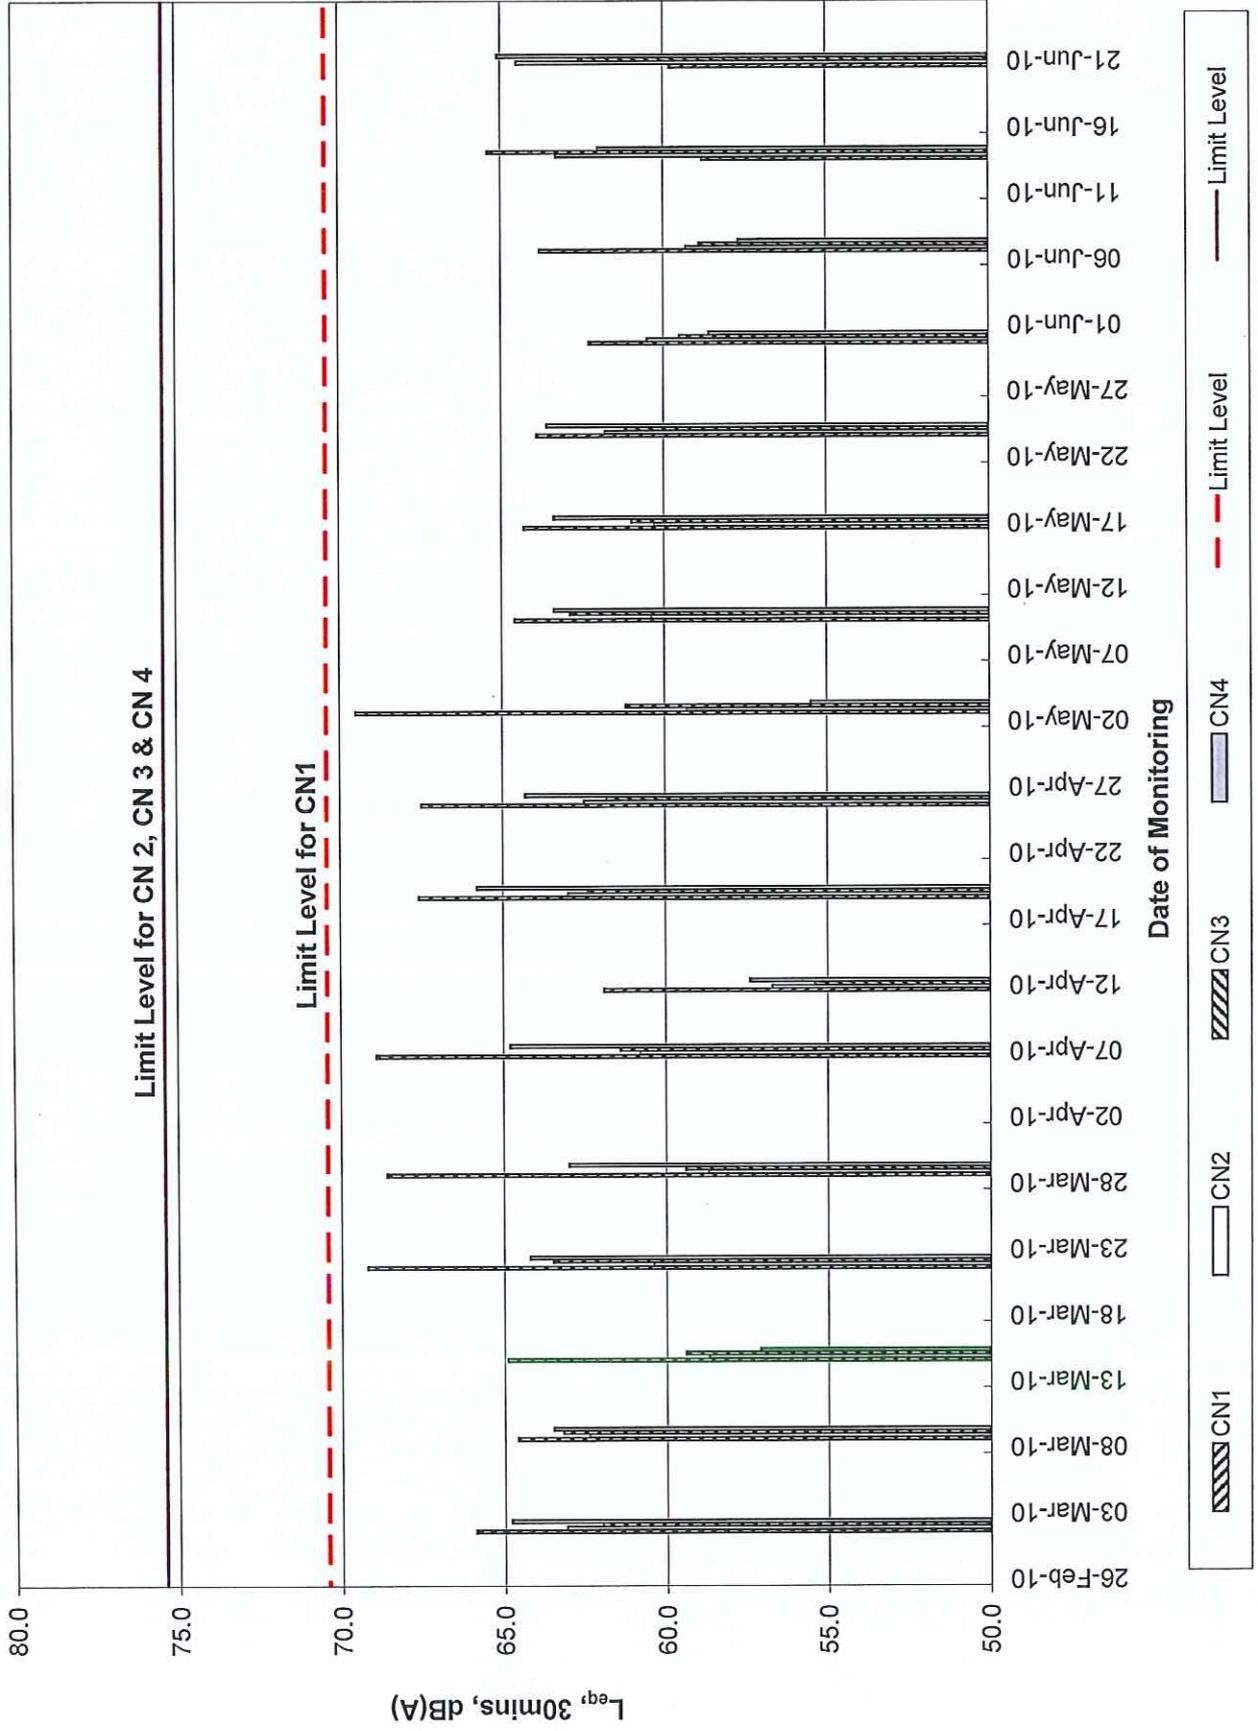
All measured noise levels during daytime and evening time were below the Action and Limited levels in the reporting quarter.

Fig D.1 - Daytime Noise Monitoring Results of Monitoring Stations CN1, CN2, CN3 & CN4
