Ocean Park Master Redevelopment Project

EP-249/2006/A – Condition 3.4

Monthly EM&A Report – June 2010

Monthly Environmental Monitoring & Audit
Report – June 2010

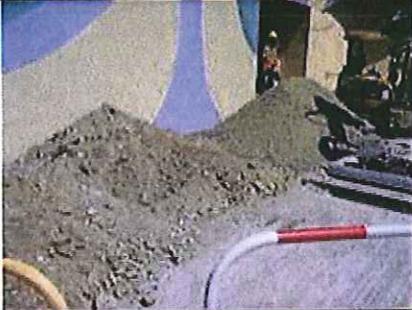
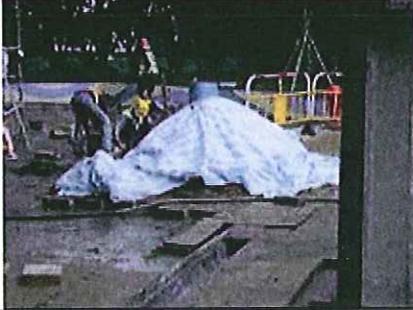
<p>P1090362: Stockpile of dusty material was not covered with tarpaulin sheets or other means. The Contract should cover all idle stockpiles of dusty materials on-site to suppress dust.</p>	<p>Closed - P1090667: Idle stockpiles of dusty materials on-site were covered with tarpaulin sheets entirely to suppress dust.</p>

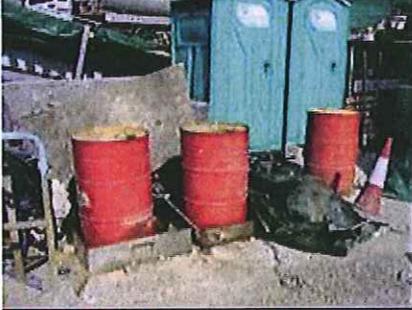
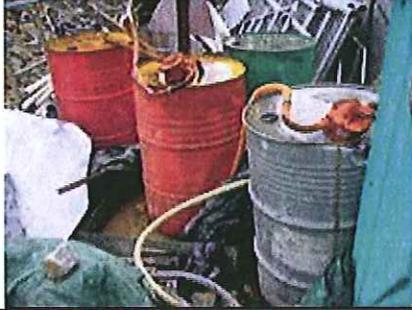
<p>P1090403: An empty oil drum was placed on bareground while drip tray with oil drum was accumulated with general refuse and rainwater. The Contractor should dispose the empty oil drum as soon as possible and maintain all drip trays more frequently.</p>	<p>P1090708: Drip tray with oil drum was accumulated with general refuse and rainwater. The Contractor should maintain all drip trays more frequently.</p>

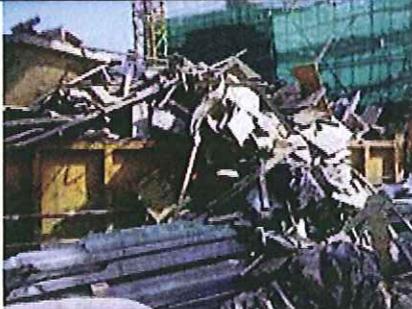
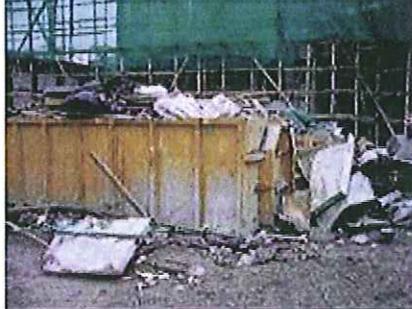
<p>P1090408: Accumulation of construction waste was observed. The Contractor should provide more skips for construction waste and remove construction waste off-site more frequently.</p>	<p>Closed – P1090713: More frequent removal of construction waste off-site had been provided.</p>
Observations in June 2010

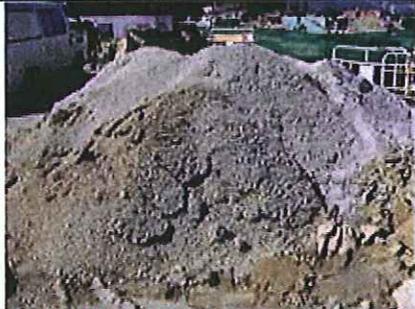
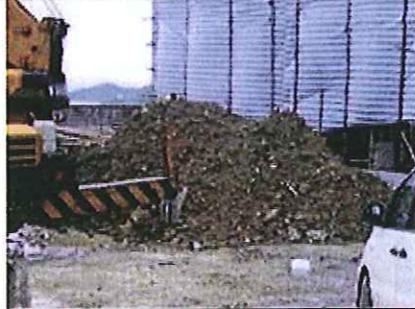
<p>P1090384: Stockpiles of dusty material was not covered with tarpaulin sheets or other means. The Contractor should cover all idle stockpiles of dusty materials on-site to suppress dust.</p>	<p>P1090698: A stockpile of dusty C&D material was not covered with tarpaulin sheets or other means. The Contractor should cover all idle stockpiles of dusty materials on-site to suppress dust.</p>

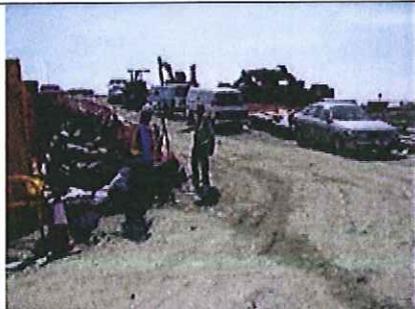
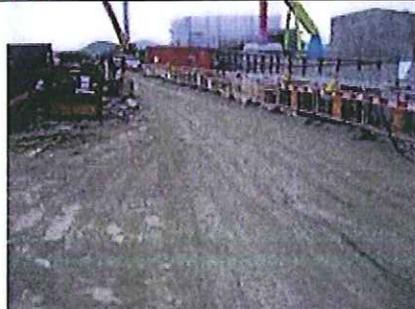
<p>P1090385: Some sections of haul road were not provided with water spray. The Contractor should provide water spray to all unpaved areas and haul roads on-site to suppress dust.</p>	<p>Closed - P1090691: Unpaved areas and haul roads were wetted to suppress dust.</p>

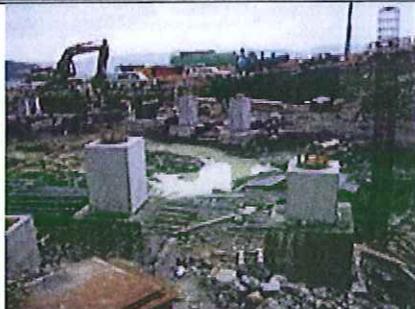
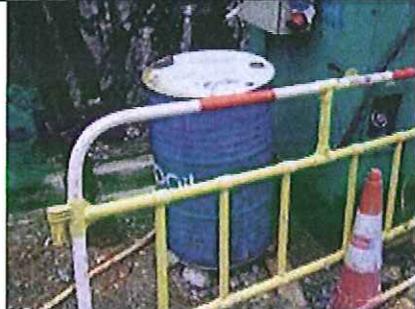
<p>P1090693: Stagnant water was observed accumulated around the site due to rainfall. Removal by pumps was in progress. The Contractor was reminded to remove them as soon as possible.</p>	<p>P1090702: An oil drum was placed on bareground. The Contractor was reminded to provide drip trays for all oil drums on site to avoid oil spillage.</p>

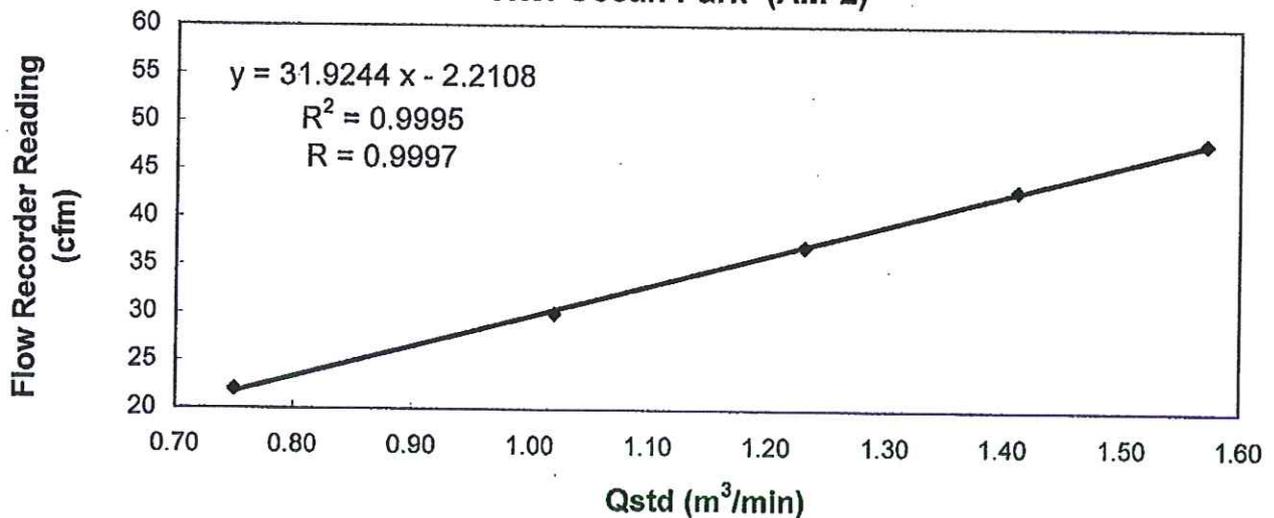
Sampler 1177 Calibration Curve
Site: Ocean Park (AM-2)

Acceptance Criteria : Correlation coefficient (r) of the calibration curve greater than 0.990 after a 5-point calibration.

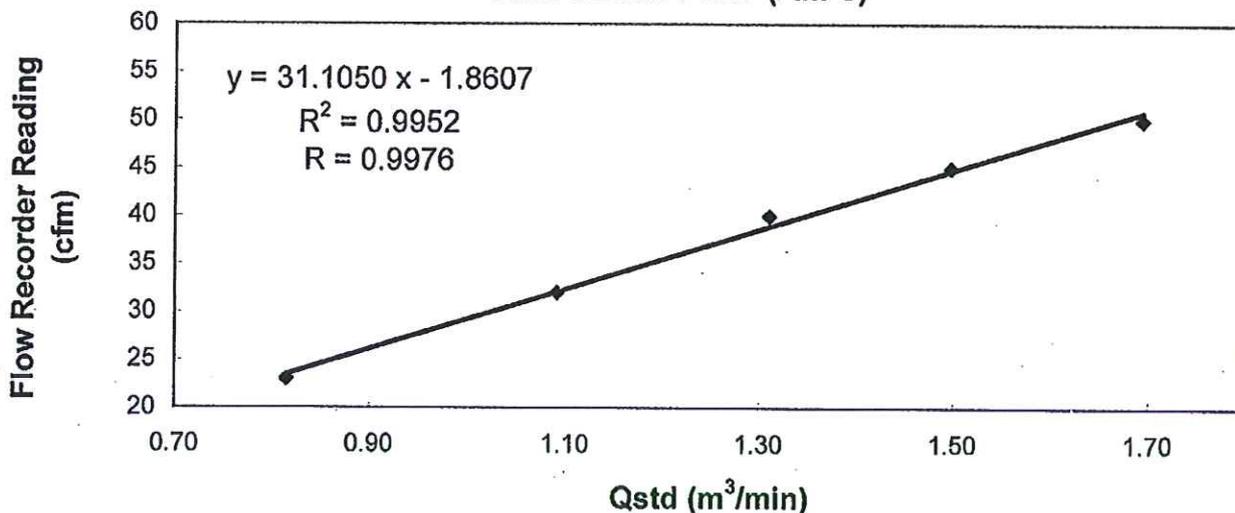
Sampler 9998 Calibration Curve
Site: Ocean Park (AM-3)

Acceptance Criteria : Correlation coefficient (r) of the calibration curve greater than 0.990 after a 5-point calibration.

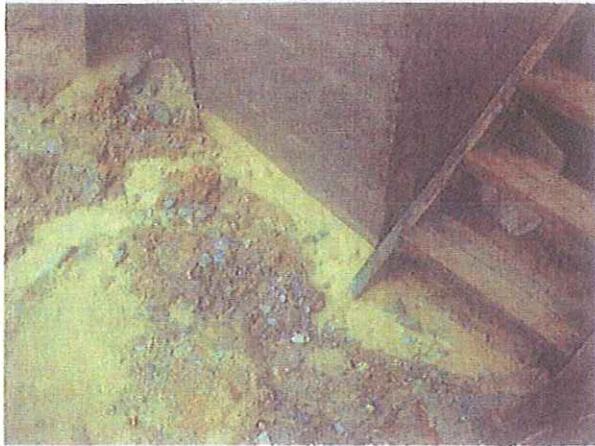
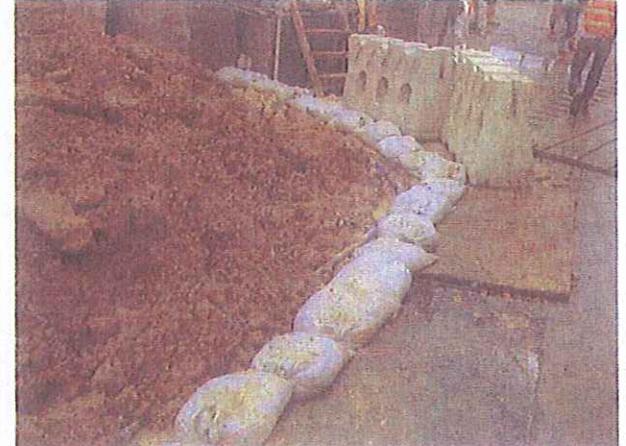
<p>1. Sandbags were removed and no protection was made to prevent washoff of soil into the surface channel.</p>	<p>1. The contractor was reminded to provide sandbag immediately.</p>

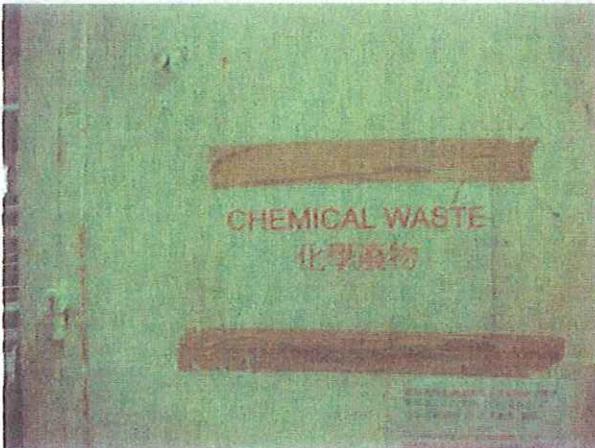
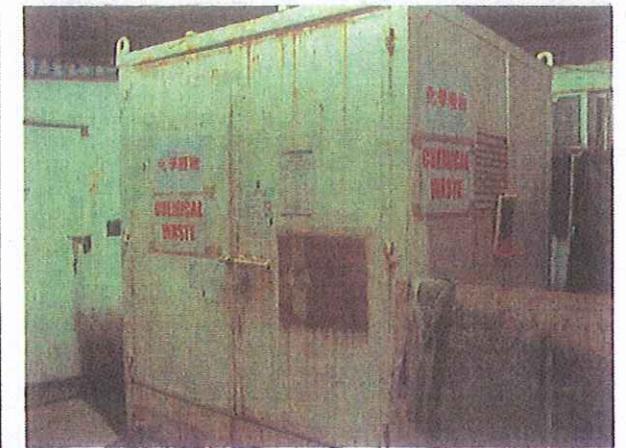
<p>2. At the chemical waste storage, the height of font "Chemical waste" was found lower than 60 mm.</p>	<p>2. The contractor was reminded to adhere to EPD's guidance and provide label with font height not less than 60 mm.</p>

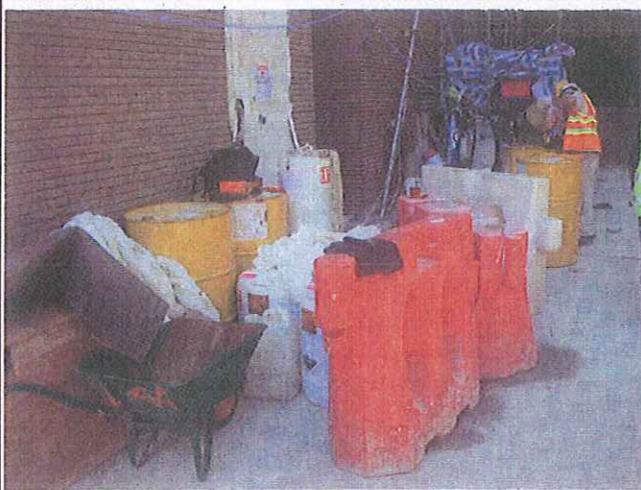
1. Drums of polyurea from Hop Shing were placed near the surface channel outside GA.

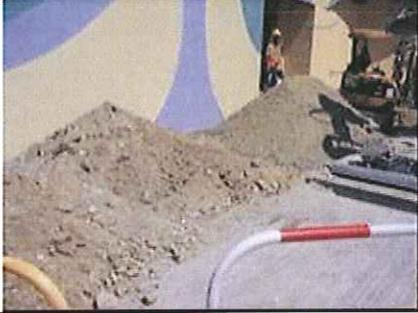
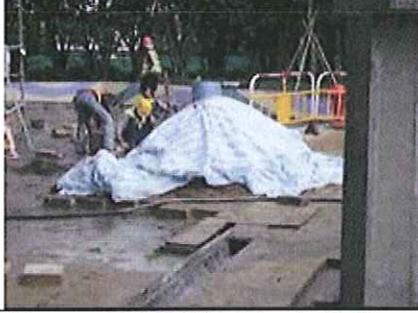
<p>P1090362: Stockpile of dusty material was not covered with tarpaulin sheets or other means. The Contract should cover all idle stockpiles of dusty materials on-site to suppress dust.</p>	<p>Closed - P1090667: Idle stockpiles of dusty materials on-site were covered with tarpaulin sheets entirely to suppress dust.</p>

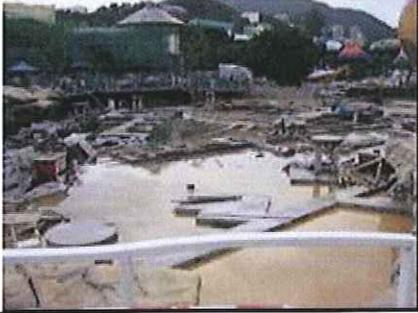
<p>P1090672: Stagnant water was accumulated around the site due to rainfall. The Contractor is reminded to remove them as soon as possible.</p>	<p></p>

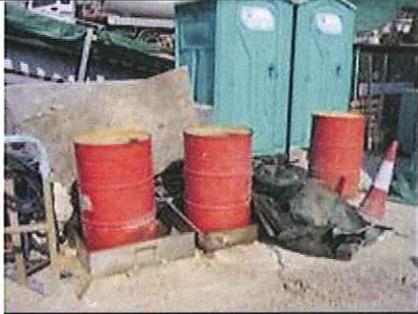
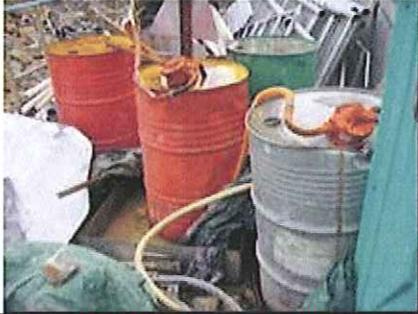
<p>P1090403: An empty oil drum was placed on bareground while drip tray with oil drum was accumulated with general refuse and rainwater. The Contractor should dispose the empty oil drum as soon as possible and maintain all drip trays more frequently.</p>	<p>P1090708: Drip tray with oil drum was accumulated with general refuse and rainwater. The Contractor should maintain all drip trays more frequently.</p>

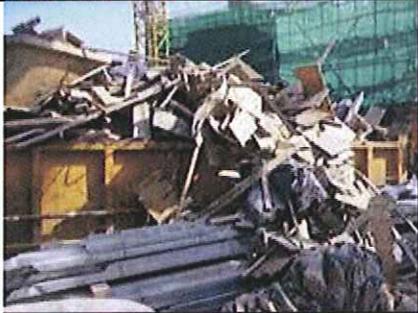
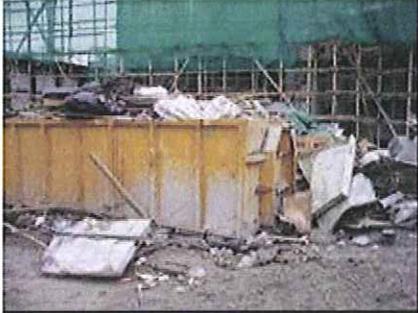
<p>P1090408: Accumulation of construction waste was observed. The Contractor should provide more skips for construction waste and remove construction waste off-site more frequently.</p>	<p>Closed – P1090713: More frequent removal of construction waste off-site had been provided.</p>
Observations in June 2010

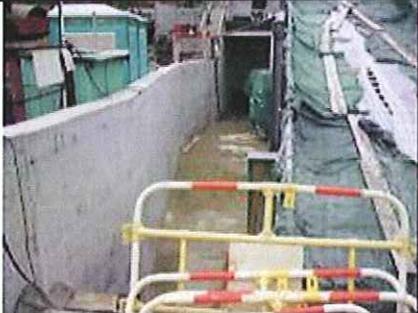
<p>P1090707: Stagnant water was observed accumulated around the site due to rainfall. Removal by pumps was in progress. The Contractor was reminded to remove them as soon as possible.</p>

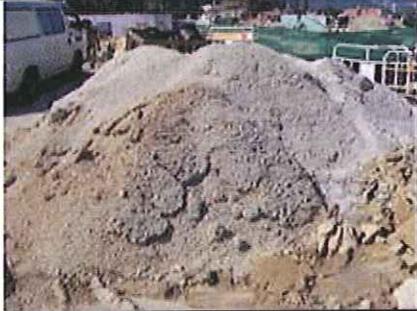
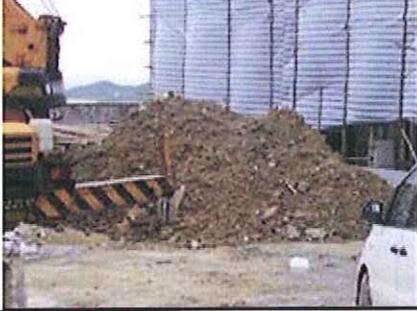
<p>P1090384: Stockpiles of dusty material was not covered with tarpaulin sheets or other means. The Contractor should cover all idle stockpiles of dusty materials on-site to suppress dust.</p>	<p>P1090698: A stockpile of dusty C&D material was not covered with tarpaulin sheets or other means. The Contractor should cover all idle stockpiles of dusty materials on-site to suppress dust.</p>

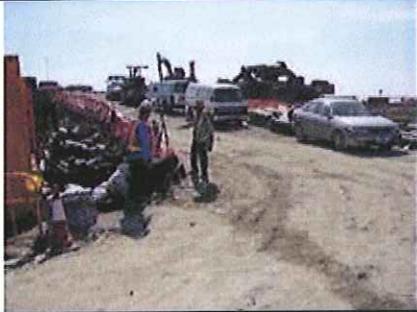
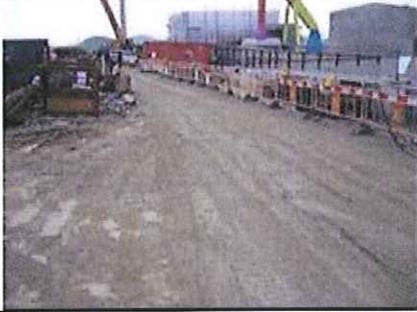
<p>P1090385: Some sections of haul road were not provided with water spray. The Contractor should provide water spray to all unpaved areas and haul roads on-site to suppress dust.</p>	<p>Closed - P1090691: Unpaved areas and haul roads were wetted to suppress dust.</p>
Observations in June 2010

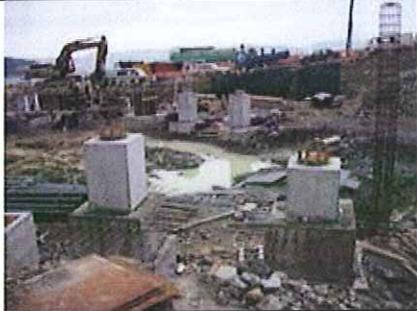
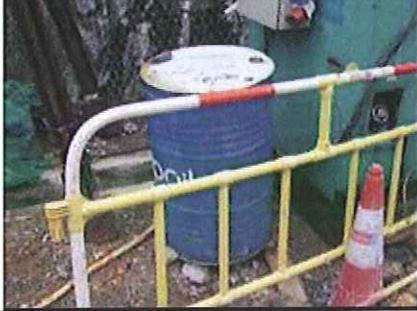
<p>P1090693: Stagnant water was observed accumulated around the site due to rainfall. Removal by pumps was in progress. The Contractor was reminded to remove them as soon as possible.</p>	<p>P1090702: An oil drum was placed on bareground. The Contractor was reminded to provide drip trays for all oil drums on site to avoid oil spillage.</p>

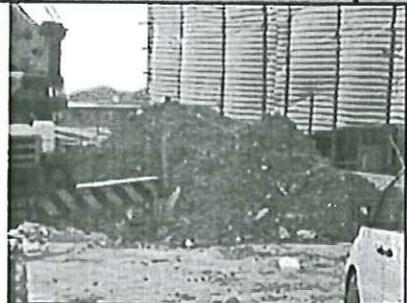
<p>P1090384: Stockpiles of dusty material was not covered with tarpaulin sheets or other means. The Contractor should cover all idle stockpiles of dusty materials on-site to suppress dust.</p>	<p>P1090698: A stockpile of dusty C&D material was not covered with tarpaulin sheets or other means. The Contractor should cover all idle stockpiles of dusty materials on-site to suppress dust.</p>

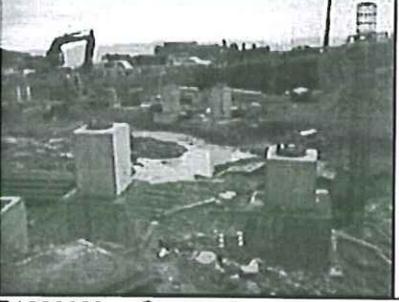
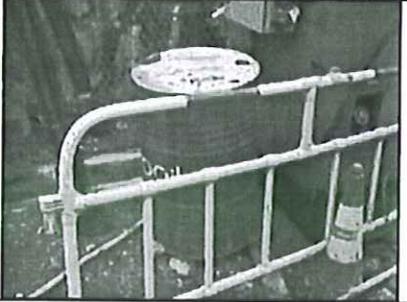
<p>P1090693: Stagnant water was observed accumulated around the site due to rainfall. Removal by pumps was in progress. The Contractor was reminded to remove them as soon as possible.</p>	<p>P1090702: An oil drum was placed on bareground. The Contractor was reminded to provide drip trays for all oil drums on site to avoid oil spillage.</p>
