Ocean Park Master Redevelopment Project

Monthly EM&A Report – August 2010

Monthly Environmental Monitoring & Audit
Report – August 2010

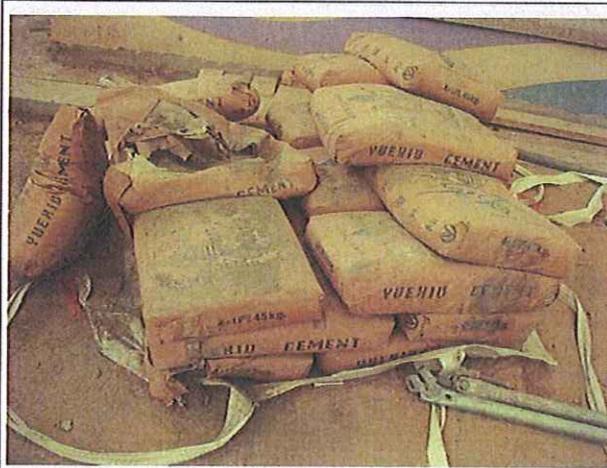
1. Under the tensile canopy on the Entry Plaza podium, opened cement bags were not covered by tarpaulin.

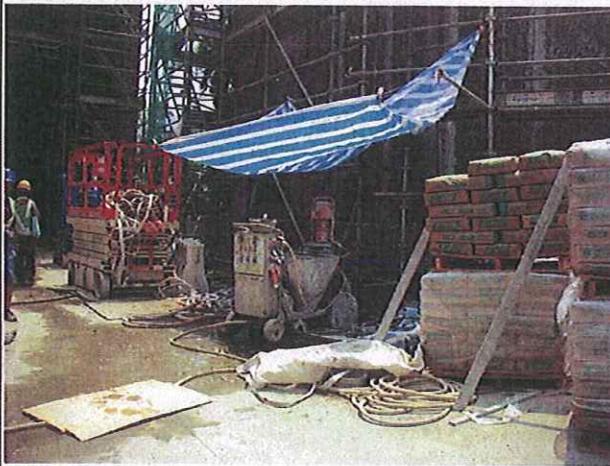
1. Cement mixing machine was found operating at exterior area near the GA slope without provision of side coverage.

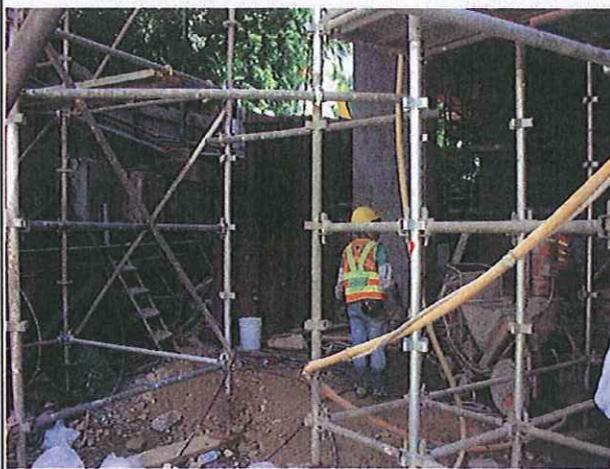
2. Cement mixing machine was found operating at exterior area near the sheet pile at Area X without provision of side coverage.

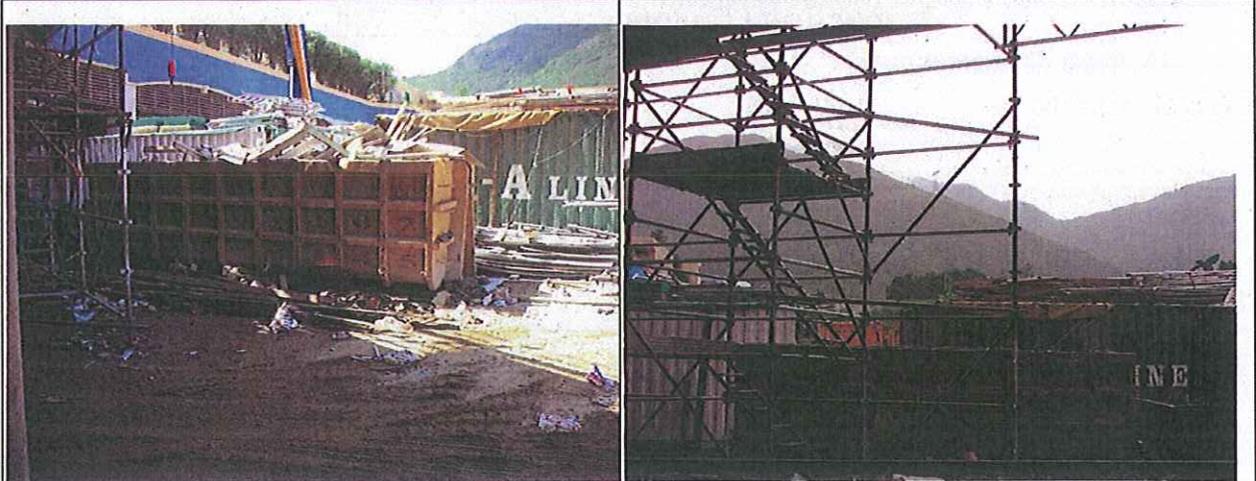
3. Waste skip was over accumulated at Area X.

3. The contractor was reminded to empty the skip more regularly.

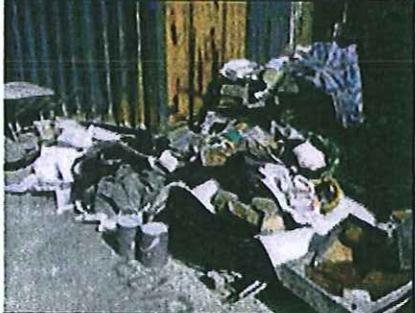
<p>P1100286: General refuse and construction waste were accumulated on-site. The Contractor was reminded to remove them from site more frequently to avoid accumulation</p>

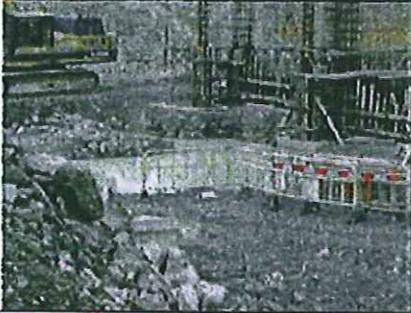
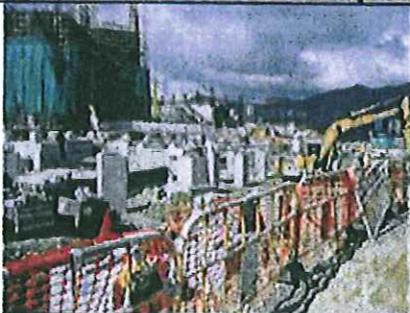
<p>P1090943: Stagnant water was accumulated around the site due to heavy rain the day before. The Contractor is reminded to remove them as soon as possible.</p>	<p>Closed - P1100270: Accumulation of stagnant water around the site had been removed more frequently.</p>

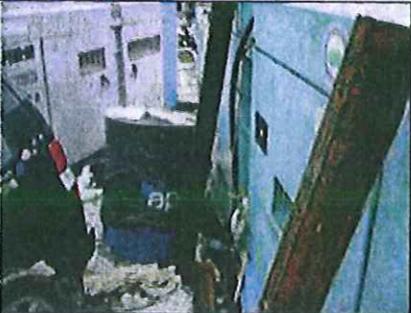
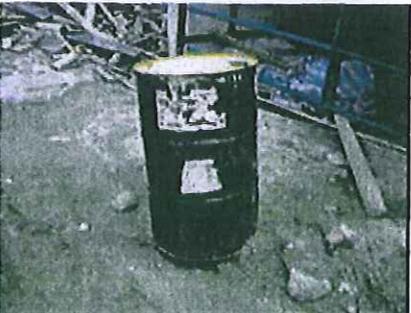
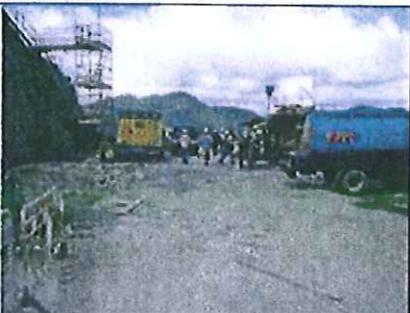
<p>P1090935 & P1090941: A few empty oil drums were placed on bareground. The Contractor is reminded to place them in the chemical waste storage area and remove them from the site as soon as possible.</p>	<p>Closed – P1100276: Empty oil drums were no longer observed while oil drums were placed in drip trays to avoid oil spillage.</p>

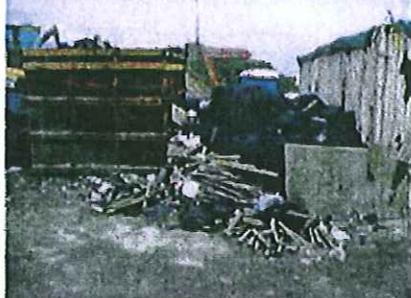
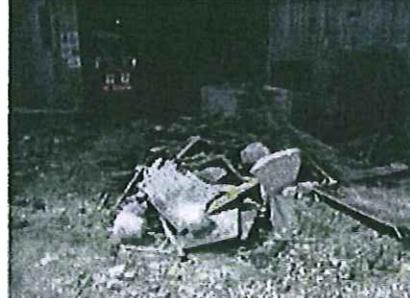
<p>P1090947: General refuse were accumulated on-site. The Contractor is reminded to store them in enclosed bins or compaction units separate from C&D materials.</p>	<p>P1100273: General refuse and construction waste were accumulated on-site. The Contractor was reminded to remove them from site more frequently to avoid accumulation.</p>

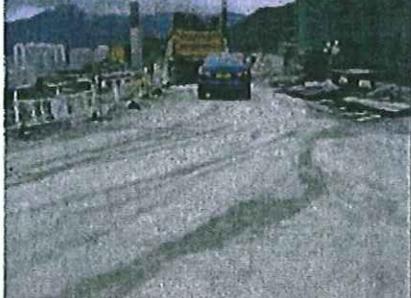
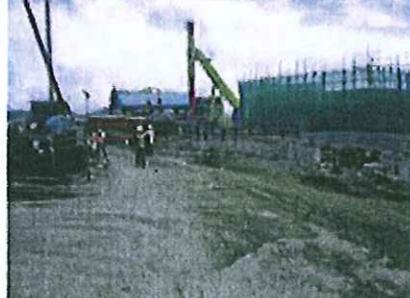
<p>P1090952: Section of paved access road near the site entrance was dry and dusty. The Contractor is reminded to provide water spray regularly to suppress dust.</p>	<p>Closed - P1100264: Water spray had been provided regularly along haul roads to suppress dust.</p>
