Ocean Park Master Redevelopment Project

Monthly EM&A Report – September 2010

Environmental Permit No. EP-249/2006/A - Condition 3.4

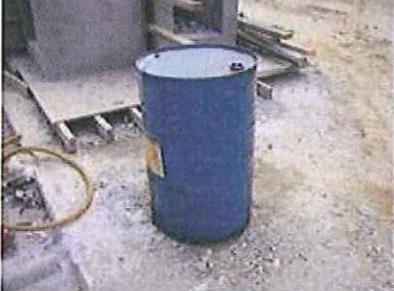
N/A
<p>P1100255: An empty oil drum was placed on bare ground. The Contractor is reminded to place it in the chemical waste storage area and remove it from the site as soon as possible.</p>	<p>Closed – Empty oil drums were not observed during the site inspection.</p>

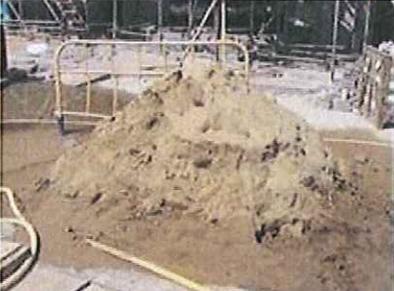
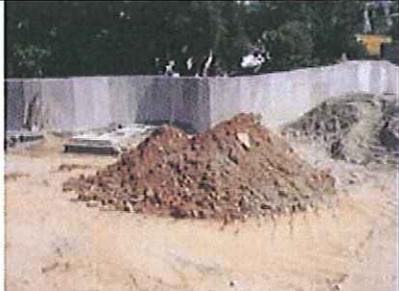
<p>P1100254: A stockpile of dusty construction material was not covered with tarpaulin sheets or other means. The Contractor is reminded to cover all dusty stockpiles on site with tarpaulin sheets or other means.</p>	<p>Closed – P1100800: Stockpile of construction material would be backfilled within the day.</p>
Observations in September 2010

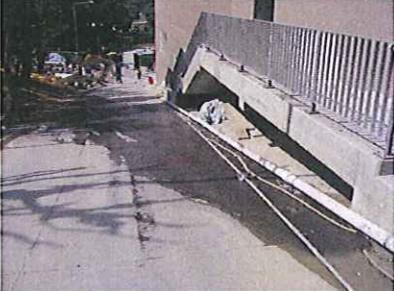
<p>P1100790: Discharge of cleansing water was observed. The Contractor is reminded to provide sedimentation/treatment to wastewater generated from the site before discharge.</p>

- ① Wastewater (for cleaning purpose) discharge was observed. The Contractor was recommended to provide treatment / sedimentation to the wastewater before discharge.

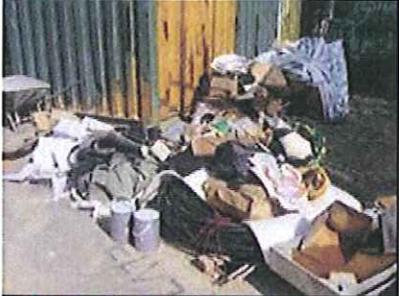
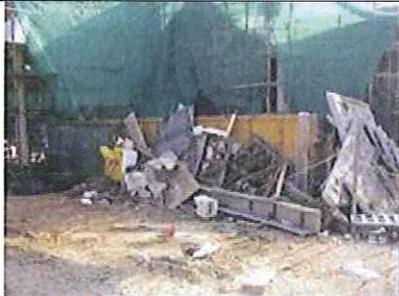
<p>P1100286: General refuse and construction waste were accumulated on-site. The Contractor was reminded to remove them from site more frequently to avoid accumulation.</p>	<p>P1100836: General refuse and construction waste were accumulated on-site. The Contractor was reminded to remove them from site more frequently to avoid accumulation.</p>
Observations in September 2010

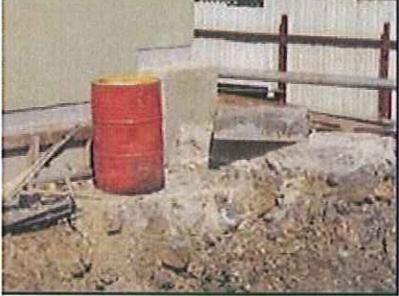
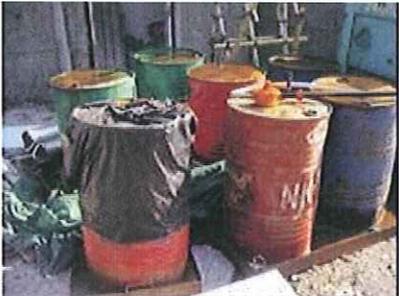
<p>P1100822 & P1100827: An oil drum was not provided with drip tray while the drip trays with oil drums were accumulated with water. The Contractor is reminded to provide drip trays to all oil drums on site to avoid oil spillage and remove water accumulated in drip trays with oil drums.</p>	
---	--

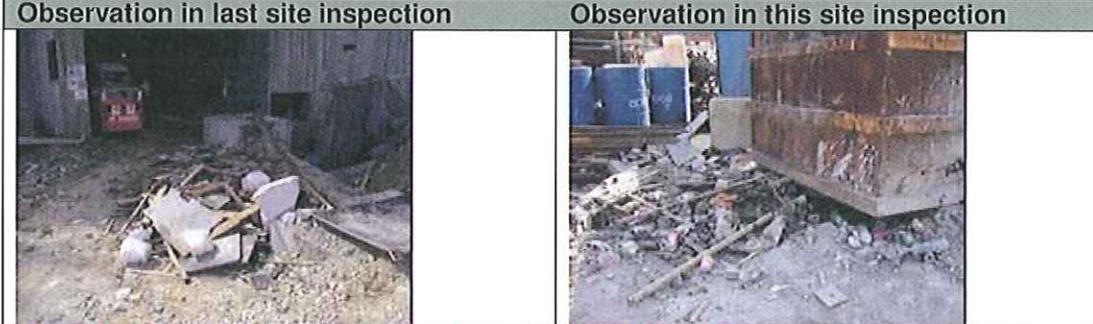
<p>P1100273: General refuse and construction waste were accumulated on-site. The Contractor was reminded to remove them from site more frequently to avoid accumulation.</p>	<p>P1100811: General refuse were scattered around the site. The Contractor is reminded to remove them from site more frequently to avoid accumulation.</p>
--	--

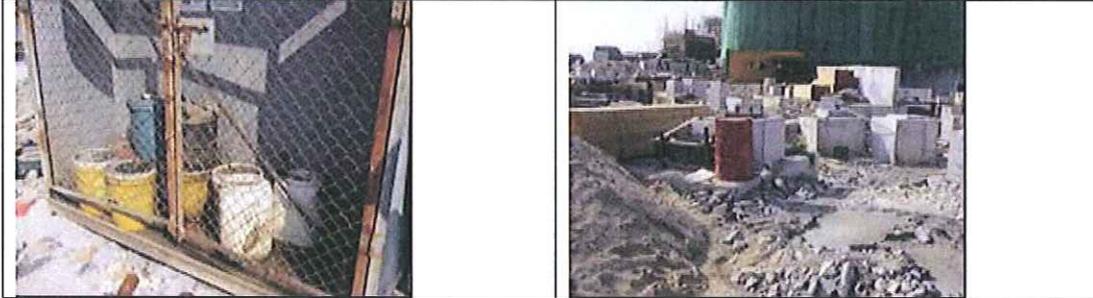
<p>P1100803: Stagnant water was accumulated within the chemical waste storage area. The Contractor is reminded to remove the stagnant water as soon as possible.</p>	<p>P1100814: An oil drum was not provided with drip tray. The Contractor is reminded to provide it with drip tray to avoid oil spillage.</p>
--	--

- ① Stagnant water was observed accumulated in the chemical waste storage area
- ② General refuse was observed accumulated around the site
- ③ An oil drum was not provided with drip tray
- ④ Part of the haul road was observed to be dry and dusty.

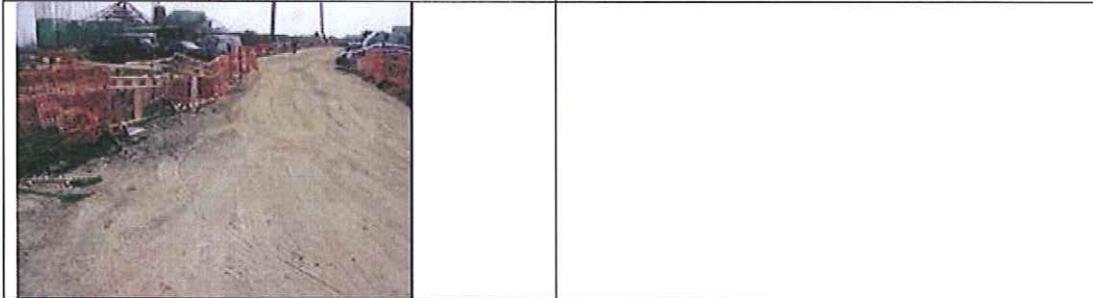
<p>P1100819: Part of the haul road was dry and dusty. The Contractor is reminded to provide watering more frequently to suppress dust.</p>	
--	--

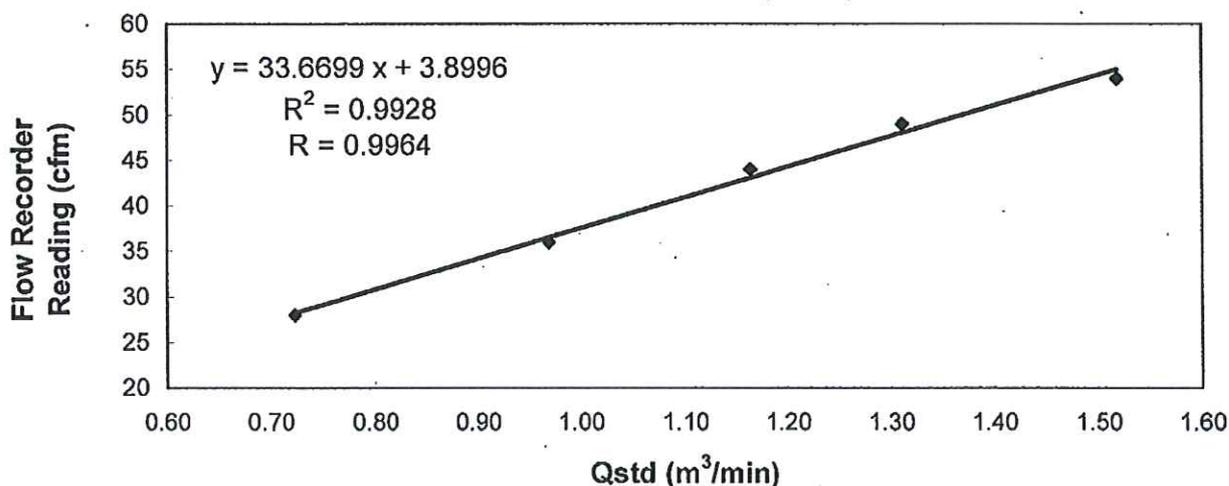
Sampler 1174 Calibration Curve
Site: Ocean Park (AM-1)

Flow recorder reading (cfm)	54	49	44	36	28
Qstd (Actual flow rate, m ³ /min)	1.52	1.31	1.16	0.97	0.72
Pressure :	756.06 mm Hg			Temp. :	304 K

Acceptance Criteria : Correlation coefficient (r) of the calibration curve greater than 0.990 after a 5-point calibration.

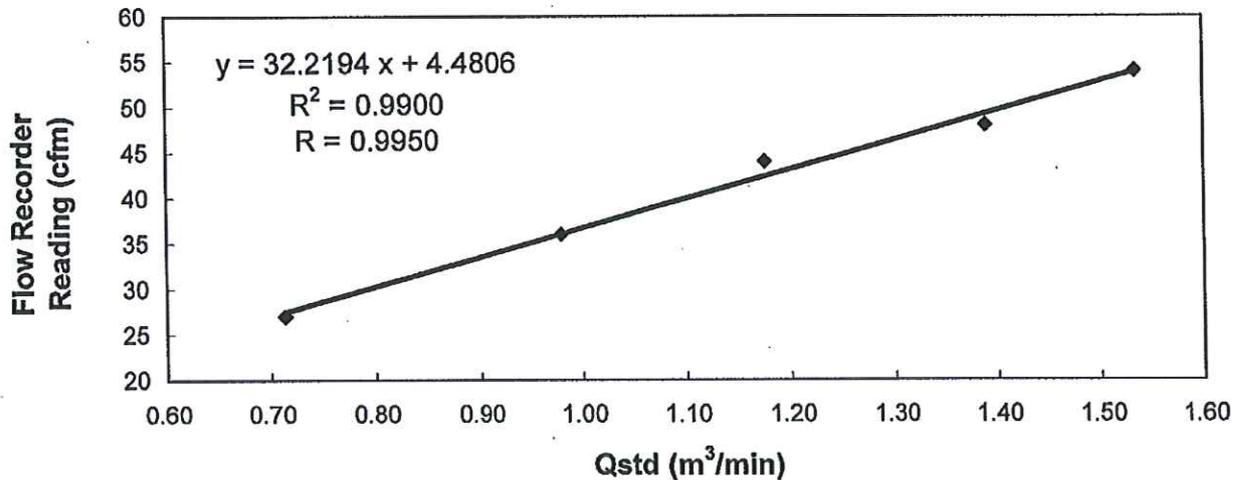
**Sampler 1174 Calibration Curve
Site: Ocean Park (AM-1)**

Flow recorder reading (cfm)	54	48	44	36	27
Qstd (Actual flow rate, m ³ /min)	1.53	1.39	1.18	0.98	0.71
Pressure :	761.31 mm Hg			Temp. :	300 K

Acceptance Criteria : Correlation coefficient (r) of the calibration curve greater than 0.990 after a 5-point calibration.

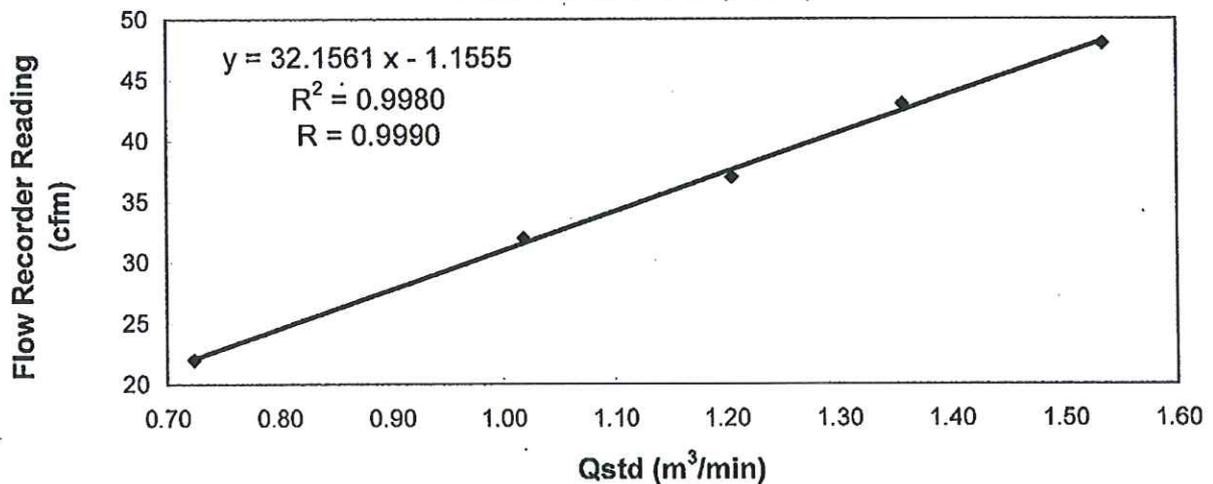
Sampler 1177 Calibration Curve
Site: Ocean Park (AM-2)

Flow recorder reading (cfm)	48	43	37	32	22
Qstd (Actual flow rate, m ³ /min)	1.53	1.36	1.21	1.02	0.72
Pressure :	756.06 mm Hg			Temp. :	304 K

Acceptance Criteria : Correlation coefficient (r) of the calibration curve greater than 0.990 after a 5-point calibration.

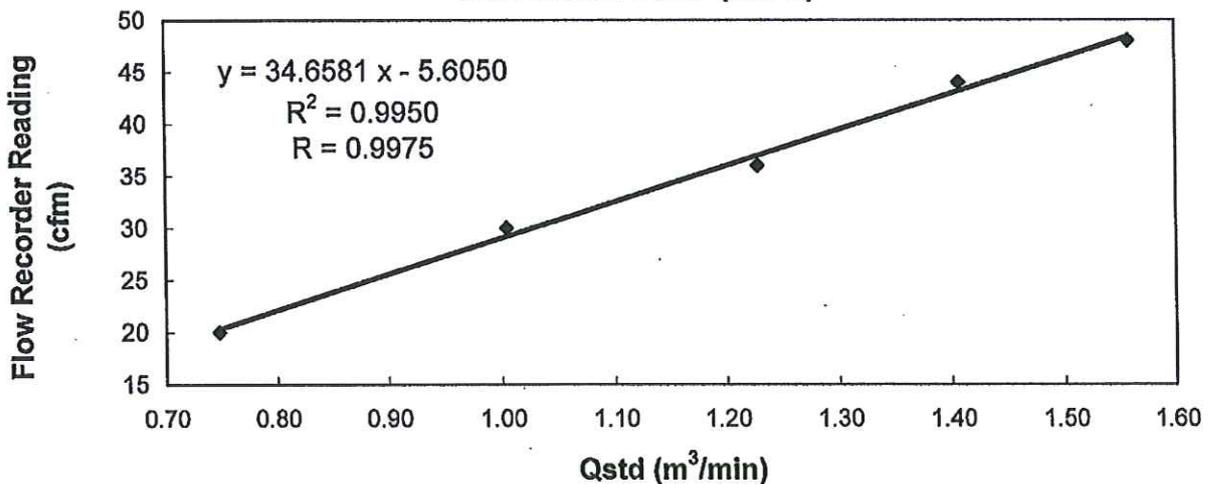
**Sampler 1177 Calibration Curve
Site: Ocean Park (AM-2)**

Flow recorder reading (cfm)	48	44	36	30	20
Qstd (Actual flow rate, m ³ /min)	1.56	1.41	1.23	1.00	0.75
Pressure :	761.31 mm Hg			Temp. :	300 K

Acceptance Criteria : Correlation coefficient (r) of the calibration curve greater than 0.990 after a 5-point calibration.

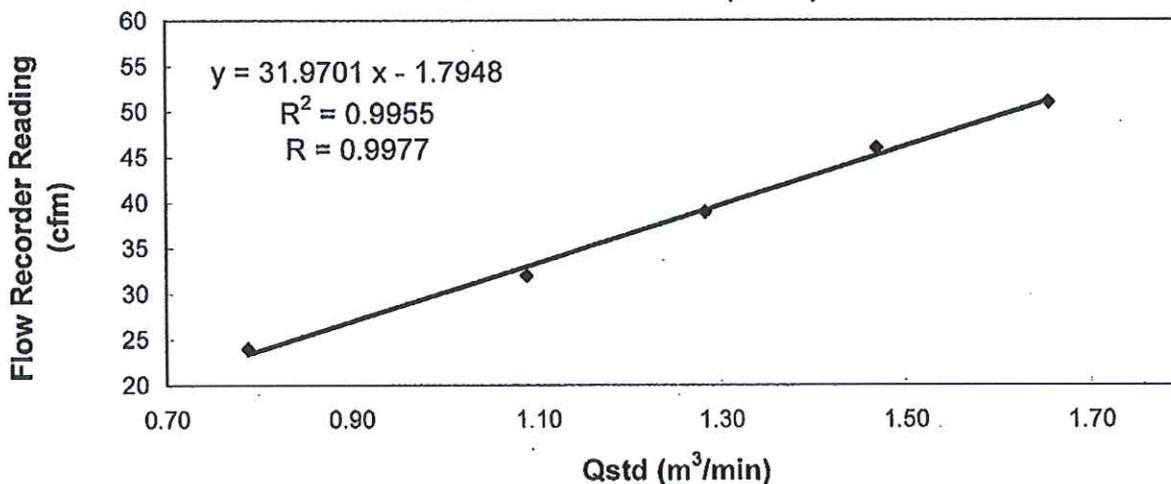
**Sampler 9998 Calibration Curve
Site: Ocean Park (AM-3)**

Results	Flow recorder reading (cfm)	51	46	39	32	24
	Qstd (Actual flow rate, m ³ /min)	1.66	1.47	1.28	1.09	0.79
	Pressure : 756.06 mm Hg	Temp. : 304 K

Acceptance Criteria : Correlation coefficient (r) of the calibration curve greater than 0.990 after a 5-point calibration.

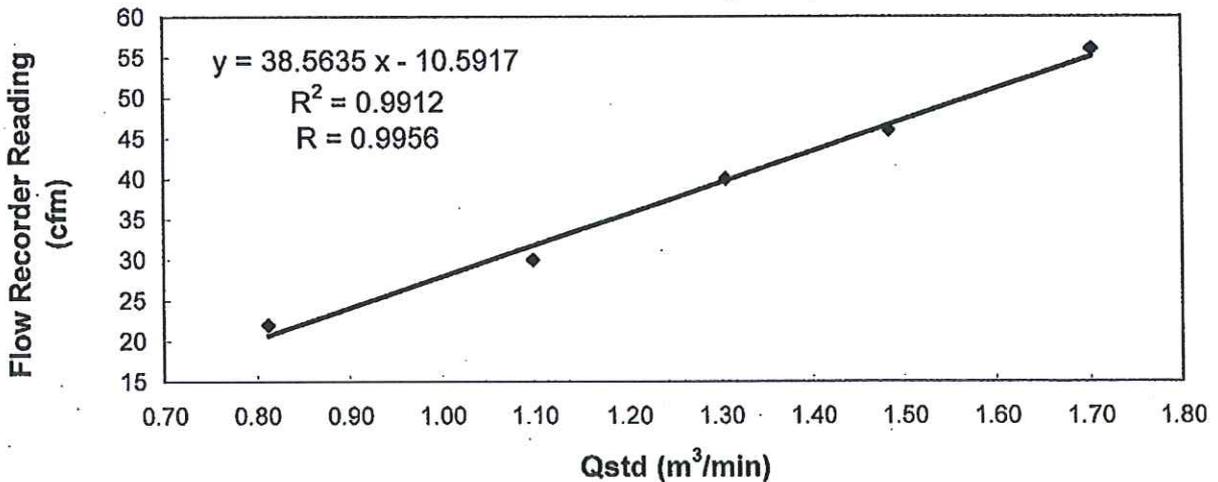
**Sampler 9998 Calibration Curve
Site: Ocean Park (AM-3)**

Flow recorder reading (cfm)	56	46	40	30	22
Qstd (Actual flow rate, m ³ /min)	1.70	1.48	1.31	1.10	0.81
Pressure :	761.31 mm Hg			Temp. :	300 K

Acceptance Criteria : Correlation coefficient (r) of the calibration curve greater than 0.990 after a 5-point calibration.

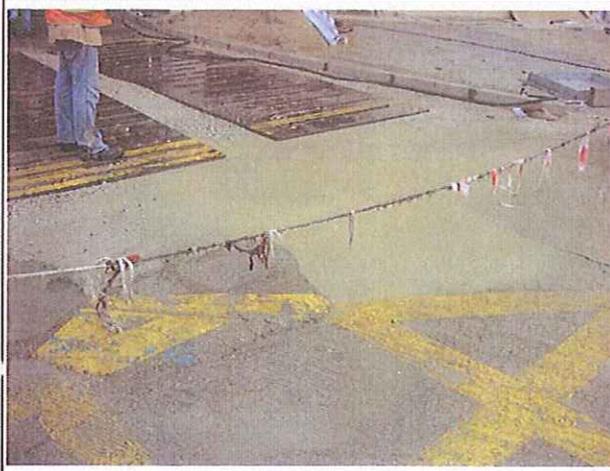
1. Muddy water was accumulated outside of Gate C.

1. The contractor was reminded to ensure any road leading to the site that is within 30m of Gate C would be tidy.

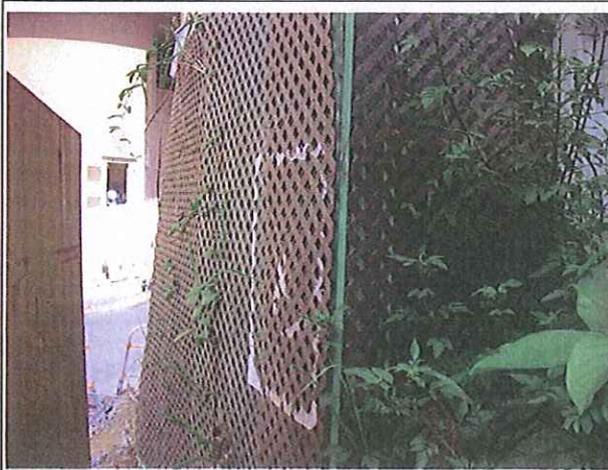
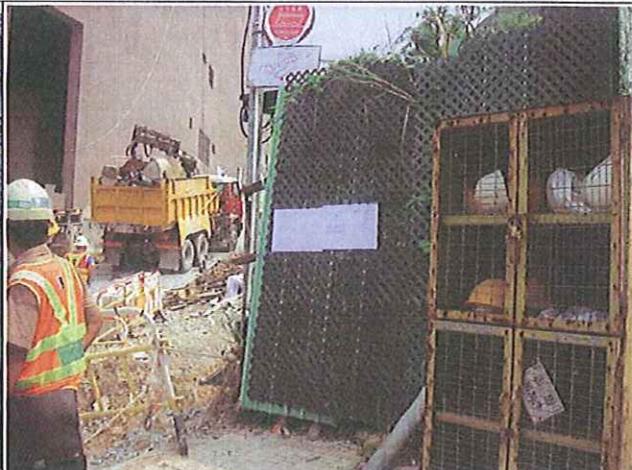
1. Environmental permit and CNP were not displayed at Gate A.

1. The contractor was reminded to ensure the documents were displayed to the public at this major site exit.

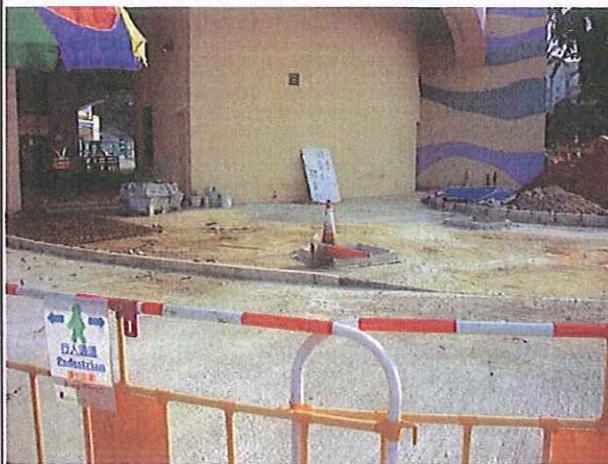
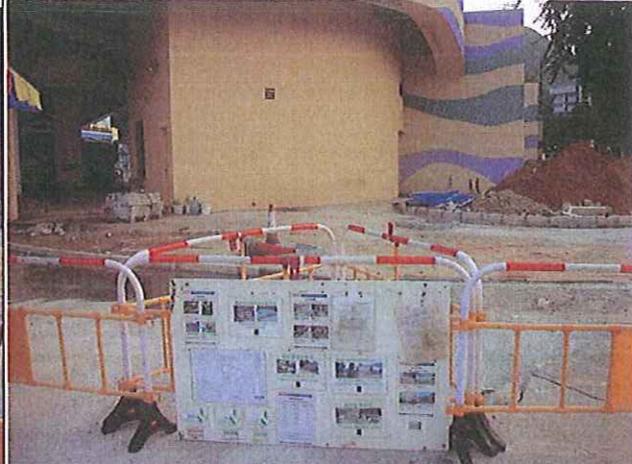
2. Environmental notice board was moved ~50 metres away from Gate C entrance.

2. The contractor was reminded to make sure the notice board was placed at the exit where visible to the public.

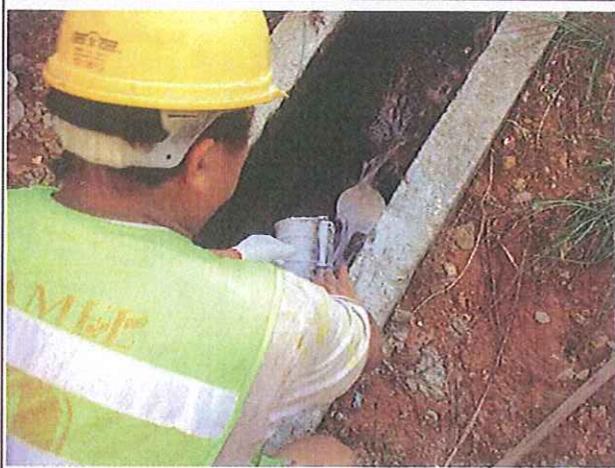
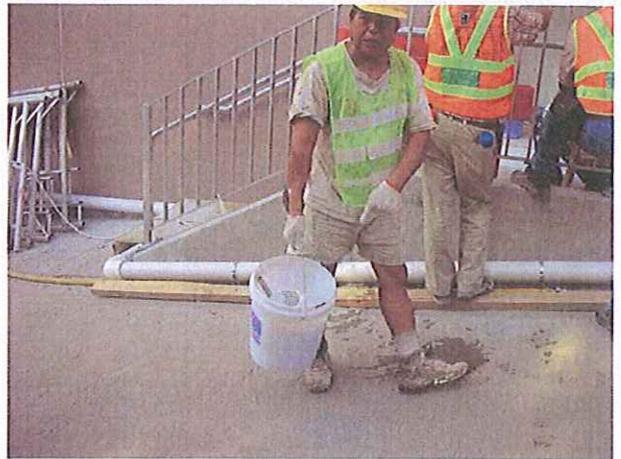
1. A worker was caught discharging waste paint into surface channel on GA slope.

1. The contractor immediately stopped his action and required him to store the waste paint in a container and dispose as chemical waste.

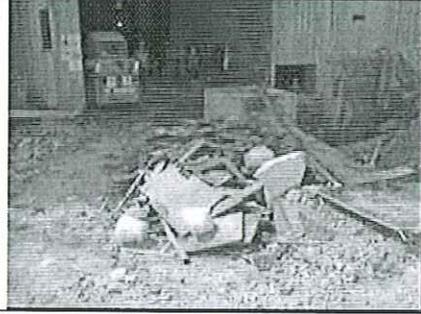
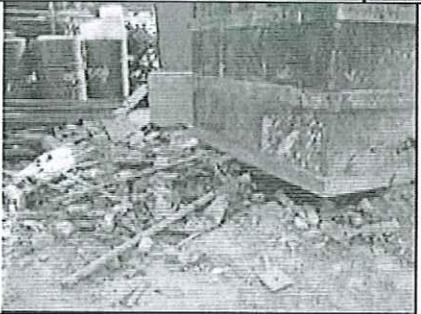
<p>P1100273: General refuse and construction waste were accumulated on-site. The Contractor was reminded to remove them from site more frequently to avoid accumulation.</p>	<p>P1100811: General refuse were scattered around the site. The Contractor is reminded to remove them from site more frequently to avoid accumulation.</p>

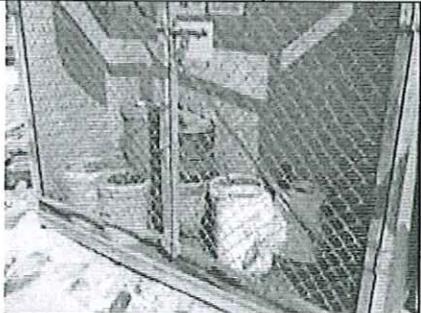
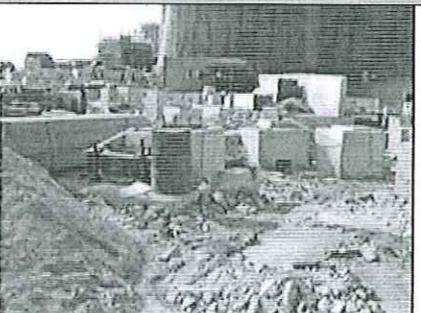
<p>P1100803: Stagnant water was accumulated within the chemical waste storage area. The Contractor is reminded to remove the stagnant water as soon as possible.</p>	<p>P1100814: An oil drum was not provided with drip tray. The Contractor is reminded to provide it with drip tray to avoid oil spillage.</p>

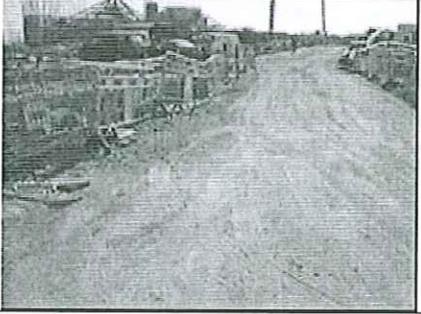
<p>P1100819: Part of the haul road was dry and dusty. The Contractor is reminded to provide watering more frequently to suppress dust.</p>
