Ocean Park Master Redevelopment Project

Monthly EM&A Report – June 2011

Environmental Permit No. EP-249/2006/B - Condition 3.4

**Ocean Park Redevelopment Project
- Thrill Mountain & Polar Adventure**

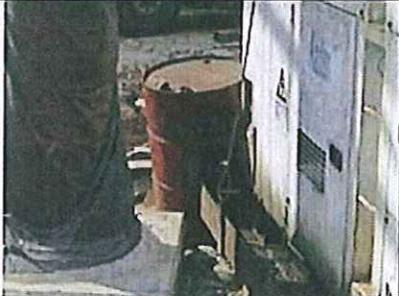
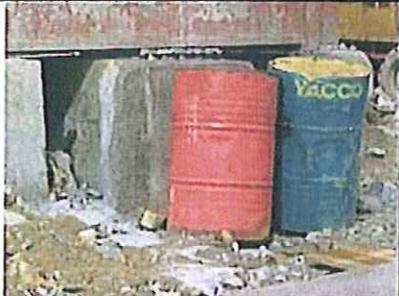
<p>P1130214: An empty oil drum was placed on bare ground. The Contractor was reminded to place it in chemical waste storage area and dispose it properly.</p>	<p>P1130315: Two empty oil drums were placed on bare ground. The Contractor was reminded to place them in chemical waste storage area and dispose them properly.</p>

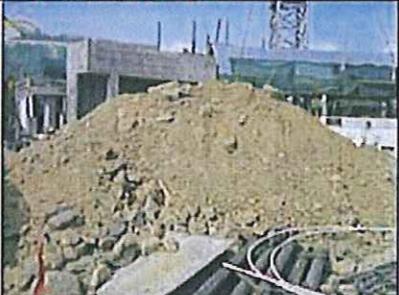
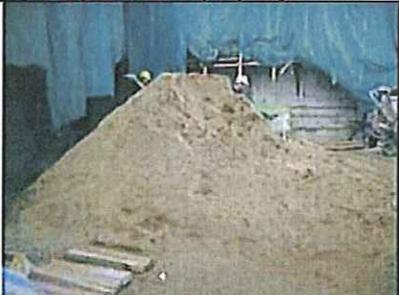
<p>P1130207: Idled stockpiles of excavated materials were not covered. The Contractor was reminded to cover them with tarpaulin sheets or other means to suppress dust.</p>	<p>P1130314: An idled stockpile of dusty construction material was not covered by any means. The Contractor was reminded to cover it with tarpaulin sheets or other means to suppress dust.</p>

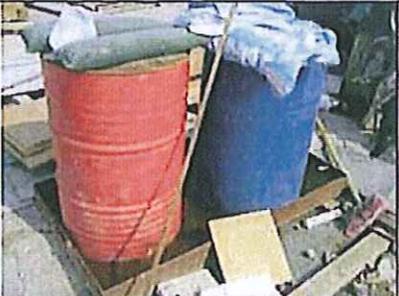
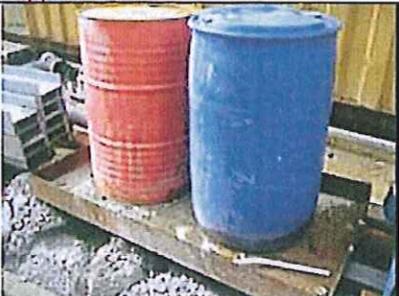
<p>P1130209: Water was accumulated in drip tray with oil drums. The Contractor was reminded to drain the water away to ensure effectiveness of the drip tray.</p>	<p>Closed - P1130313: Water in drip tray with oil drums had been removed.</p>

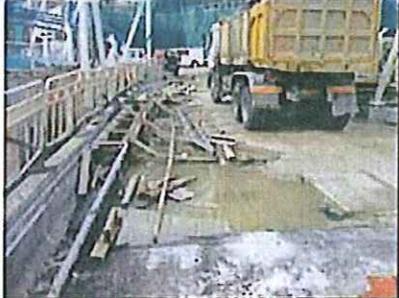
<p>P1130316: Stagnant water was accumulated on site after heavy rain. The Contractor was reminded to remove them as soon as possible.</p>

- ① An idled stockpile was not covered with tarpaulin sheets or other means. The Contractor was reminded to cover with tarpaulin sheets or other means to suppress dust.
- ② Two empty oil drums were placed on bareground. The Contractor was reminded to dispose them properly.
- ③ Stagnant water was observed after heavy rain. The Contractor was reminded to remove them as soon as possible.

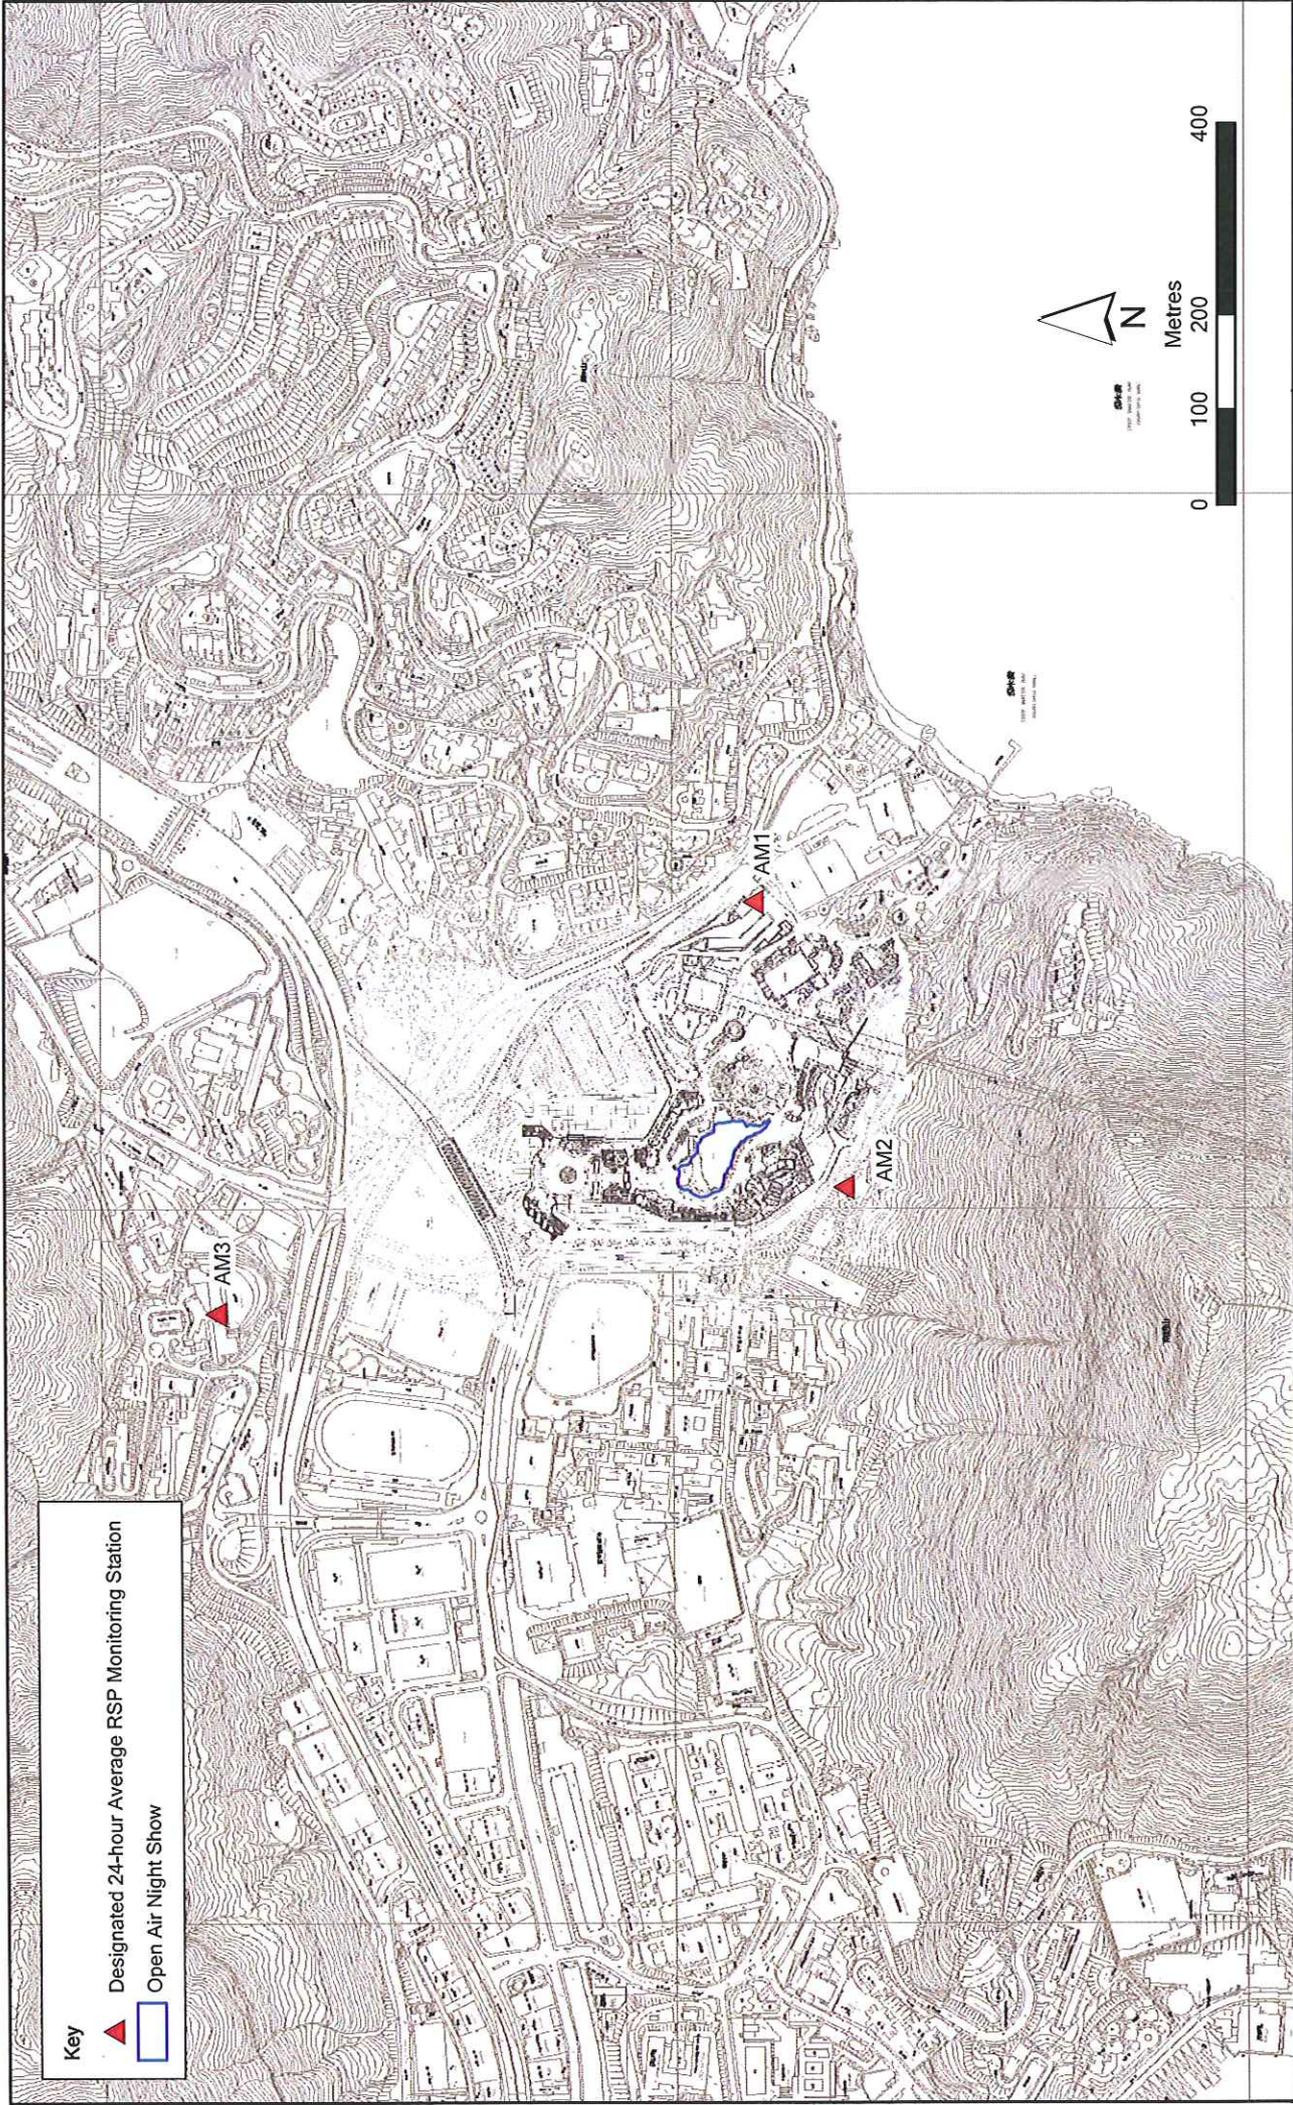
Figure 2.1

One 24-hr average RSP sample was collected on each scheduled day for monitoring by a High Volume Sampler (HVS) following the USEPA method, EPA IO-2.1. Calibration of the equipment has followed the requirements set out in EPA IO-2.1 with the calibration record given in *Annex A1*. A summary of the sampling methodology and equipment is presented in *Table 2.2*.

Designated 24-hour Average RSP Monitoring Stations during Operation of Open Air Night Show

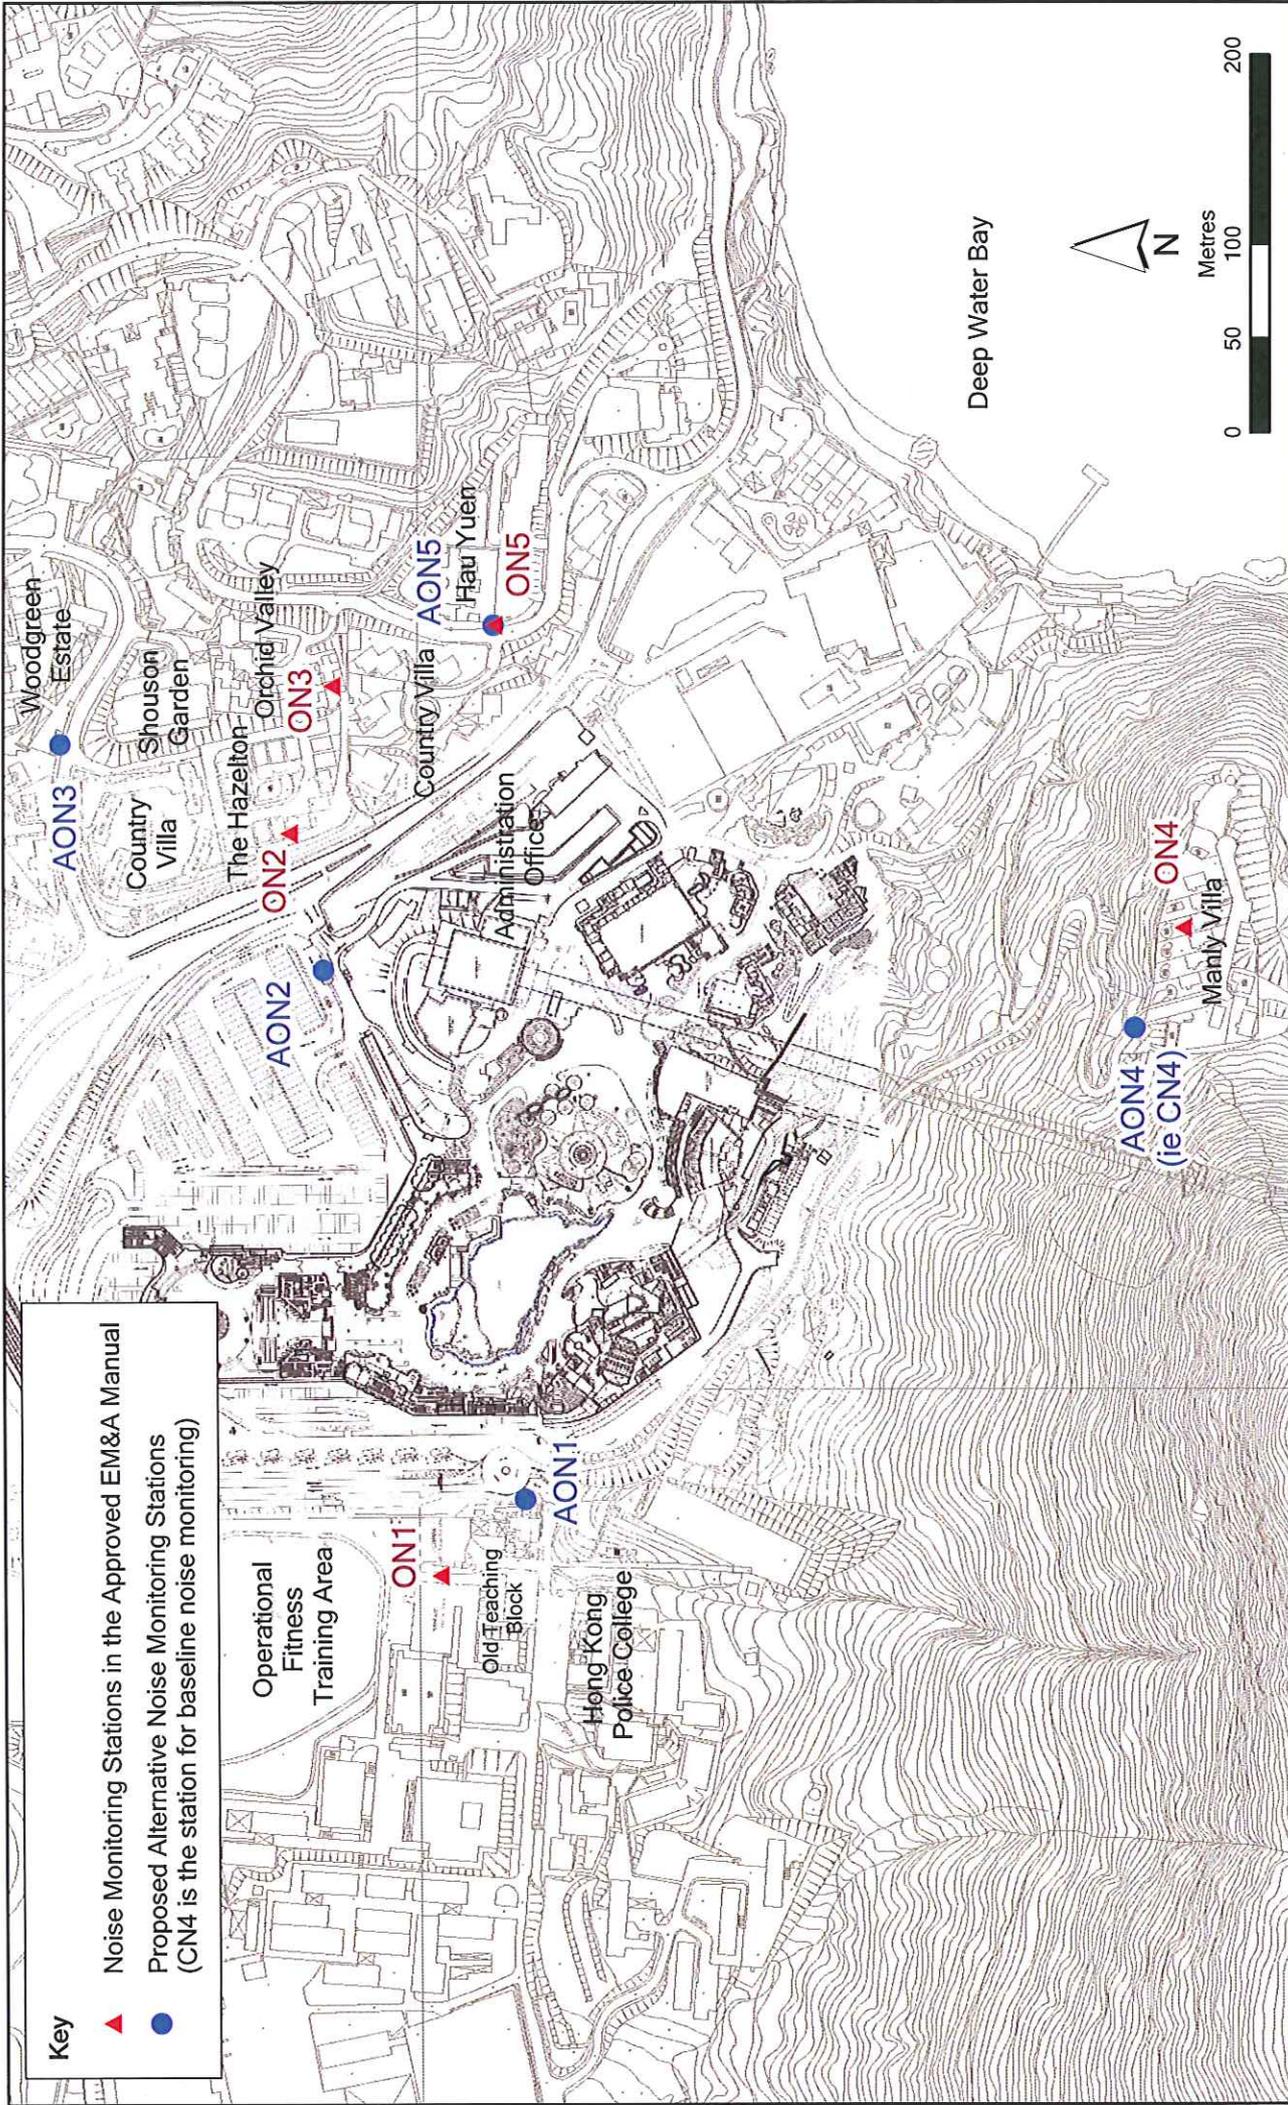
Noise monitoring was conducted at five designated noise monitoring locations in accordance with the approved EM&A Manual. Alternative noise monitoring has been proposed because of accessibility problem, as presented in *Table 3.1*, and shown in *Figure 3.1*. The monitoring location for AON3 at Orchid Valley has been replaced by Woodgreen Estate starting from 8 May 2011. The alternative noise monitoring locations have been agreed by the ET and IEC.

- ▲ Noise Monitoring Stations in the Approved EM&A Manual
- Proposed Alternative Noise Monitoring Stations (CN4 is the station for baseline noise monitoring)

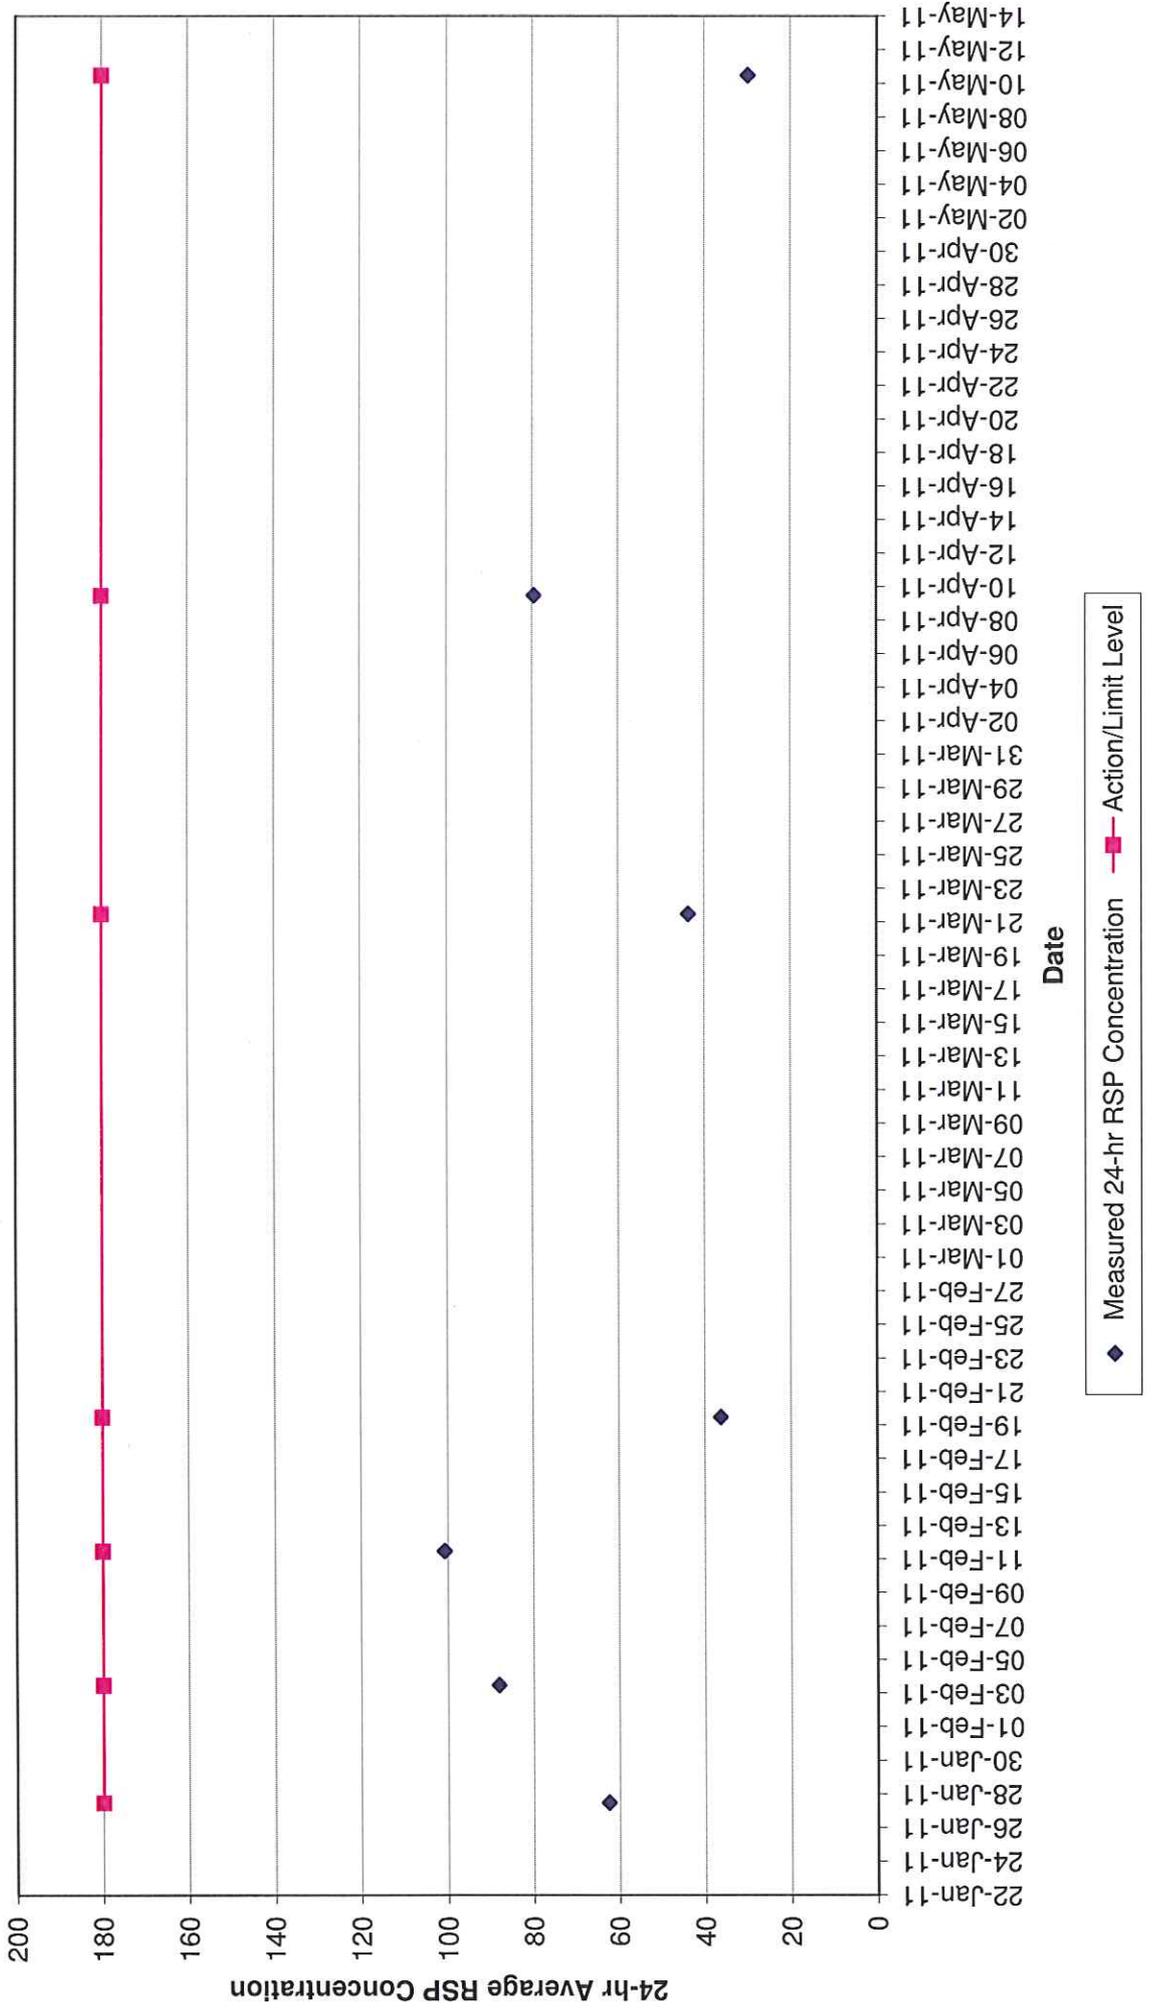
**Measured 24-hr Average RSP Concentration
AM1 - Rooftop of Administrative Building (Former Staff Quarters) in Ocean Park**

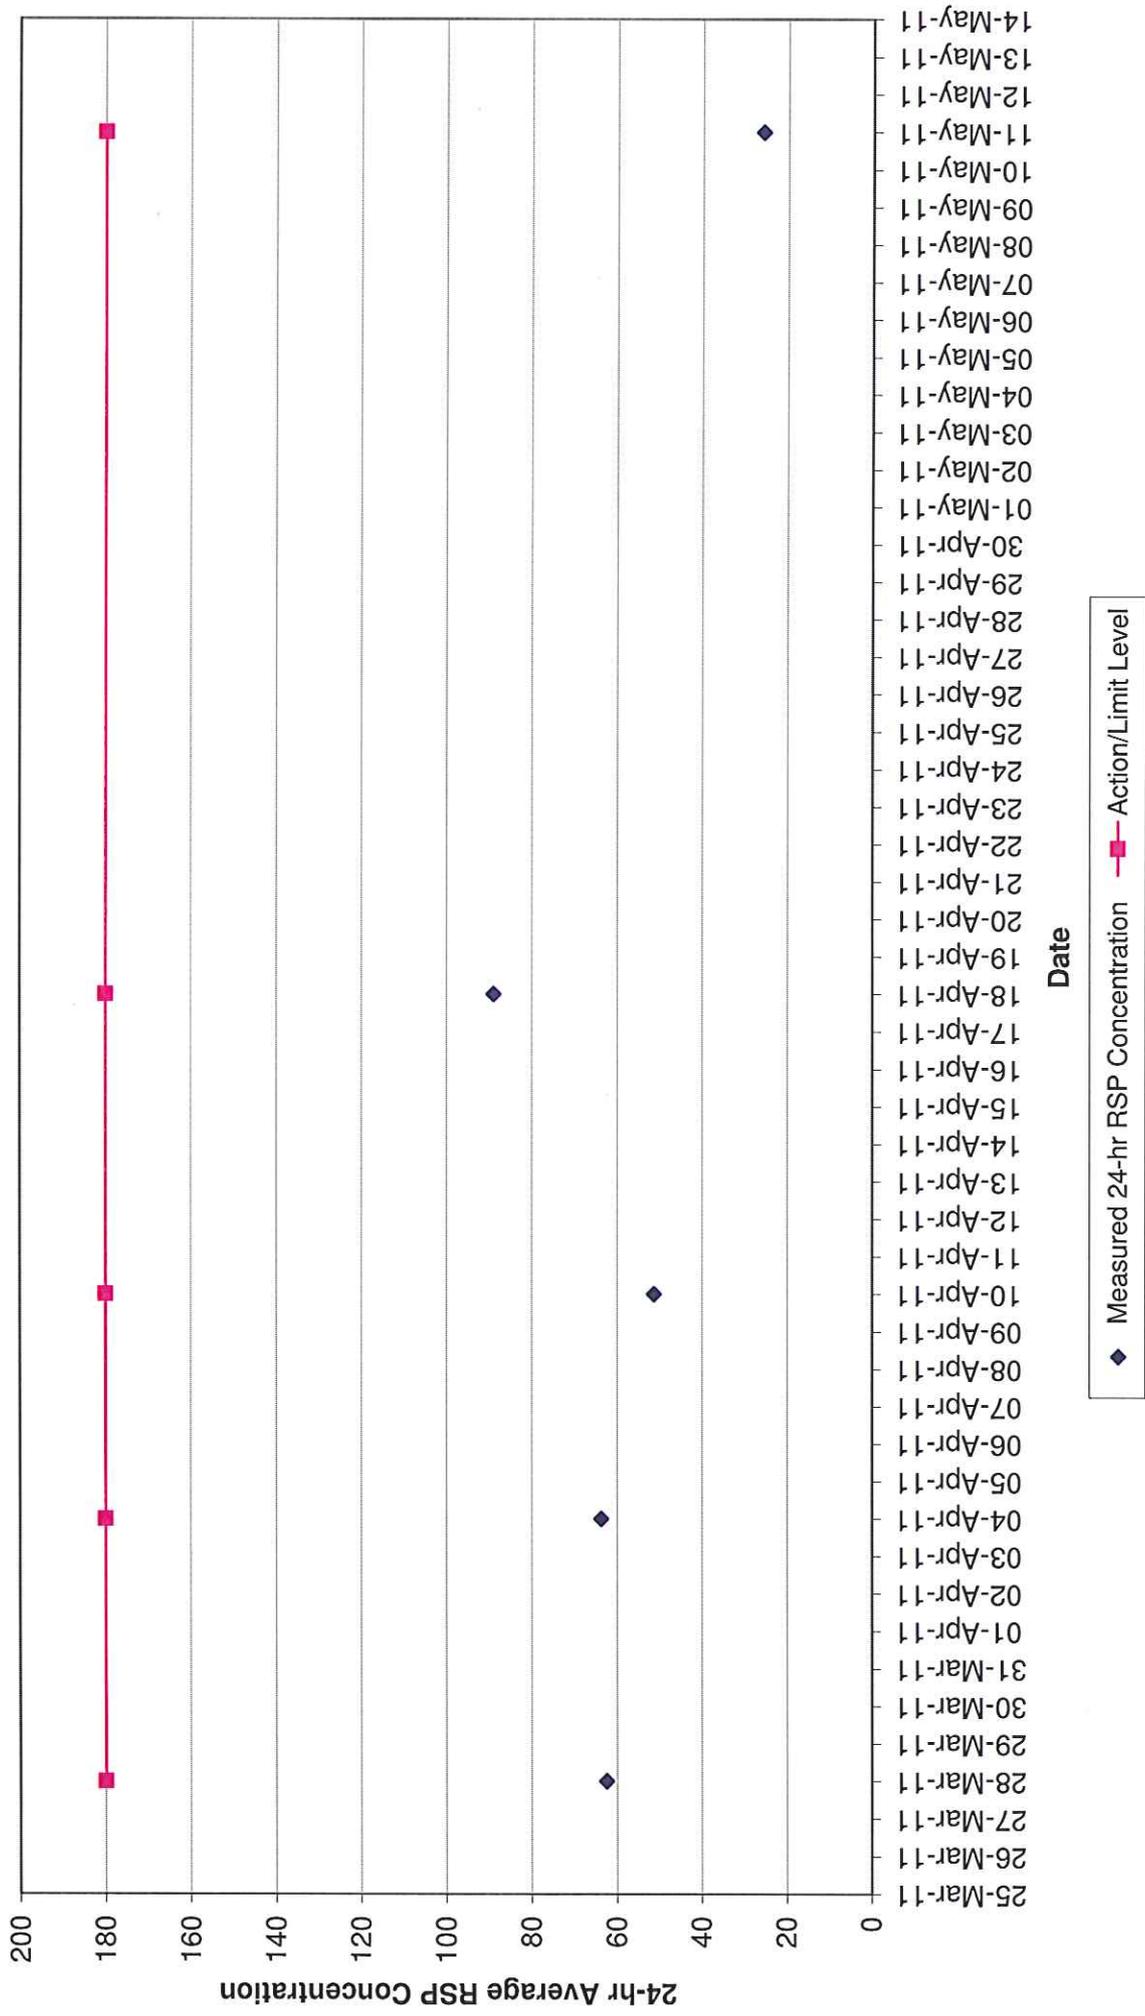
**Measured 24-hr Average RSP Concentration
AM 2 - Landscape Storage Area in Ocean Park**

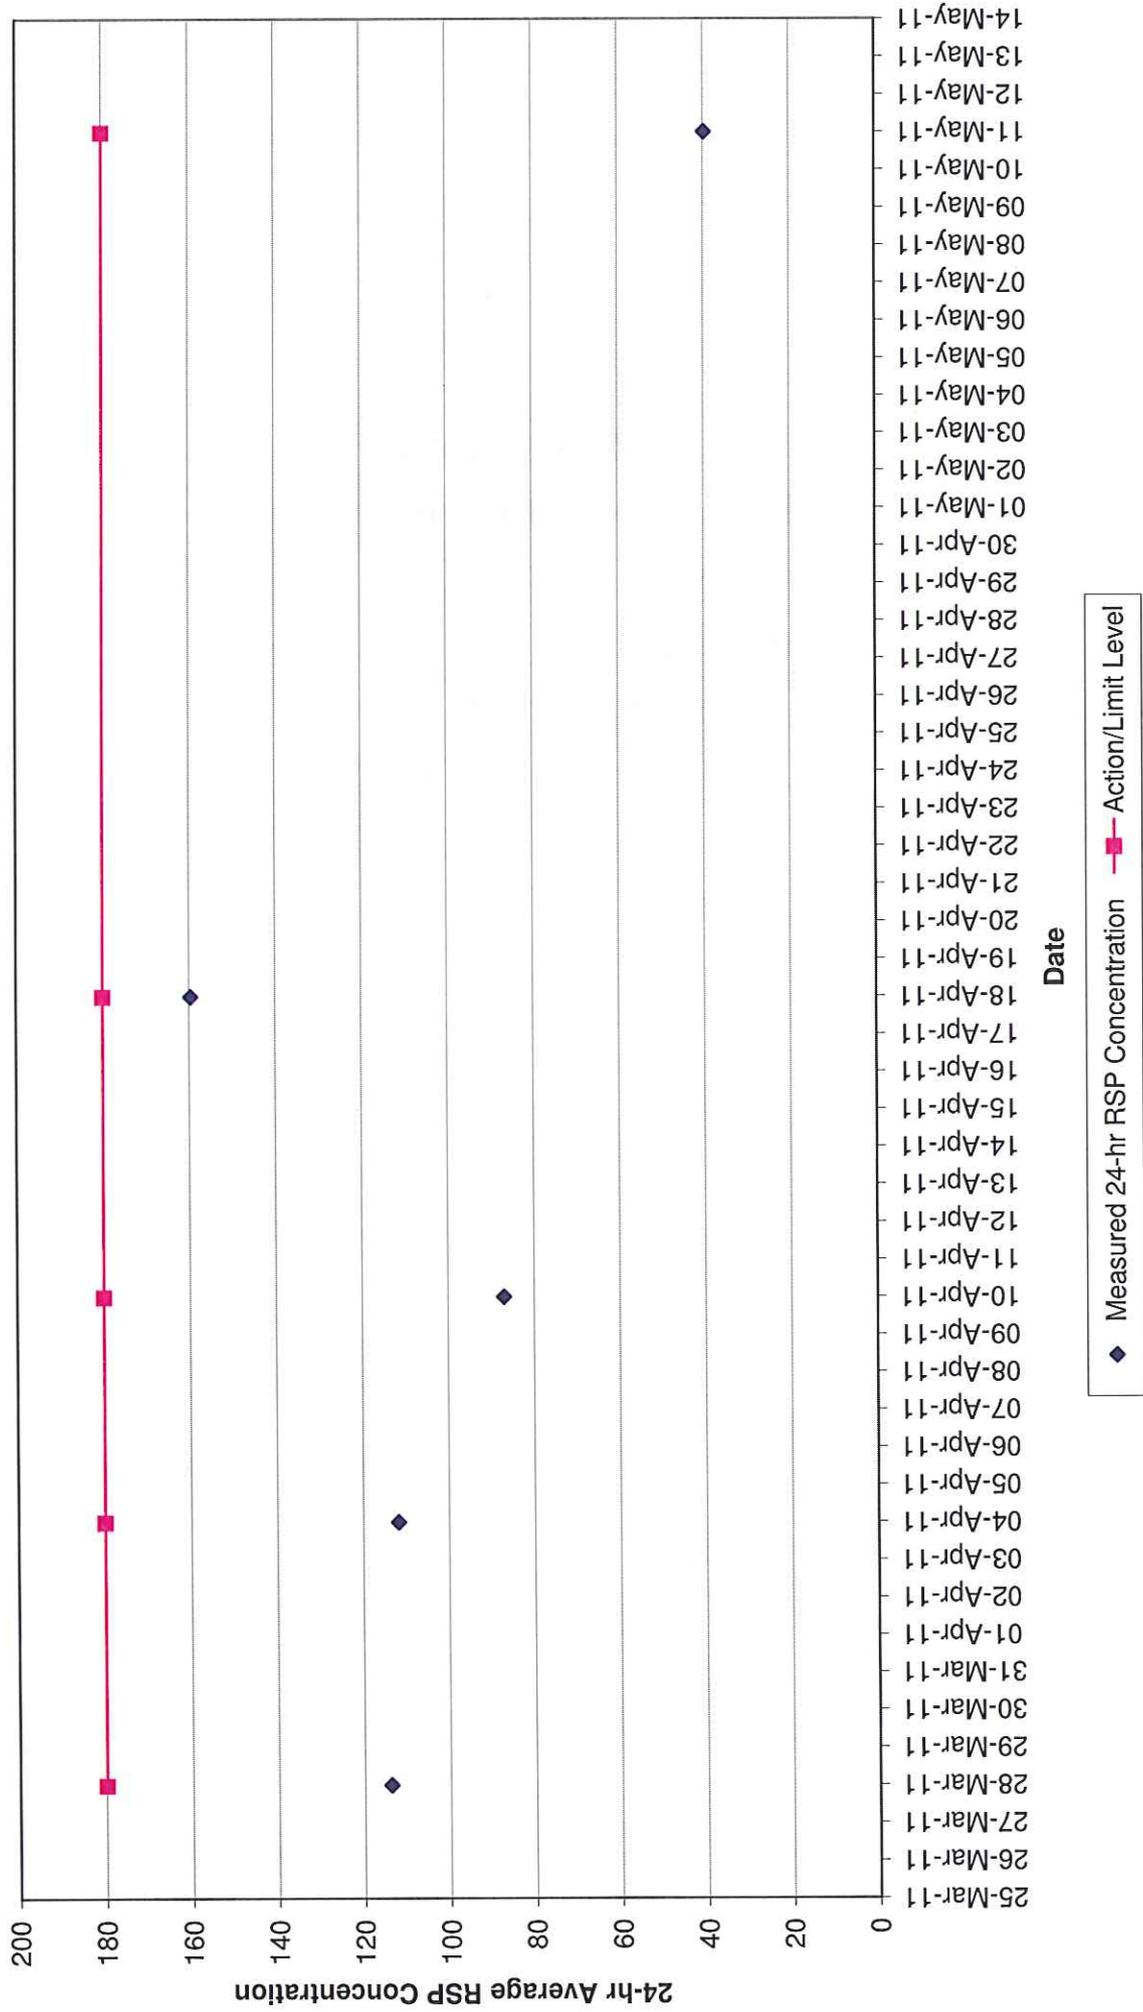
**Measured 24-hr Average RSP Concentration
AM3 - Rooftop of Main Medical Block of Graham Hospital**

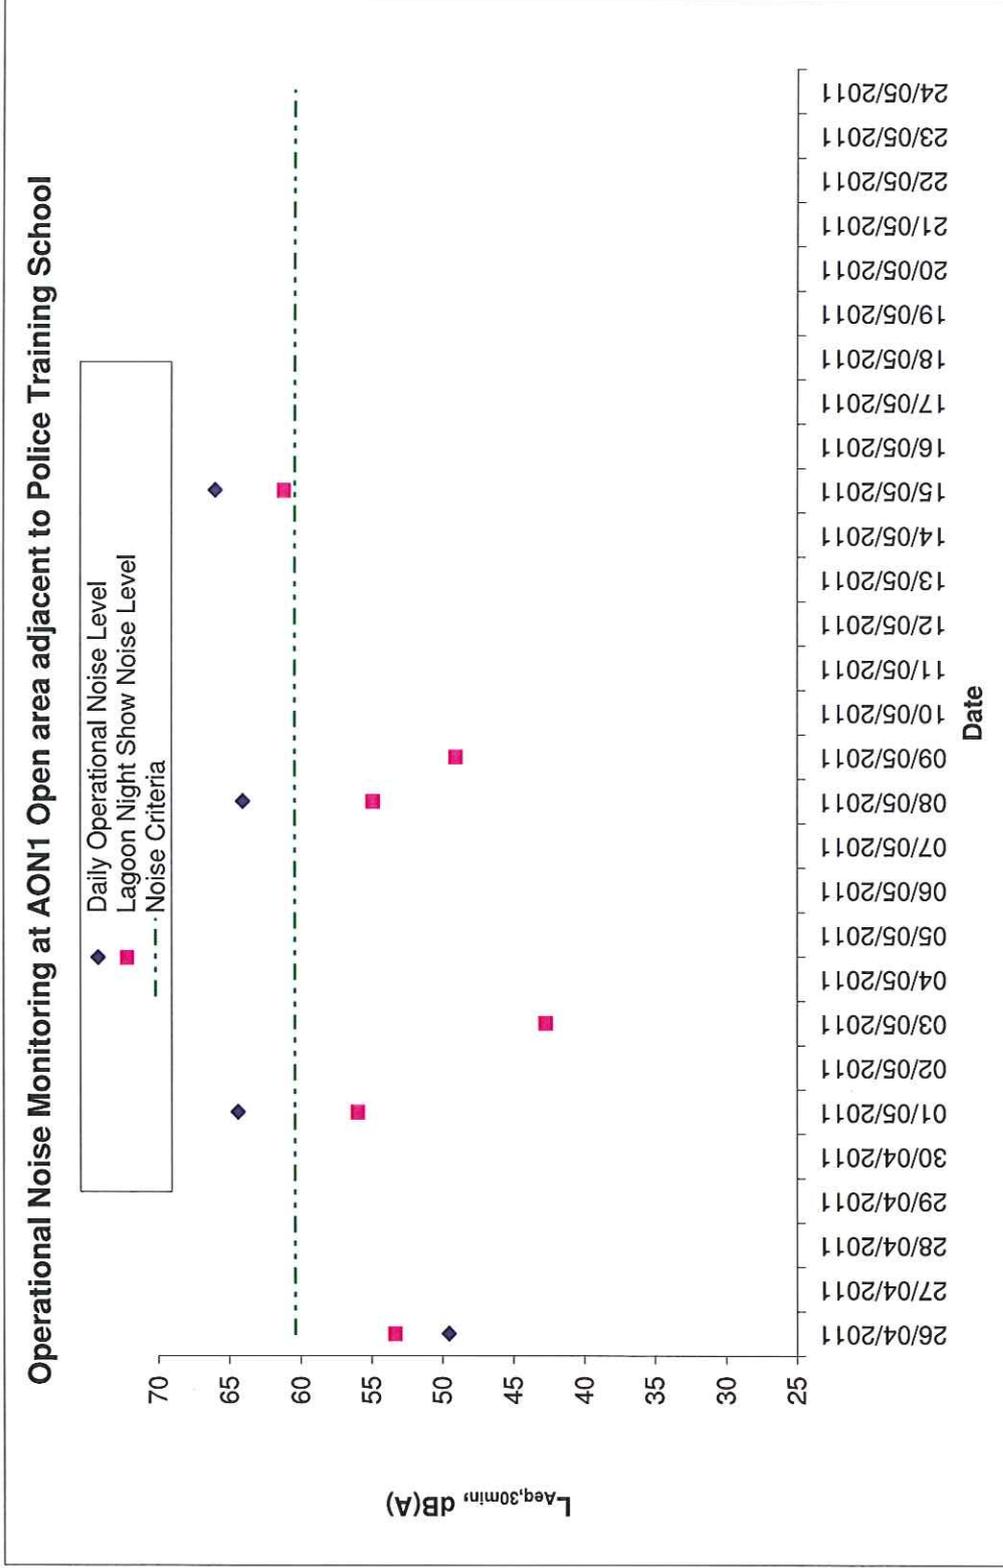
Note: The exceedance were due to the high level of background noise from visitors and traffic on public holidays, especially on 1, 8 and 15 May 2011, which were public holidays.

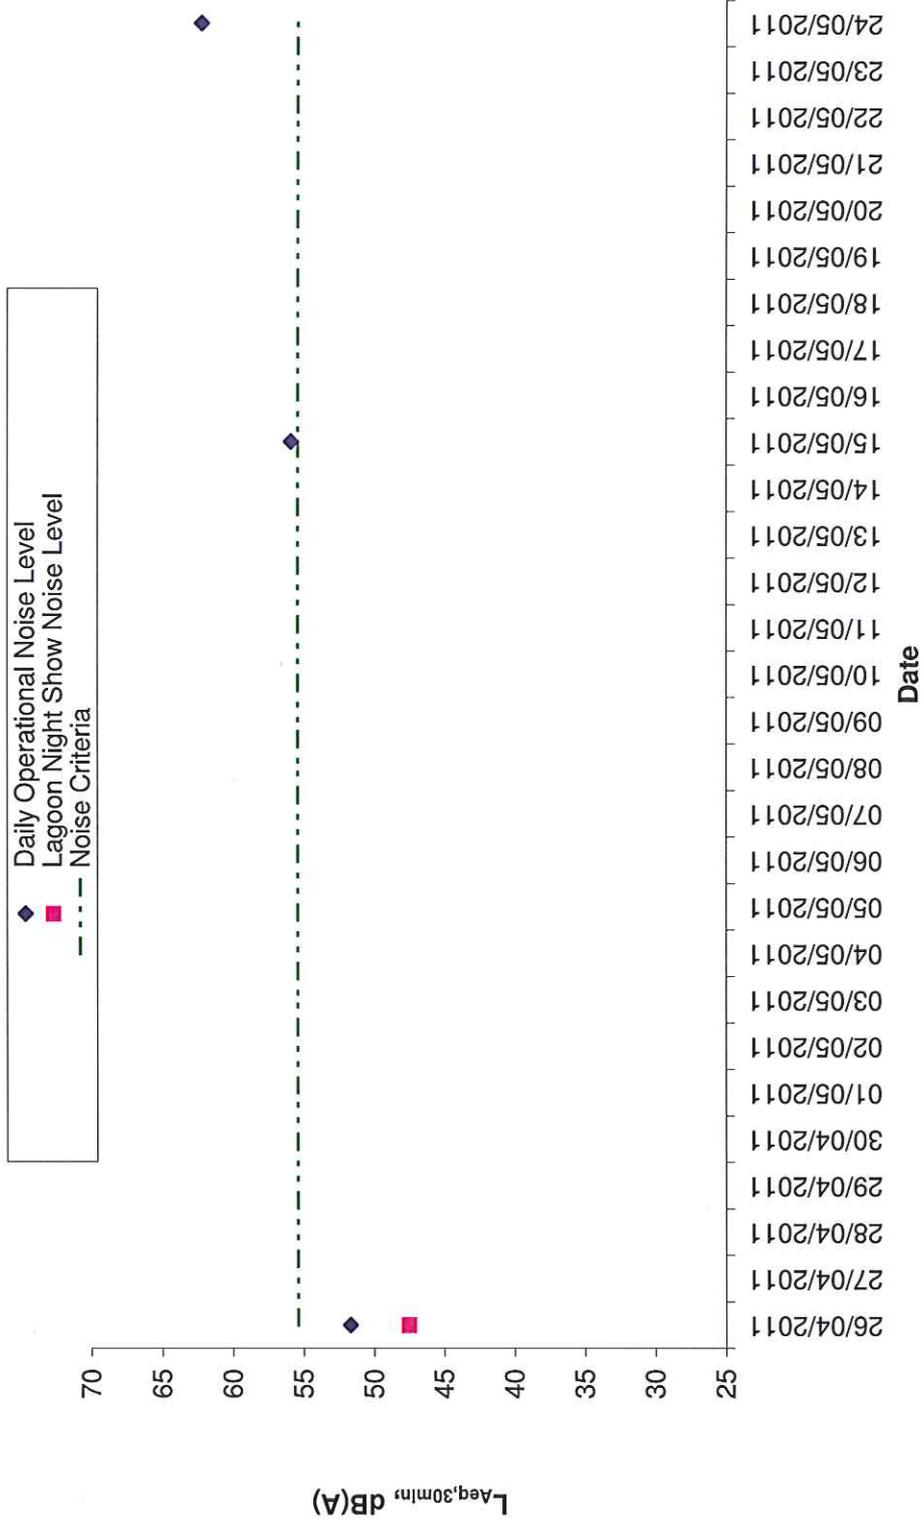
Operational Noise Monitoring at AON3 Orchid Valley/ Woodgreen Estate

Note: The exceedances were due to the traffic noise from Shouson Hill Road
 The monitoring location has been re-located from Orchid Valley to Woodgreen Estate commencing from 8 May 2011.
