**Ocean Park Master Redevelopment Project**

**Monthly EM&A Report – August 2011**

## Monthly Environmental Monitoring & Audit Report – August 2011

**Ocean Park Redevelopment Project  
- Thrill Mountain & Polar Adventure**

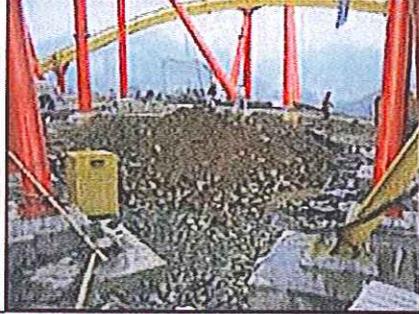
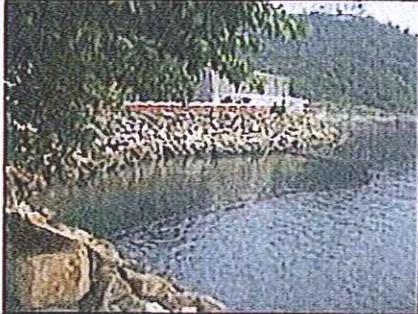
Observations in August 2011

<p>P1130730: The Contractor was recommended to dispose surplus C&amp;D material to public fill as soon as possible.</p>	<p>P1130732: The Contractor was recommended to maintain the silt curtain regularly and properly.</p>

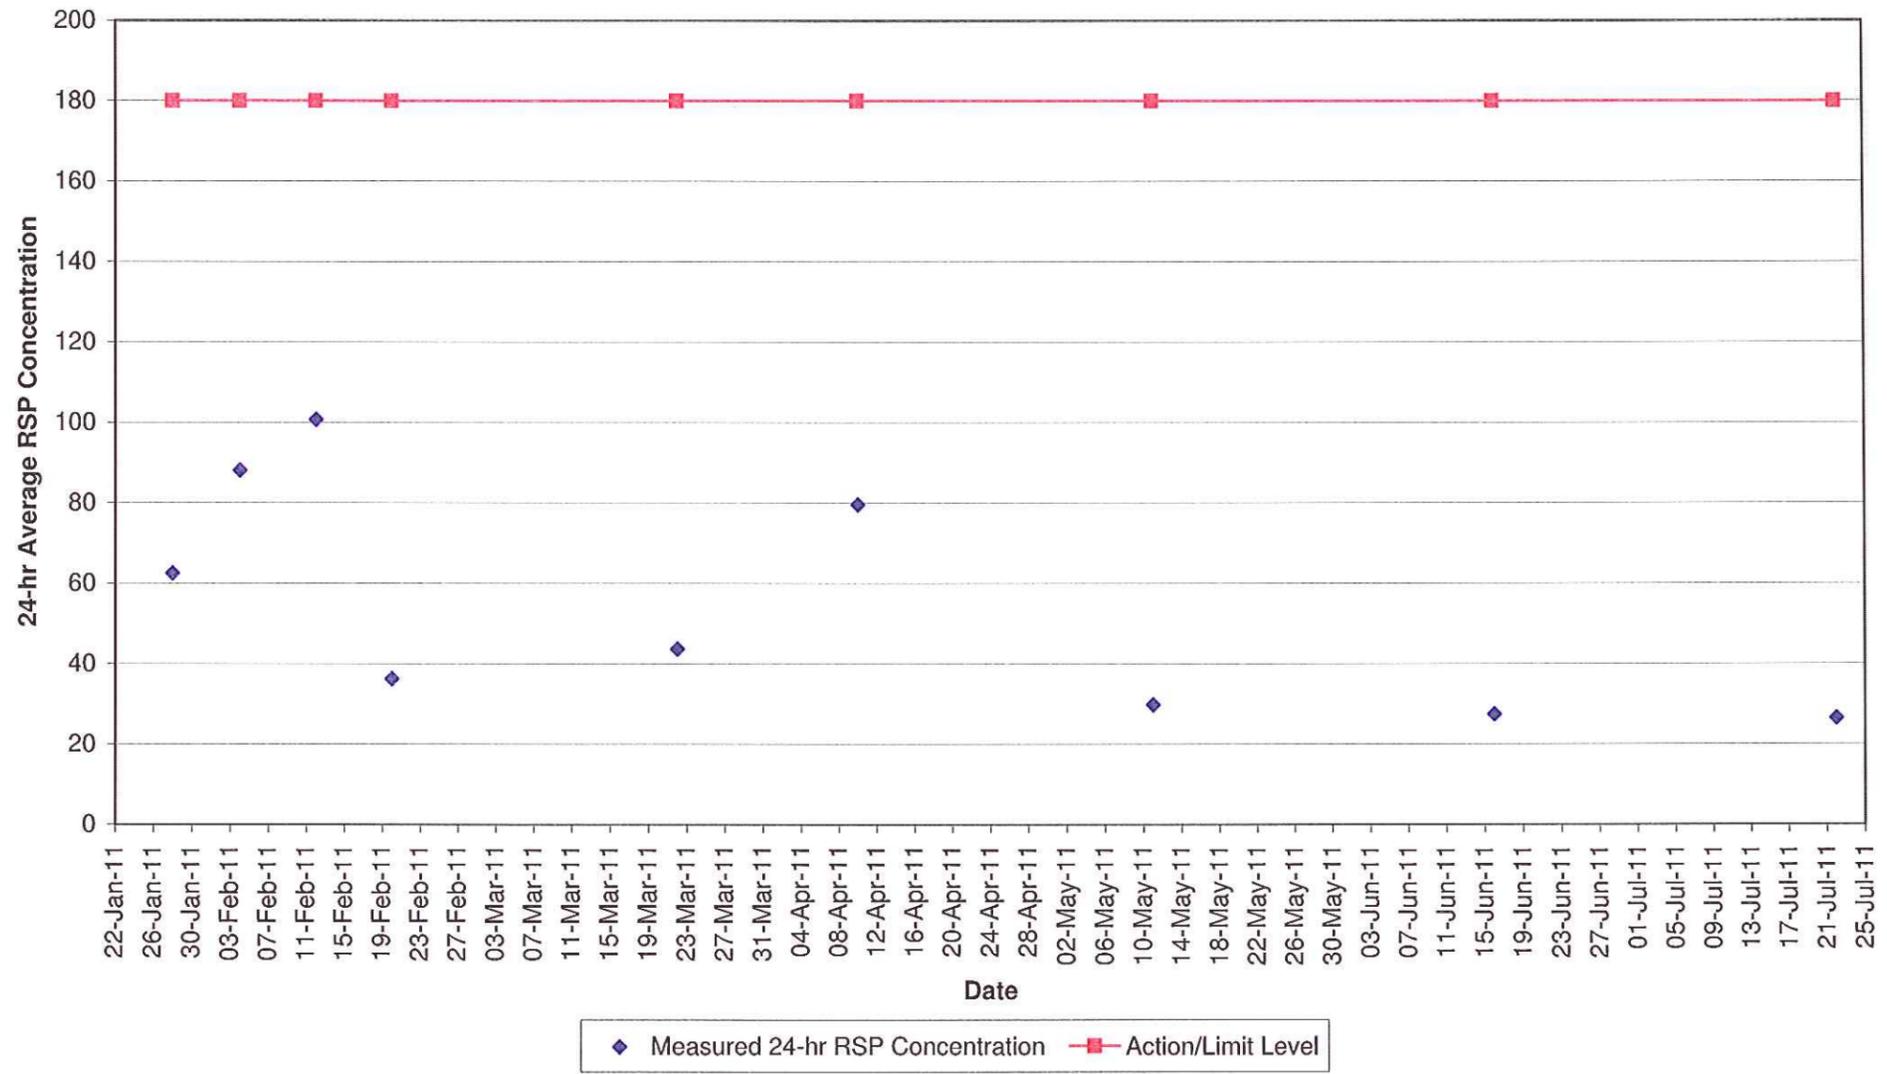
Measured 24-hr Average RSP Concentration  
AM1 - Rooftop of Administrative Building (Former Staff Quarters) in Ocean Park

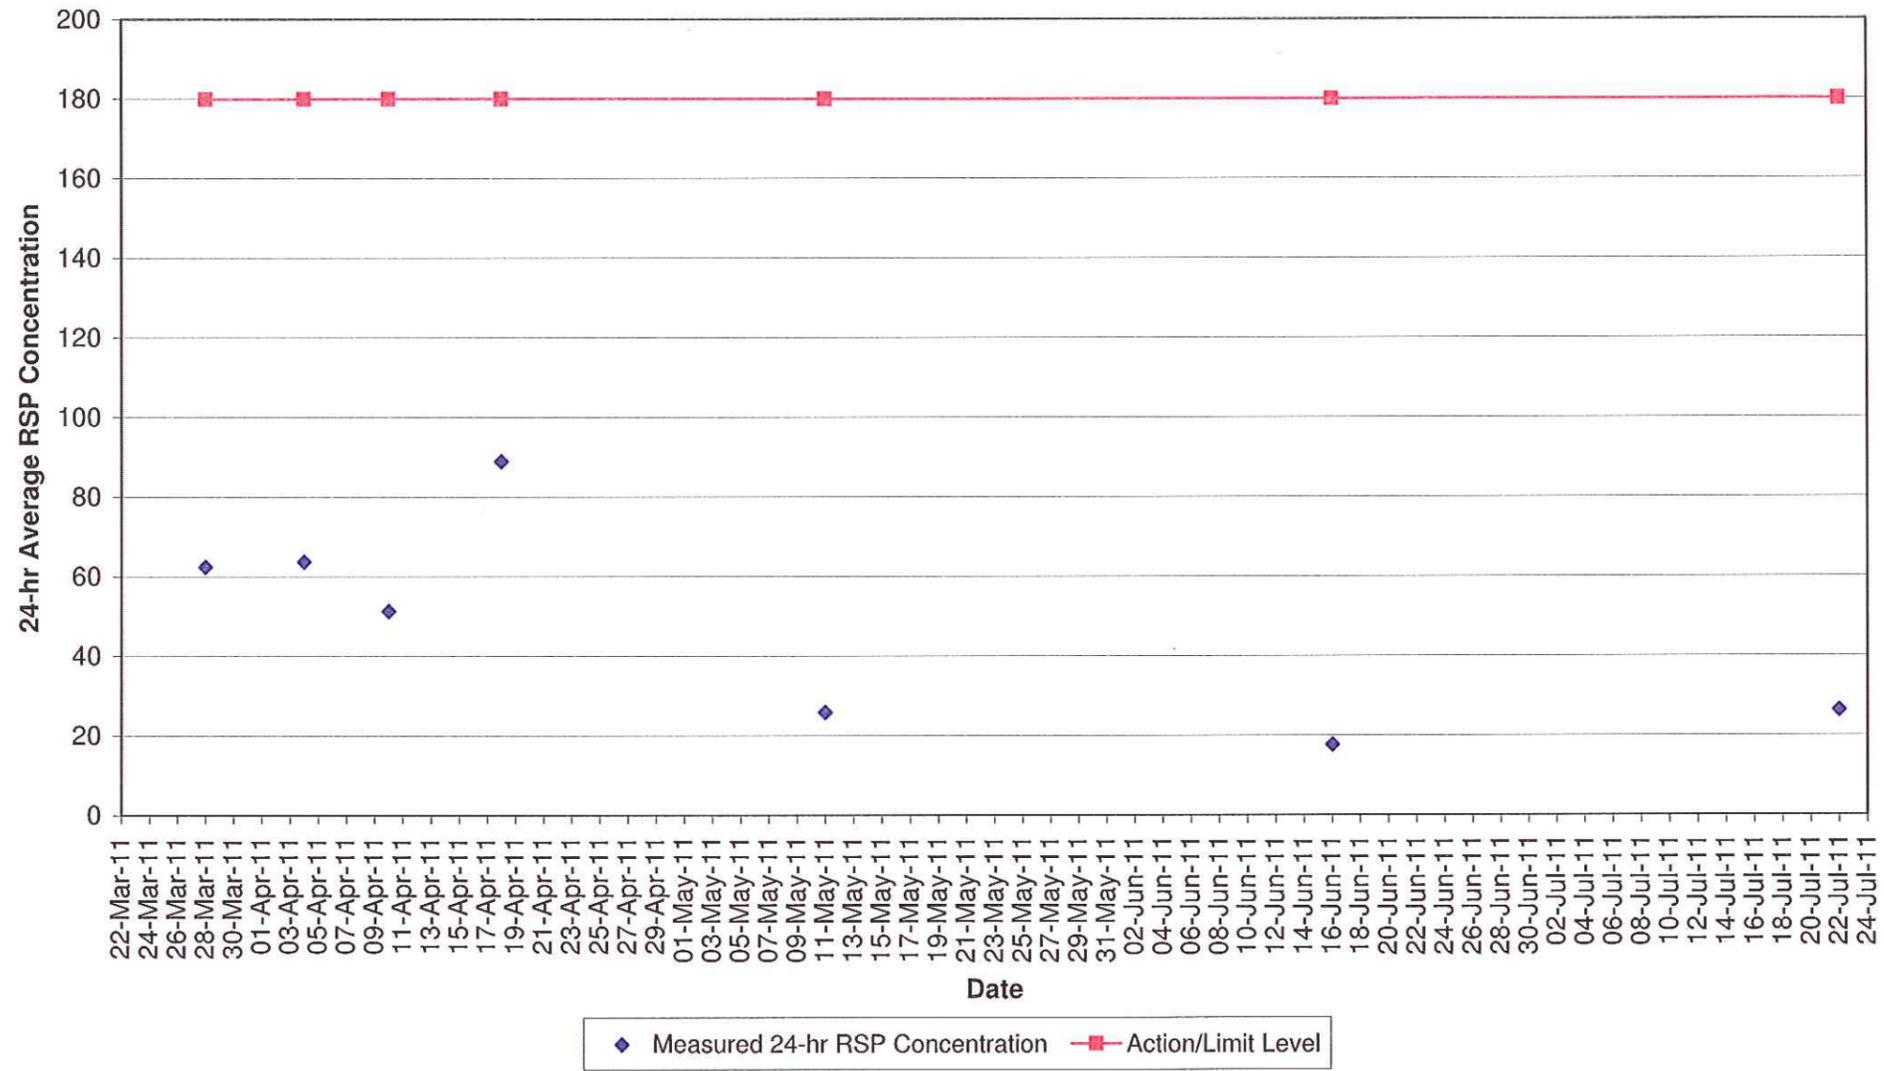
Measured 24-hr Average RSP Concentration  
AM 2 - Landscape Storage Area in Ocean Park

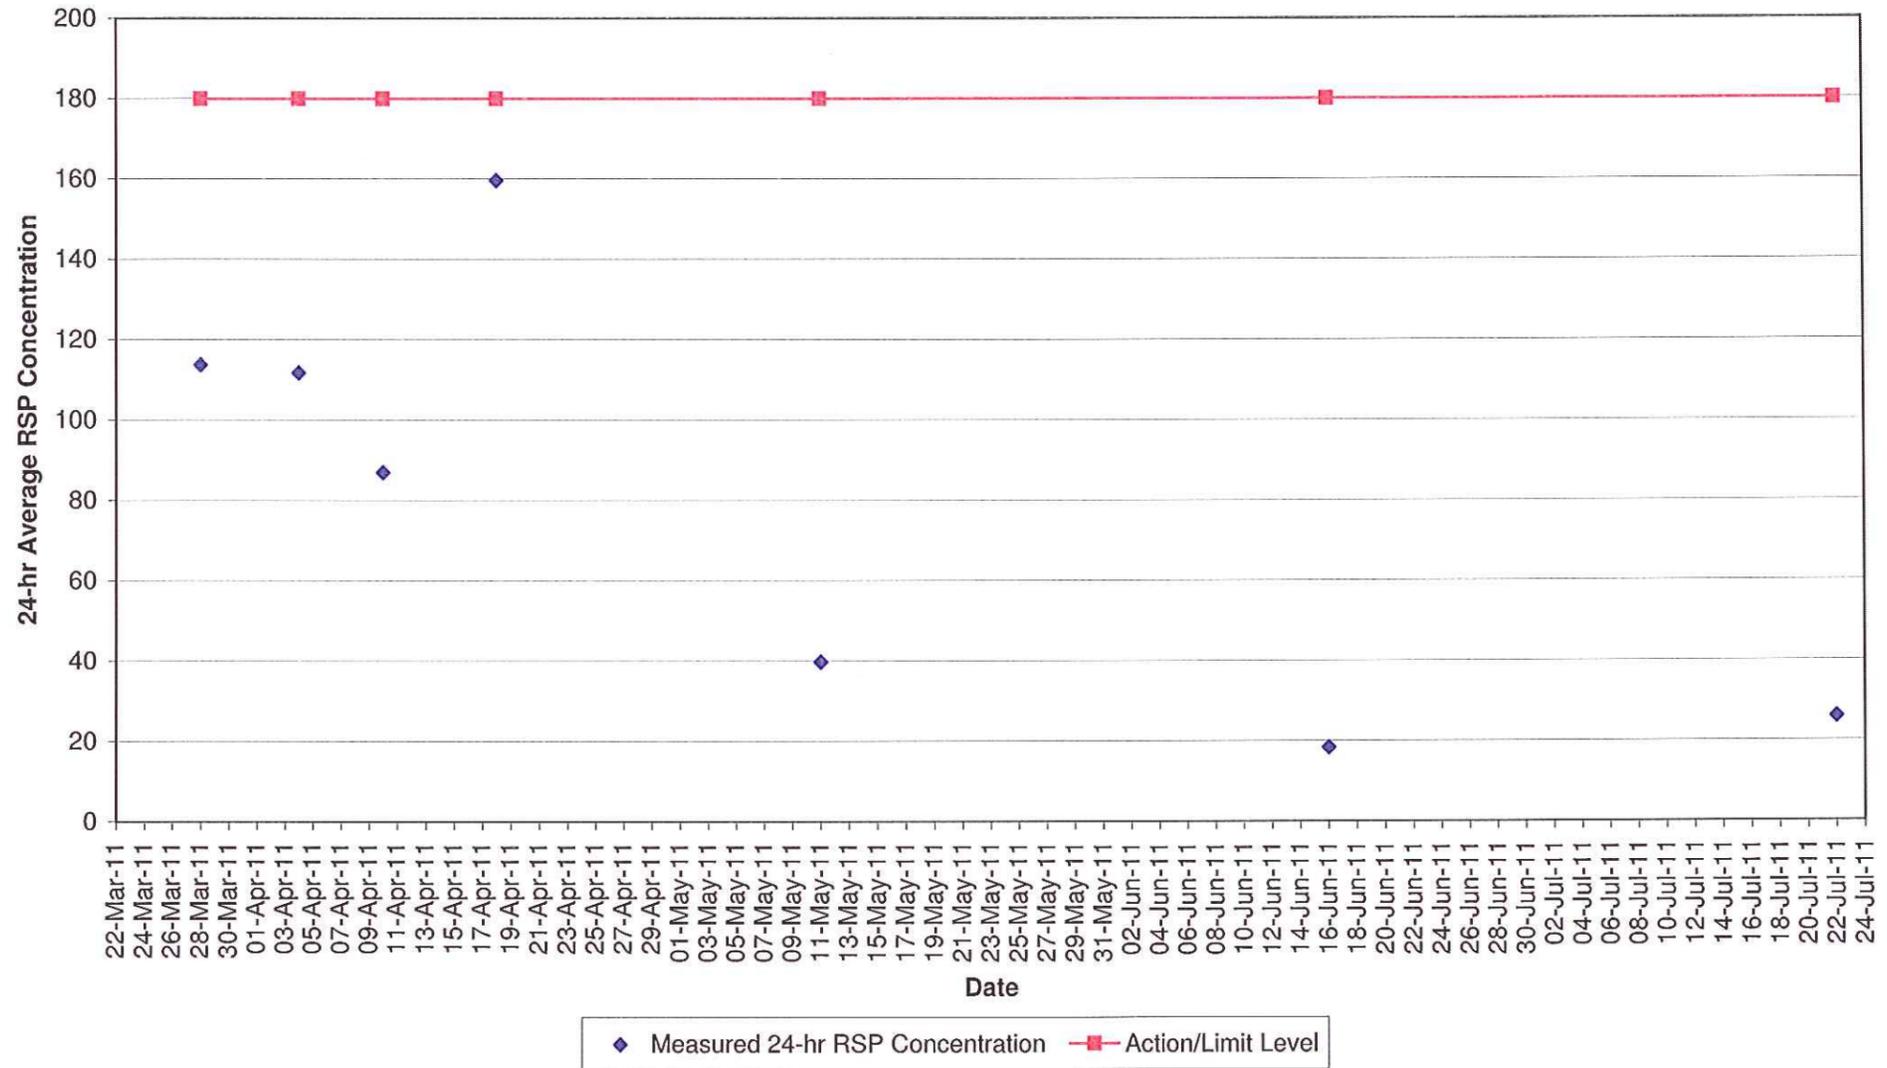
Measured 24-hr Average RSP Concentration  
AM3 - Rooftop of Main Medical Block of Graham Hospital

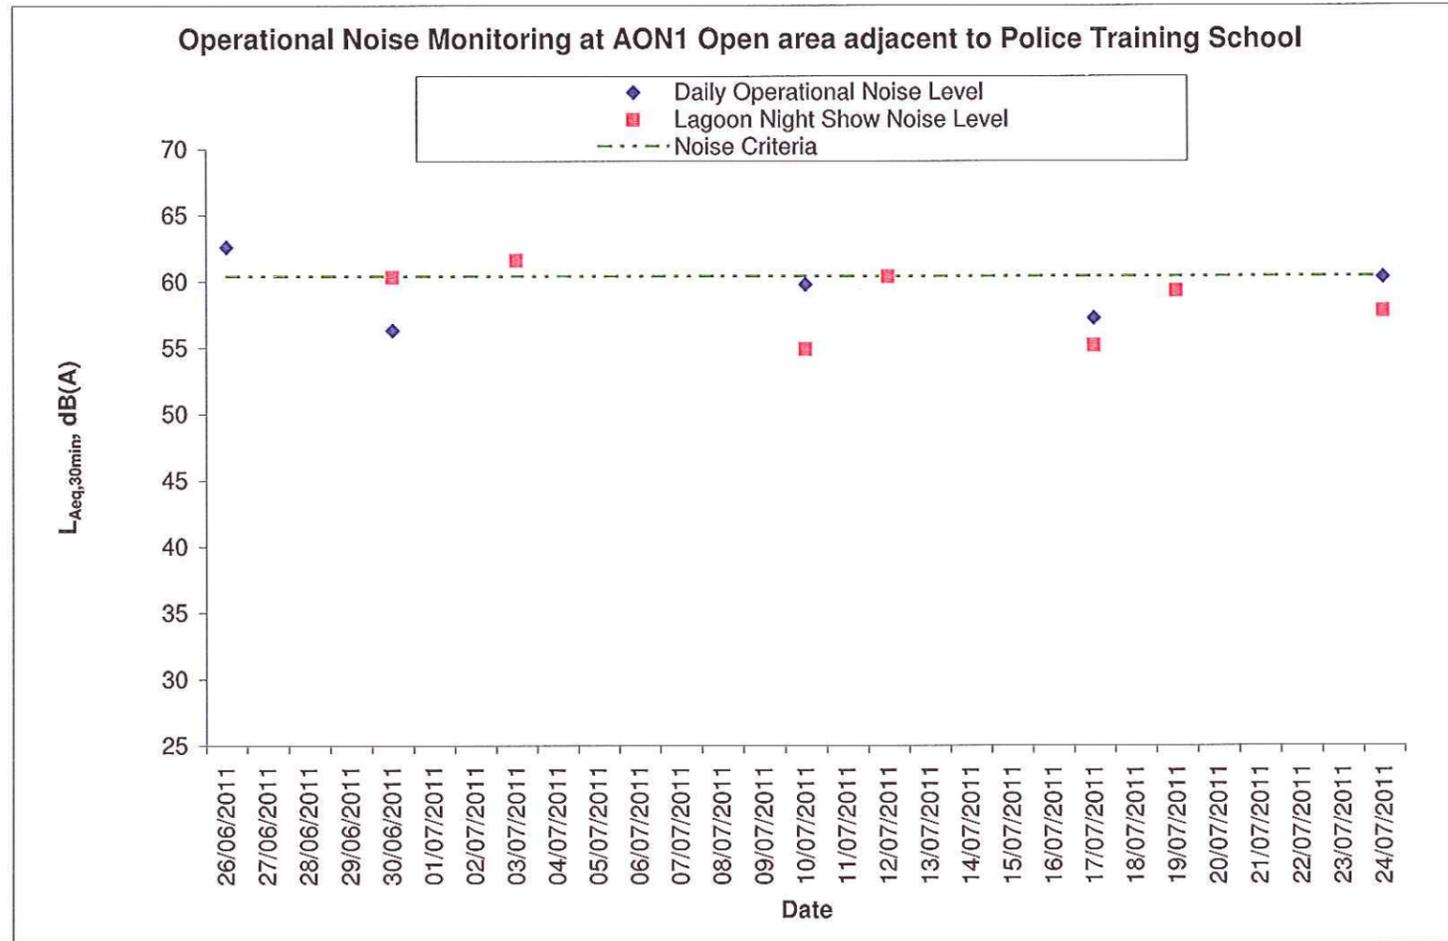
Annex B3-1

**Note:** The exceedances were due to the high level of background noise from visitors and traffic on public holidays, especially on 26 June and 3 July 2011, which were public holidays.

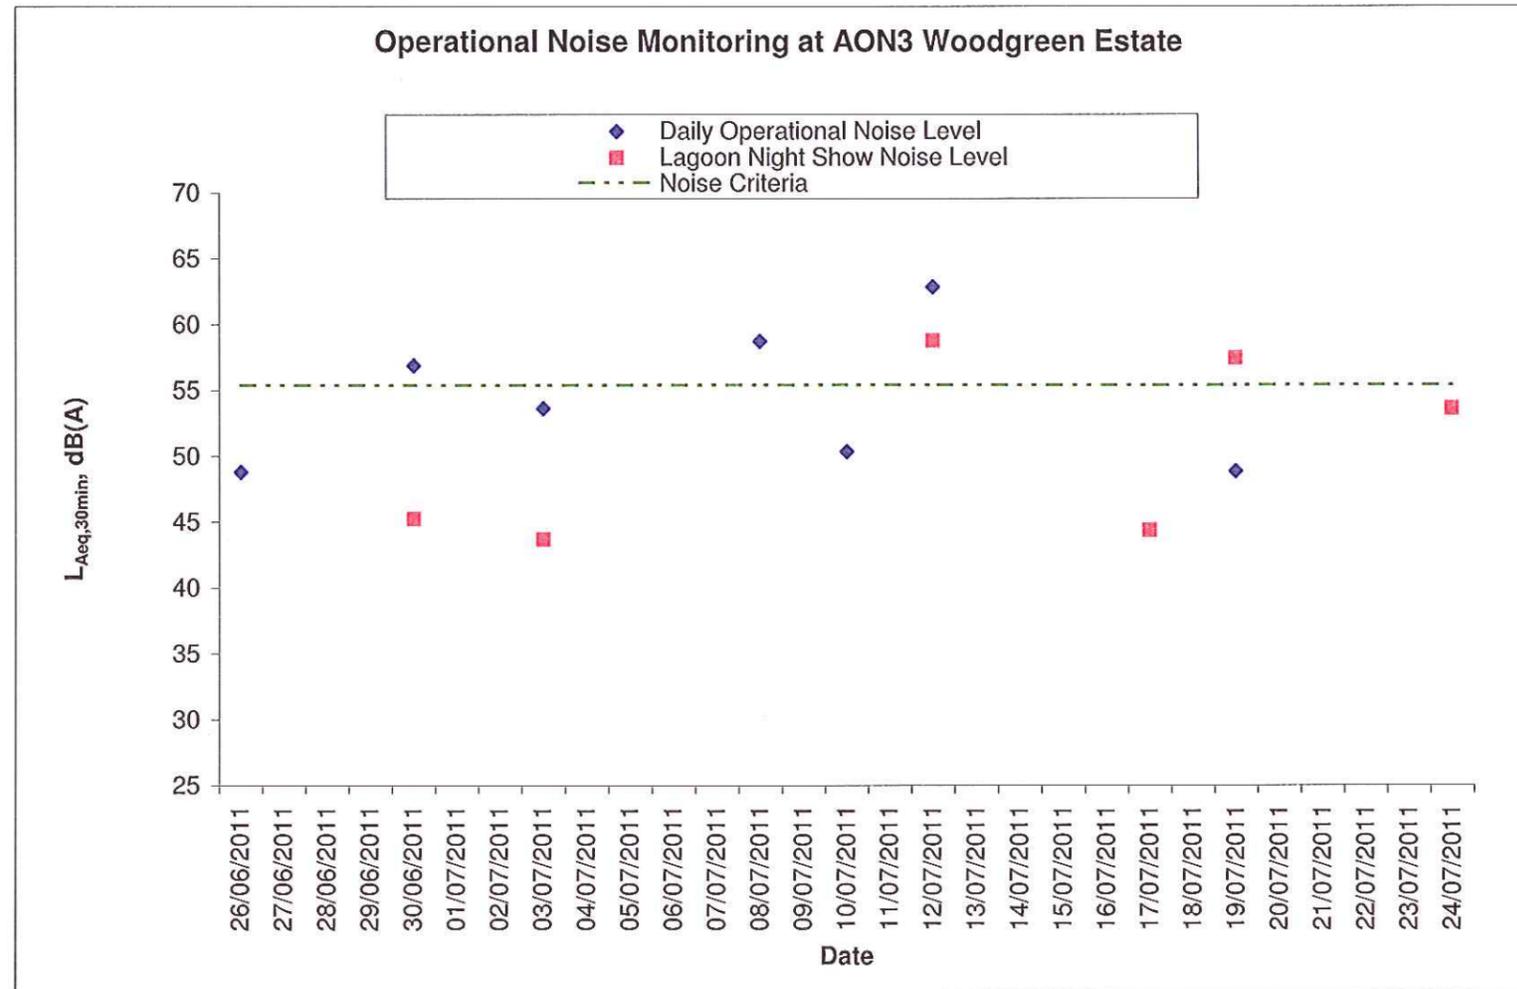
Annex B3-3

**Note:** The exceedances were due to the traffic noise from Shouson Hill Road

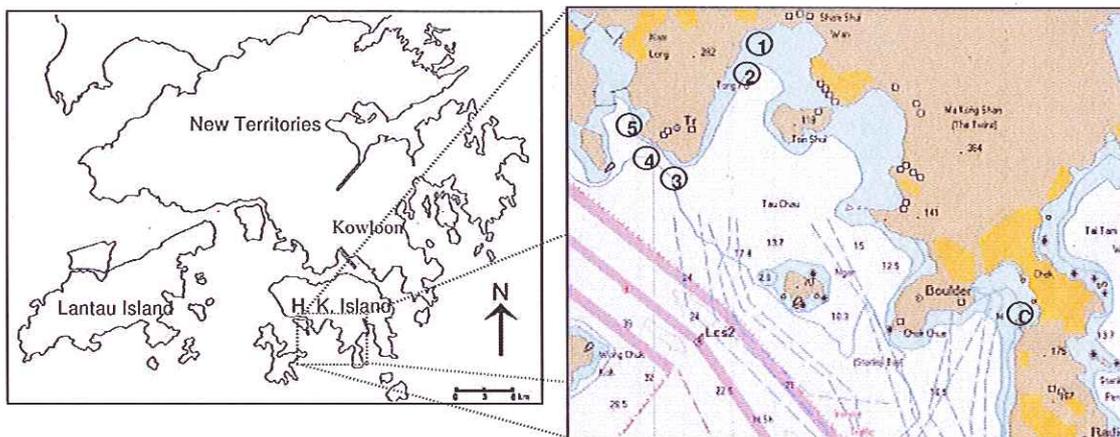
**Fig. 2.1 Map Showing the Locations of the Five Impact Monitoring Sites (1 to 5) and One Control Site (C).**

2.1.1 Five locations close to the potential impact areas were identified and designated as Impact Monitoring Sites (Sites 1 to 5; Fig. 2.1). In order to identify background environmental perturbations that are not associated with the construction, St. Stephen Beach, which is away from the impact areas, was designated as the Control Site (Control Site C; Fig. 2.1). Locations (GPS coordinates) of the five Impact Monitoring Sites and one Control Site C are summarized in Table 3.1.
