**Ocean Park Master Redevelopment Project**

**EP-249/2006/A – Condition 3.4**

**Monthly EM&A Report – September 2011**

Monthly Environmental Monitoring & Audit  
Report – September 2011

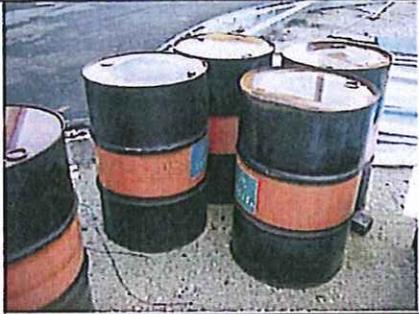
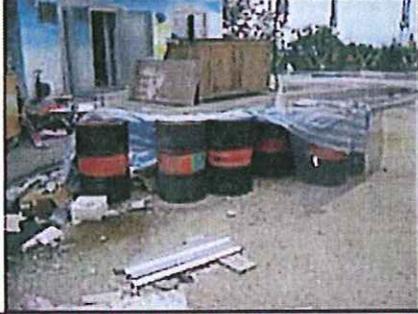
- ① Stagnant water was accumulated on site after heavy rain. The Contractor was reminded to backfill them as soon as possible.
- ② A few hydraulic vegetable oil drums were placed on bareground. The Contractor indicated that the oil will be used up for installation and any left will be placed in permanent storage area.
- ③ Stockpiles of sand awaiting backfill were uncovered. The Contractor was recommended to cover them with tarpaulin sheet or other means.
- ④ General refuse were scattered around the site. The Contractor was recommended to store them in waste skips.
- ⑤ The Contractor was recommended to maintain the silt curtain regularly and properly.

<p>P1130727: A few drums with hydraulic vegetable oil were placed on bare ground. The Contractor indicated that the oil will be used for installation works and any oil drums not used will be placed in permanent storage area.</p>	<p>P1130862: A few hydraulic vegetable oil drums were placed on bare ground. The Contractor indicated that the oil will be used for installation works and any oil drums not used will be placed in permanent storage area.</p>

- Remove waste more frequently.
- Ensure drip tray to be provided for oil drum.
- Ensure water spray on haul road to avoid dusty environment.
- Ensure stockpile materials to be covered by tarpaulin or other means.
- Ensure stagnant water is removed promptly after heavy rain.
- Repair and maintain the silt curtain

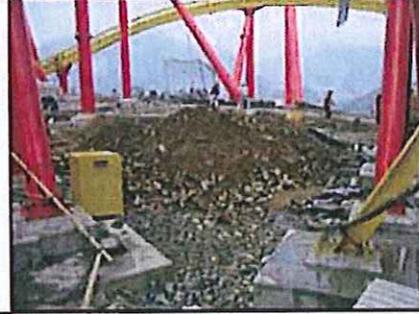
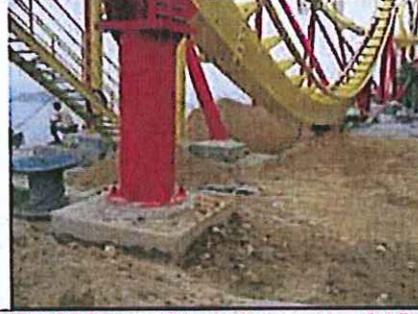
<p>P1130730: The Contractor was recommended to dispose surplus C&amp;D material to public fill as soon as possible.</p>	<p>P1130859: Stockpiles of C&amp;D materials awaiting backfilling were uncovered. The Contractor was reminded to cover them with tarpaulin sheets or other means to suppress dust.</p>

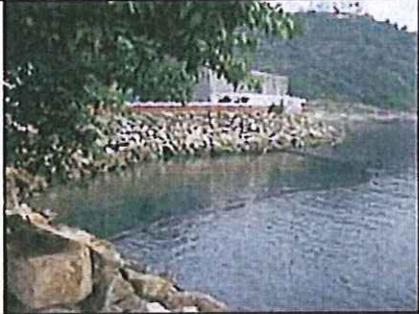
<p>P1130732: The Contractor was recommended to maintain the silt curtain regularly and properly.</p>		<p>P1130871: The Contractor was recommended to maintain the silt curtain regularly and properly.</p>

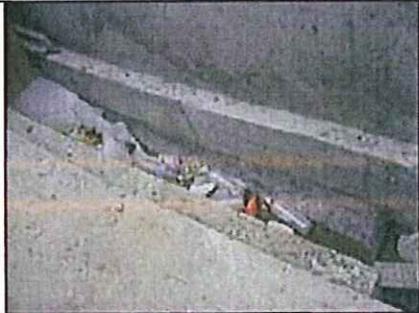
<p>P1130864: General refuse were scattered around the site. The Contractor was reminded to provide more waste skips for storage of general refuse.</p>

Parameters	Date	Observations / Recommendations	Remediation/ Follow up
<b>Waste/ Chemical Management</b>	20/09/11	General refuse were scattered around the site.	General refuse was stored in waste skip and remove offsite regularly.
	20/09/11	A few drums with hydraulic vegetable oil were placed on bareground.	These oil were used for installation work. Any oil drum not used will be placed in permanent storage area.
	20/09/11	Stagnant water was accumulated on site after heavy rain.	Backfilled the area to prevent stagnant water.
