Ocean Park Master Redevelopment Project

Monthly EM&A Report – December 2011

Monthly Environmental Monitoring & Audit Report – December 2011

**Ocean Park Redevelopment Project
- Thrill Mountain & Polar Adventure**

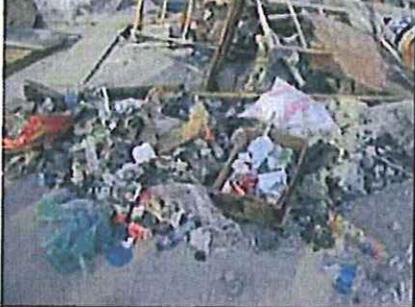
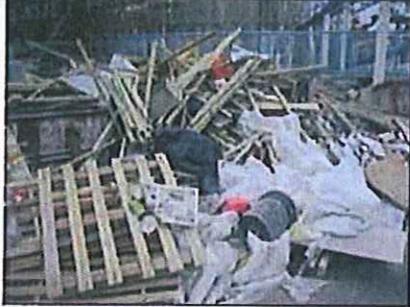
<p>P1140353: General refuse were scattered around the site. The Contractor was reminded to provide more waste skips for storage of general refuse.</p>	<p>P1140567: General refuse were scattered around the site. The Contractor was reminded to provide more waste skips for storage of general refuse.</p>

Parameters	Date	Observations / Recommendations	Remediation/ Follow up
Waste/ Chemical Management	2/12/11	General refuse were scattered around the site.	General refuse was stored in waste skip and remove offsite regularly.
	16/12/11	A few drums with hydraulic vegetable oil were placed on bareground.	These oil were used for installation work. Any oil drum not used will be placed in permanent storage area.
Dust Control	20/12/11	An idled stockpile of sand was not covered.	Stockpiles of sand was covered by tarpaulin sheet.

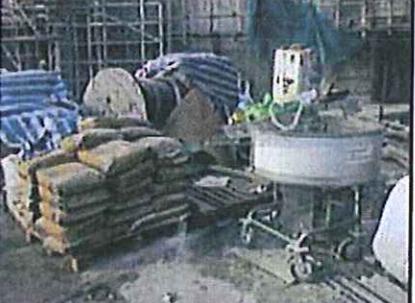
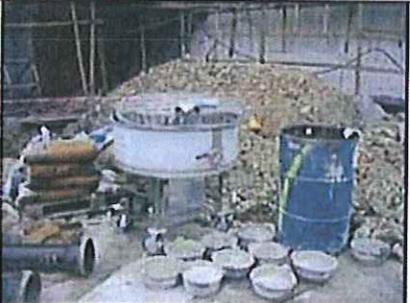
<p>P1140348: The Contractor was recommended to ensure all mortar mixing works were carried out within an enclosure with the top and three sides enclosed.</p>	<p>P1140570: The Contractor was recommended to ensure all mortar mixing works were carried out within an enclosure with the top and three sides enclosed.</p>

Parameters	Date	Observations / Recommendations	Remediation/ Follow up
	20/12/11	Over 20 bags of cement were not covered.	Cement stock was covered by tarpaulin sheet.
	20/12/11	The contractor was recommended to ensure all motor mixing works were carried out within an enclosure with the top and 3 sides enclosed.	All motor mixing works will be carried out within an enclosure with the top and 3 sides enclosed.
Water Pollution	9/12/11	Nil.	
Air Pollution	30/12/11	Nil

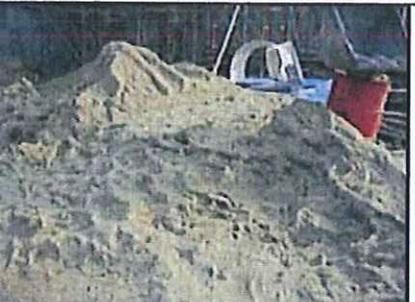
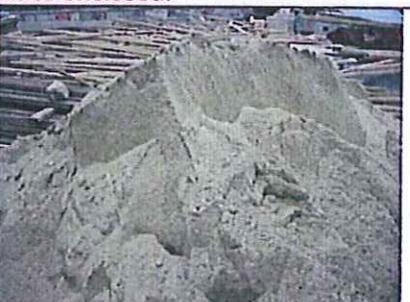
<p>P1140351: An idled stockpile of sand was not covered. The Contractor was reminded to cover any idled dusty stockpile on-site to suppress dust.</p>	<p>P1140569: An idled stockpile of sand was not covered. The Contractor was reminded to cover any idled dusty stockpile on-site to suppress dust.</p>

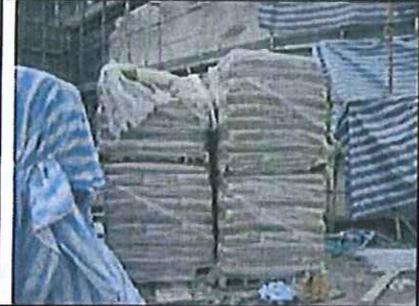
<p>P1140565: Over 20 cement bags were not covered. The Contractor was reminded to cover any piles of over 20 cement bags on-site with tarpaulin sheets or other means to suppress dust.</p>
