Ocean Park Master Redevelopment Project

EP-249/2006/B – Condition 3.4

Monthly EM&A Report – February 2012

Monthly Environmental Monitoring & Audit Report – February 2012

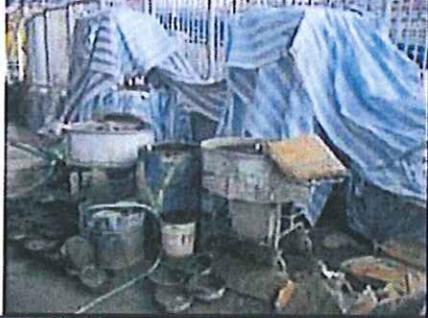
<p>P1140769: The Contractor was recommended to ensure all mortar mixing works were carried out within an enclosure with the top and three sides enclosed.</p>	<p>N/A Closed – Mortar mixing works was not observed during the site inspection.</p>

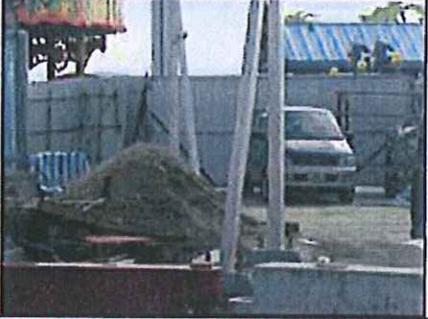
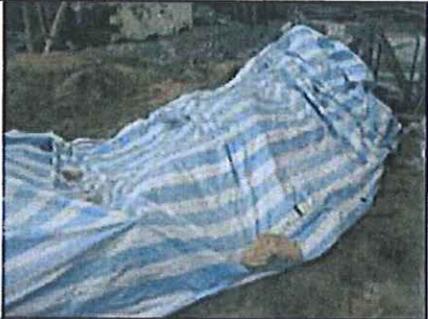
<p>P1140765: An idled stockpile of excavated material was not covered. The Contractor was reminded to cover any idled dusty stockpile on-site to suppress dust.</p>	<p>Closed - P1140949: Stockpiles of dusty materials were covered with tarpaulin sheets to suppress dust.</p>

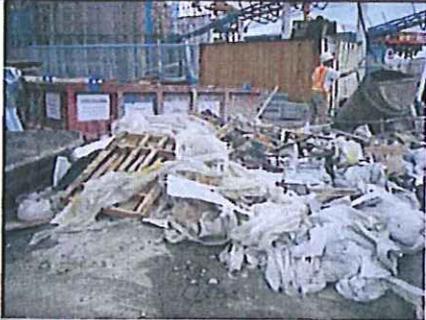
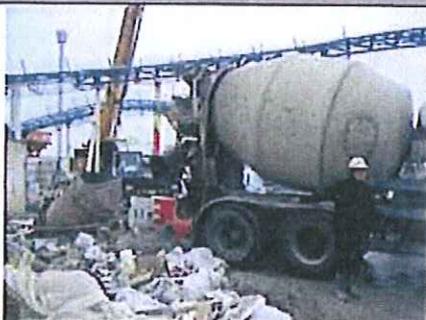
Observations In February 2012

<p>P1140944: General refuse and construction waste were scattered around the site. The Contractor was reminded to provide sufficient disposal points and remove the general refuse from site more frequently.</p>	<p>P1140956: Washing of concrete mixer truck at a non-designated area was observed. The Contractor was reminded to provide a designated location with proper signage for washing of concrete mixer truck.</p>

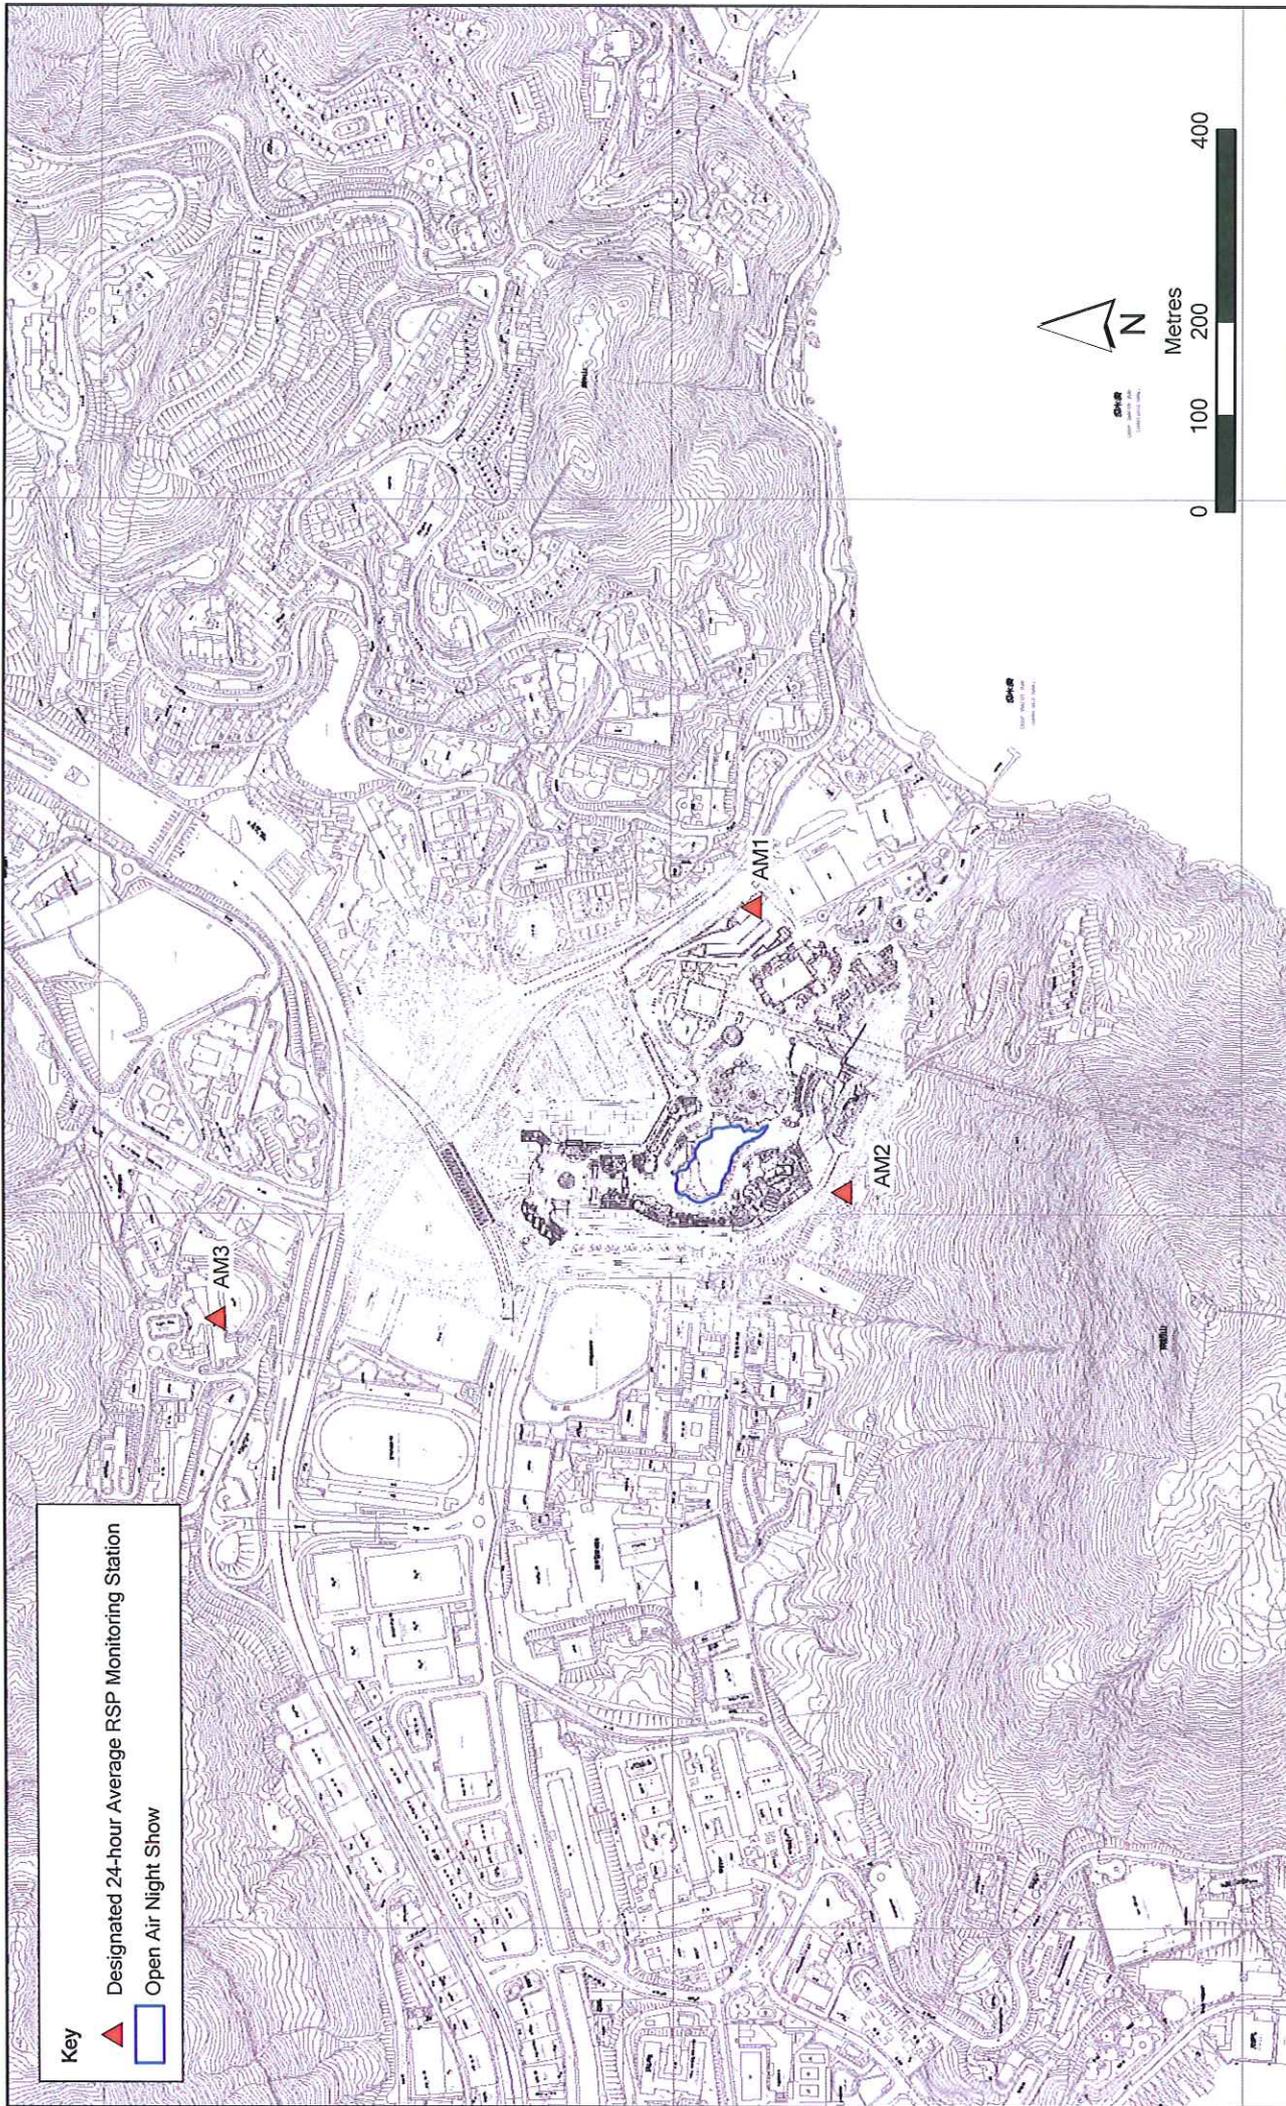
Figure 2.1

Designated 24-hour Average RSP Monitoring Stations during Operation of Open Air Night Show

One 24-hr average RSP sample was collected on each scheduled day by a High Volume Sampler (HVS) following the USEPA method, EPA IO-2.1. Calibration of the equipment has followed the requirements set out in EPA IO-2.1 with the calibration record given in *Annex A1*. A summary of the sampling methodology and equipment is presented in *Table 2.2*.

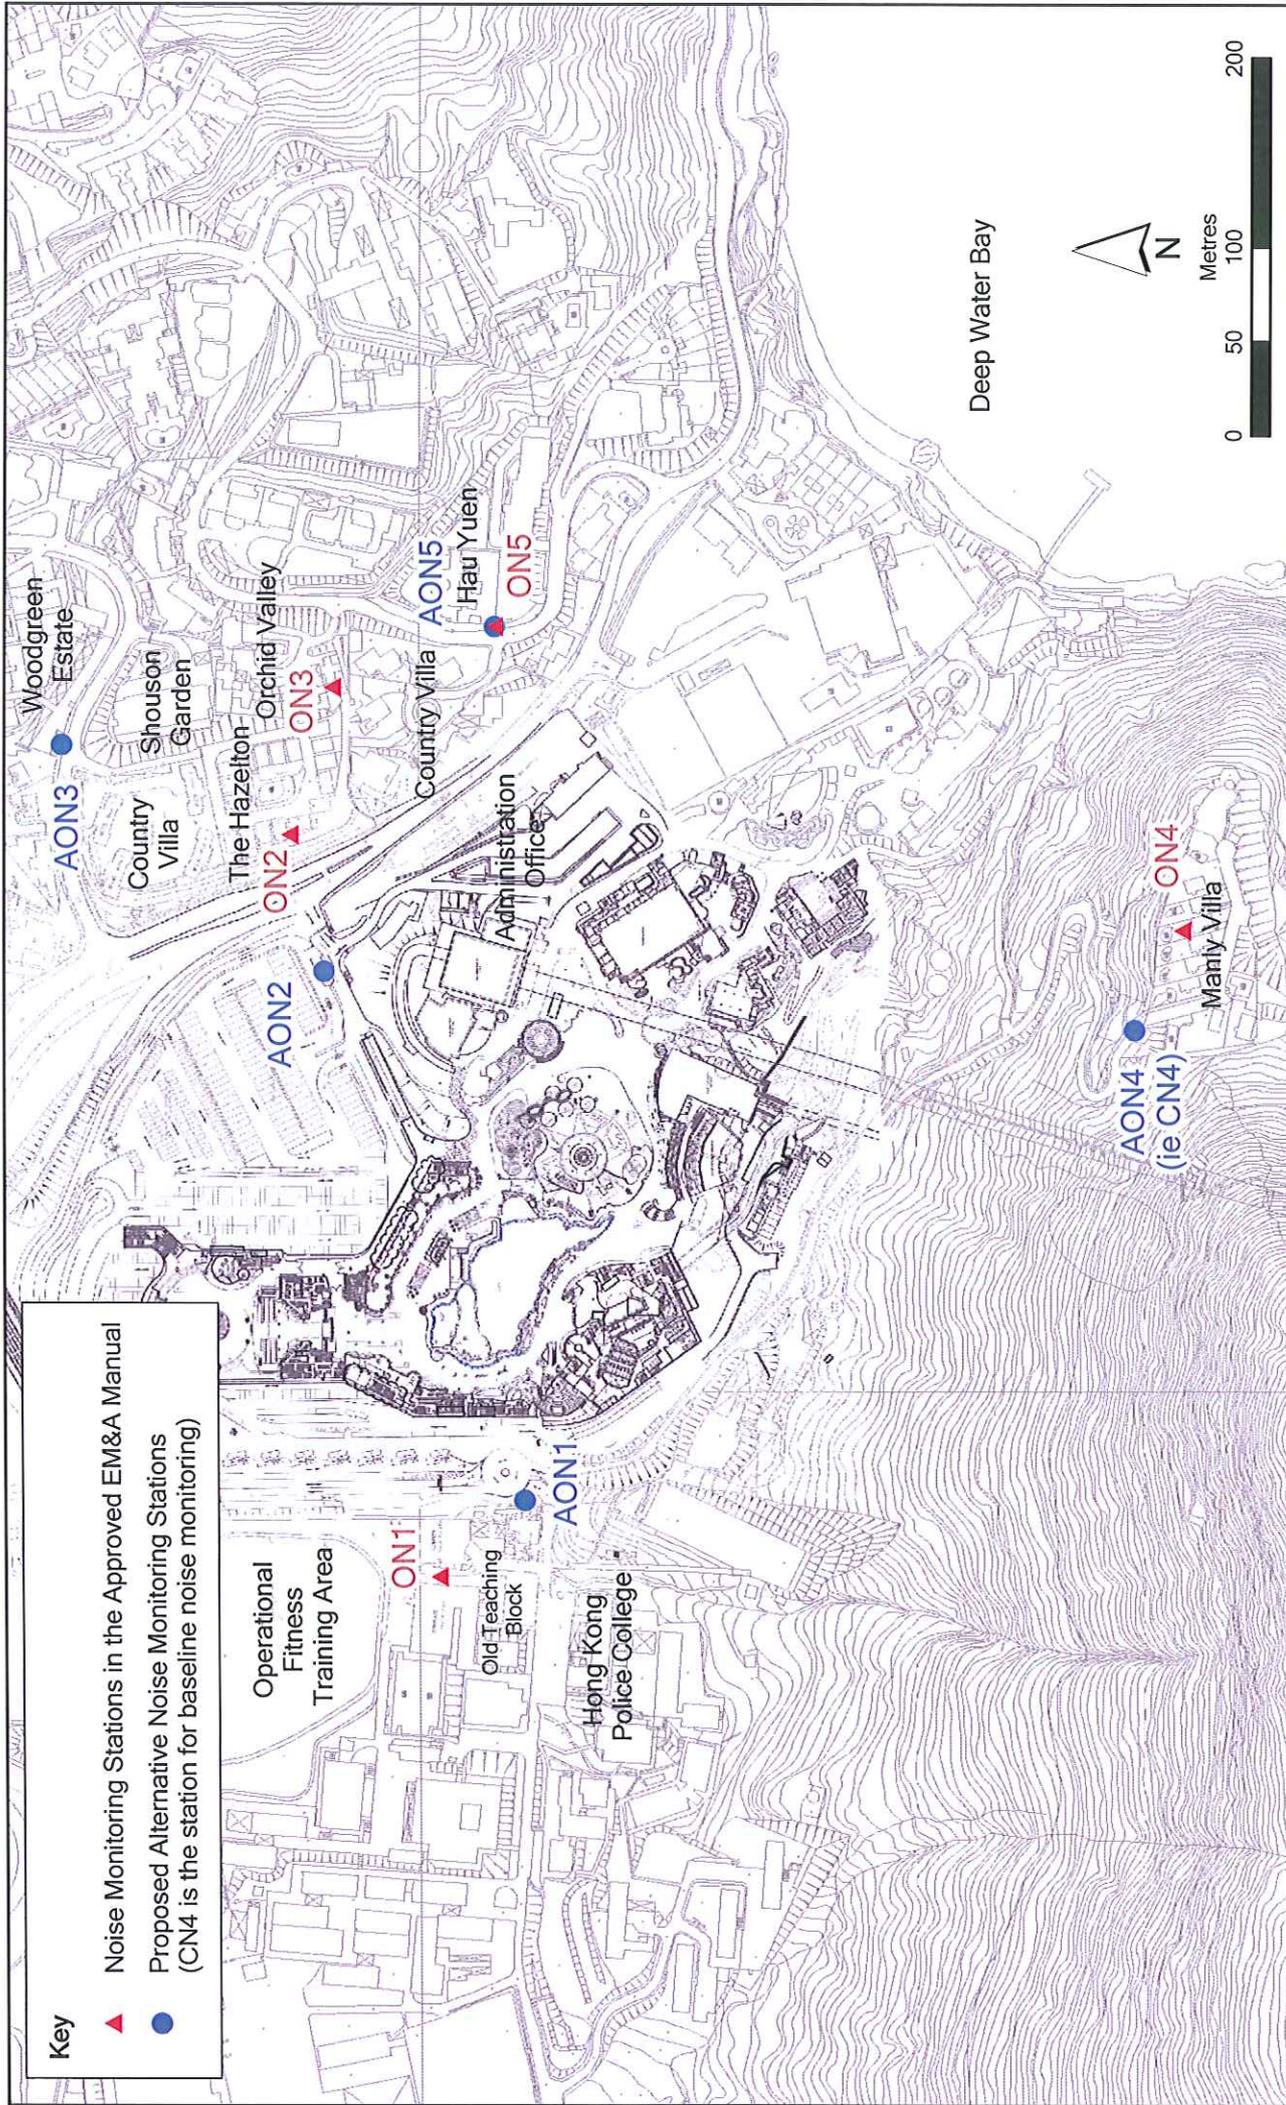
Figure 3.1

Proposed Noise Monitoring Stations in the Approved EM&A Manual and Proposed Alternative Noise Monitoring Stations

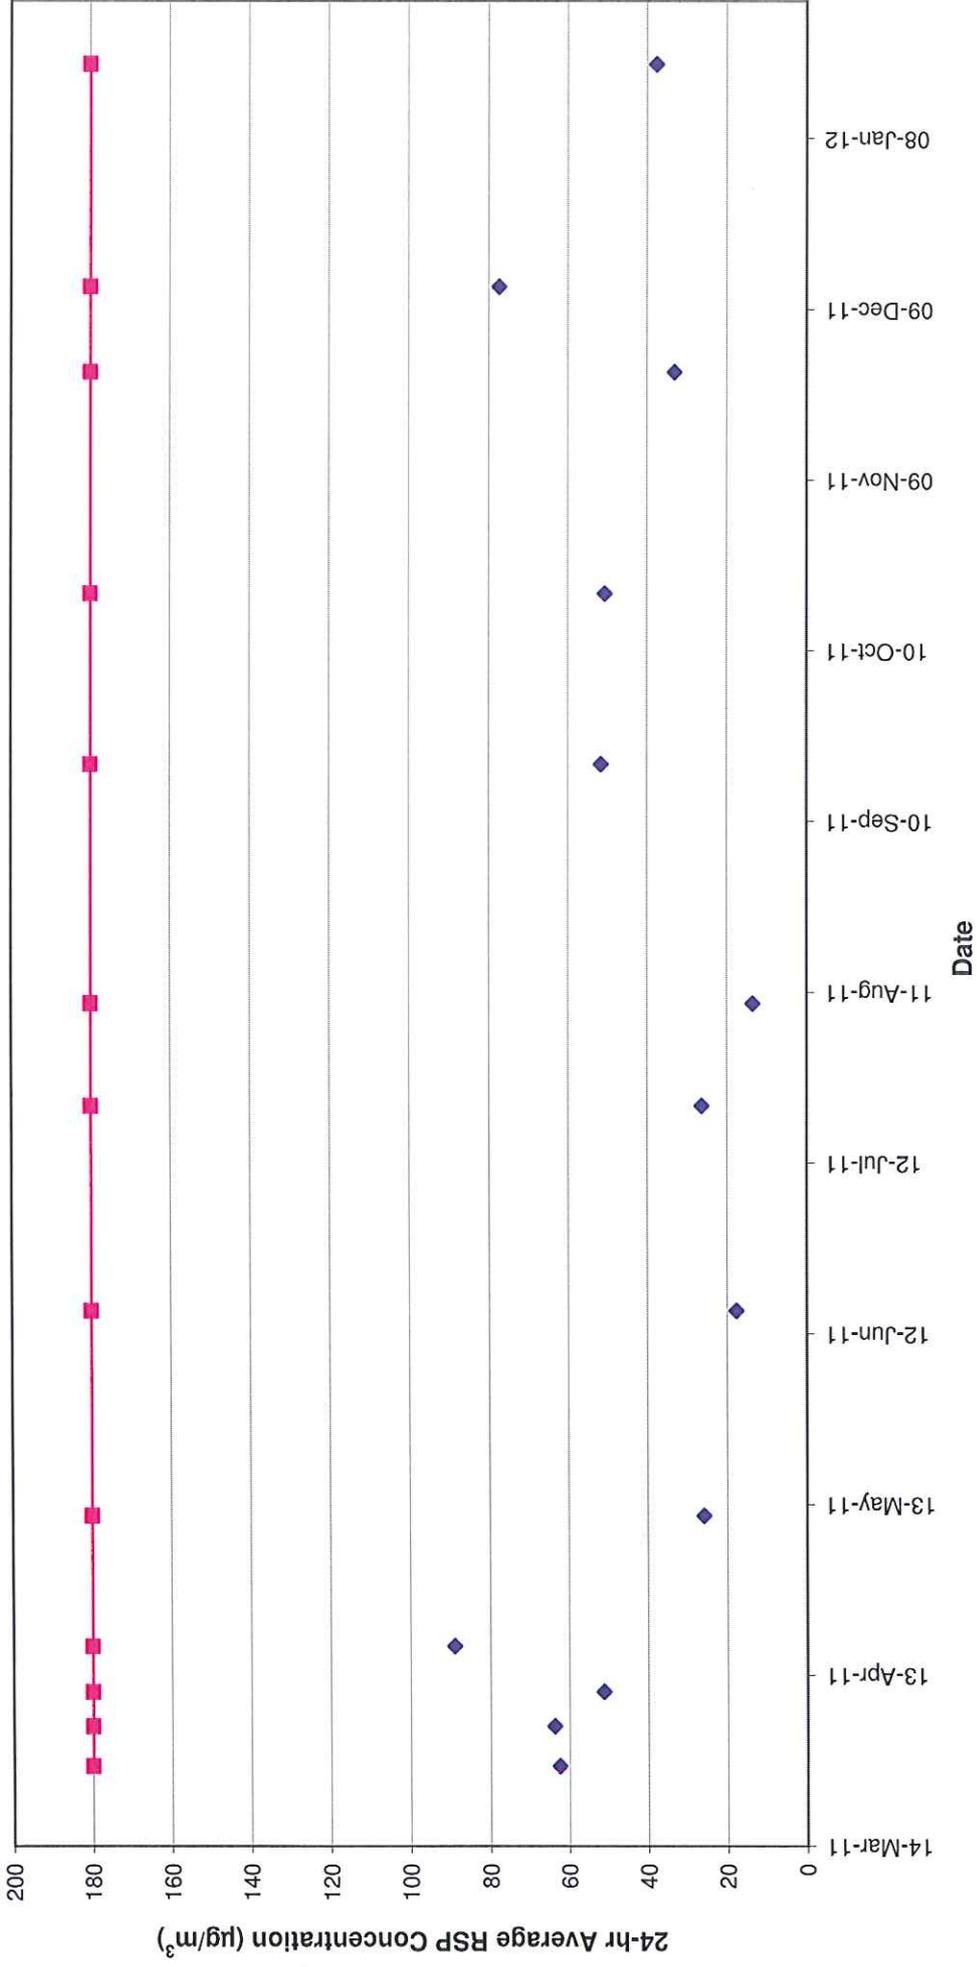
Annex A3

Measured 24-hr Average RSP Concentration
AM 2 - Landscape Storage Area in Ocean Park

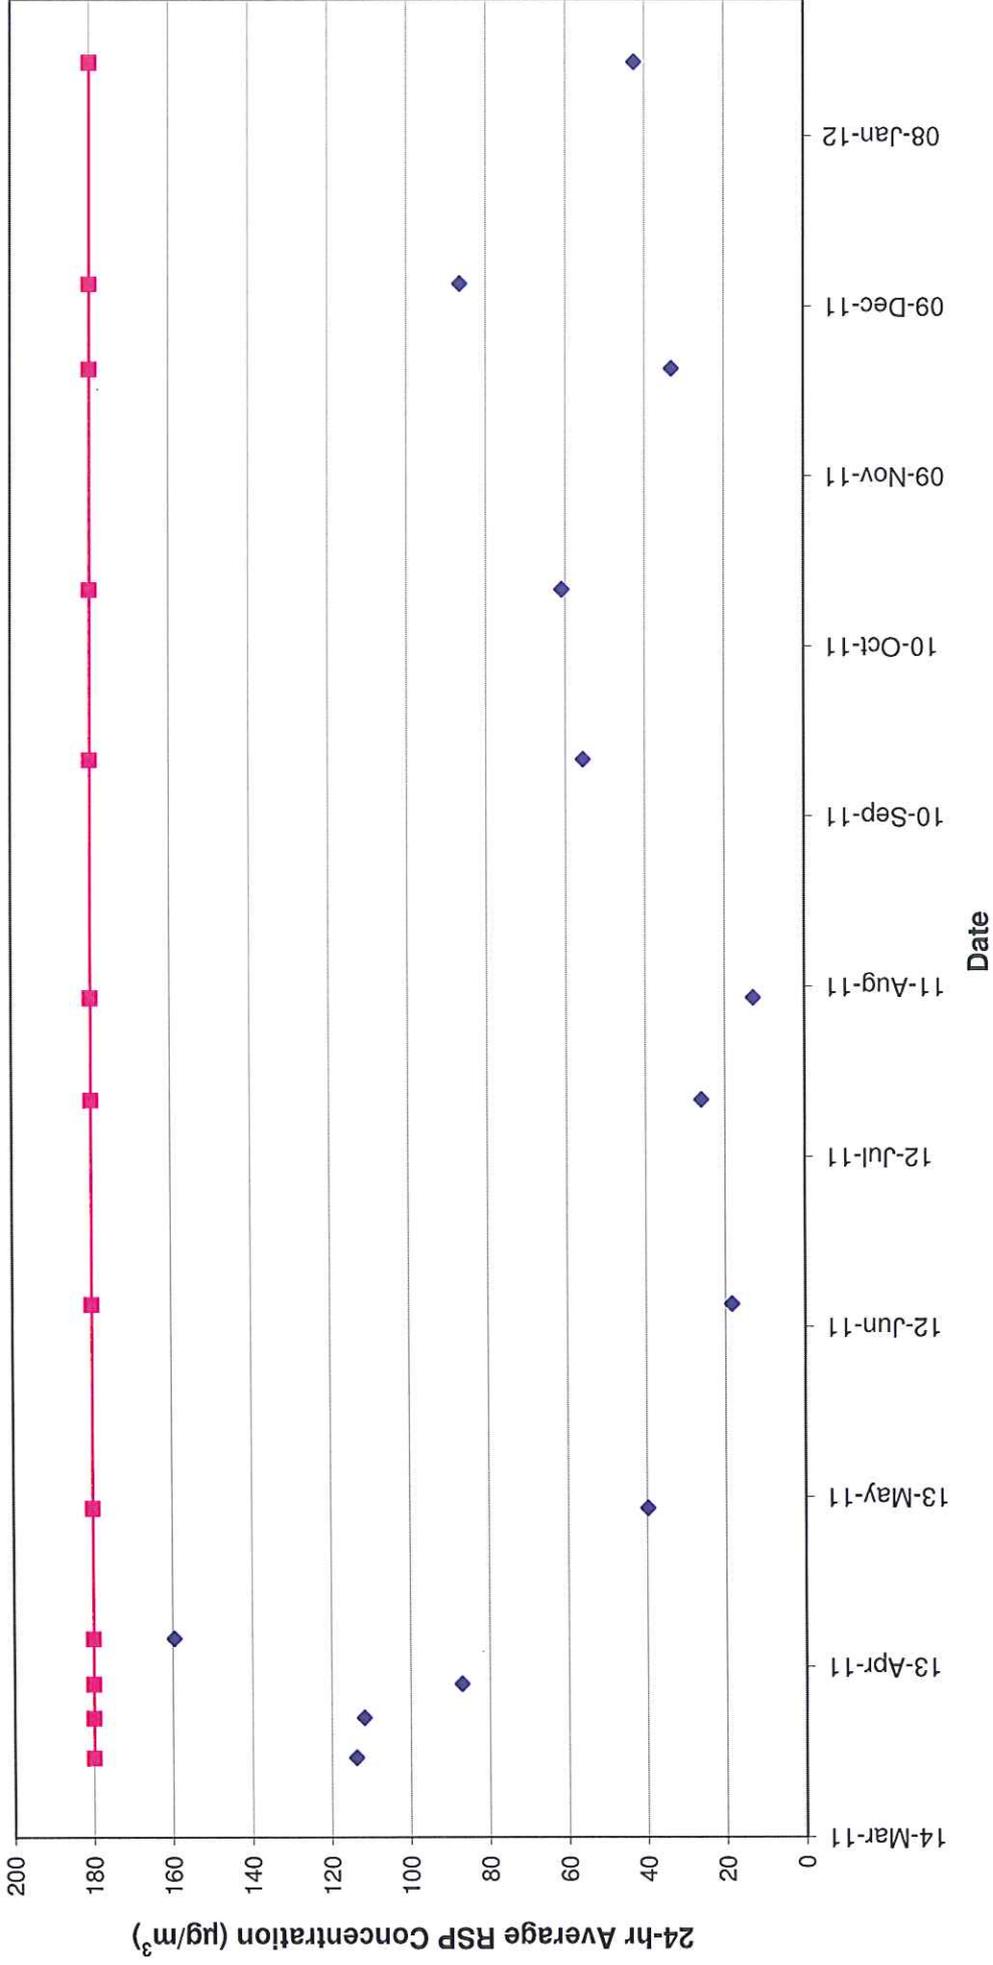
Annex A3

Measured 24-hr Average RSP Concentration
AM3 - Rooftop of Main Medical Block of Graham Hospital

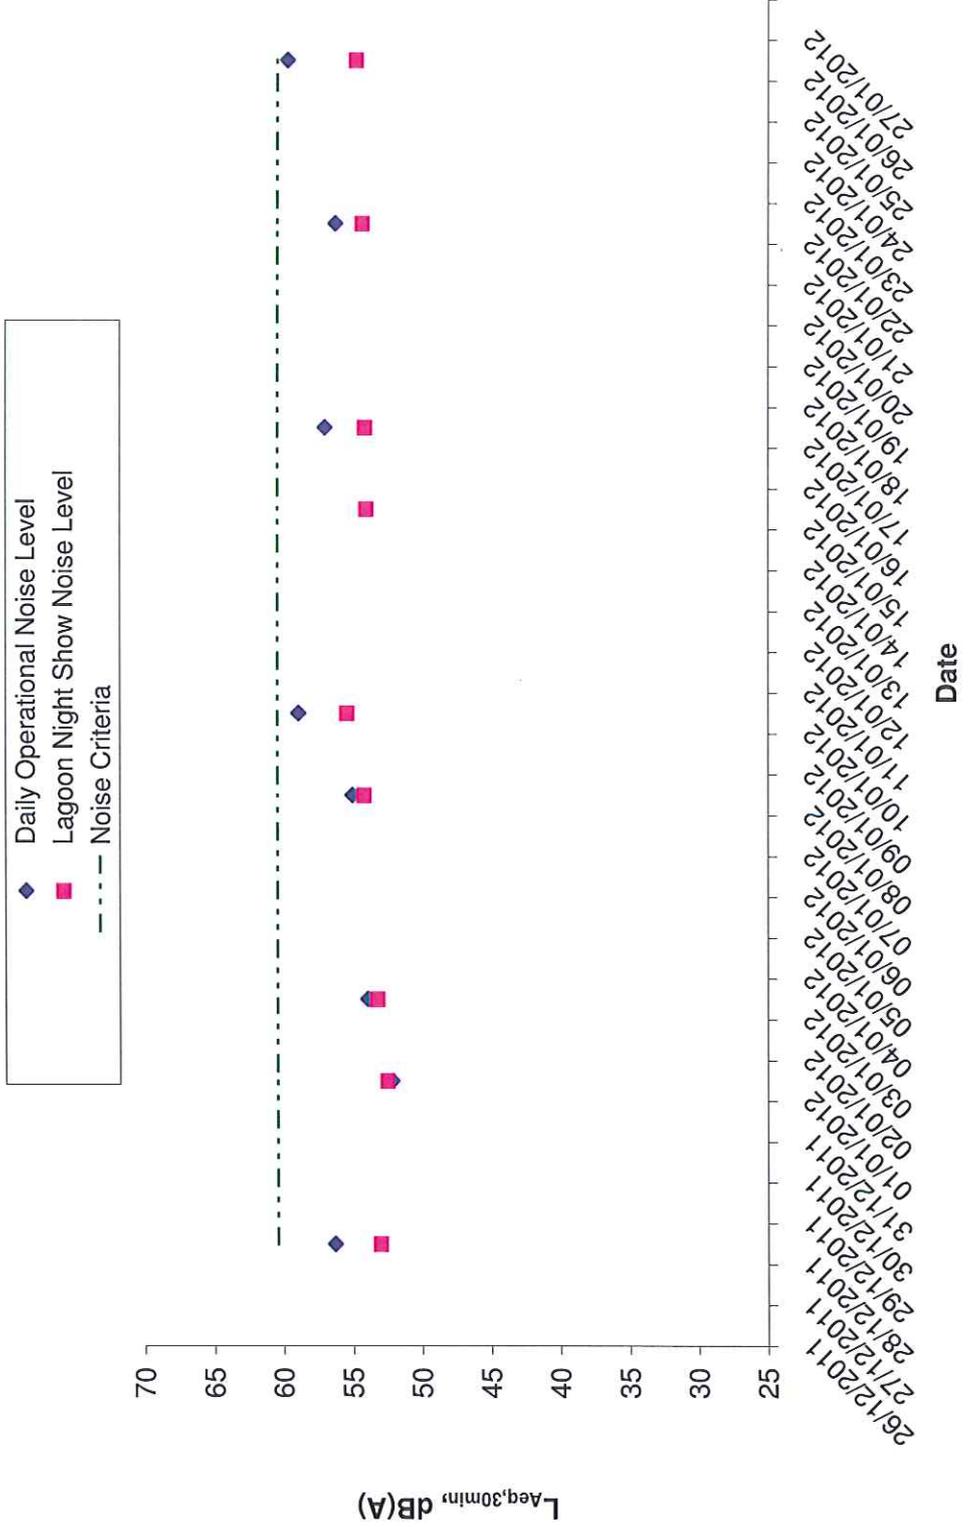
Operational Noise Monitoring at AON2 Old Canteen Building

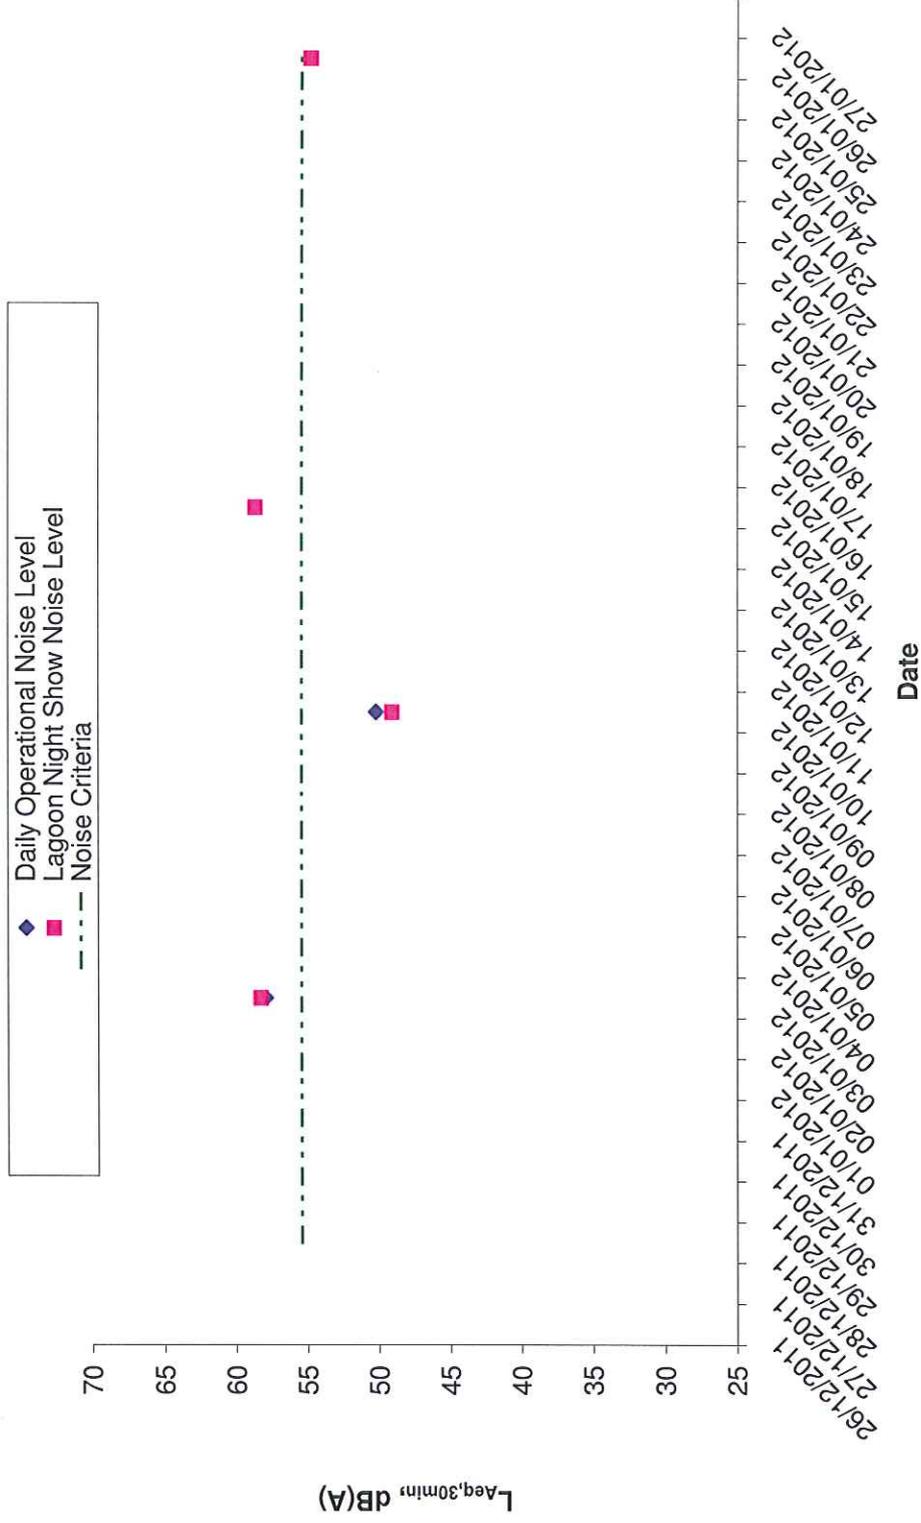
Operational Noise Monitoring at AON3 Woodgreen Estate

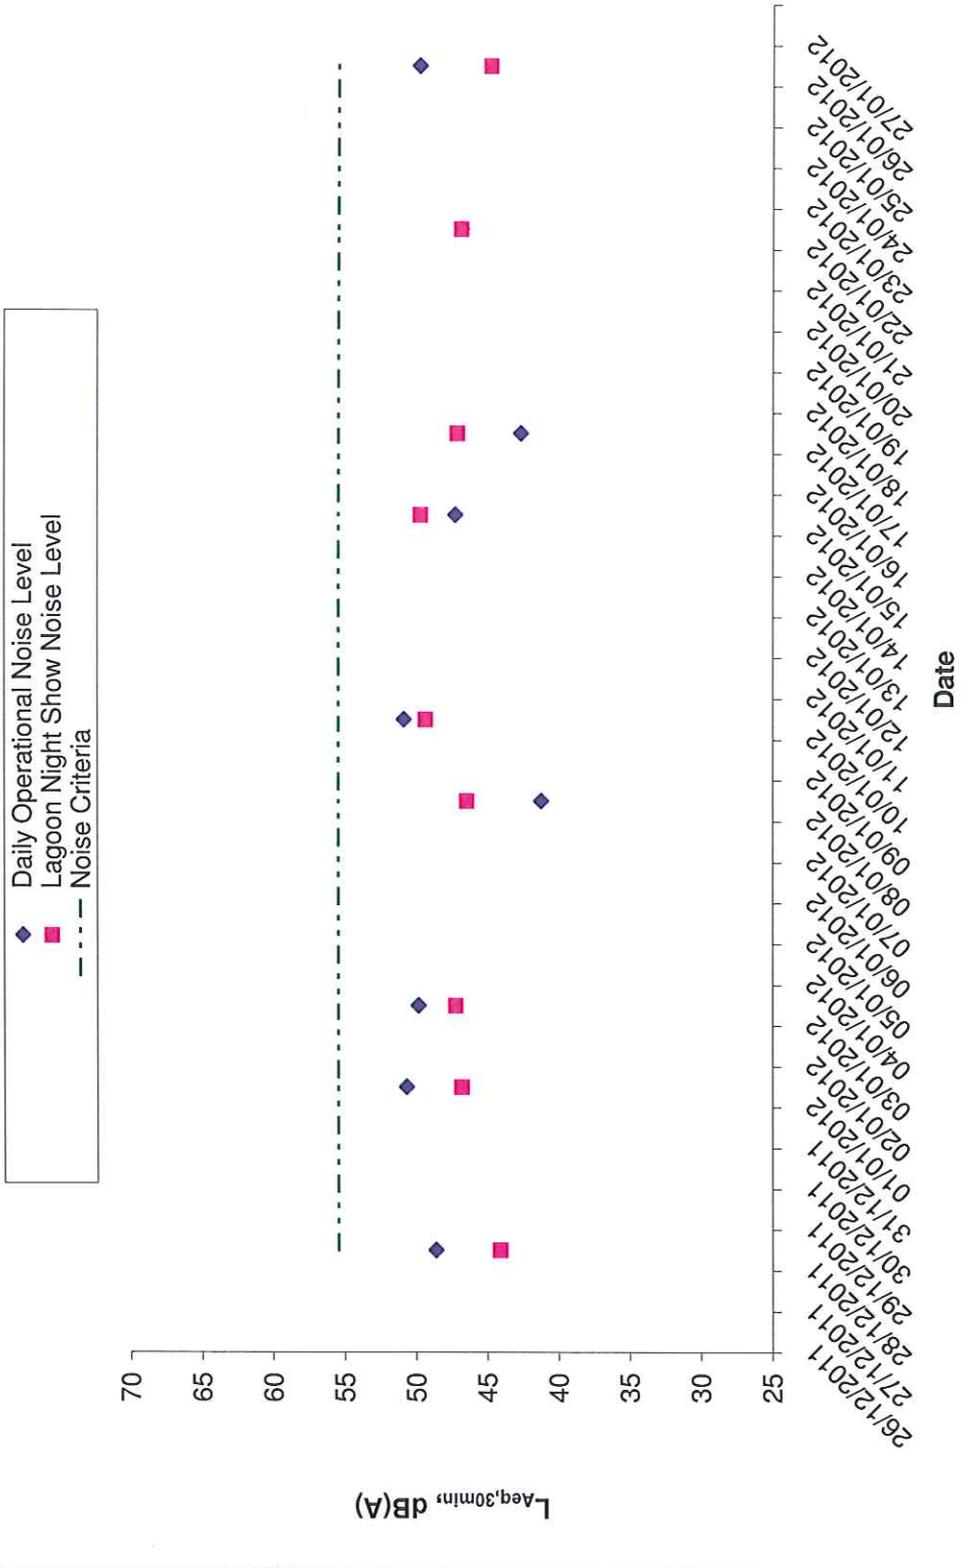
Operational Noise Monitoring at AON4 Manly Villa

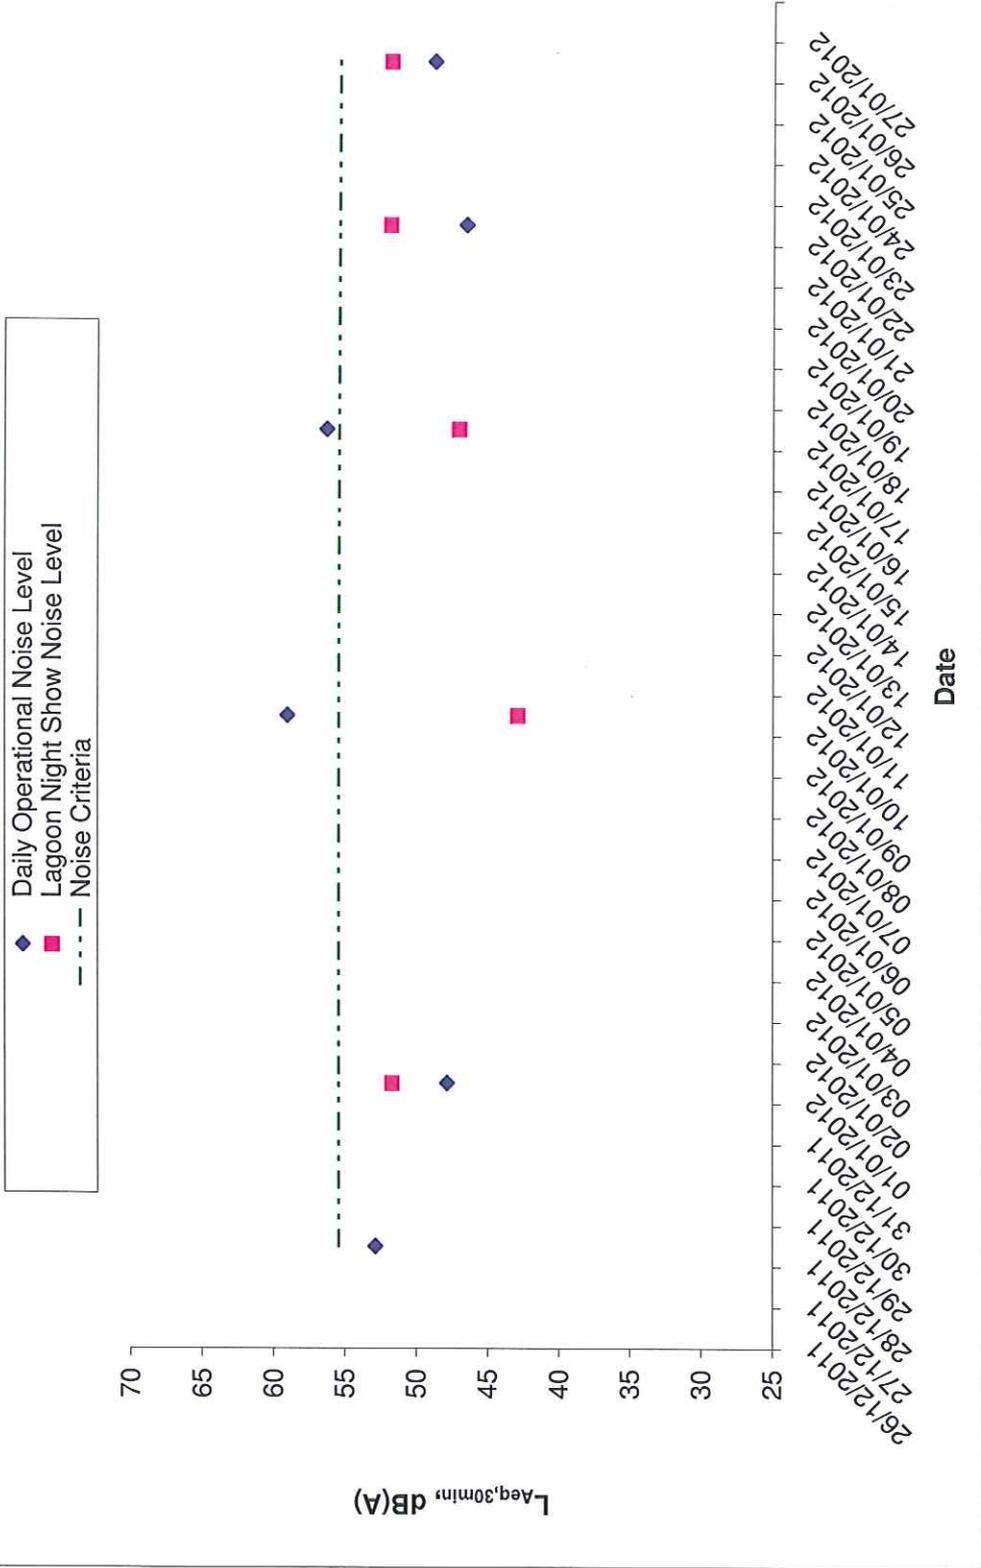
Operational Noise Monitoring at AON5 Hau Yuen

Note: The exceedances were due to the traffic noise from Shouson Hill Road.

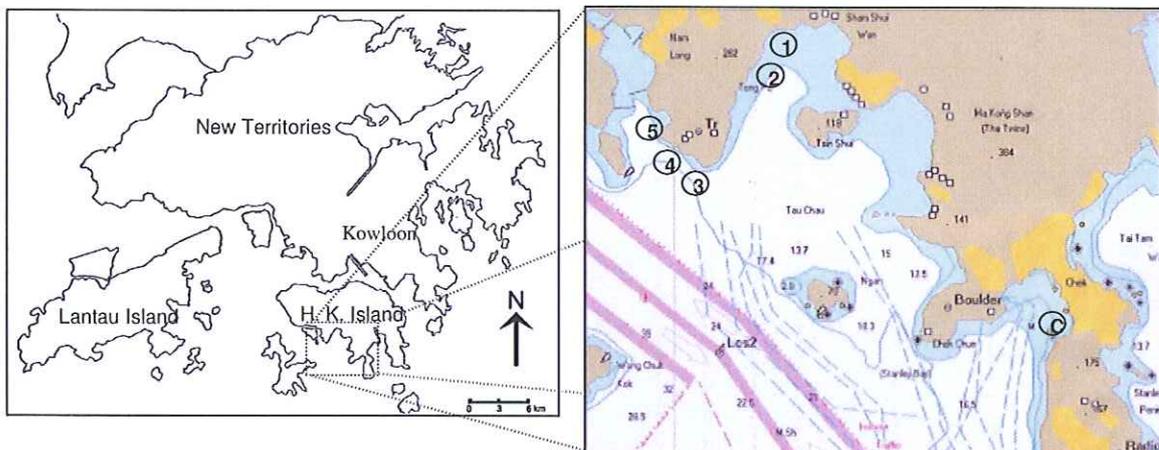
Fig. 2.1 Map Showing the Locations of the Five Impact Monitoring Sites (1 to 5) and One Control Site (C).

2.1.1 Five locations close to the potential impact areas were identified and designated as Impact Monitoring Sites (Sites 1 to 5; Fig. 2.1). In order to identify background environmental perturbations that are not associated with the construction, St. Stephen Beach, which is away from the impact areas, was designated as the Control Site (Control Site C; Fig. 2.1). Locations (GPS coordinates) of the five Impact Monitoring Sites and one Control Site C are summarized in Table 3.1.
