**Ocean Park Master Redevelopment Project**

**Monthly EM&A Report – March 2012**

**Environmental Permit No. EP-249/2006/B - Condition 3.4**

**Ocean Park Master Redevelopment Project**  
**Contract P007**  
**Independent Environmental Checker**  
**MONTHLY SITE INSPECTION PHOTOS**

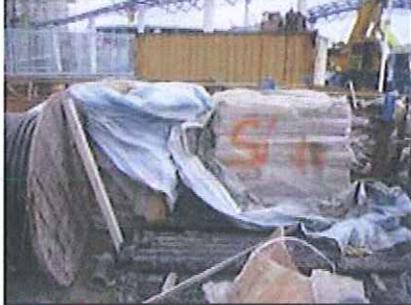
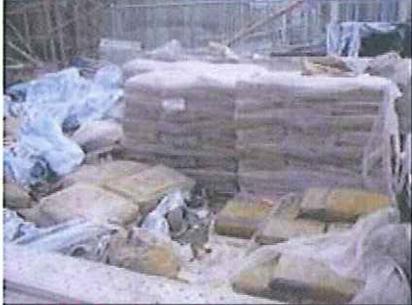
<p>P1140945: Over 20 cement bags were not fully covered. The Contractor was reminded to fully cover any piles of over 20 cement bags on-site with tarpaulin sheets or other means to suppress dust.</p>	<p>P1150156: Over 20 cement bags were not fully covered. The Contractor was reminded to fully cover any piles of over 20 cement bags on-site with tarpaulin sheets or other means to suppress dust.</p>

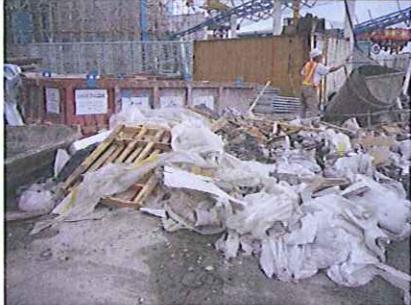
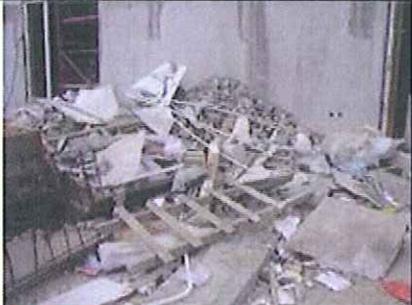
<p>P1140944: General refuse and construction waste were scattered around the site. The Contractor was reminded to provide sufficient disposal points and remove the general refuse from site more frequently.</p>	<p>P1150158: General refuse and construction waste were scattered around the site. The Contractor was reminded to provide sufficient disposal points and remove the general refuse from site more frequently.</p>

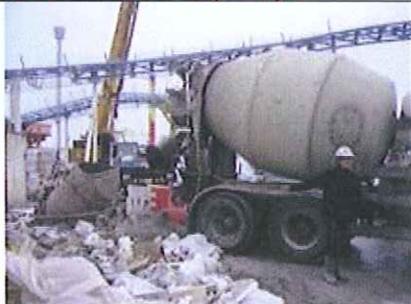
<p>N/A</p>
<p>P1140956: Washing of concrete mixer truck at a non-designated area was observed. The Contractor was reminded to provide a designated location with proper signage for washing of concrete mixer truck.</p>	<p>Closed – Washing of concrete mixer truck was not observed during the site inspection.</p>

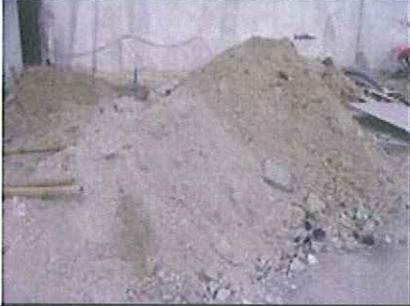
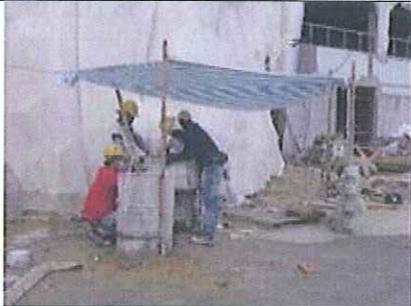
<p>P1150150: A few idled stockpiles of C&amp;D materials were not covered. The Contractor was reminded to cover them with tarpaulin sheets or other means to suppress dust.</p>	<p>P1150154: Concrete mixing was carried with top cover only. The Contractor was reminded to carryout concrete mixing in an enclosure with top and 3 sides enclosed to suppress dust.</p>

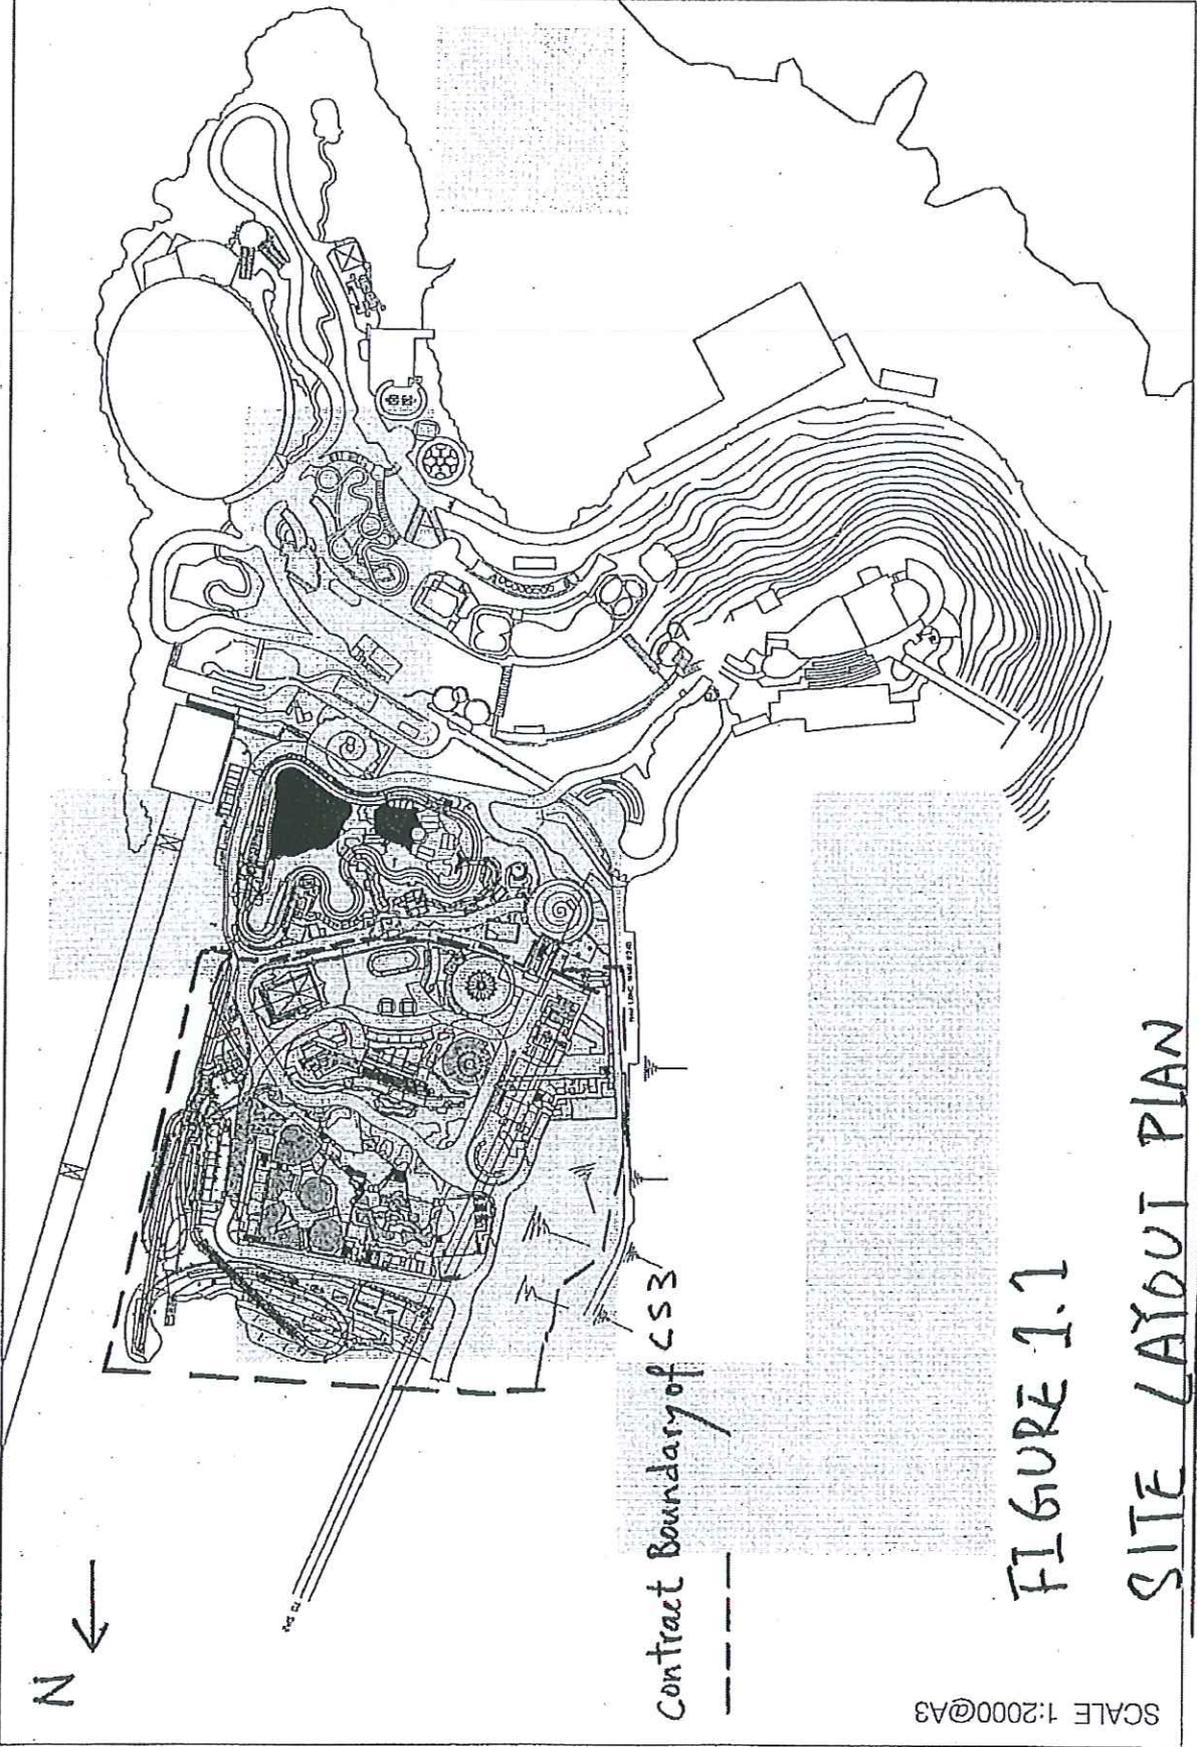
FIGURE 1.1

- 1.1 Kaden-ATAL JV (the Contractor) was commissioned by the Employer to undertake the construction of the Contract No. CS03 “Ocean Park Redevelopment Project – Thrill Mountain & Polar Adventure” (the Project) and the project was commenced on 2<sup>nd</sup> November 2009. The site layout plan is illustrated in Figure 1.1.

SITE LAYOUT PLAN

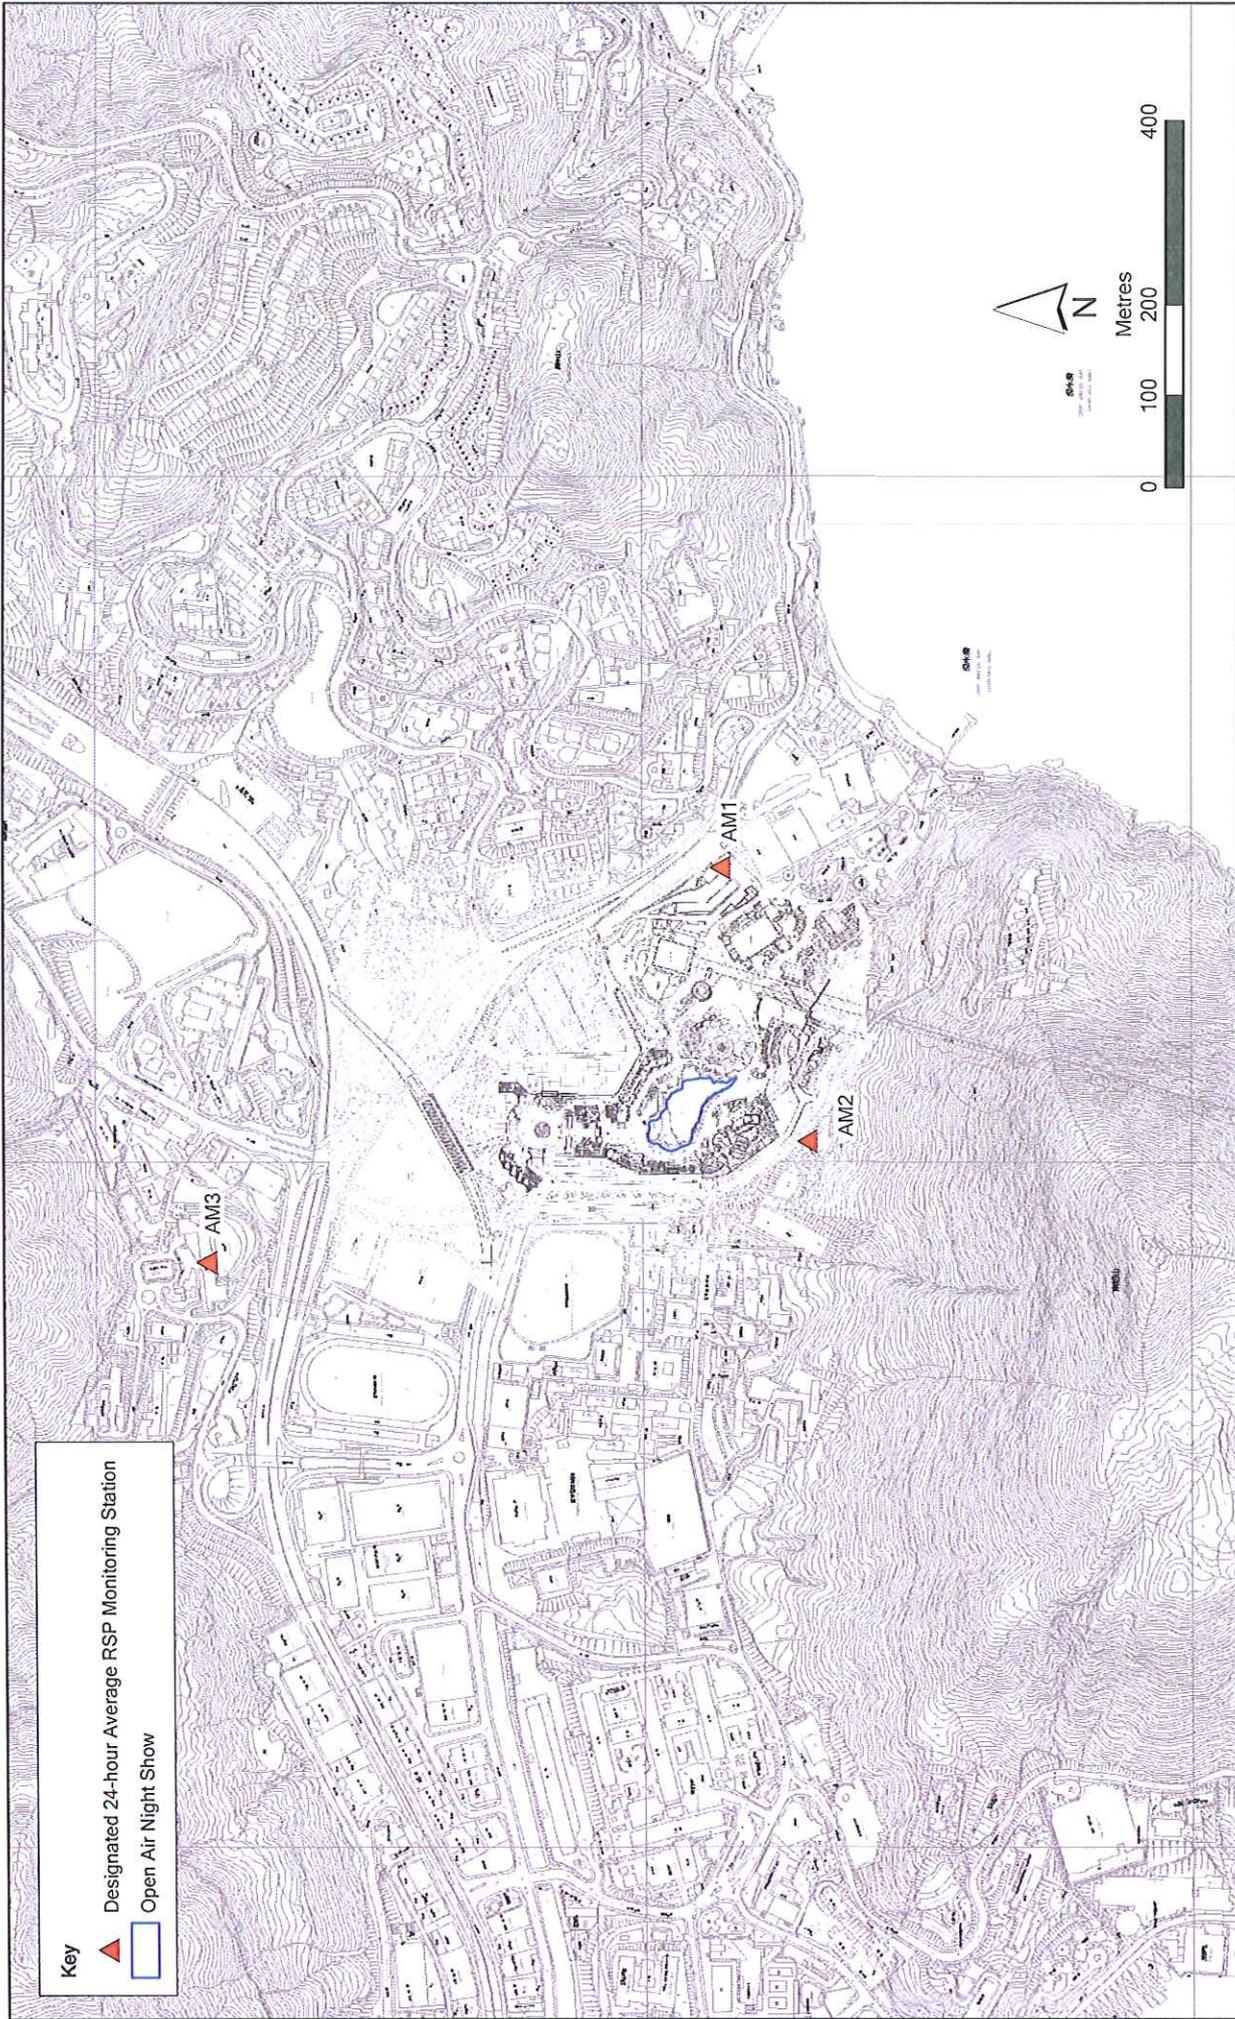
Figure 2.1

Designated 24-hour Average RSP Monitoring Stations during Operation of Open Air Night Show

One 24-hr average RSP sample was collected on each scheduled day by a High Volume Sampler (HVS) following the USEPA method, EPA IO-2.1. Calibration of the equipment has followed the requirements set out in EPA IO-2.1 with the calibration record given in *Annex A1*. A summary of the sampling methodology and equipment is presented in *Table 2.2*.

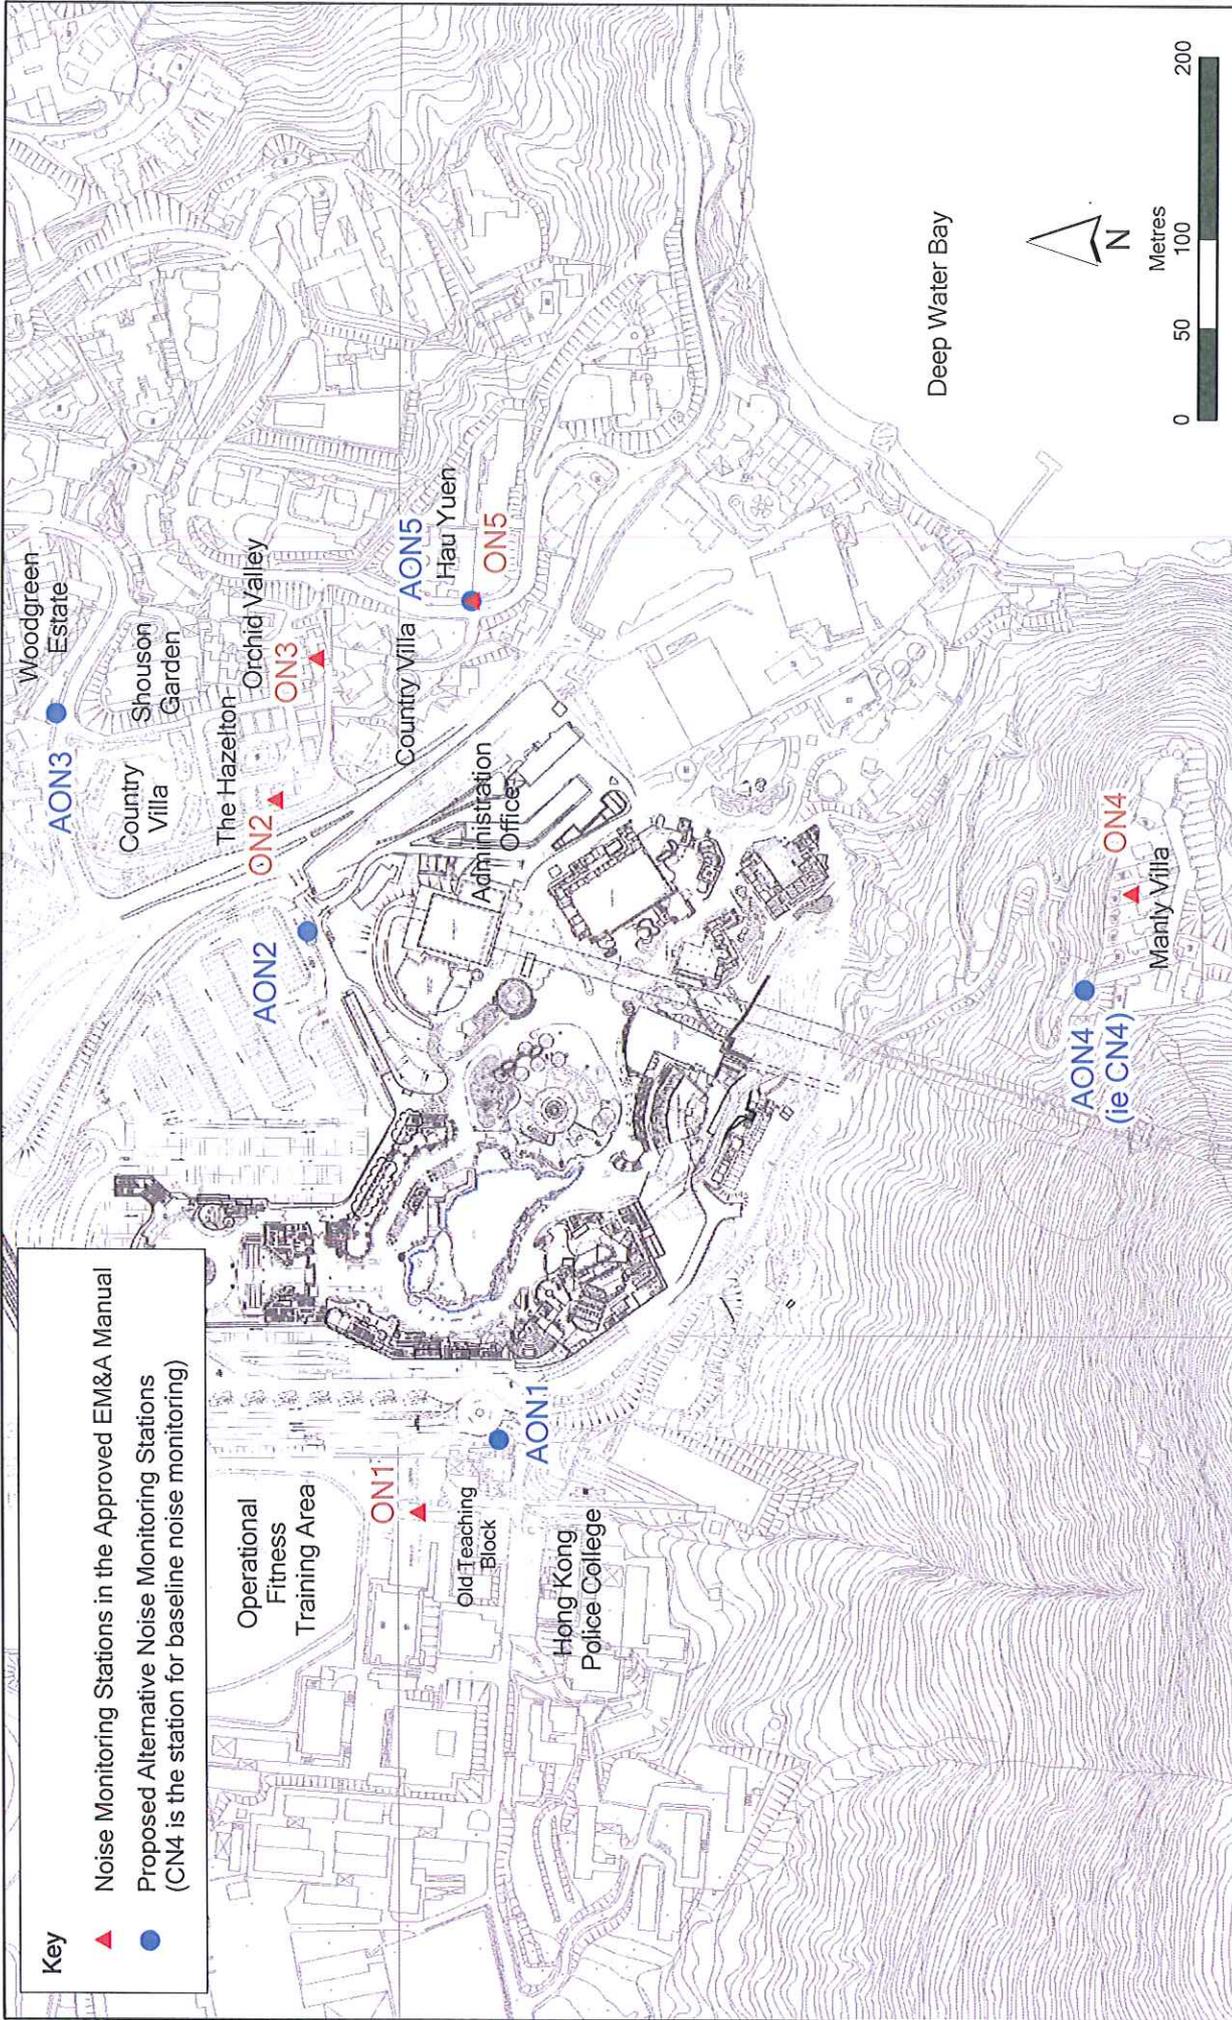
Figure 3.1

Proposed Noise Monitoring Stations in the Approved EM&A Manual and Proposed Alternative Noise Monitoring Stations

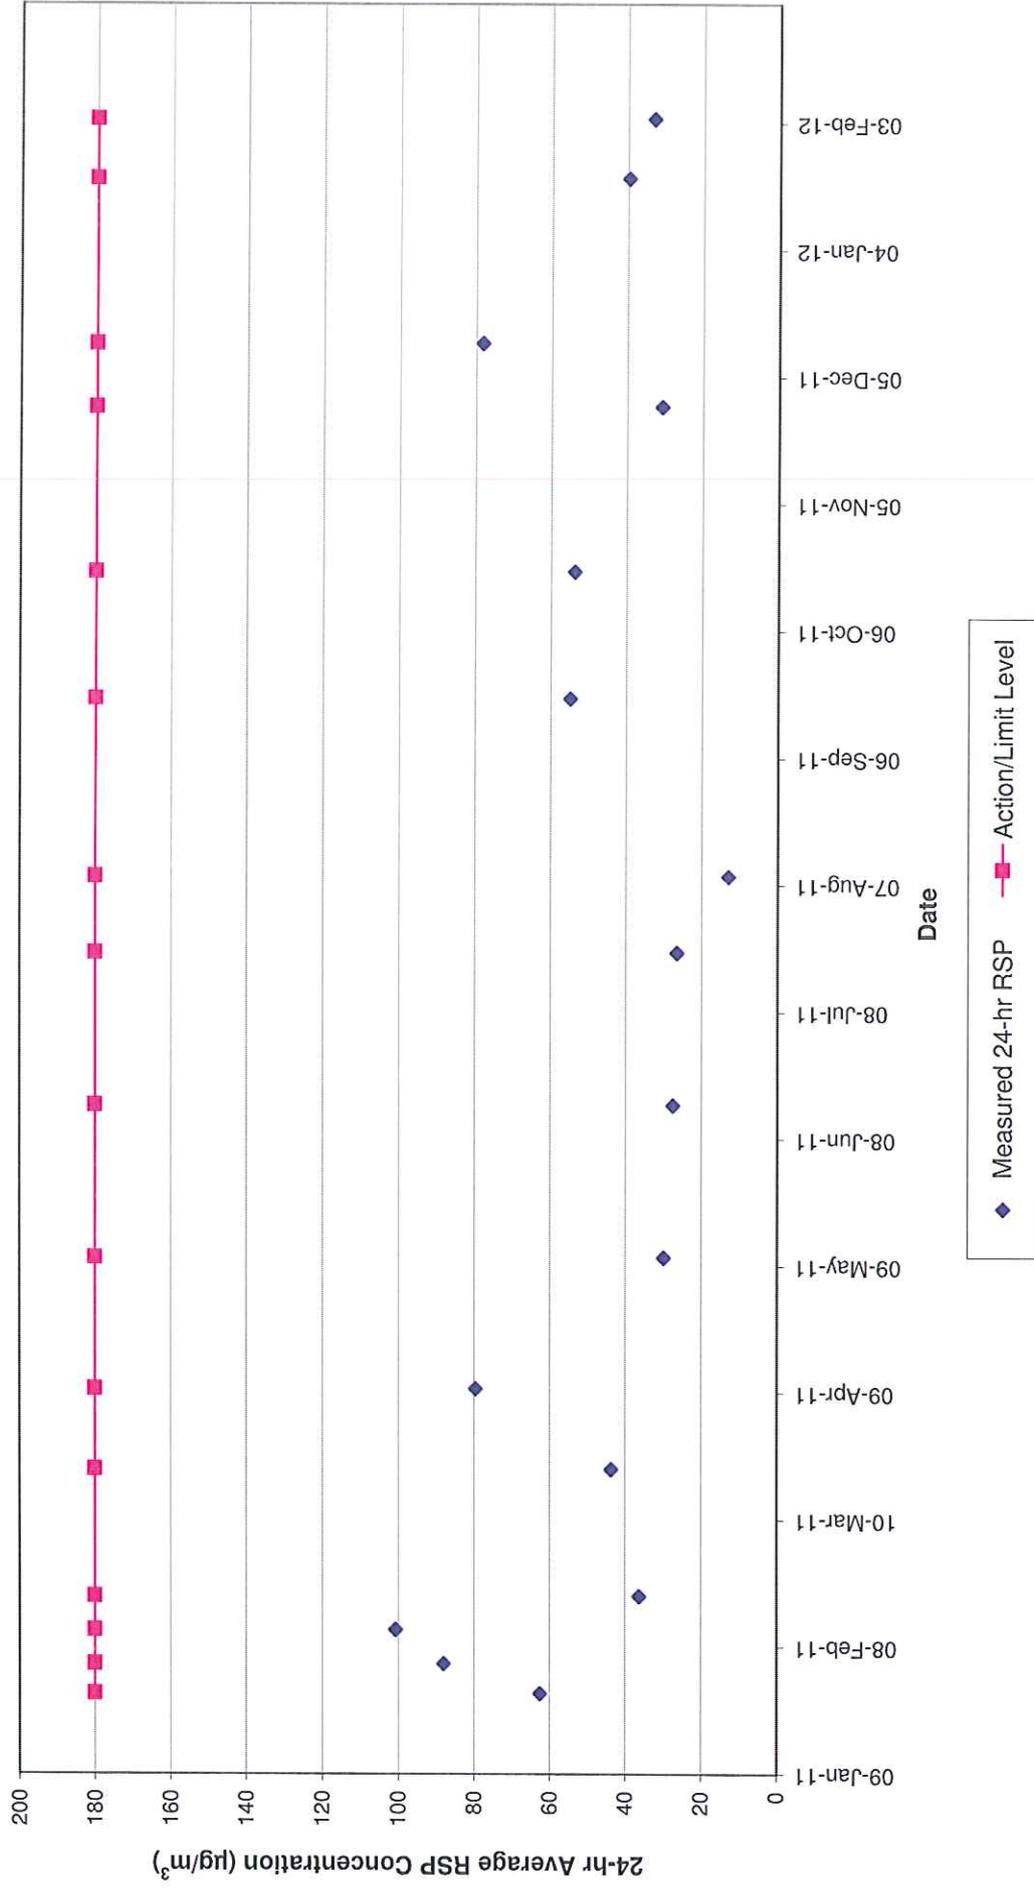
Measured 24-hr Average RSP Concentration  
AM1 - Rooftop of Administrative Building (Former Staff Quarters) in Ocean Park

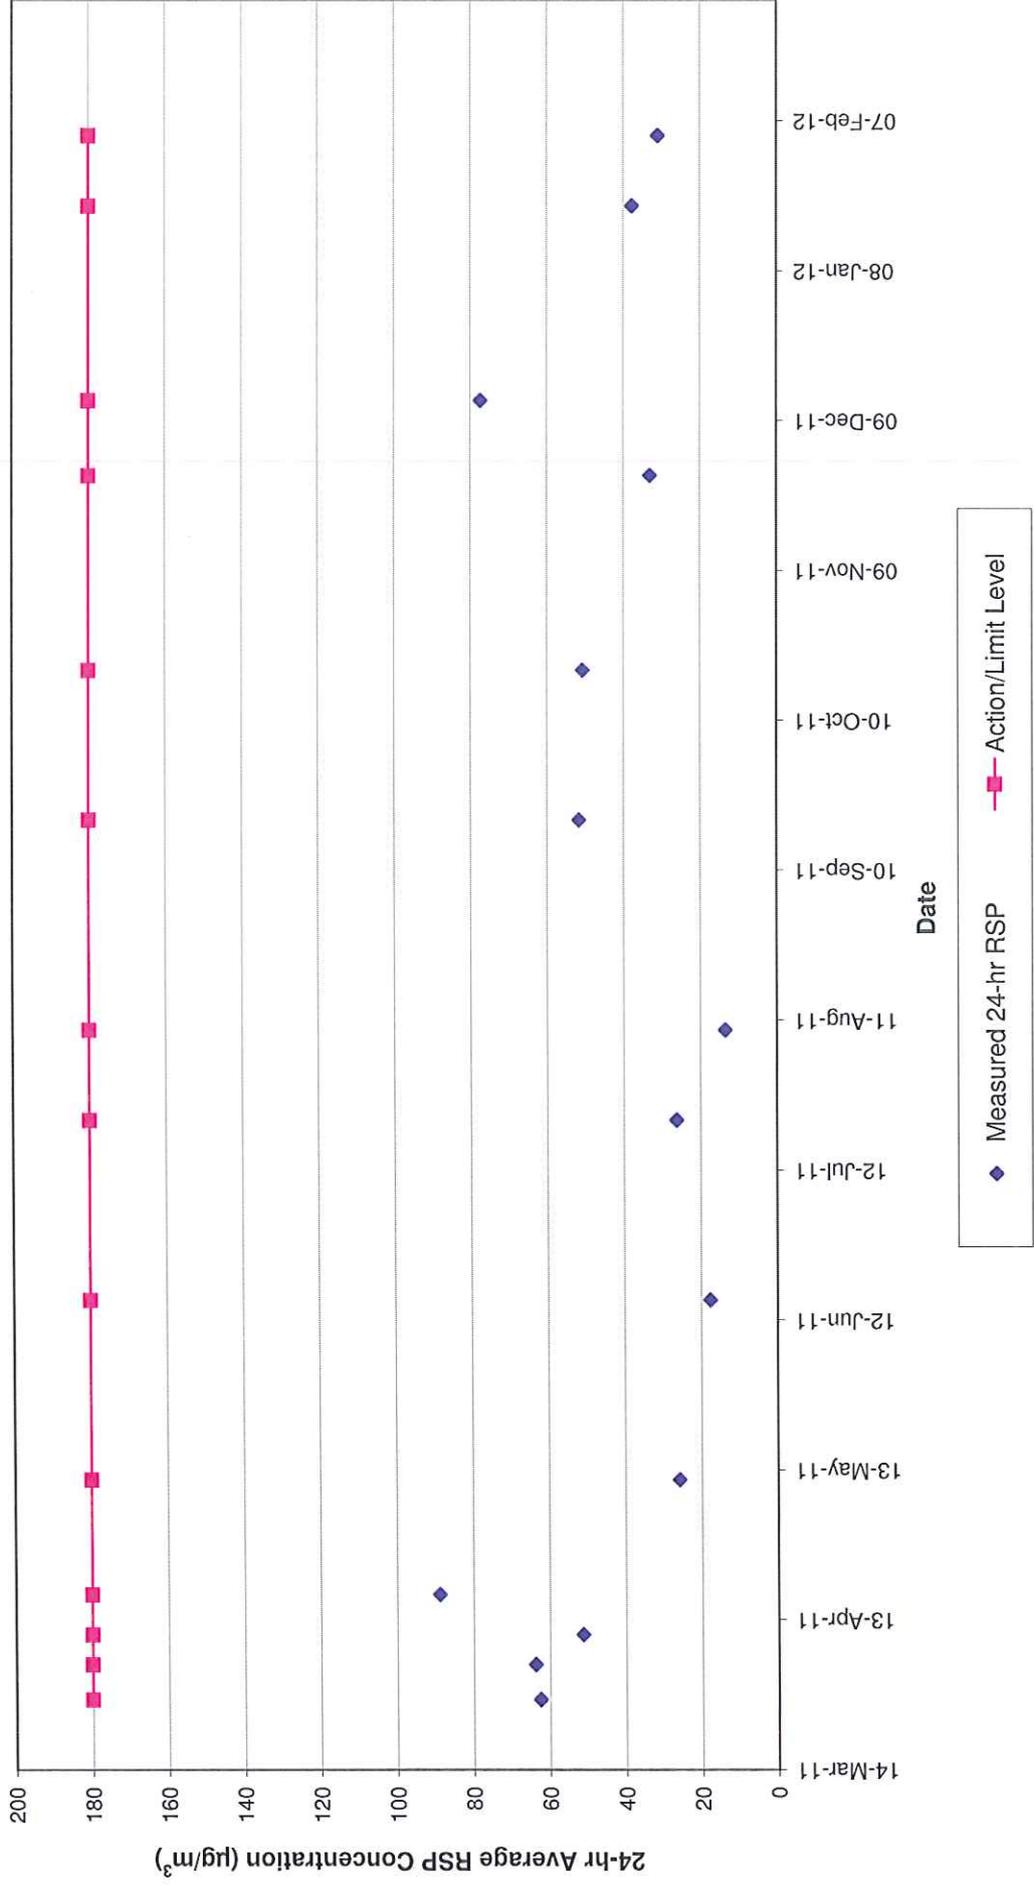
Measured 24-hr Average RSP Concentration  
AM 2 - Landscape Storage Area in Ocean Park

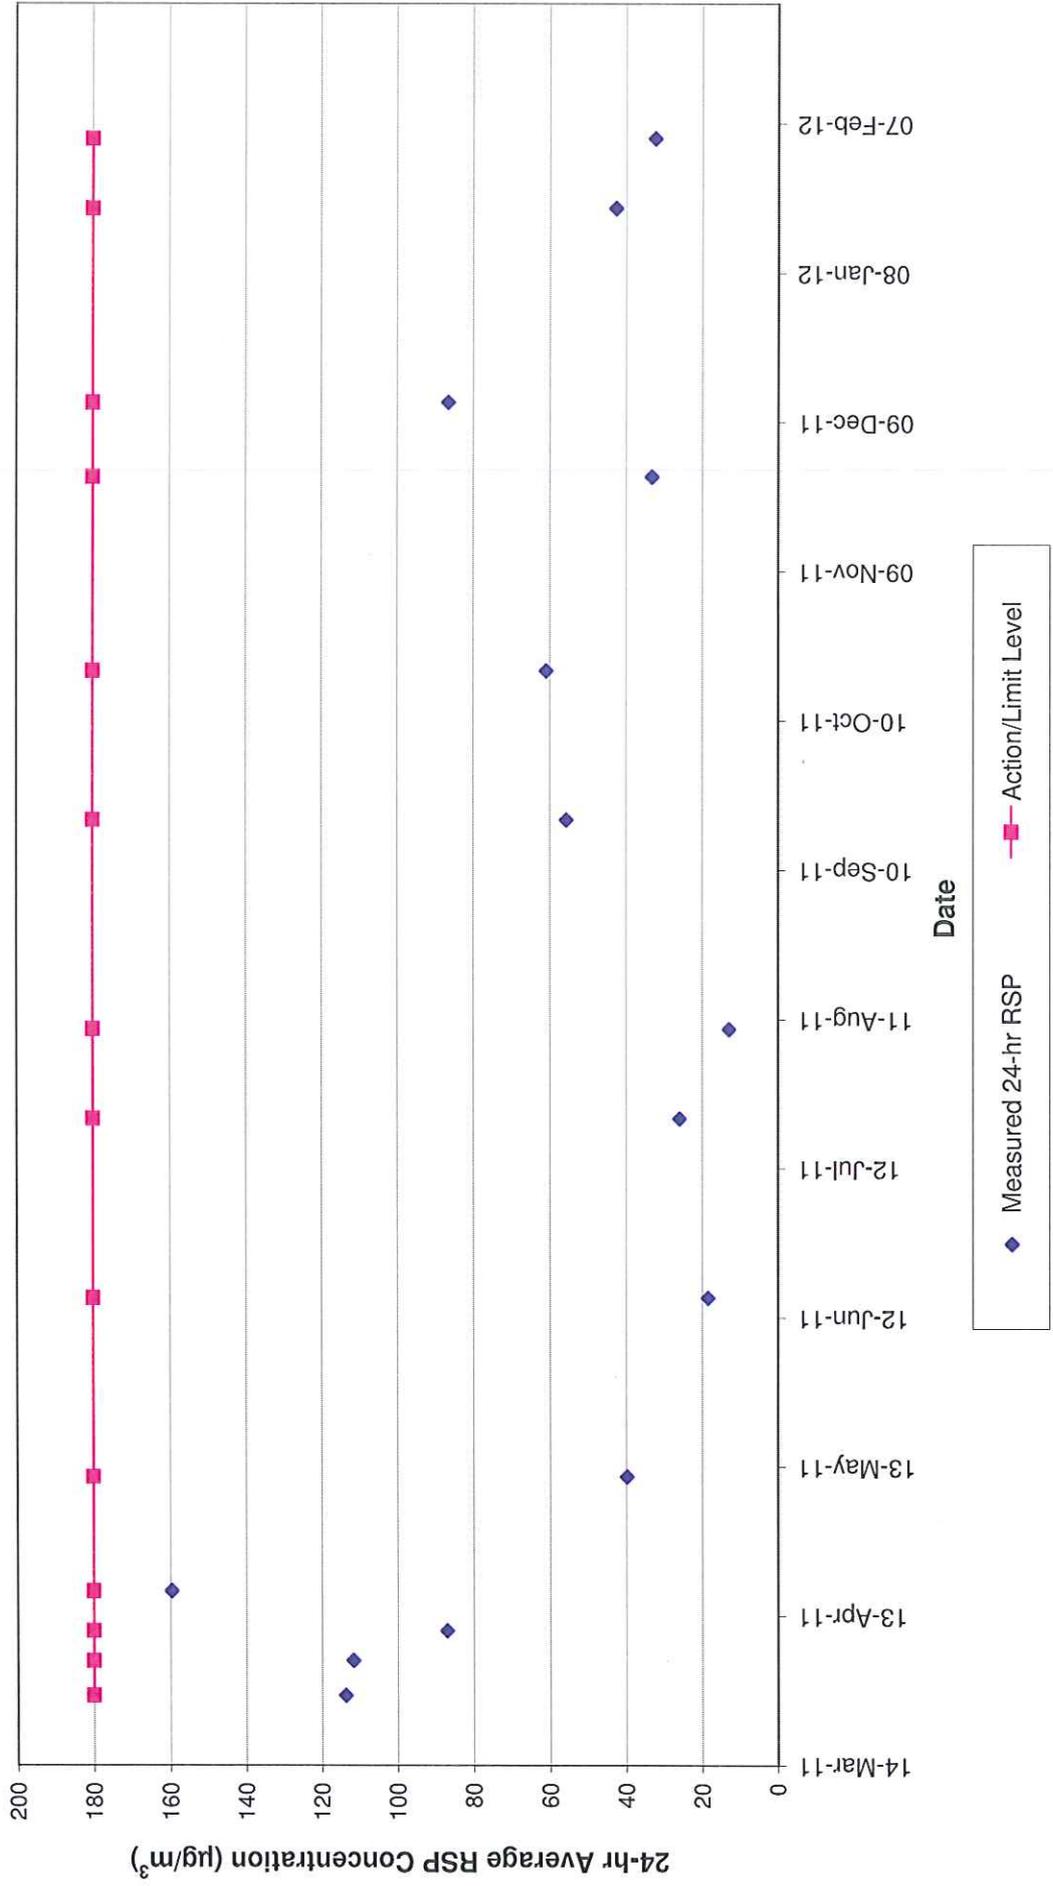
Measured 24-hr Average RSP Concentration  
AM3 - Rooftop of Main Medical Block of Graham Hospital

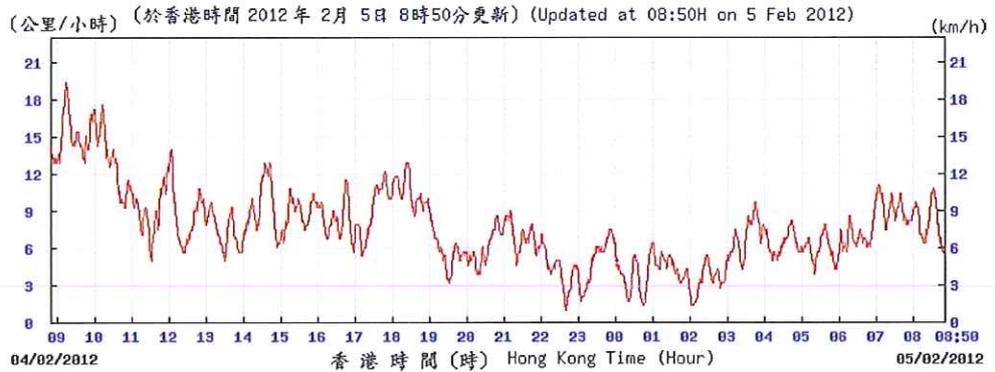
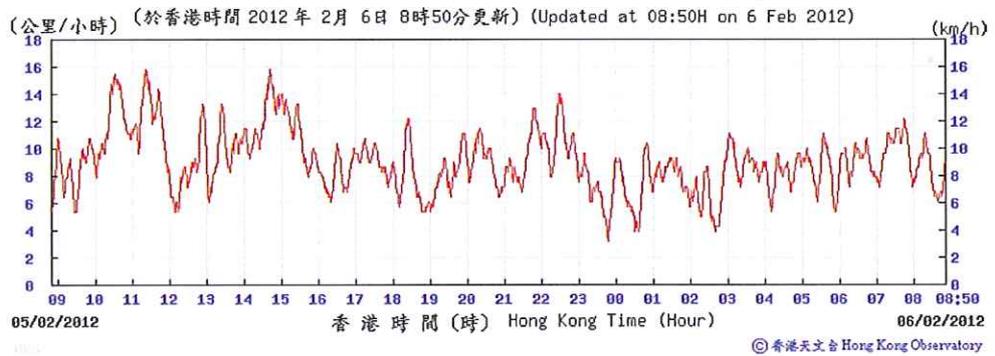
Prevailing Wind Speed

Recorded Weather Data at HKO's Weather Station in Wong Chuk Hang on 4 February 2012

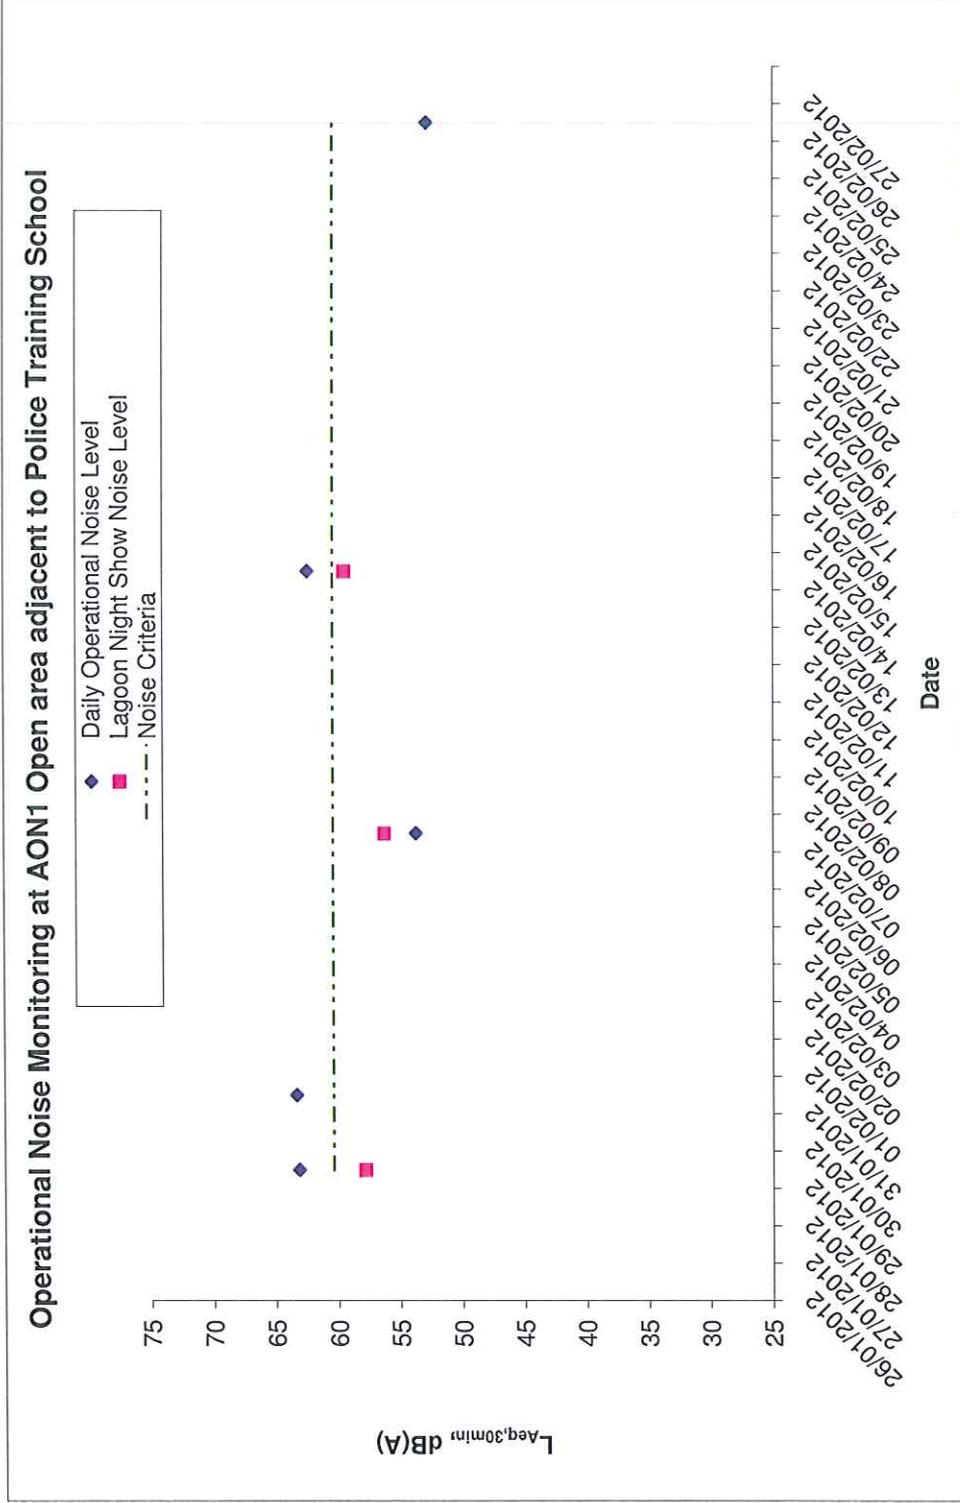
## Graphical Presentation of Noise Monitoring Result

**Note:** The exceedances were due to the high level of background noise from visitors and traffic.

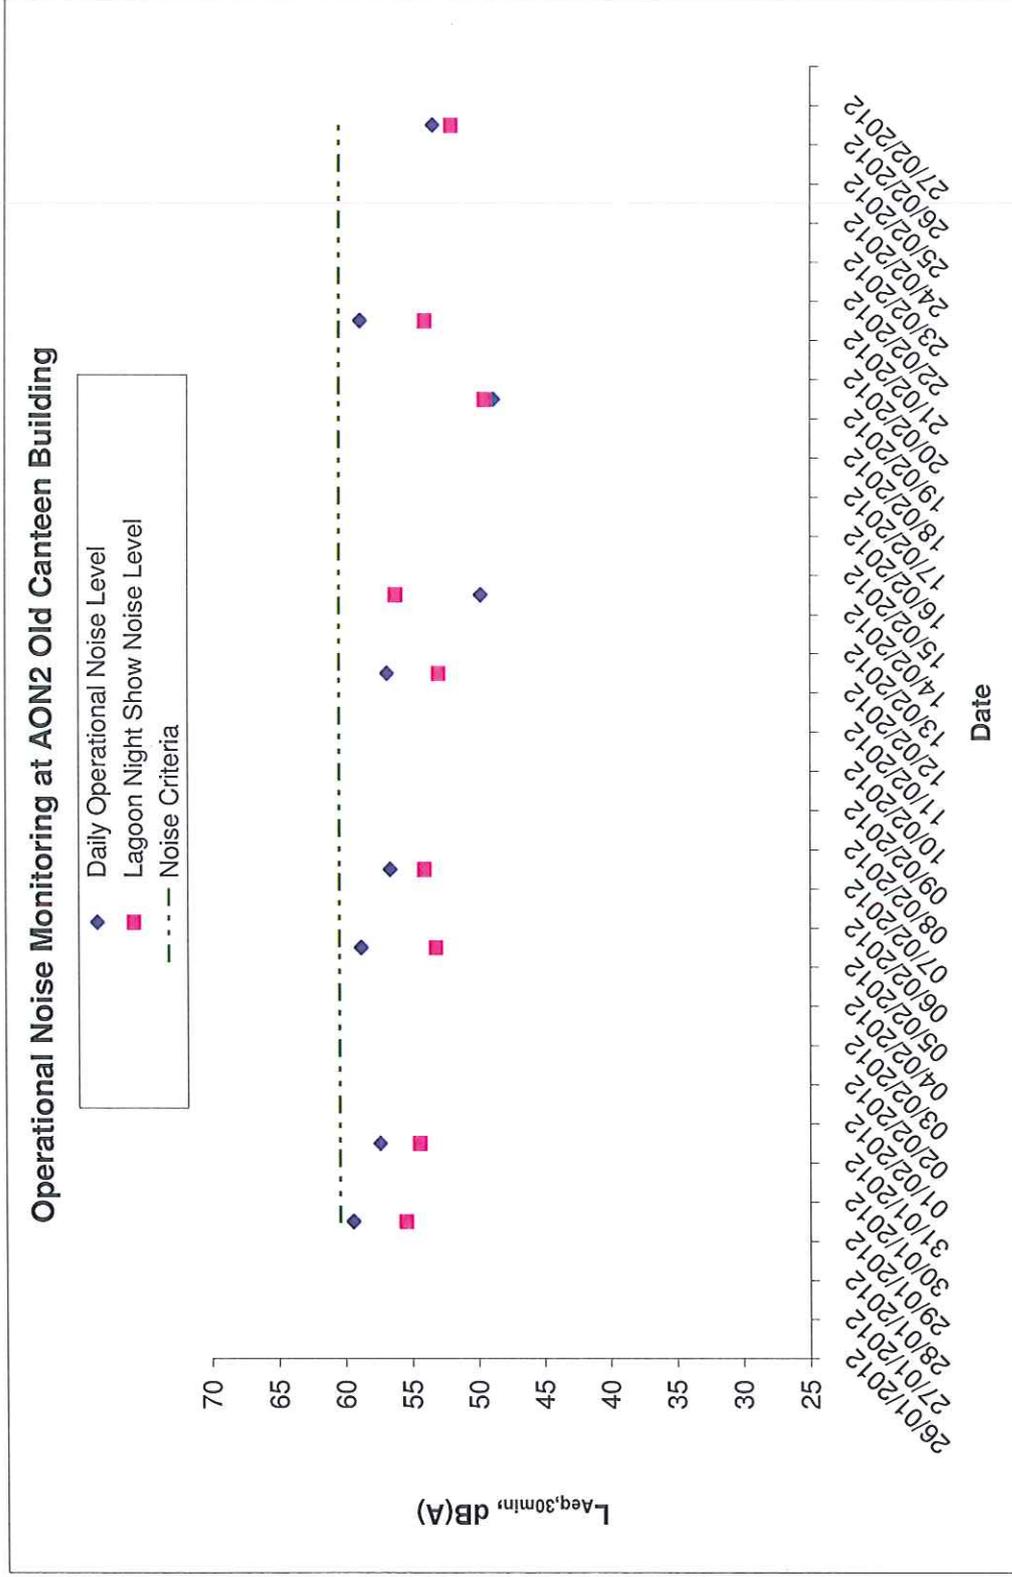
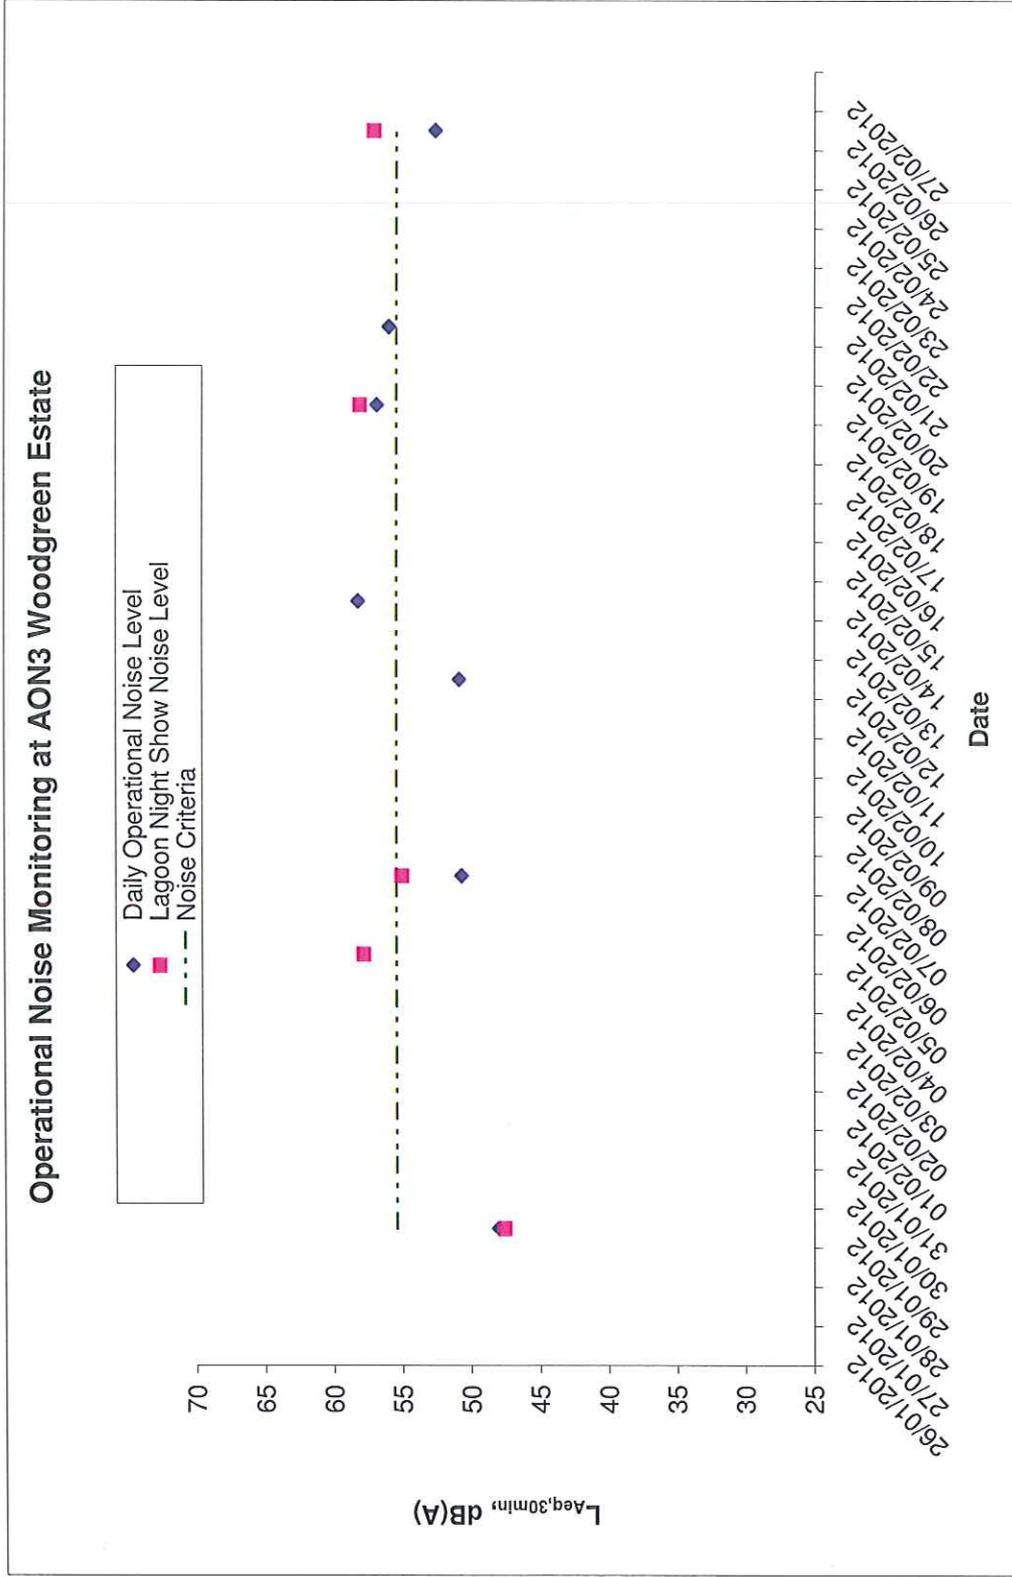
**Note:** The exceedances were due to the traffic noise from Shouson Hill Road.

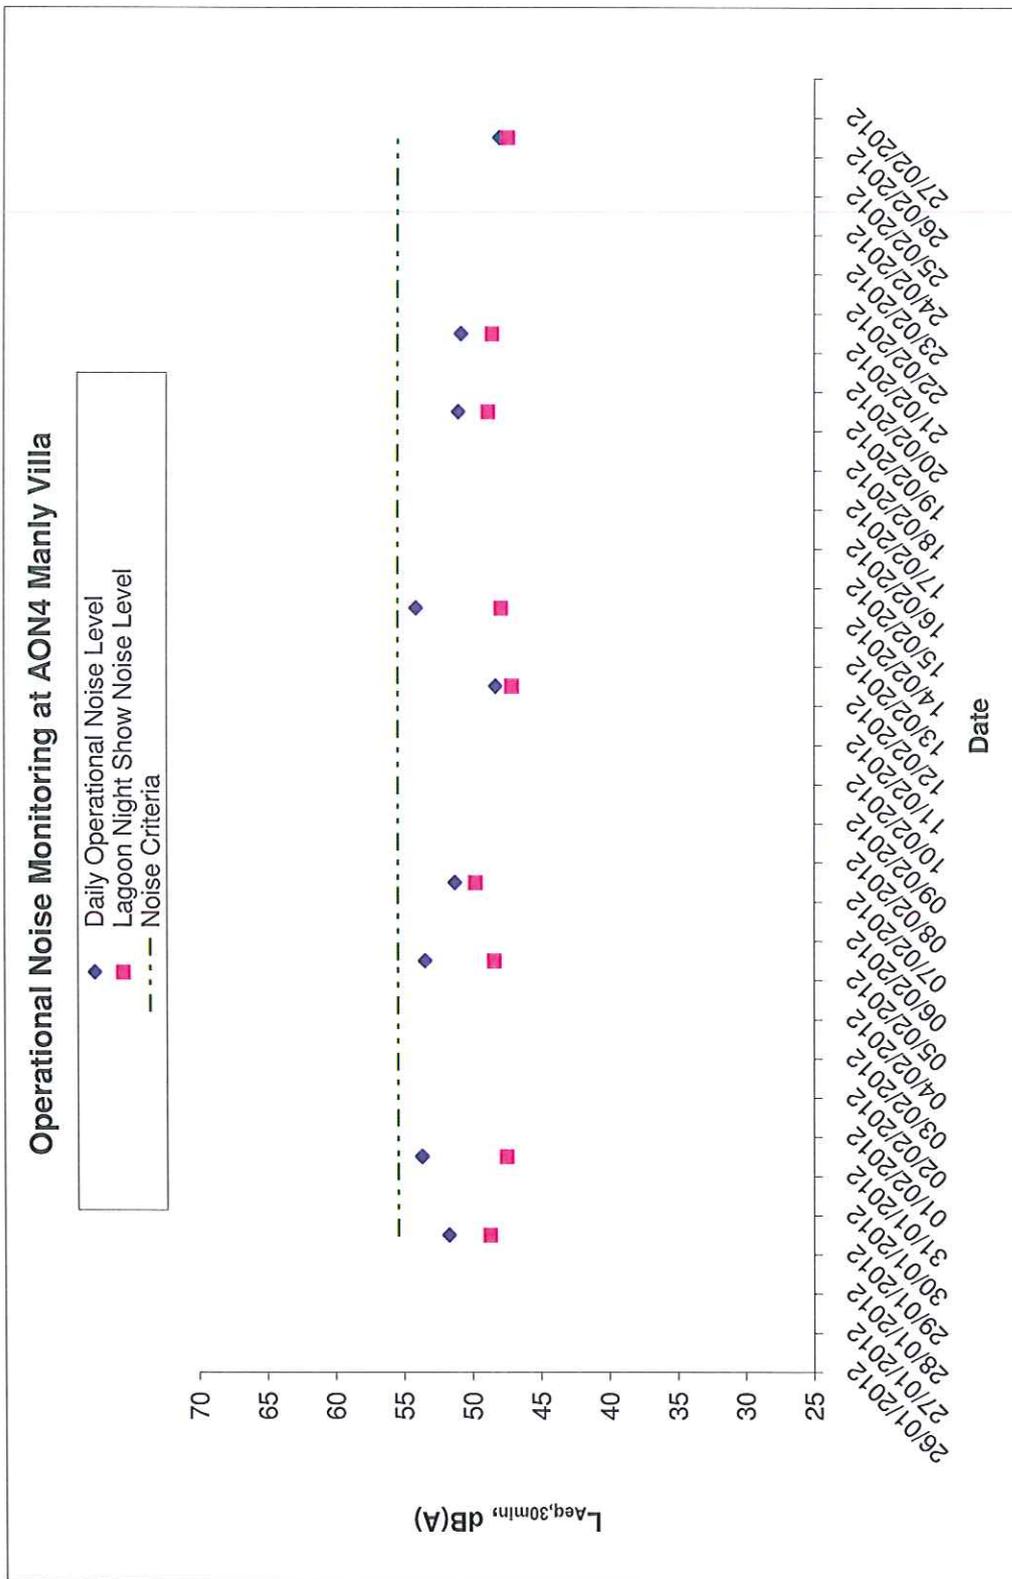
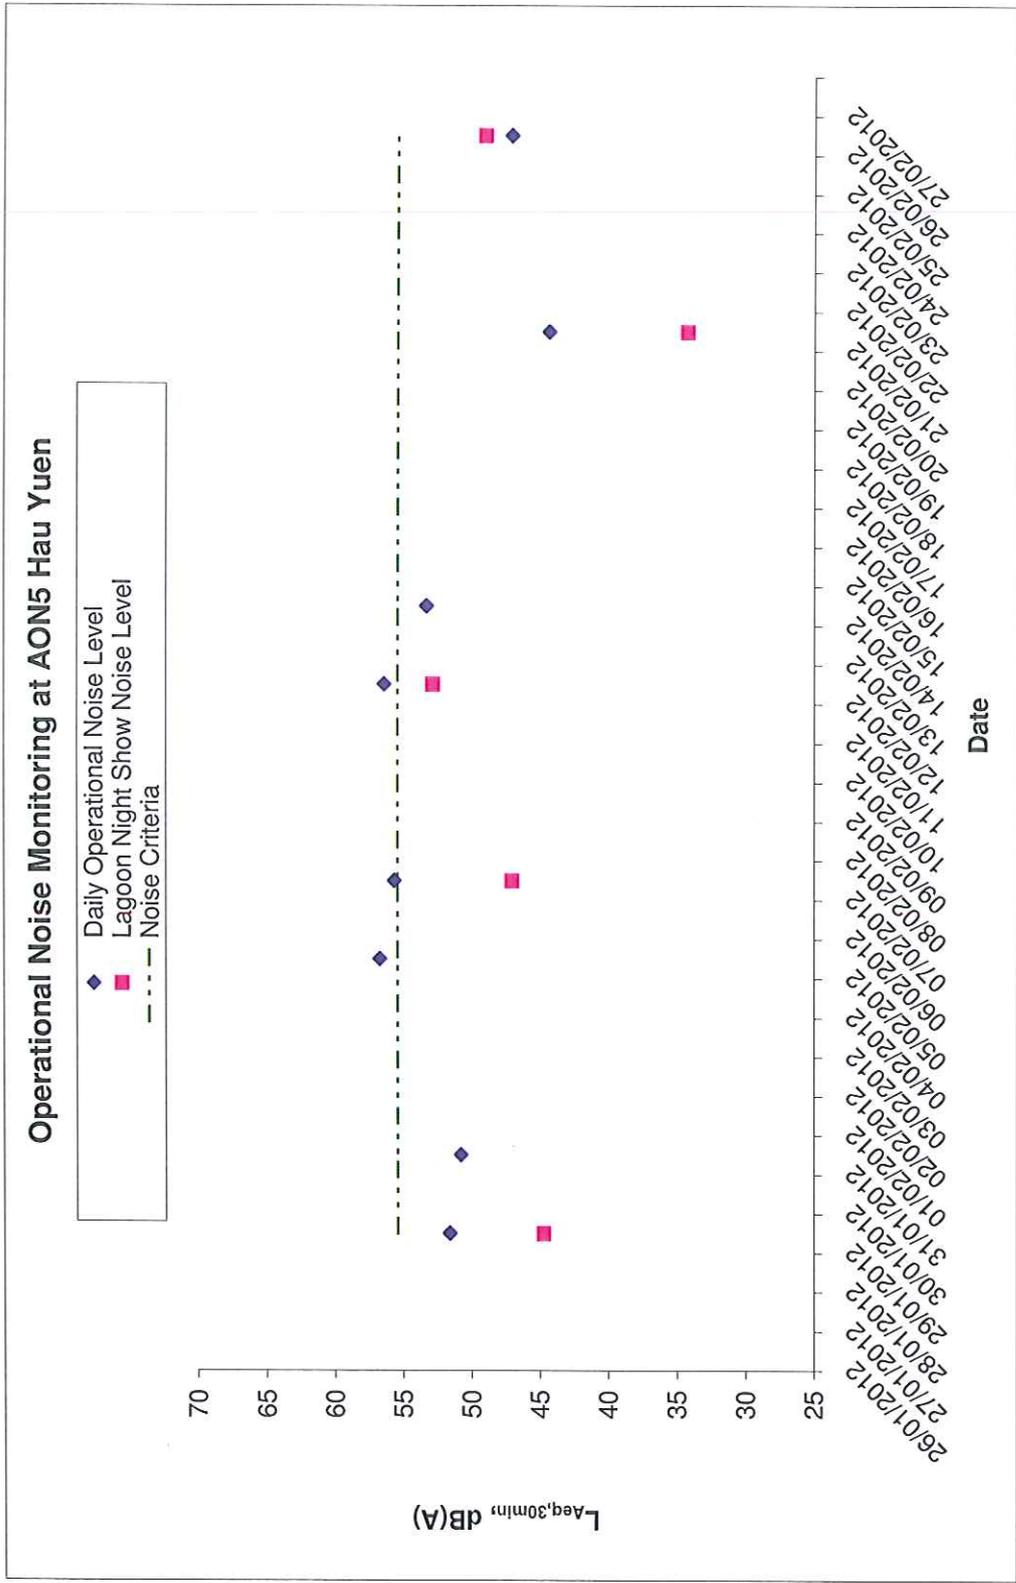
**Note:** The exceedances were due to the traffic noise from Shouson Hill Road.
